**SHA TIN NEW TOWN STAGE II
CONTRACT NO. ST 86/2000
CONSTRUCTION OF ROAD T7 IN MA ON SHAN
ENVIRONMENTAL MONITORING AND AUDIT
MONTHLY EM&A REPORT - SEPTEMBER 2003**

Report No.: 23156-34

MONTHLY EM&A REPORT - SEPTEMBER 2003

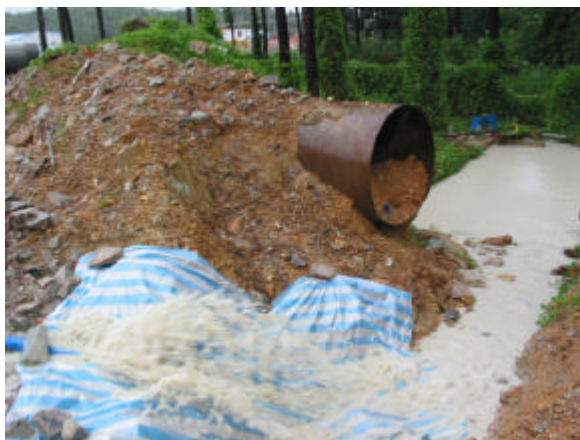
Figure 6-1 - Surface runoff near discharge point no. 8 after rainstorm

- Surface runoff with high suspended solid were observed at discharge point no. 3, 4, 6, 7, 8 and box culvert beside Wu Kai Sha Youth Village after rainstorm. The contractor reviewed the design of drainage system and increased slit cleaning frequency after rainstorm. Photos showing the muddy runoff are given in Figure 6-1 and Figure 6-2.

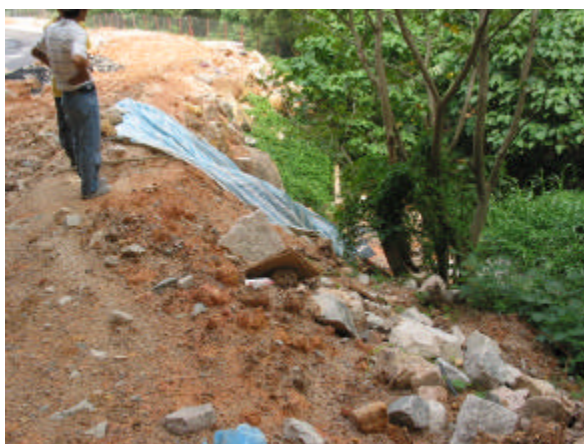
Figure 6-3 - The exposed slope near discharge point no. 6

- The slope near discharge point no. 3 and 6 were exposed. As instructed by ET, the Contractor agreed to cover or hydroseed the exposed slopes. Photos showing the exposed slope and hydroseeded slope are given in Figure 6-3 and Figure 6-4 respectively.

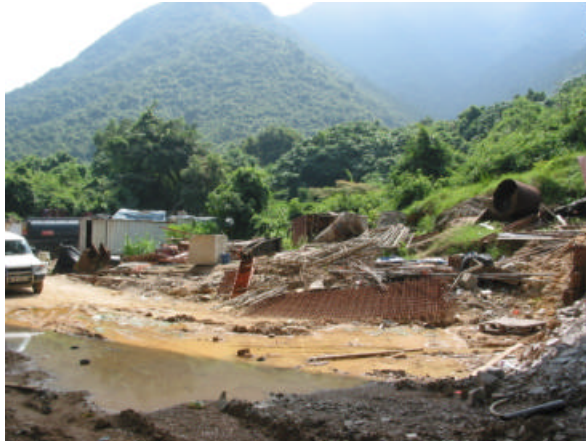
Figure 6-5 - The poor housekeeping in area Cap 3.

- Poor housekeeping and stagnant water was observed in area Cap 3. As instructed by the ET, housekeeping in area Cap 3 improved. Photo showing the area Cap C is given in Figure 6-5.
- Sandbags for flood prevention near discharge points were damaged. Photo showing the damaged sandbags is given in Figure 6-6.

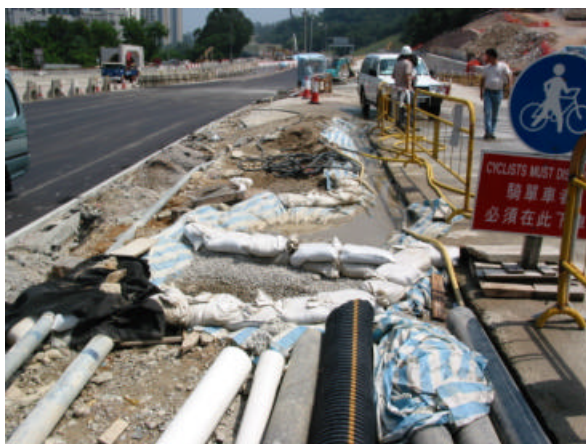
Figure 6-7 - Sand trap of the wheel washing bay in casting yard.

- Sand trap of the wheel washing bay in casting yard was ineffective. As instructed by the ET, contractor provided additional sandbags and geo-textile to achieve better water screening. Photos of the wheel washing basin are shown in Figure 6-7 and Figure 6-8.
