**SHA TIN NEW TOWN STAGE II  
CONTRACT NO. ST 86/2000  
CONSTRUCTION OF ROAD T7 IN MA ON SHAN  
ENVIRONMENTAL MONITORING AND AUDIT  
MONTHLY EM&A REPORT - NOVEMBER 2003**

Report No.: 23156-36

SHA TIN NEW TOWN STAGE II  
CONTRACT NO. ST 86/2000  
CONSTRUCTION OF ROAD T7 IN MA ON SHAN  
ENVIRONMENTAL MONITORING AND AUDIT

MONTHLY EM&A REPORT - OCTOBER 2003

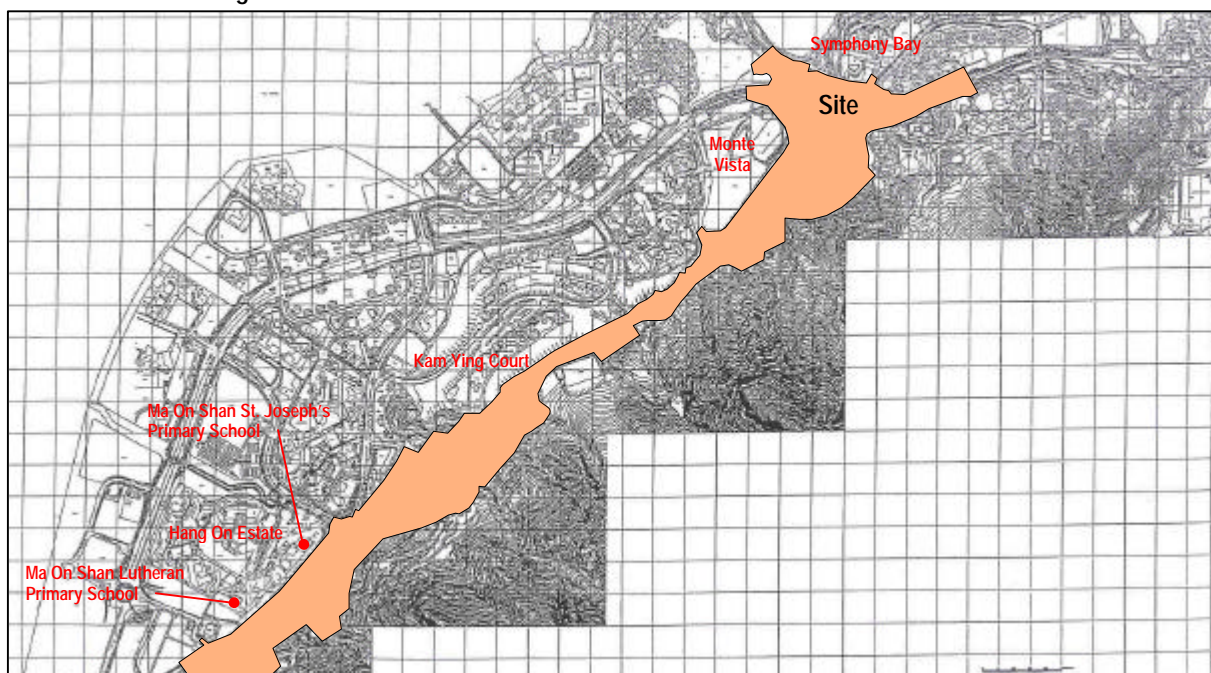
Figure 2-1 - Locations of construction site and environmental sensitive receivers.

Detailed locations of the environmental sensitive receivers are shown in Figure 2-1.

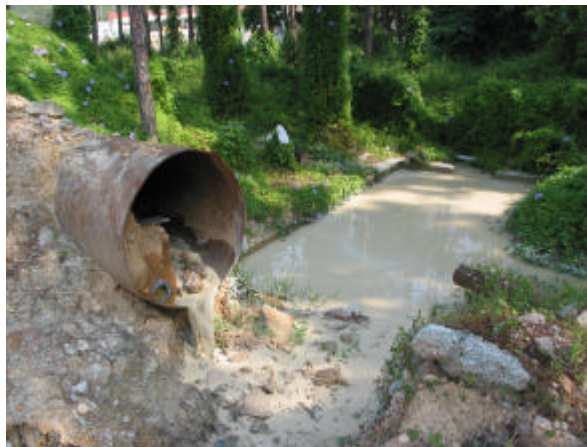
- Surface runoff with high suspended solid were observed and silt accumulated at discharge point no. 8. Photo showing the muddy runoff is given in Figure 6-1.

Figure 6-1 - Surface runoff near discharge point no. 8

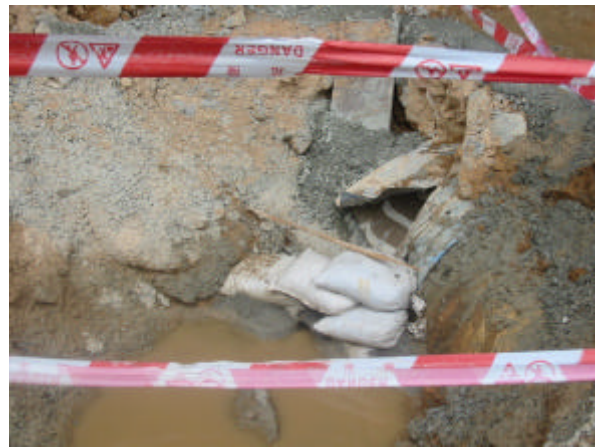
Figure 6-2 - Sand trap near discharge point no. 3

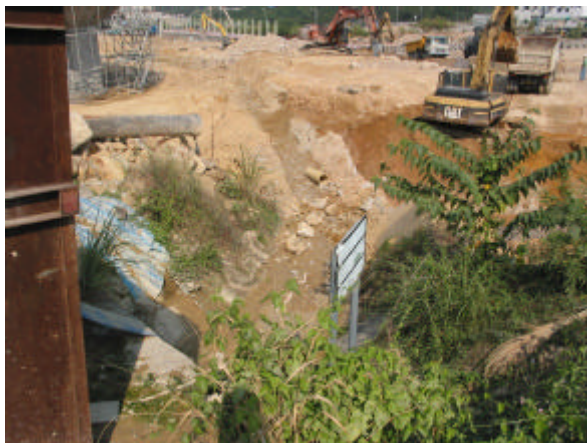
Figure 6-3 - Drainage channel S3 was not well maintained.

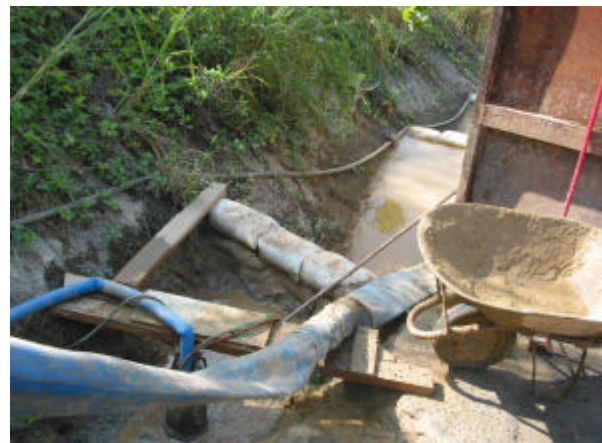
- Wheel washing bay in Road D22 Gate 7 was ineffective. Muddy water at sand trap did not have adequate settling and silt accumulated. Photo showing the improving work is given in Figure 6-4.

Figure 6-4 - Sand trap is now well maintained.

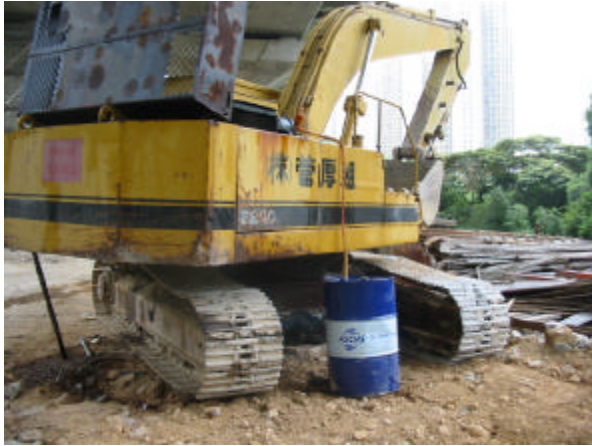
- Poor housekeeping was observed in area between Pier 4 and 5 under Bridge C. Chemicals, oil drums, empty containers and contaminated mud were scattered around this area. Photos showing the area are given in Figure 6-5 and Figure 6-6.

Figure 6-5 - Oil drums and contaminated mud.

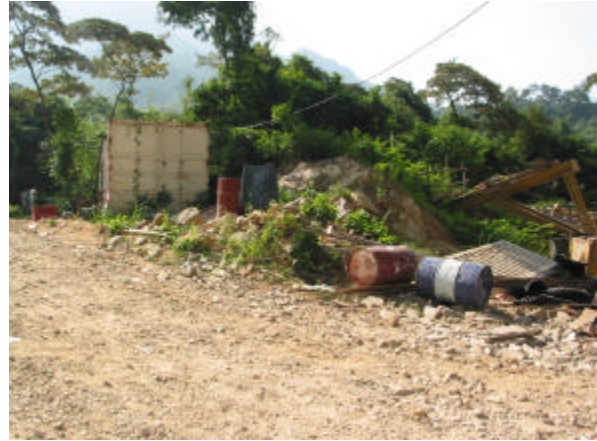
Figure 6-6 - Poor housekeeping under Bridge C.

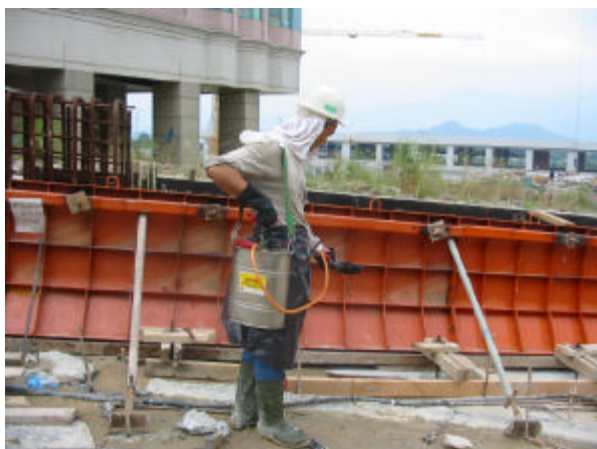
Figure 6-7 - Pest control was conducting.
