**SHA TIN NEW TOWN STAGE II  
CONTRACT NO. ST 86/2000  
CONSTRUCTION OF ROAD T7 IN MA ON SHAN  
ENVIRONMENTAL MONITORING AND AUDIT  
MONTHLY EM&A REPORT - NOVEMBER 2003**

Report No.: 23156-36

**MONTHLY EM&A REPORT - NOVEMBER 2003**

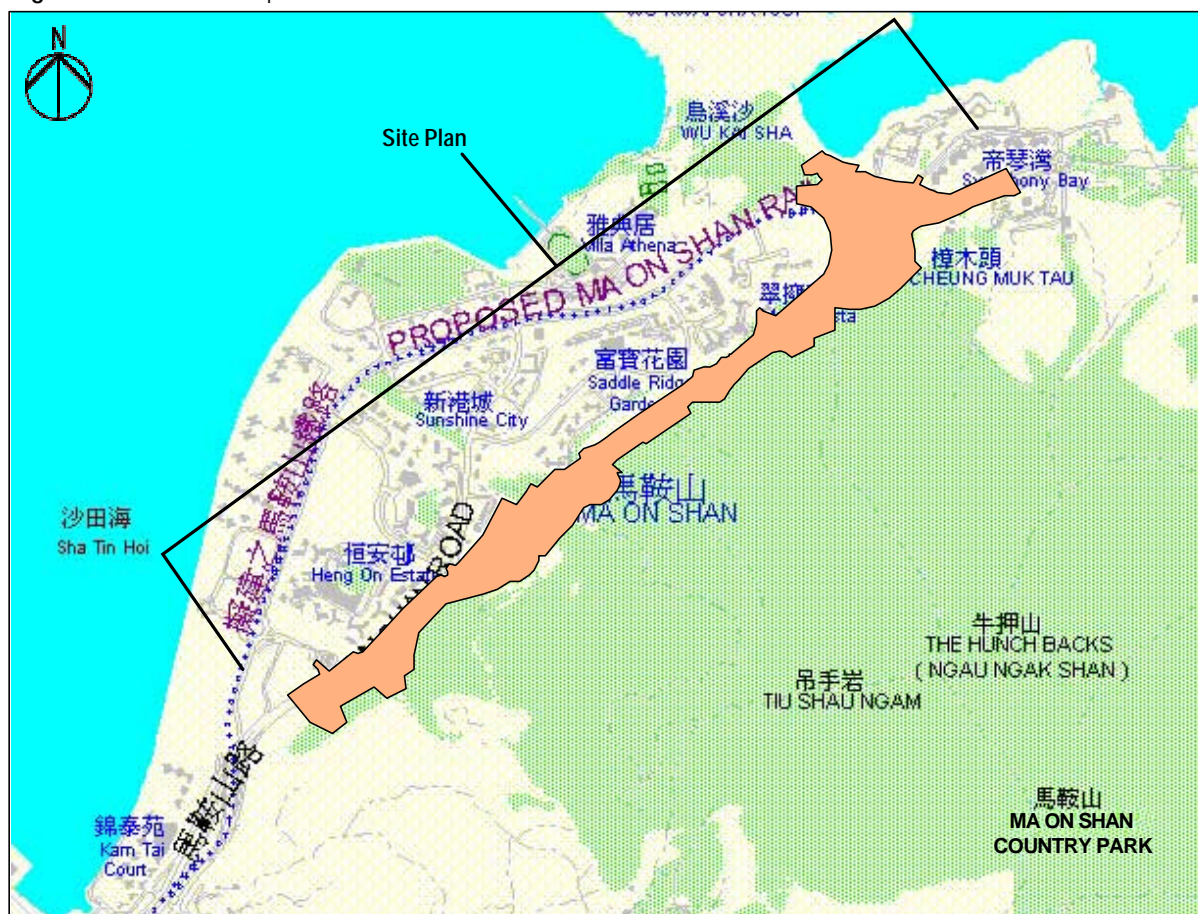
Figure 1-1 - Site location plan of construction of Road T7.

The site starts from the existing Ma On Shan Road (close to Heng On Estate), runs along the boundary of Ma On Shan Country Park, and terminates at Sai Sha Road (close to Symphony Bay). The site location plan is shown in Figure 1-1.

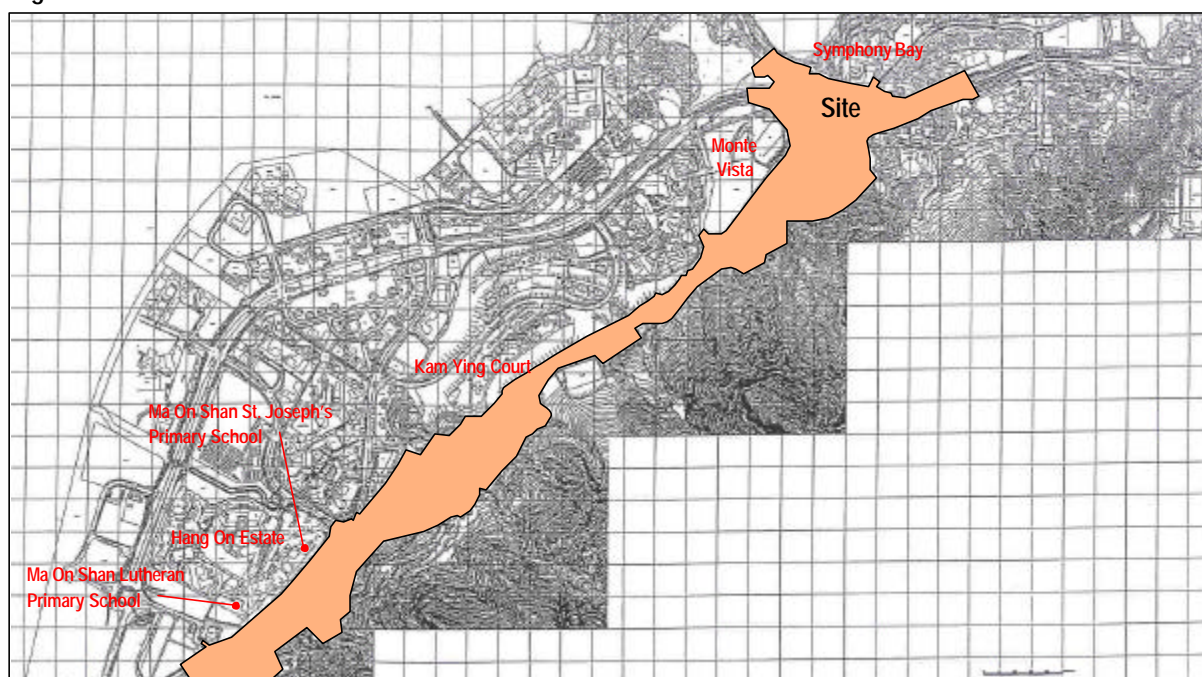
Figure 2-1 - Locations of construction site and environmental sensitive receivers.

Detailed locations of the environmental sensitive receivers are shown in Figure 2-1.

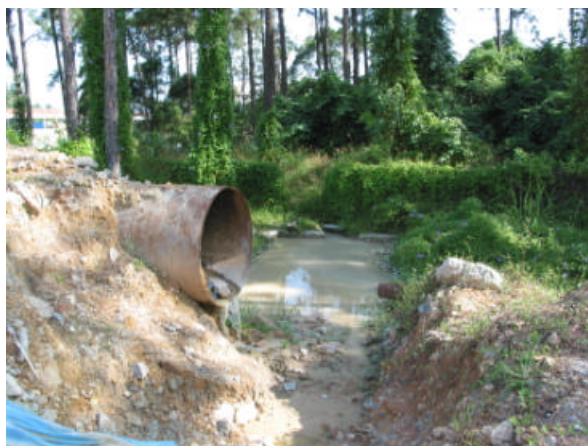
Figure 6-1 - Surface runoff near discharge point no. 8

- De-silting tank at Discharge Point 8 was full of silt.
- Silt was found at the temporary drainage channels at Discharge point 3 and 6.
- Wheel washing facility was not provided at Gate 34 and mud trails were found on the public road.
- Wastewater from wheel washing at Gate 25 had not been treated before discharge.
- Sand trap of wheel washing bay near discharge point no. 3 was full of silt.
- Muddy water was found on Leung Yau Road.
- Unpaved roads near Gate 34 and Area J21B were dry and considerable amount of dust had not been generated.
- Exposed slope at Area NB1 near Heng On Estate was not covered with tarpaulin sheet.

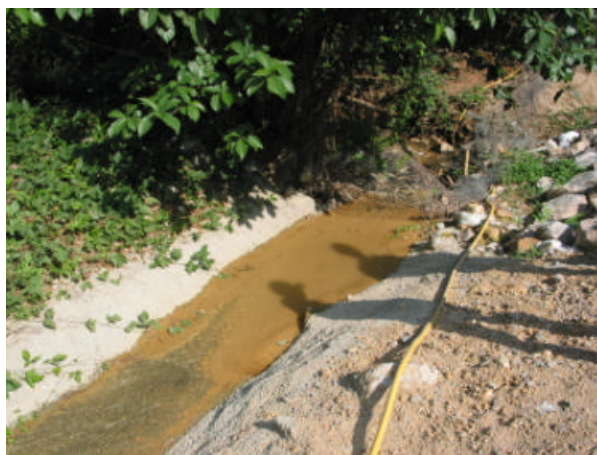
Figure 6-2 - Sand trap near discharge point no. 6

- Silt was found at the temporary drainage channels at Discharge point 3 and 6. Contractor had cleaned the channels after inspection. Photo showing the silty channel is given in Figure 6-2.

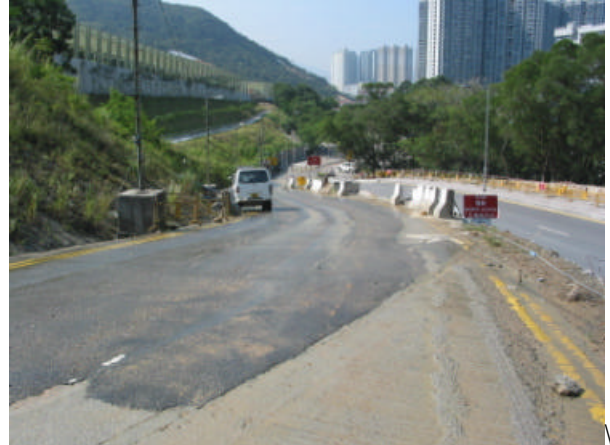
Figure 6-4 - Muddy water on Leung Yau Road.

- Muddy water was found on Leung Yau Road. Photo showing the muddy road is given in Figure 6-4.

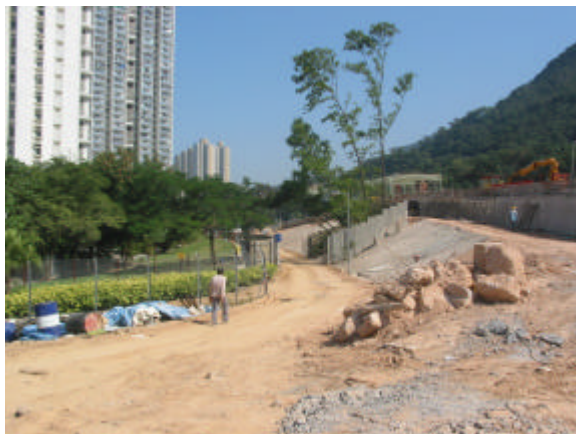
Figure 6-5 - Unpaved road at Area J21B.

- Unpaved roads near Gate 34 and Area J21B were dry and considerable amount of dust had been generated. Contractor had watered the roads near Gate 34 and installed water sprayer at Area J21B. Photo of Area J21B is given in Figure 6-5.
- Exposed slope at Area NB1 near Heng On Estate was not covered with tarpaulin sheet. Contractor had covered the slope with tarpaulin sheet after inspection.
- Water spraying was not operating during excavation under Bridge C. Water spraying was restored after inspection.

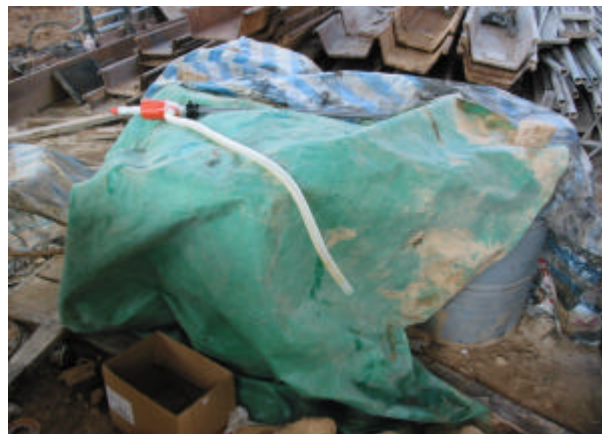
Figure 6-6 - Oil drums was not provided with drip trays.

- Poor housekeeping was observed in area between Pier 4 and 5 under Bridge C. Chemicals, oil drums, empty containers and contaminated mud were scattered around this area. Contractor removed contaminated mud and chemicals and oil drums were placed in drip trays. However, housekeeping still has to be improved. Photos showing the area are given in Figure 6-6.
