**SHA TIN NEW TOWN STAGE II
CONTRACT NO. ST 86/2000
CONSTRUCTION OF ROAD T7 IN MA ON SHAN
ENVIRONMENTAL MONITORING AND AUDIT
MONTHLY EM&A REPORT - JANUARY 2004**

Report No.: 23156-38

MONTHLY EM&A REPORT - JANUARY 2004

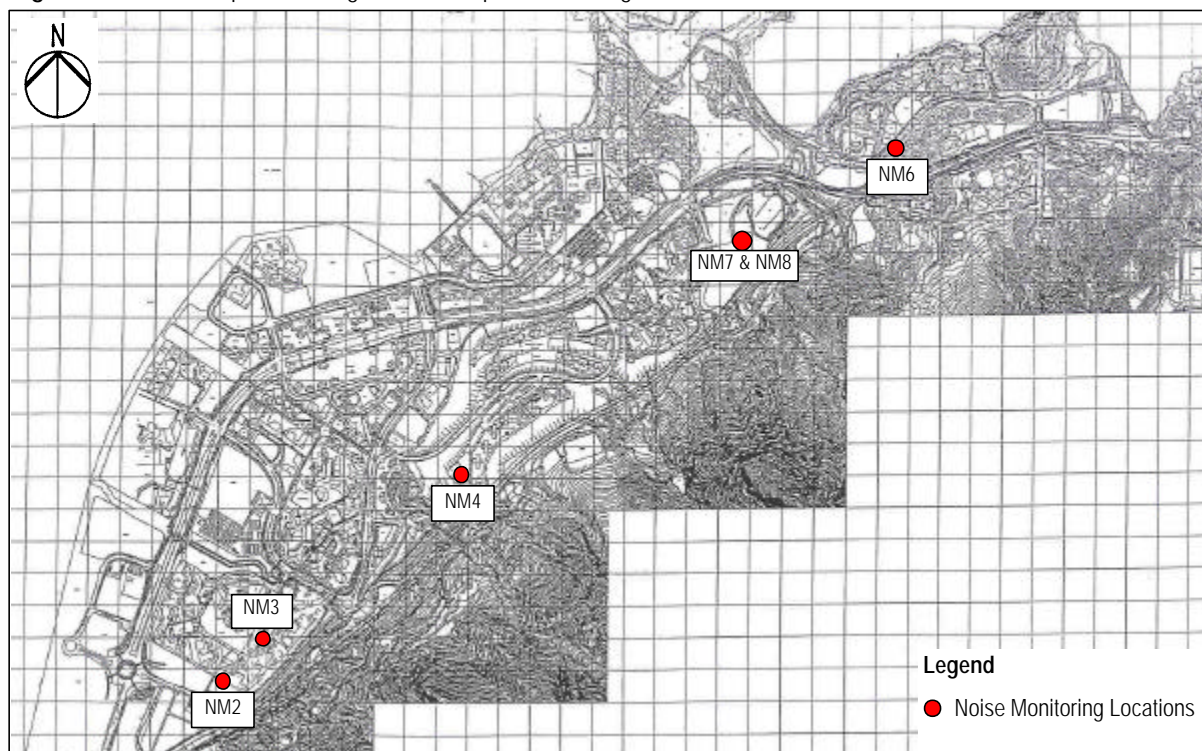
Figure 3-1 - Location plan showing the noise impact monitoring locations

A total of six monitoring locations were specified. They are given in Table 3-2 and shown in Figure 3-1. The measurements shall be taken away from any nearby reflective surface and at a position of 1.2m above ground. No façade correction is required.

NSR No.	Location	Monitoring Point
NM2	Ma On Shan Lutheran Primary School	Roof-top of the school
NM3	Heng Shan House, Heng On Estate	Podium floor of Heng Shan House
NM4	Kam Yiu House, Kam Ying Court	Roof-top of Kam Yiu House
NM6	Villa Concerto, Symphony Bay	Roof-top of Block 1
NM7	Monte Vista, Block 15	Podium floor of Block 15
NM8	Monte Vista, Block 15	Roof floor of Block 15

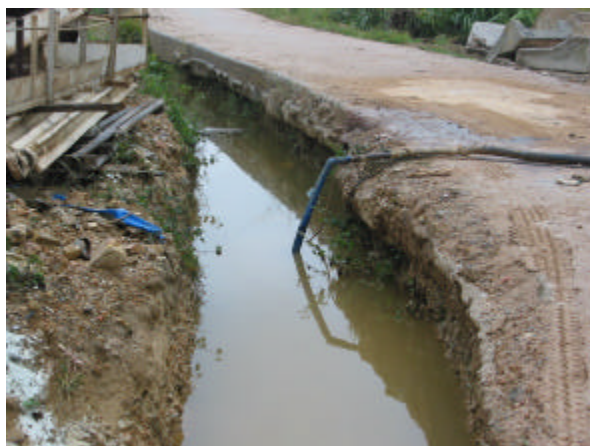
Figure 6-1 - Drainage channel S2A.

- De-silting tank of Discharge Point 8 were silty. Contractor had removed silt and provided sludge pit for wastewater treatment plant.
- Drainage channel S2A near Discharge Point 8 was blocked. Contractor increased pumping capacity to drain the effluent. Photo showing the channel is given in Figure 6-1.
- Existing channel near Discharge Point 5 was blocked by waste. Contractor removed wastes after site inspection.
- Wheel washing bay at Gate 10 was not appropriately designed that muddy water overflowed onto the street. Contractor had changed the design to prevent muddy water from flowing outside.
- Road gullies outside Gate 10 were not covered and sealed. Contractor used geotextile and de-silting pit to screen out the sediment before discharged.

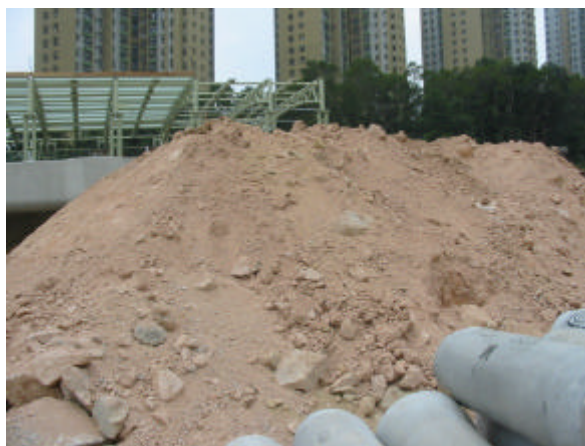
Figure 6-2 - Exposed slope near Discharge Point 3.

- Stockpile of sands near Discharge Point 3 had been exposed. Contractor had re-covered the slope with tarpaulin sheet. Photo showing the exposed slope is given in Figure 6-2.
- Mud trails were found outside Gate 25 and Gate 34. Contractor had cleaned the road surface after inspection.
- Haul roads in Casting Yard was dry and dusty. Contractor had watered the haul roads after inspection.
