Report No.: 0041/17/ED/0528A

## Quarterly EM&A Report November 2019 - January 2020

Project : Contract No. CM 14/2016  
Environmental Team for Operational  
Environmental Monitoring and Audit for Siu  
Ho Wan Sewage Treatment Works

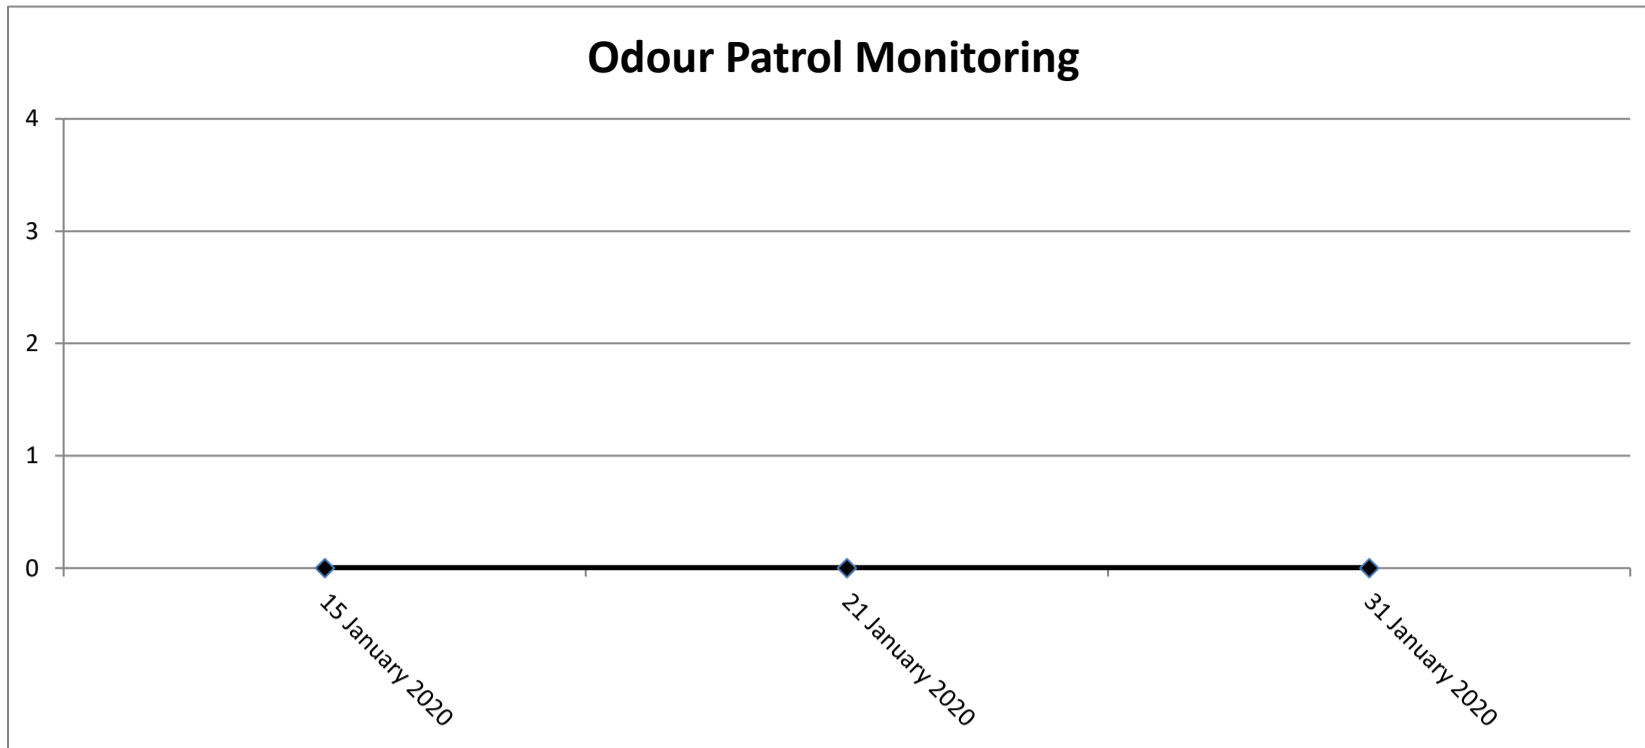
Note:  
Y-axis refers to the Odour Level: 0 - Not Detected; 1- Slight; 2 - Moderate; 3 - Strong; 4 - Extreme

Odour patrol monitoring was resumed and carried out on January 2020. Action level was triggered as one odour complaint was received during the reporting period.

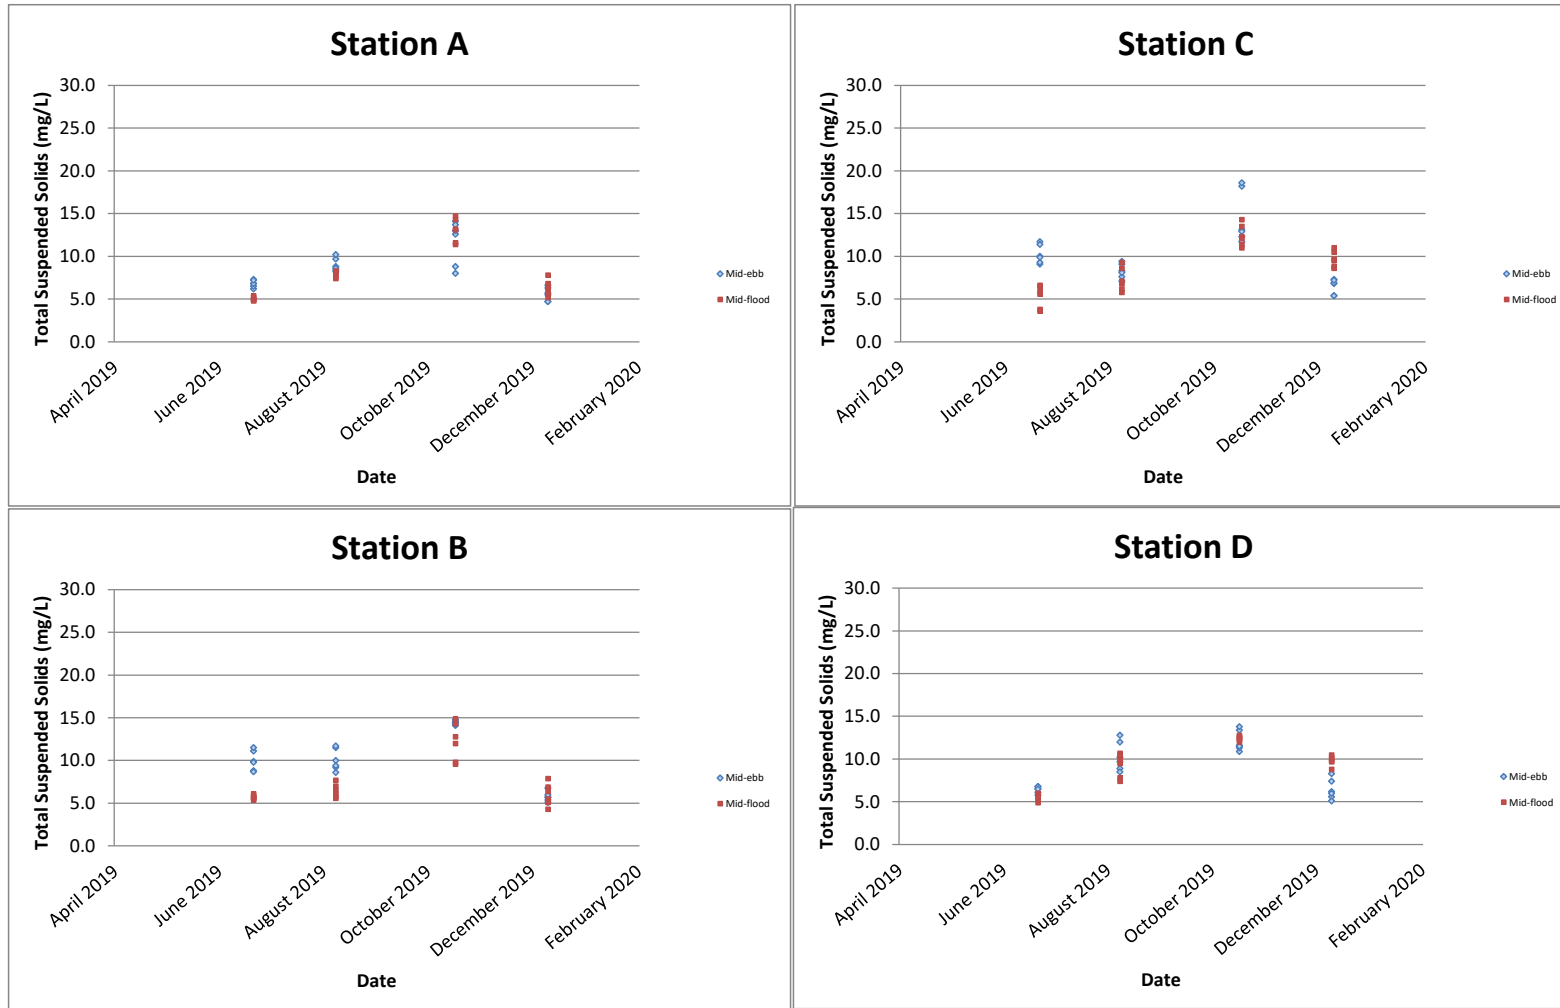
Total Suspended Solids (mg/L)

Remark: All below the Limit of Report sample results (<0.5 mg/L) for Total Suspended Solids is regarded as 0.5 mg/L in graphical presentation.

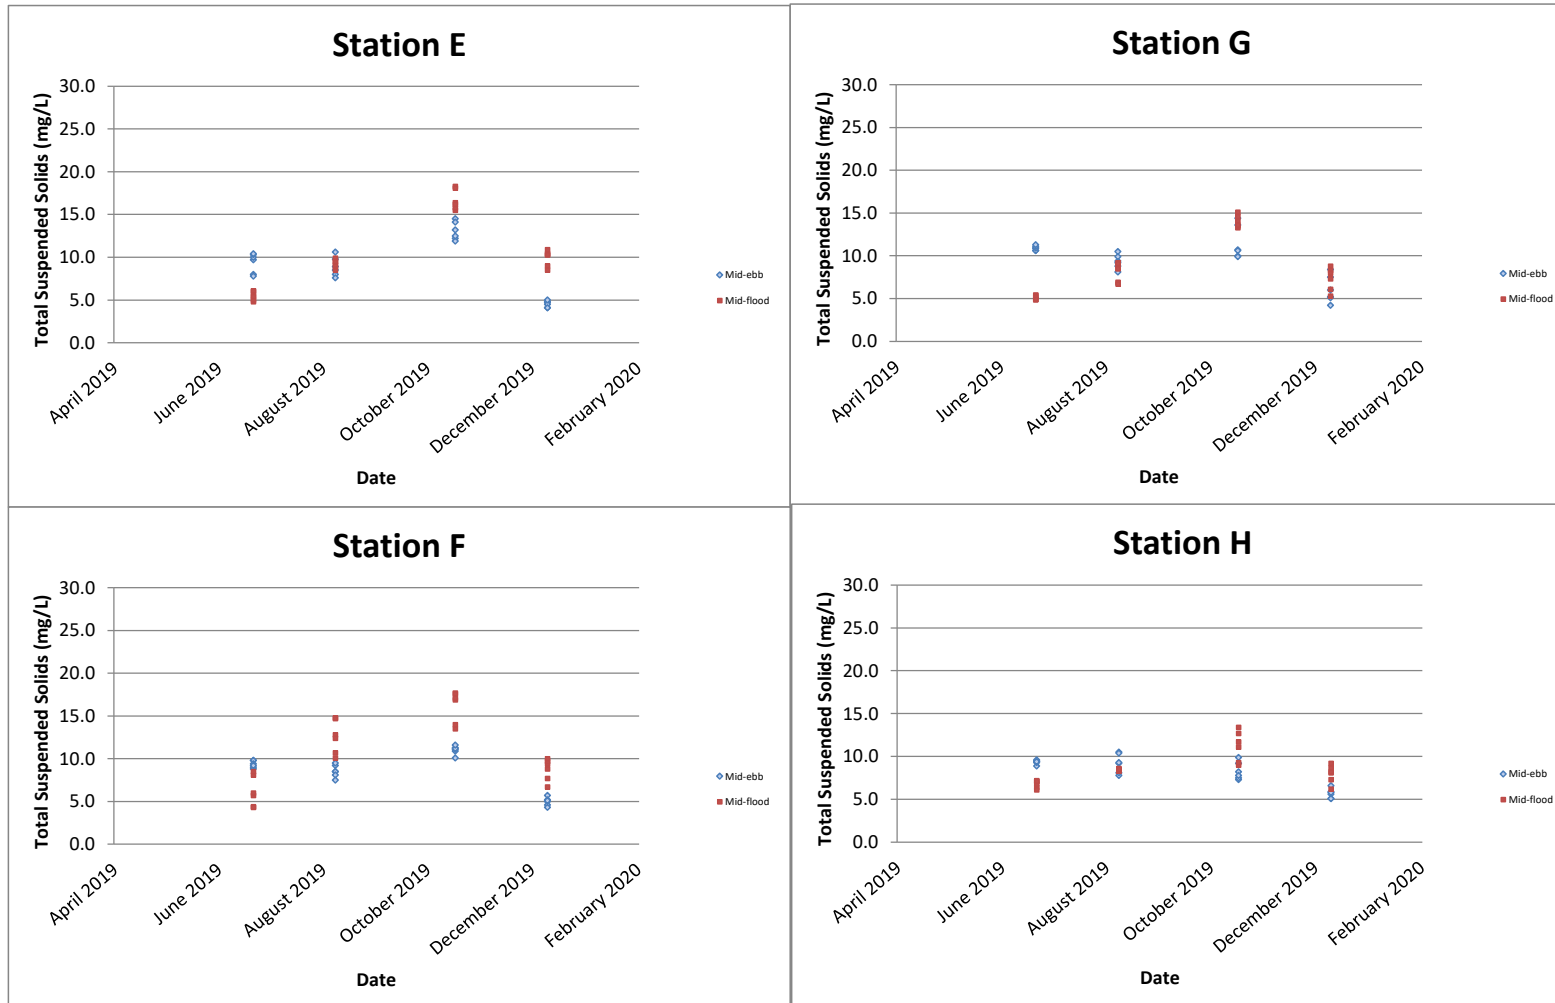
Total Suspended Solids (mg/L)

Remark: All below the Limit of Report sample results (<0.5 mg/L) for Total Suspended Solids is regarded as 0.5 mg/L in graphical presentation.

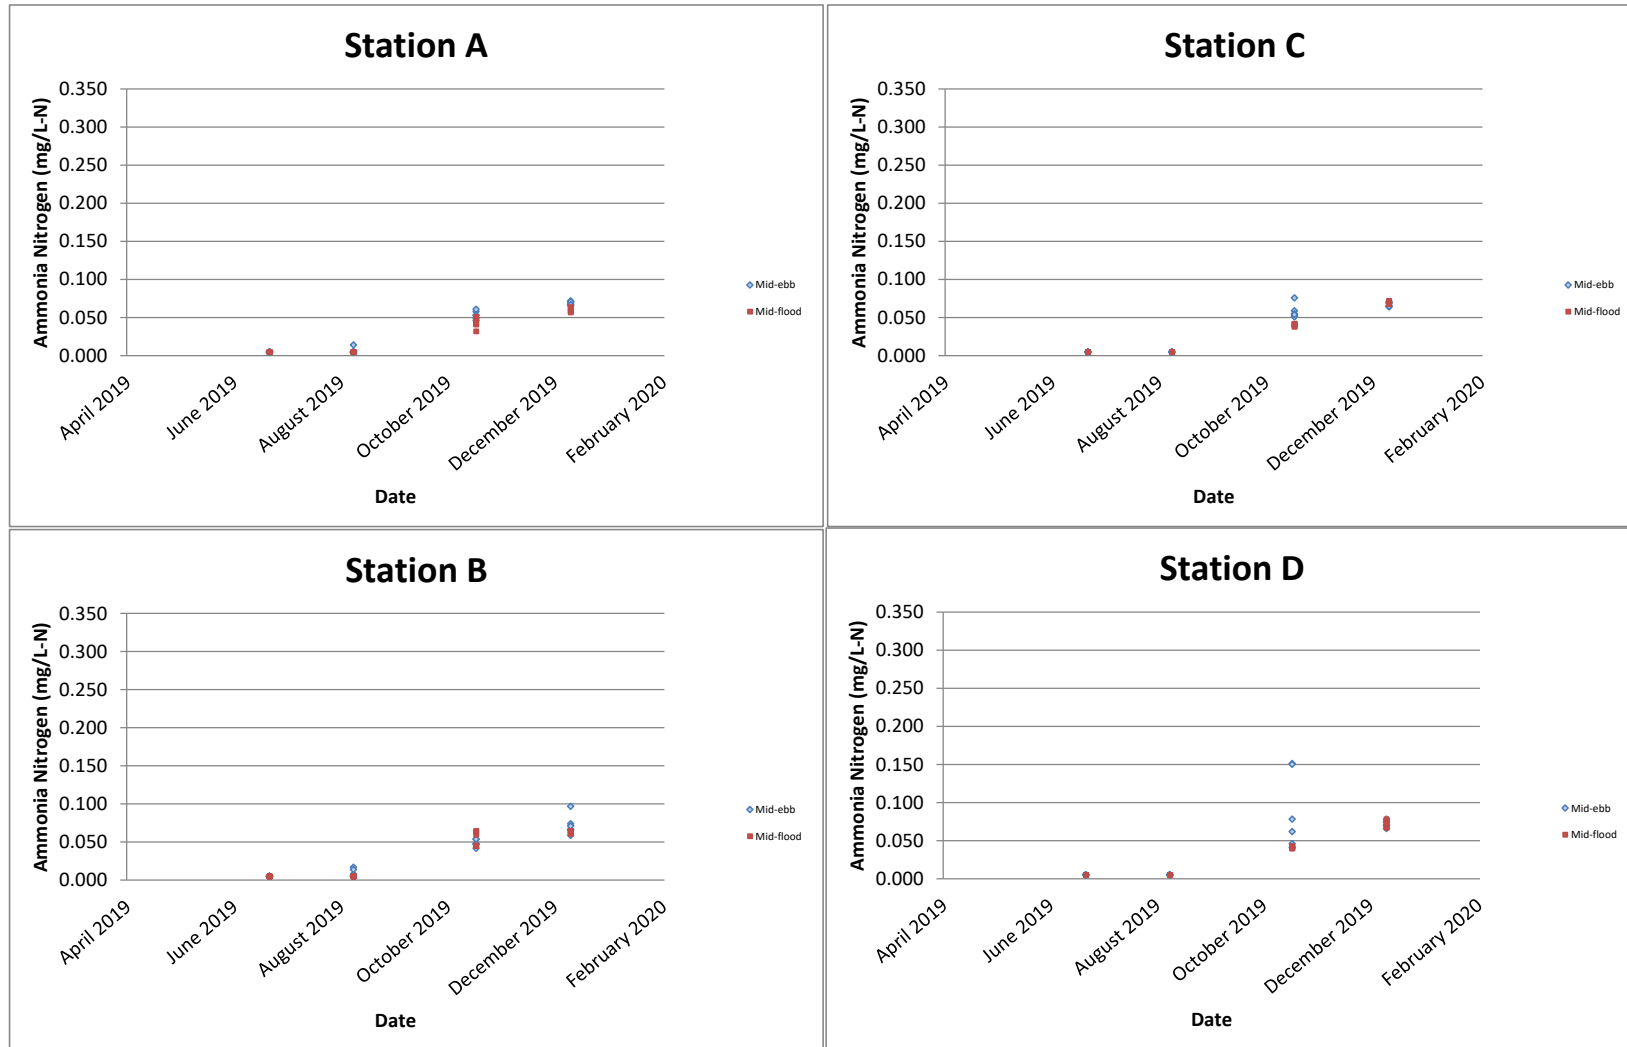
Ammonia Nitrogen (mg/L-N)

Remark: All below the Limit of Report sample results (<0.005 mg/L) for Ammonia Nitrogen is regarded as 0.005 mg/L in graphical presentation.

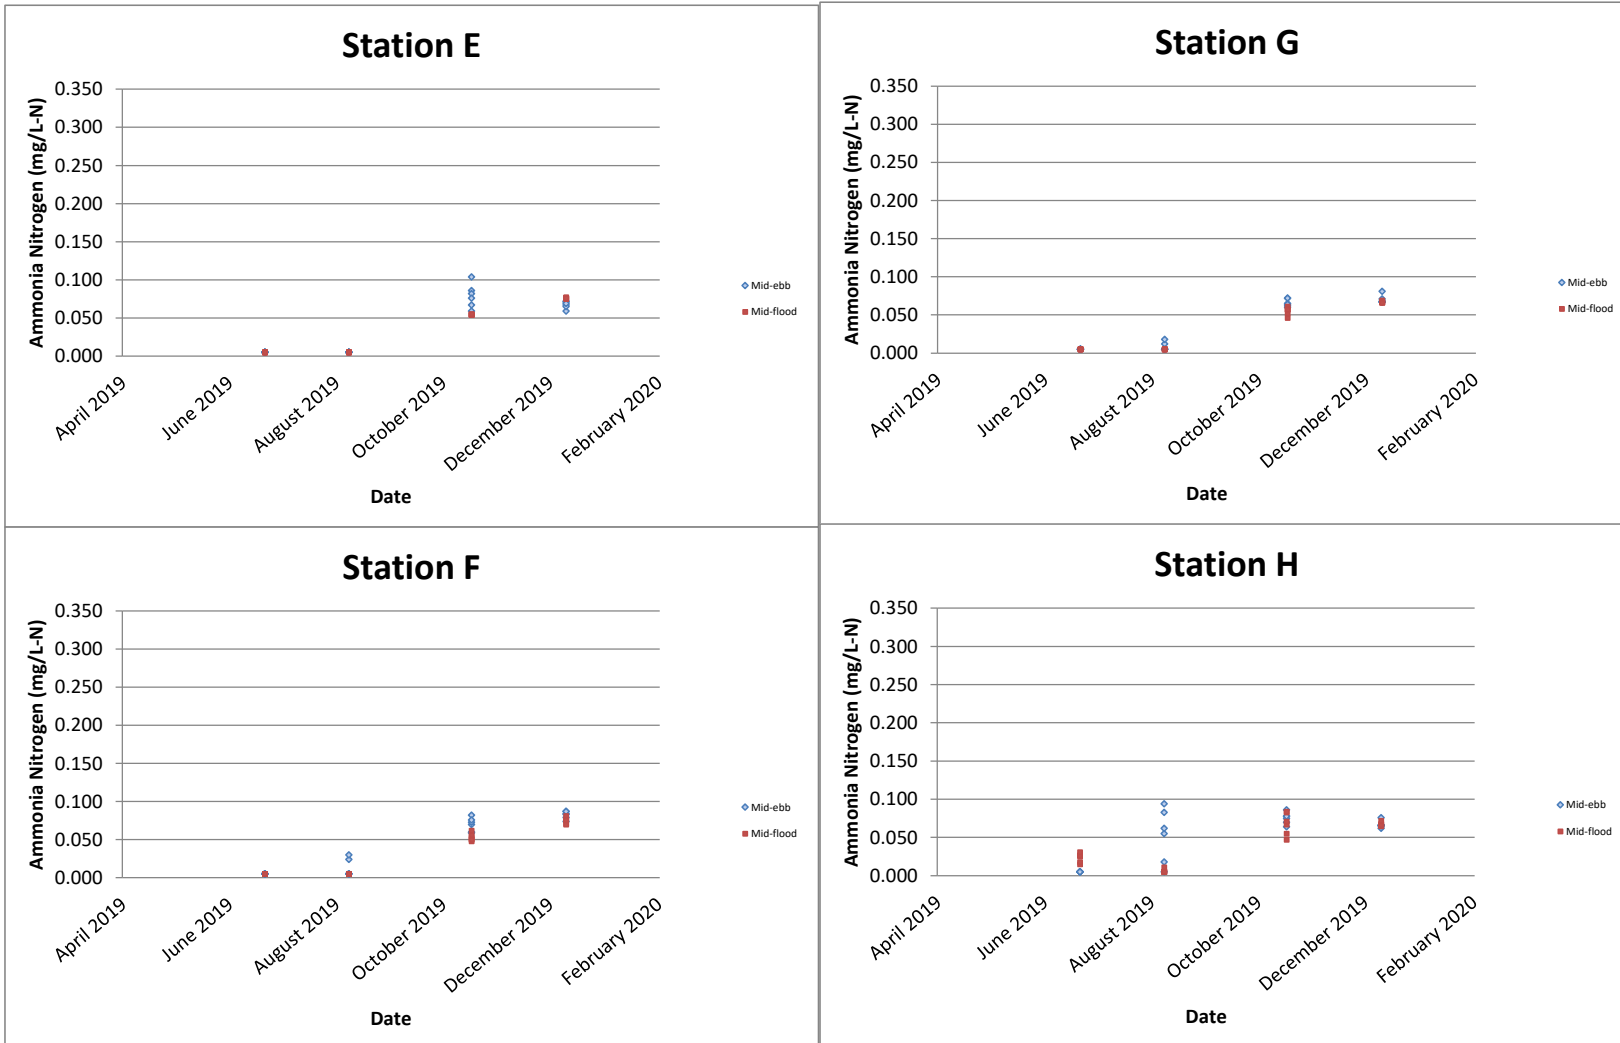
Ammonia Nitrogen (mg/L-N)

Remark: All below the Limit of Report sample results (<0.005 mg/L) for Ammonia Nitrogen is regarded as 0.005 mg/L in graphical presentation.

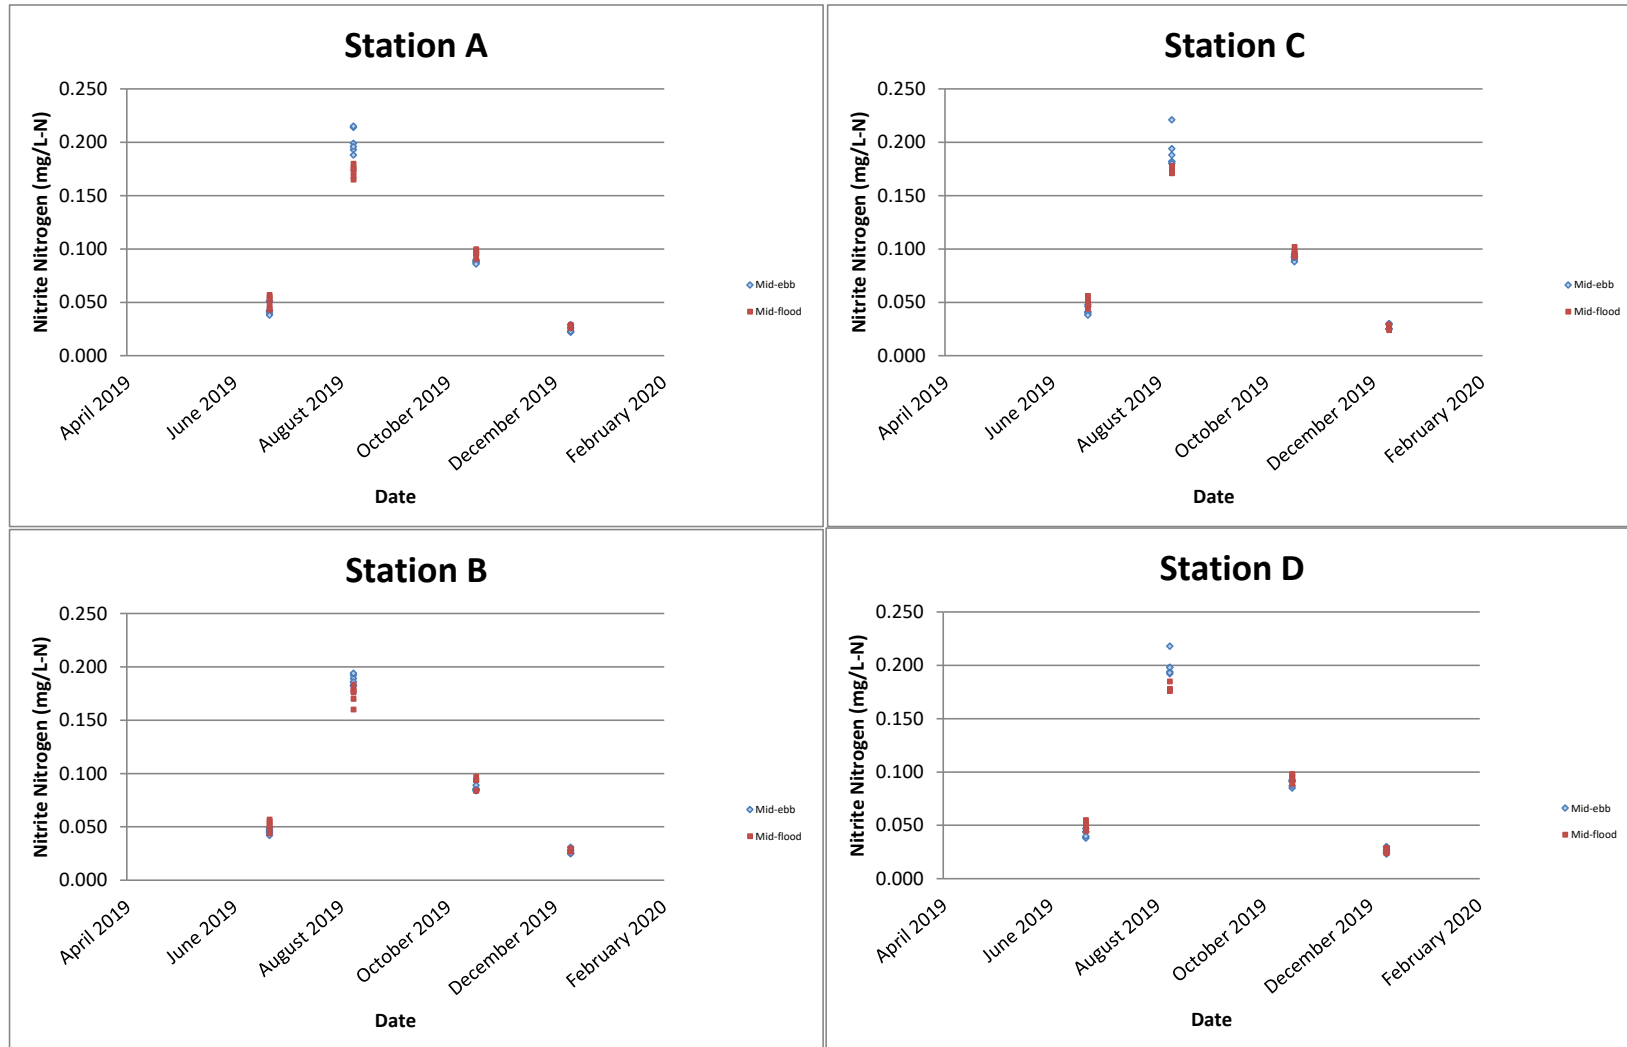
Nitrite Nitrogen (mg/L-N)

Remark: All below the Limit of Report sample results (<0.005 mg/L) for Nitrite Nitrogen is regarded as 0.005 mg/L in graphical presentation.

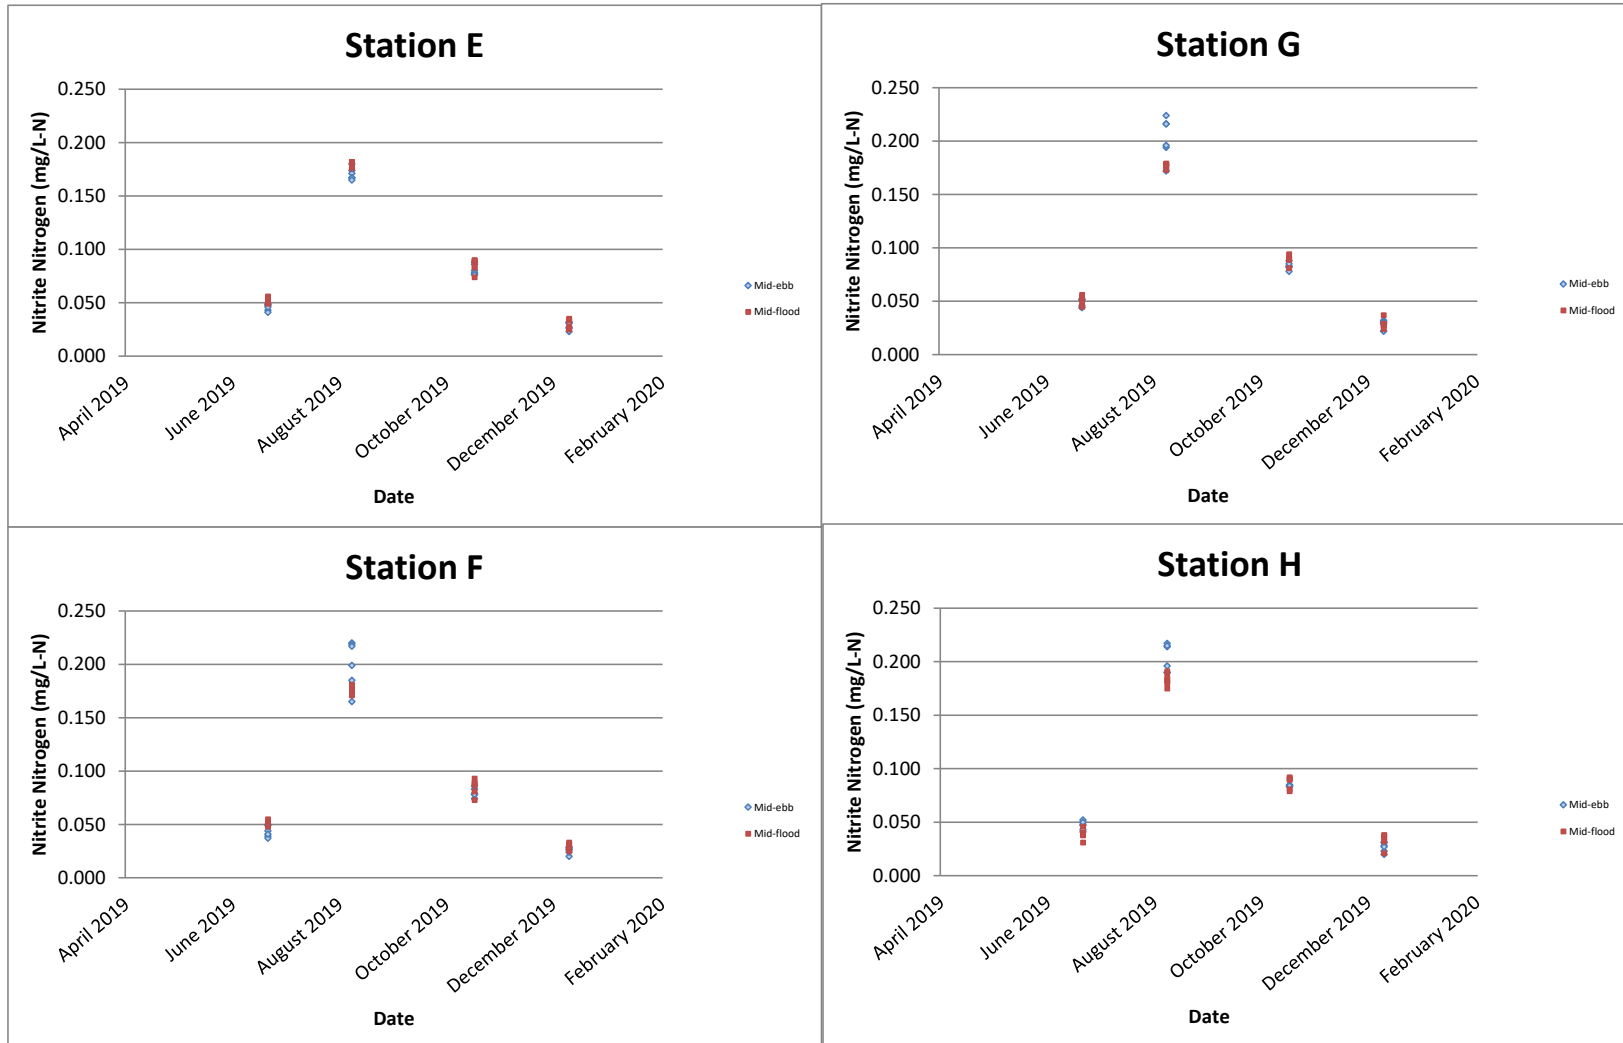
Nitrite Nitrogen (mg/L-N)

Remark: All below the Limit of Report sample results (<0.005 mg/L) for Nitrite Nitrogen is regarded as 0.005 mg/L in graphical presentation.

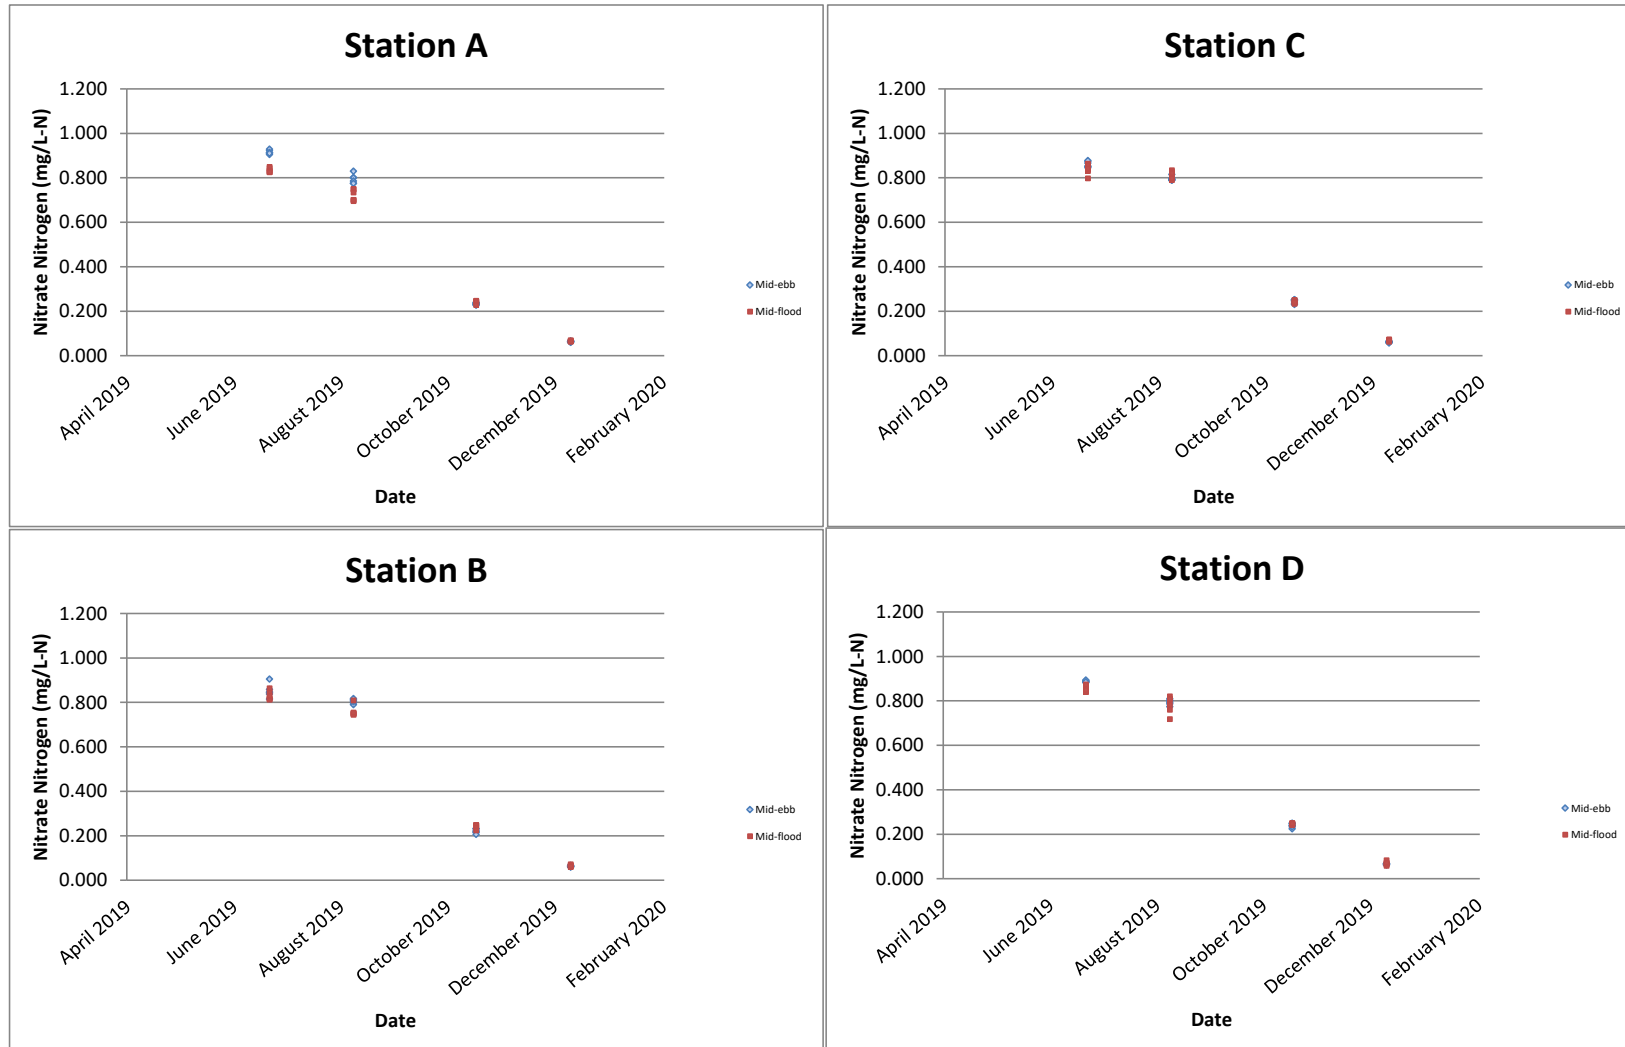
Nitrate Nitrogen (mg/L-N)

Remark: All below the Limit of Report sample results (<0.005 mg/L) for Nitrate Nitrogen is regarded as 0.005 mg/L in graphical presentation.

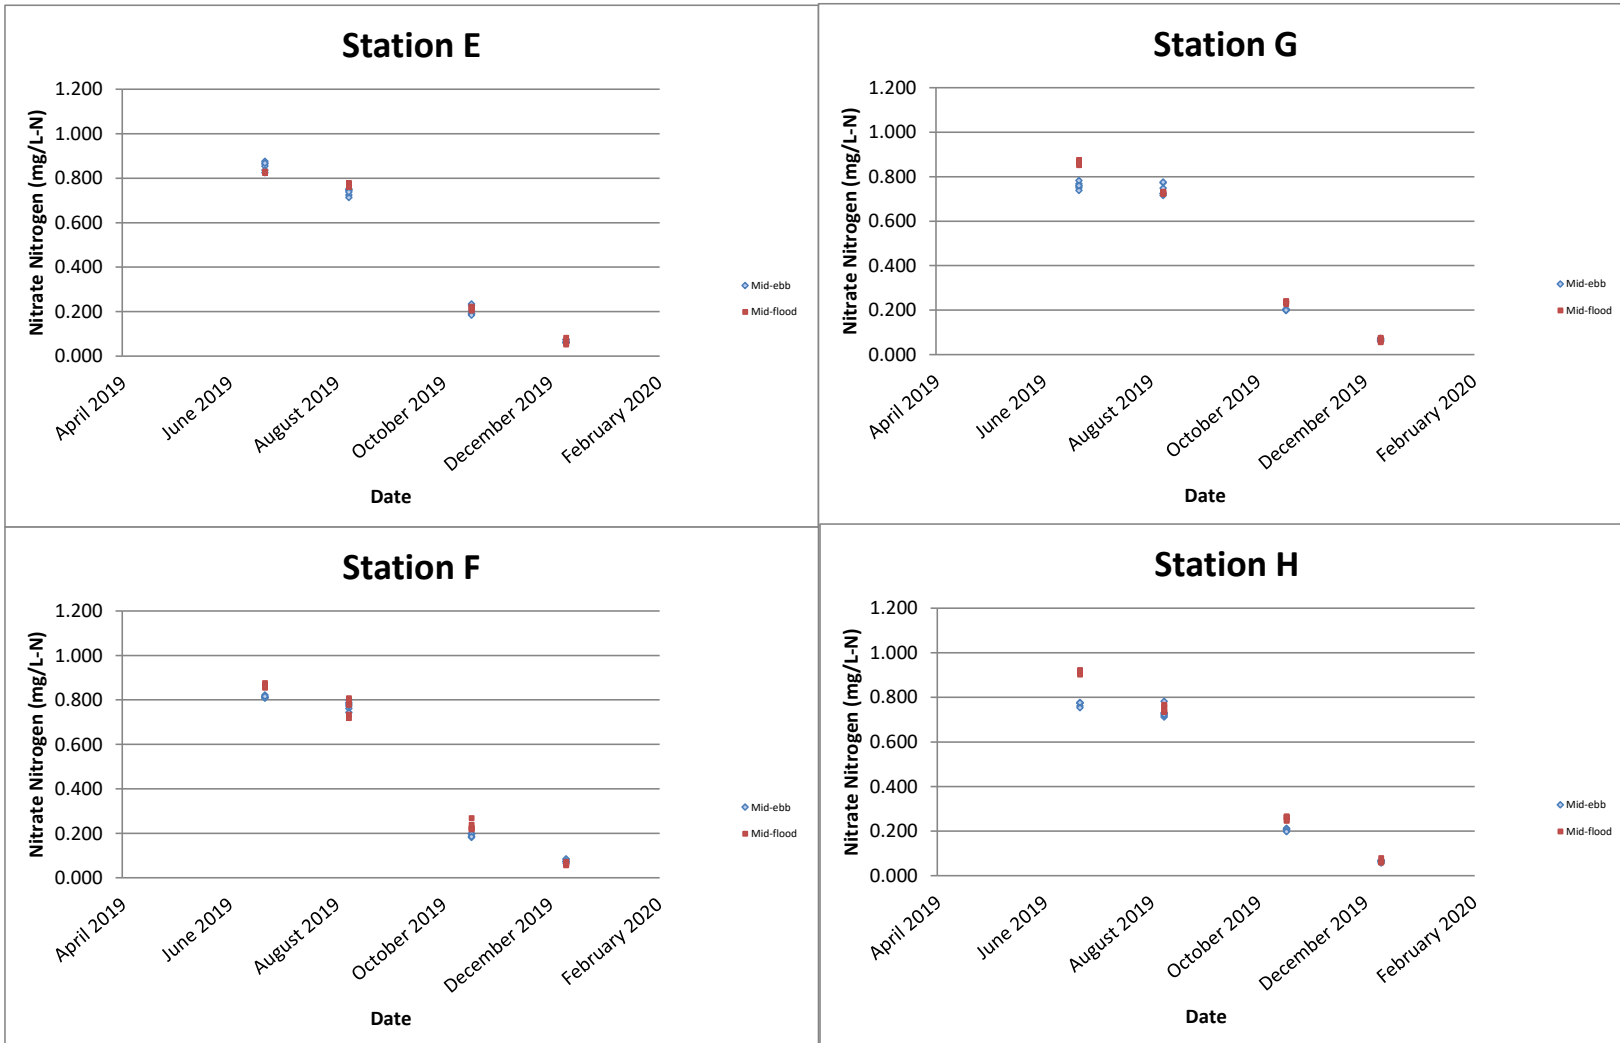
Nitrate Nitrogen (mg/L-N)

Remark: All below the Limit of Report sample results (<0.005 mg/L) for Nitrate Nitrogen is regarded as 0.005 mg/L in graphical presentation.

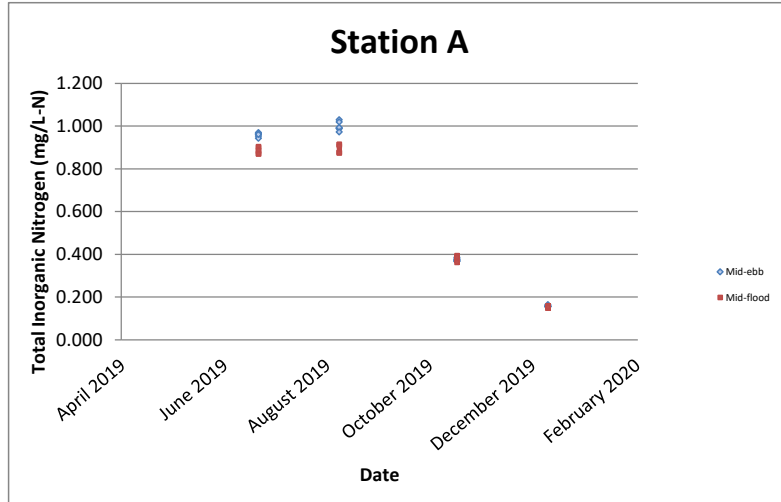
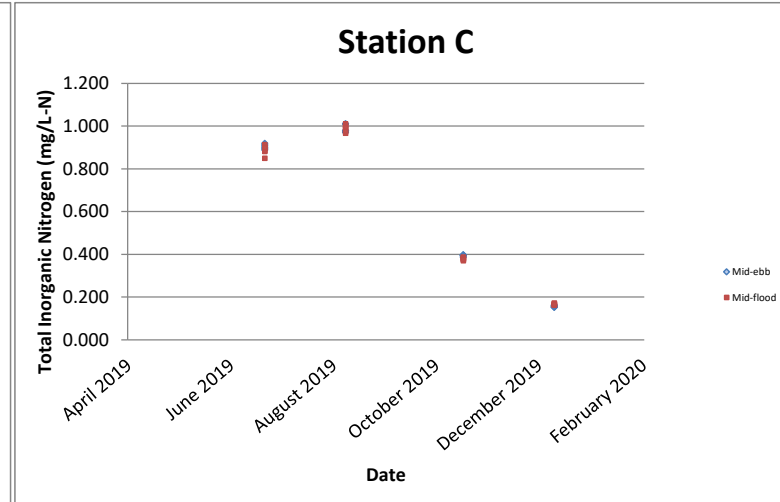
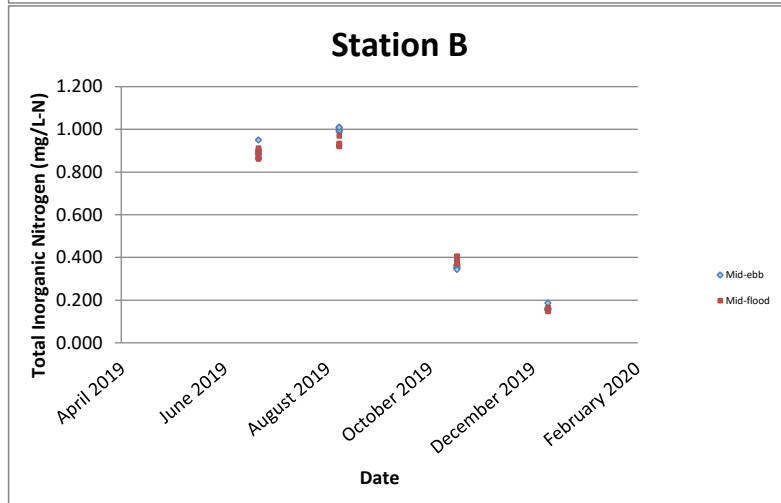
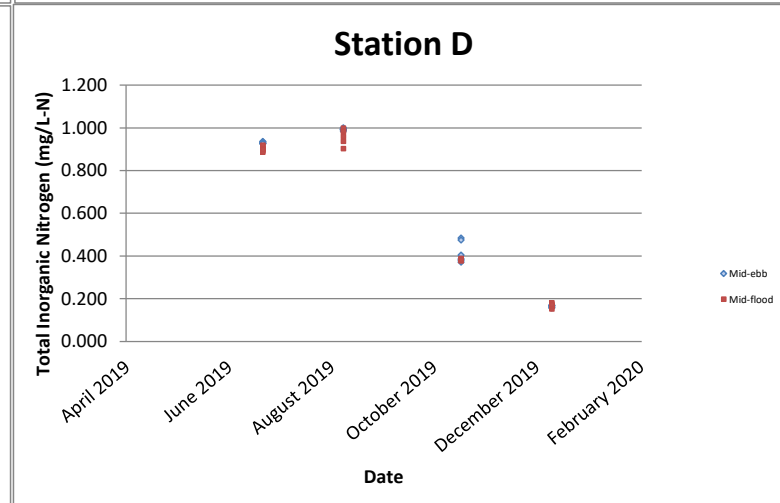
Total Inorganic Nitrogen (mg/L-N)

Remark: All below the Limit of Report sample results (<0.010 mg/L) for Total Inorganic Nitrogen is regarded as 0.010 mg/L in graphical presentation.

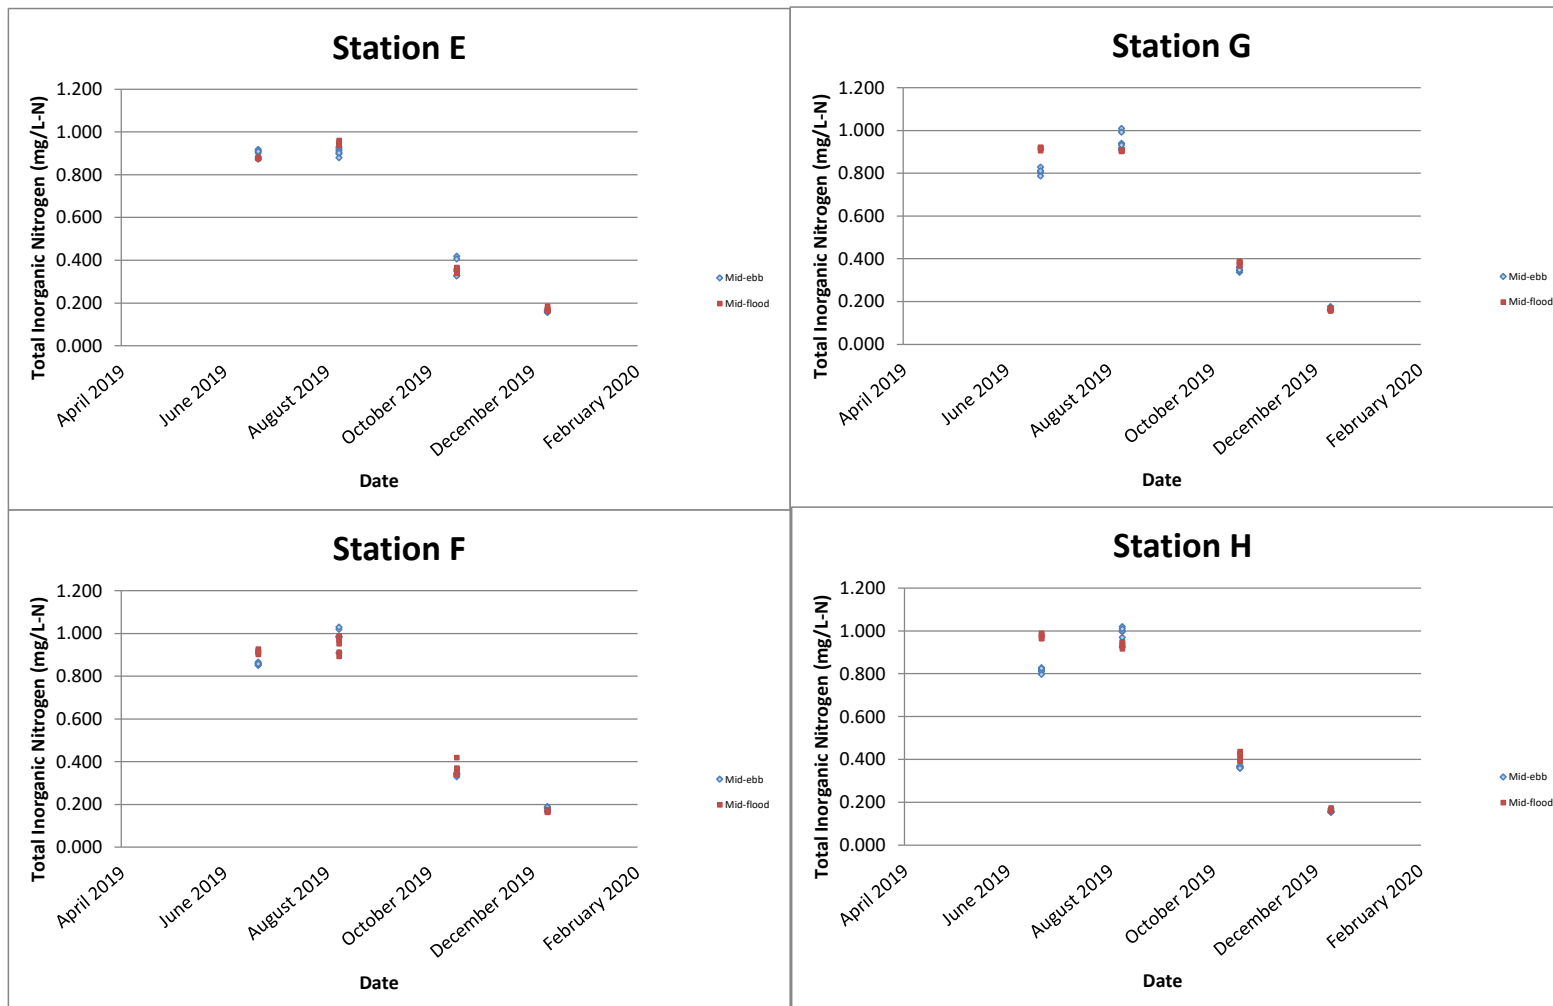
Total Inorganic Nitrogen (mg/L-N)

Remark: All below the Limit of Report sample results (<0.010 mg/L) for Total Inorganic Nitrogen is regarded as 0.010 mg/L in graphical presentation.

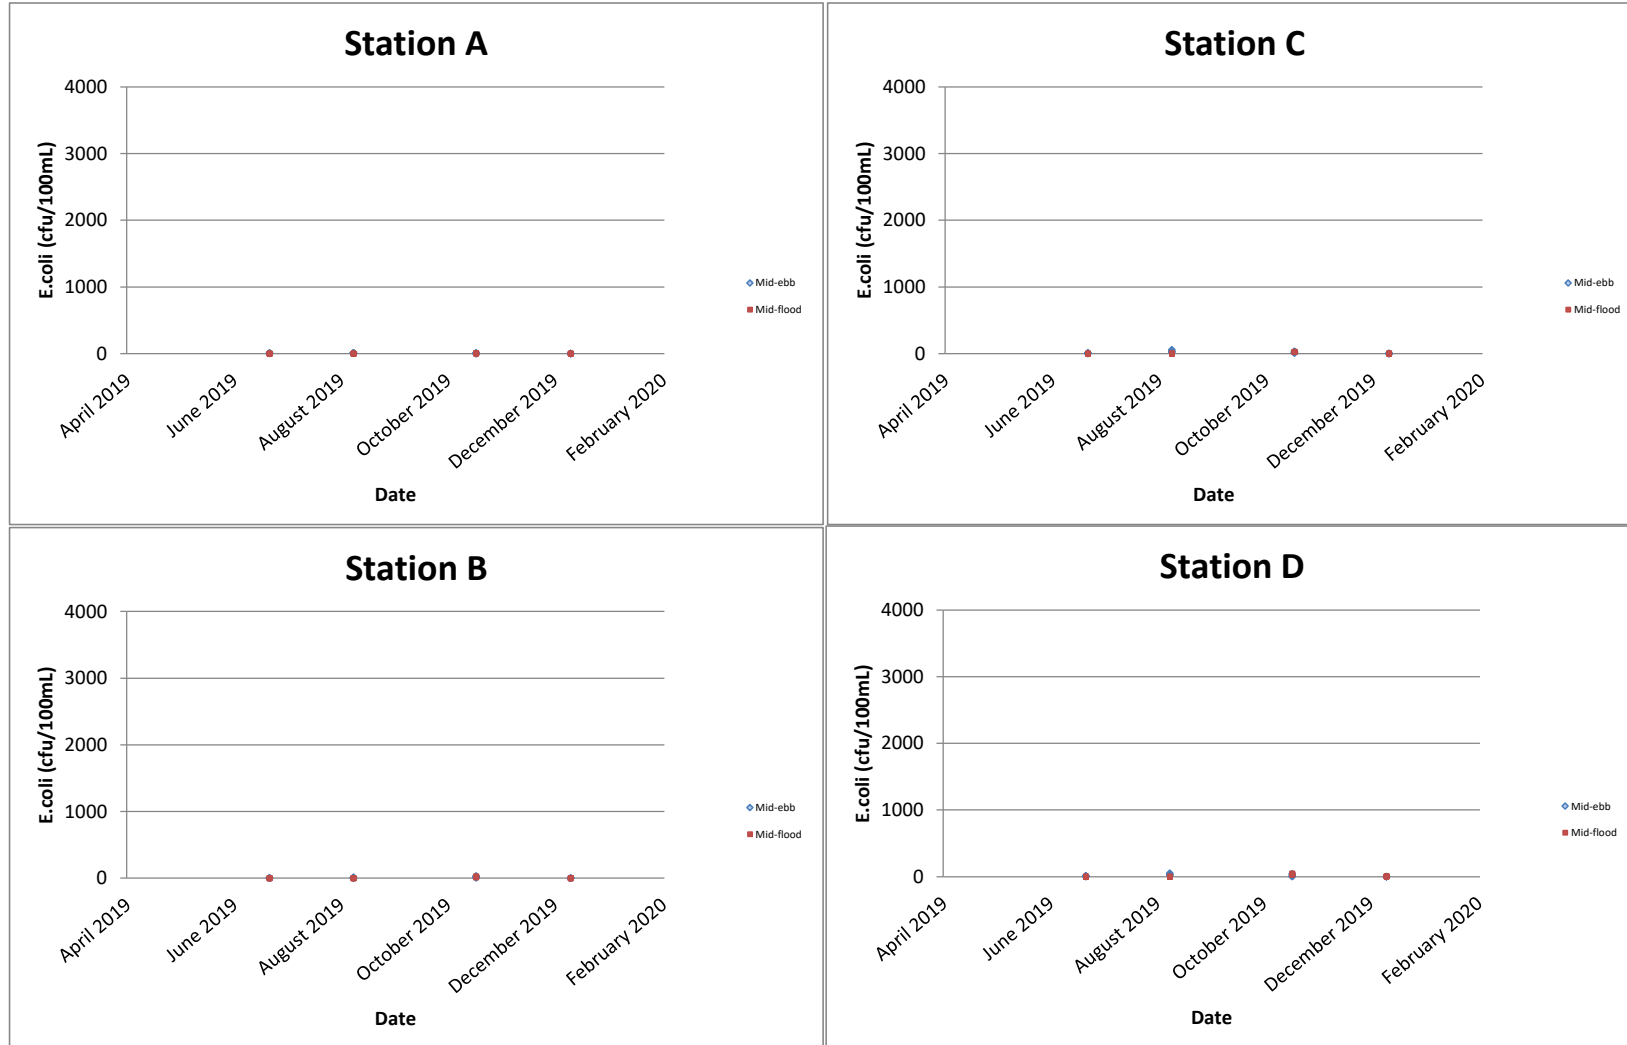
E.coli (cfu/100mL)

Remark: All below the Limit of Report sample results (<1 CFU/100mL) for E.coli is regarded as 1 CFU/100mL in graphical presentation.

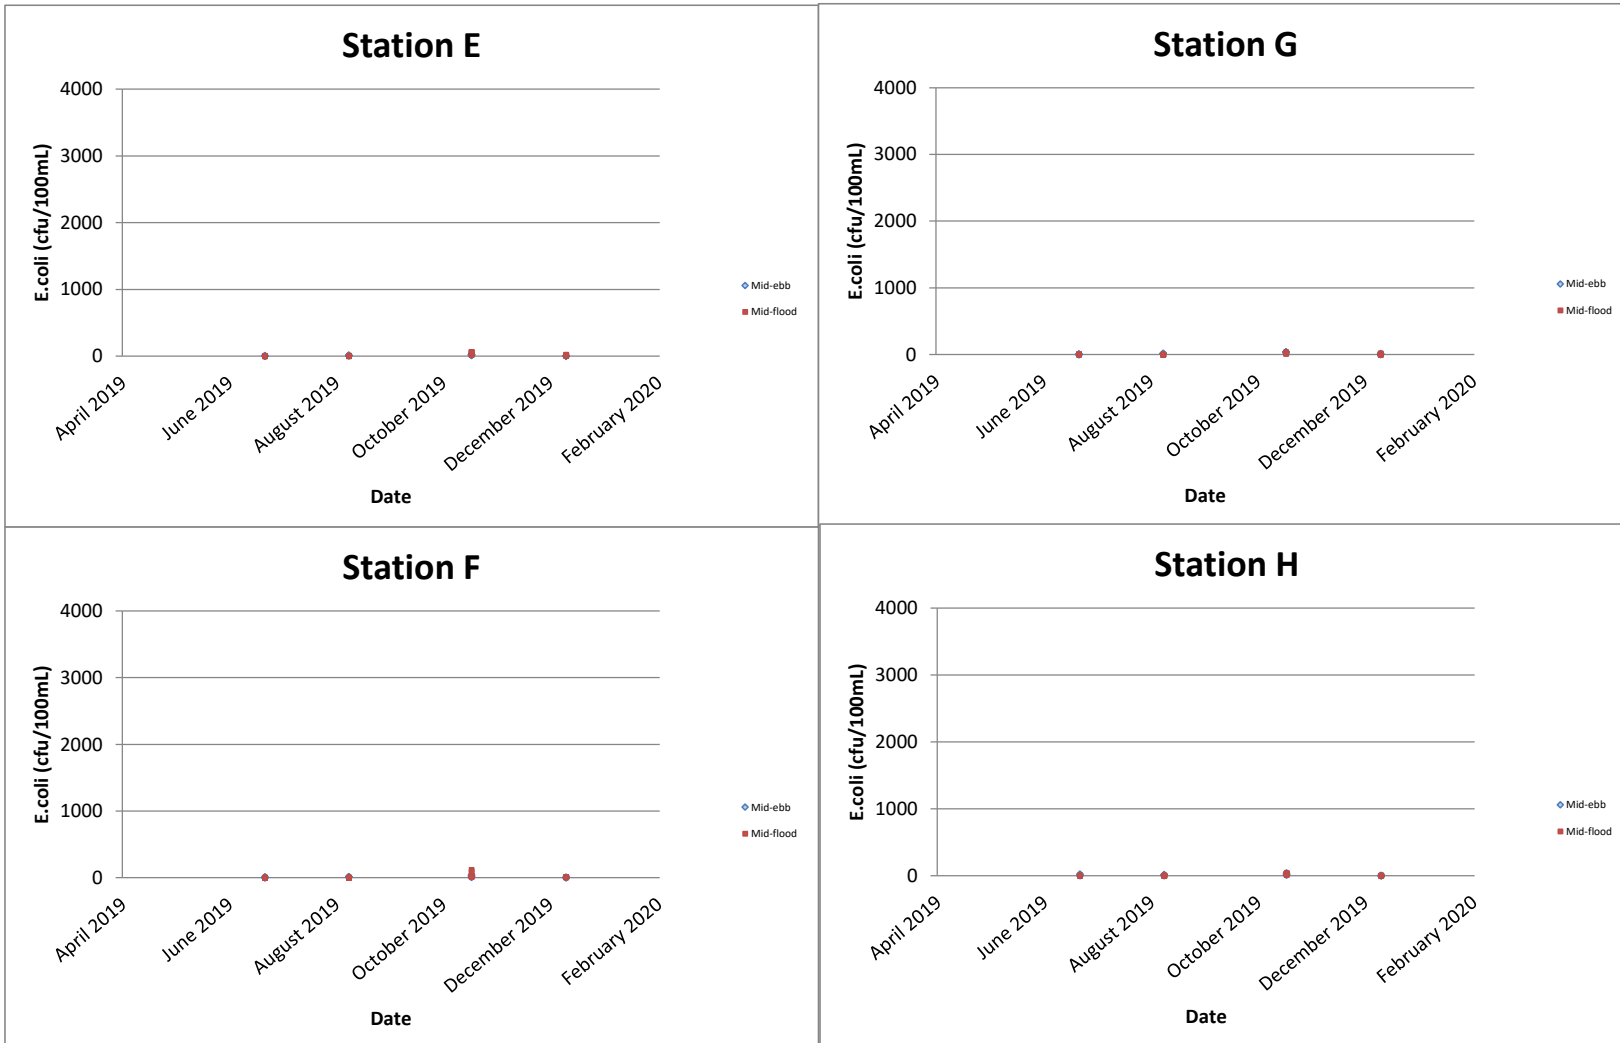
E.coli (cfu/100mL)

Remark: All below the Limit of Report sample results (<1 CFU/100mL) for E.coli is regarded as 1 CFU/100mL in graphical presentation.
