Report No.: 0041/17/ED/0528A

## Quarterly EM&A Report November 2019 - January 2020

Project : Contract No. CM 14/2016  
Environmental Team for Operational  
Environmental Monitoring and Audit for Siu  
Ho Wan Sewage Treatment Works

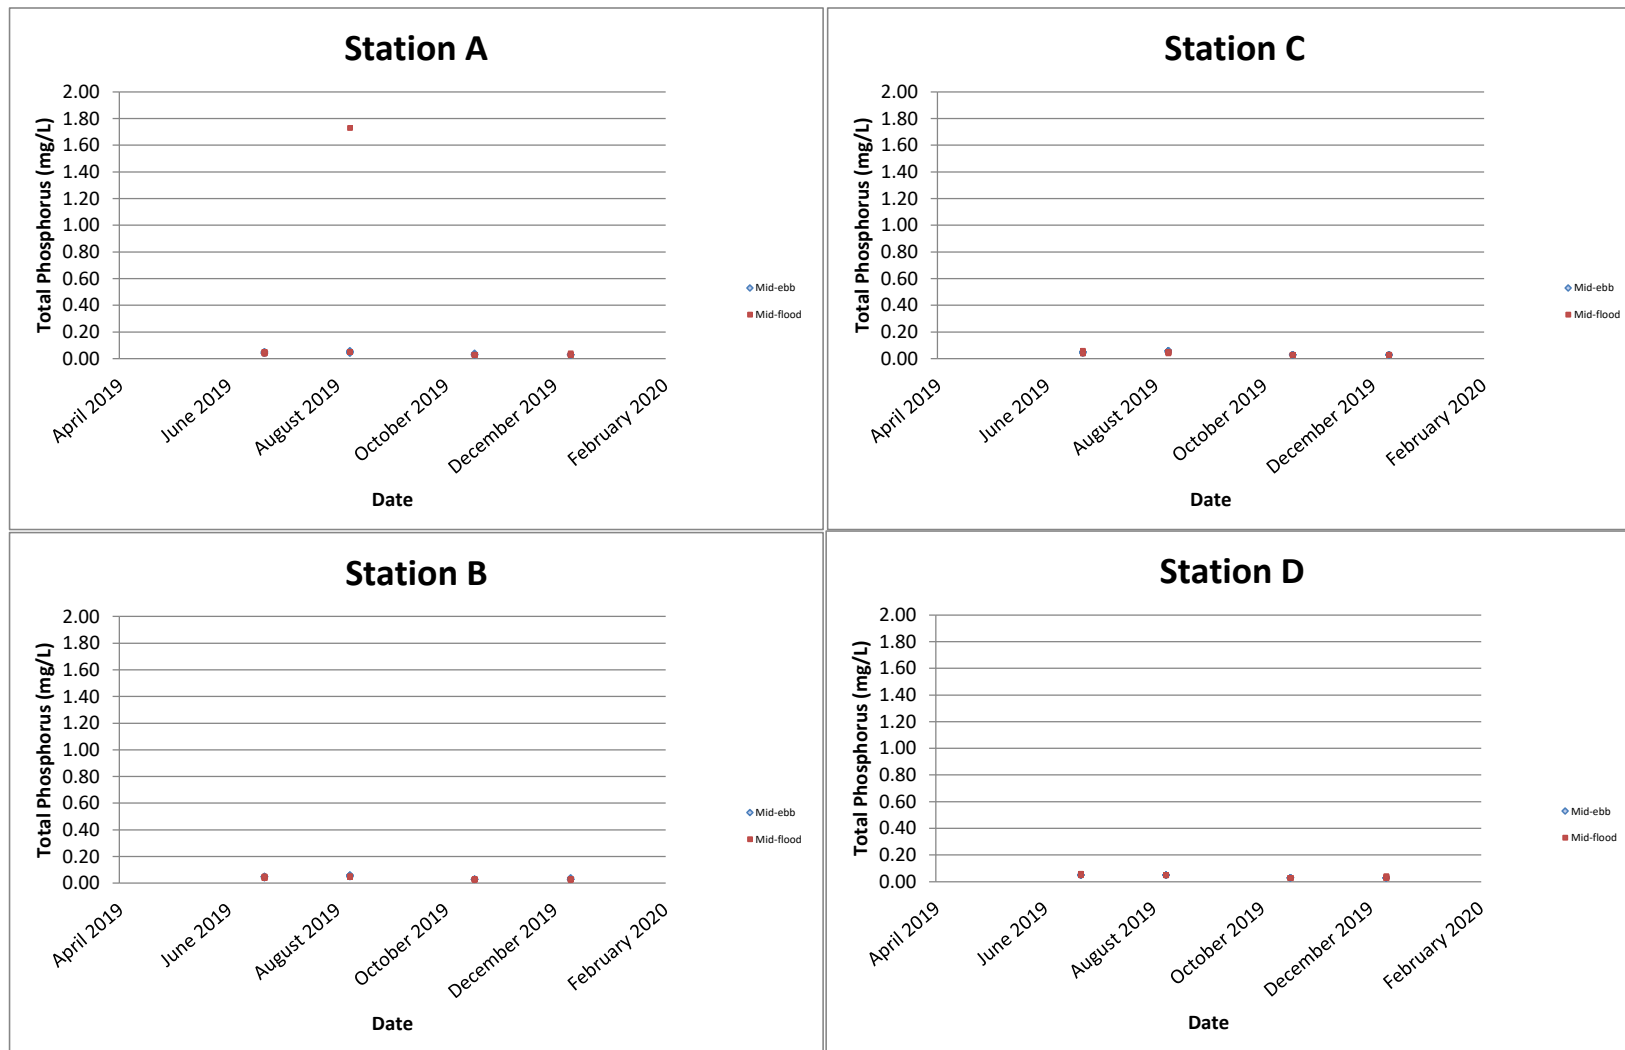
Total Phosphorus (soluble and particulate) (mg/L)

Remark: All below the Limit of Report sample results (<0.01 mg/L) for Total Phosphorus is regarded as 0.01 mg/L in graphical presentation.

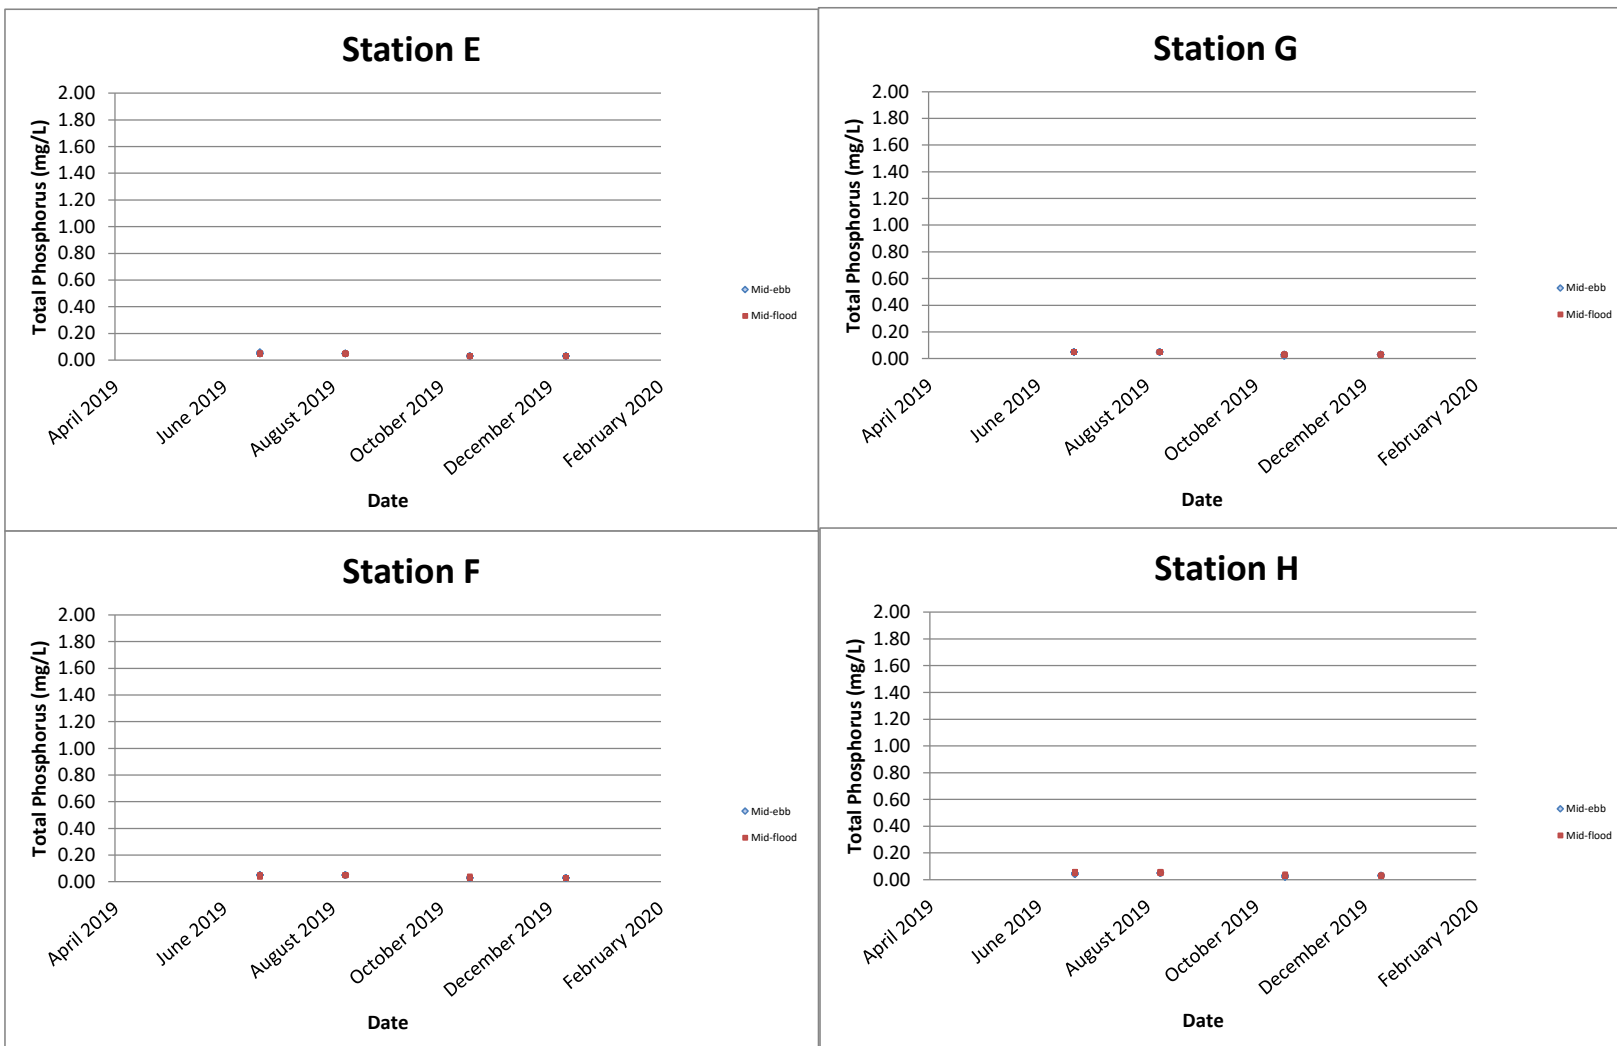
Total Phosphorus (soluble and particulate) (mg/L)

Remark: All below the Limit of Report sample results (<0.01 mg/L) for Total Phosphorus is regarded as 0.01 mg/L in graphical presentation.

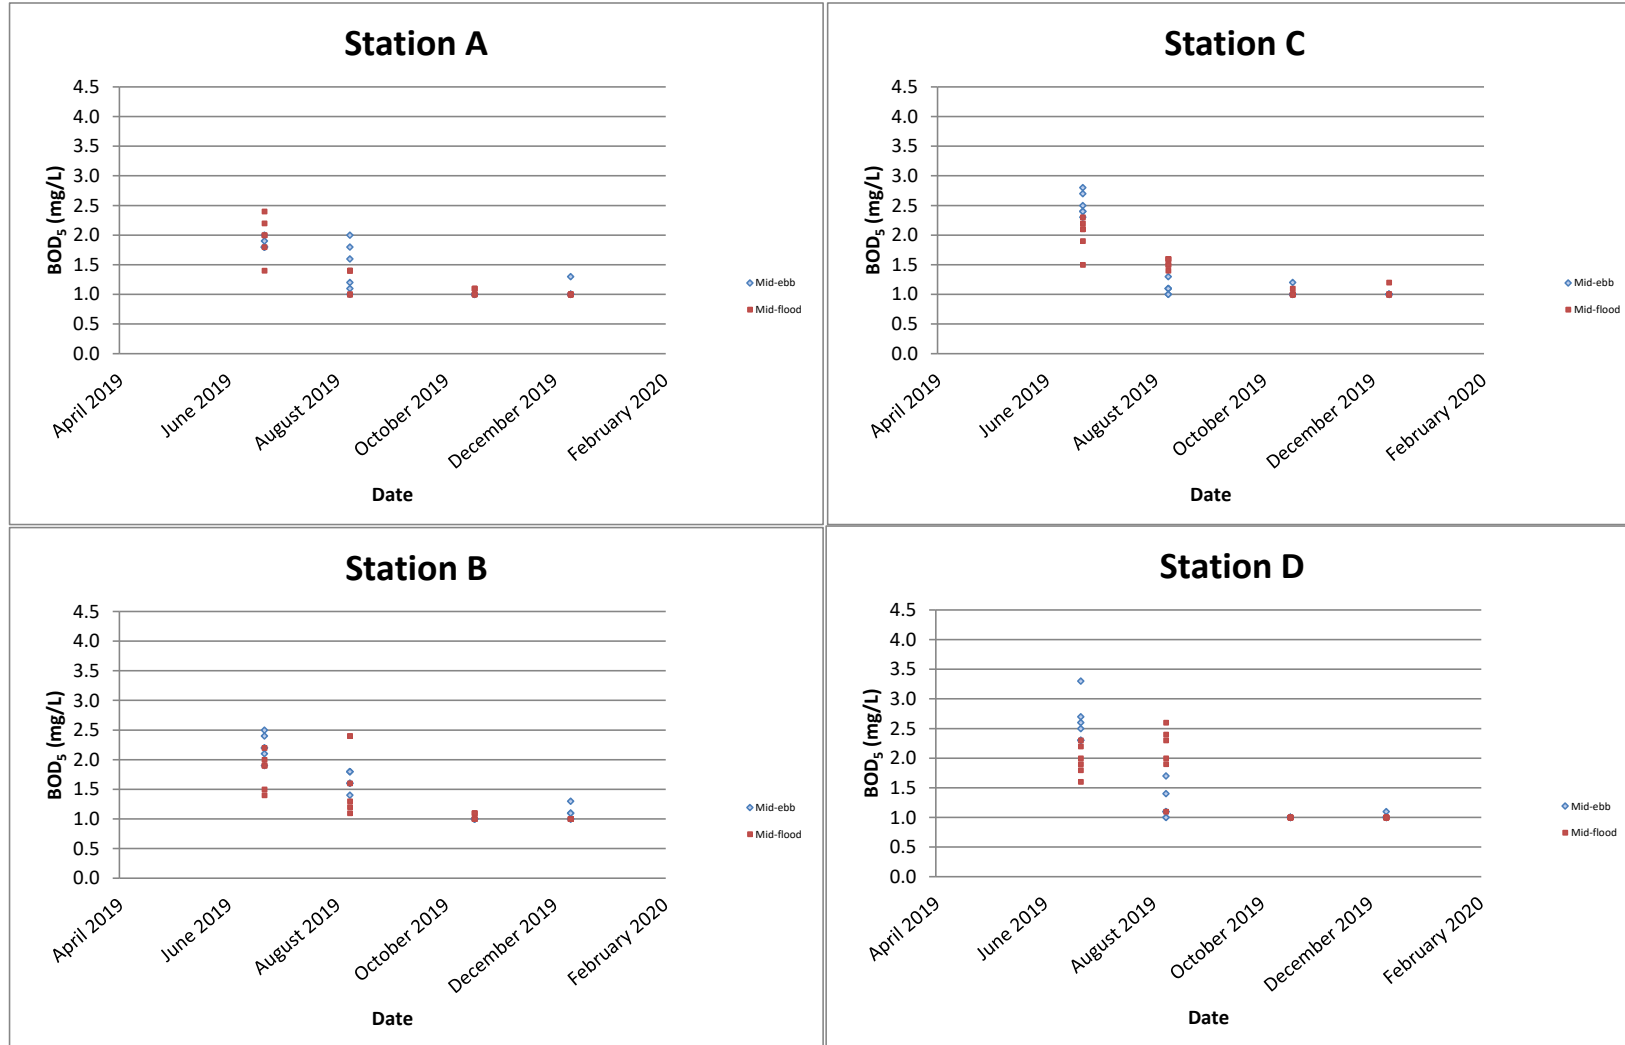
BOD<sub>5</sub> (mg/L)

Remark: All below the Limit of Report sample results (<1.0 mg/L) for BOD<sub>5</sub> is regarded as 1.0 mg/L in graphical presentation.

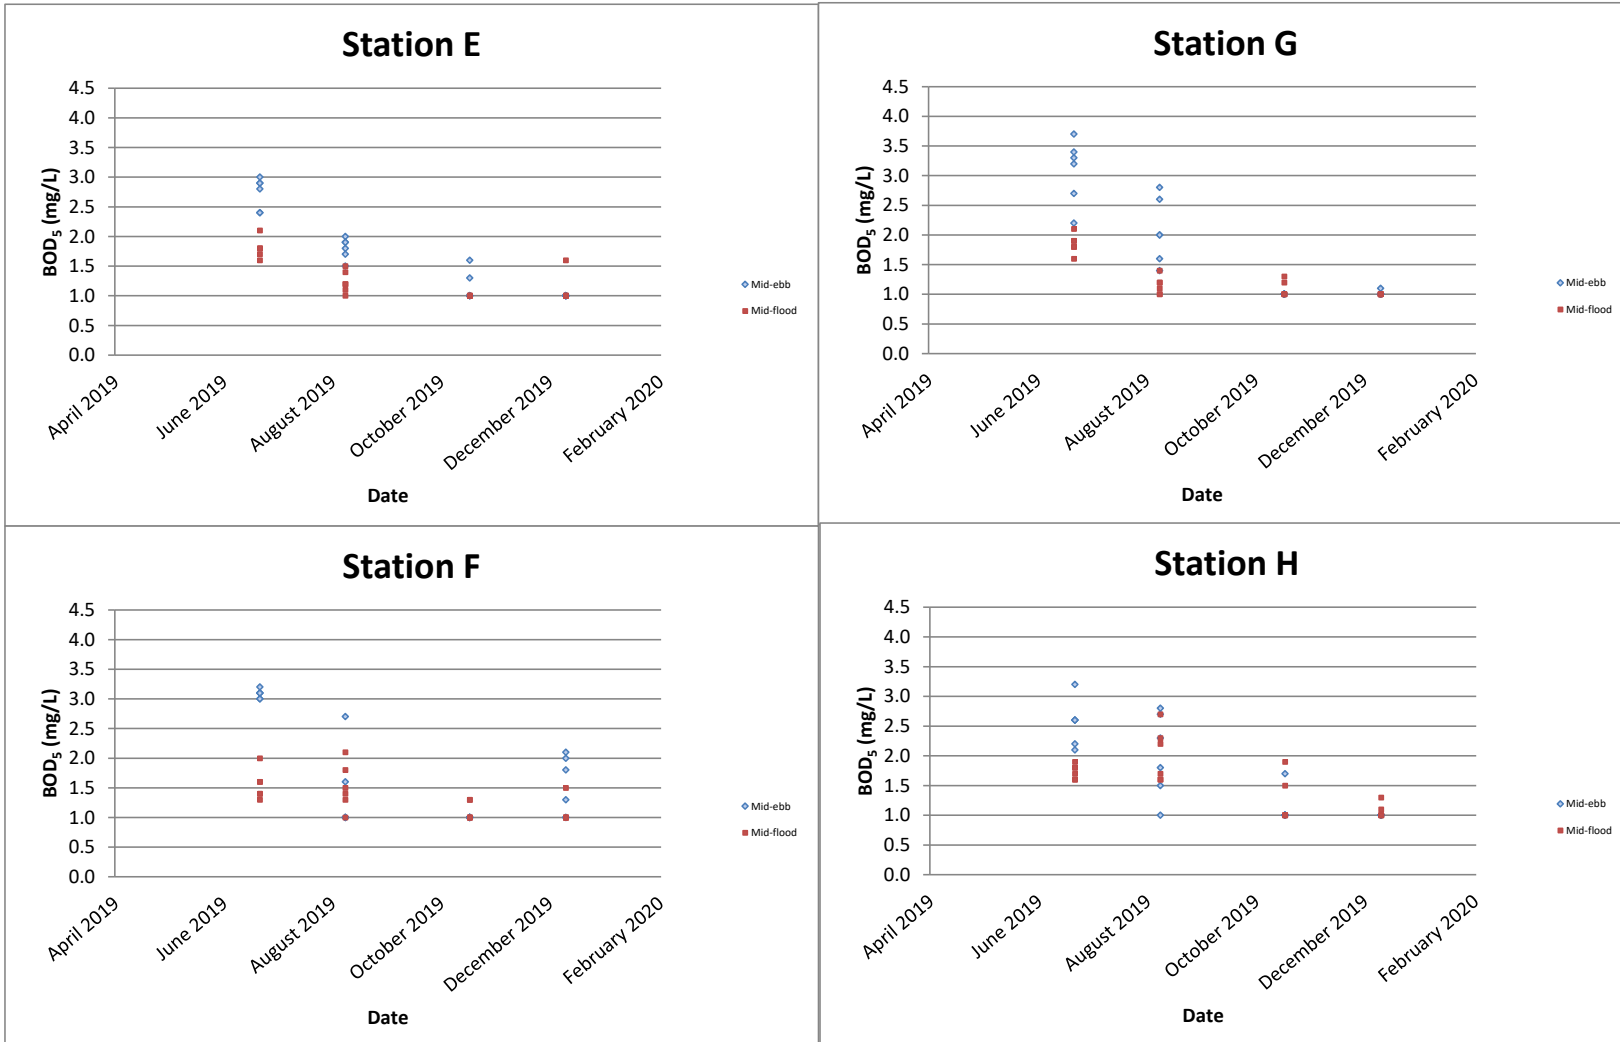
BOD<sub>5</sub> (mg/L)

Remark: All below the Limit of Report sample results (<1.0 mg/L) for BOD<sub>5</sub> is regarded as 1.0 mg/L in graphical presentation.

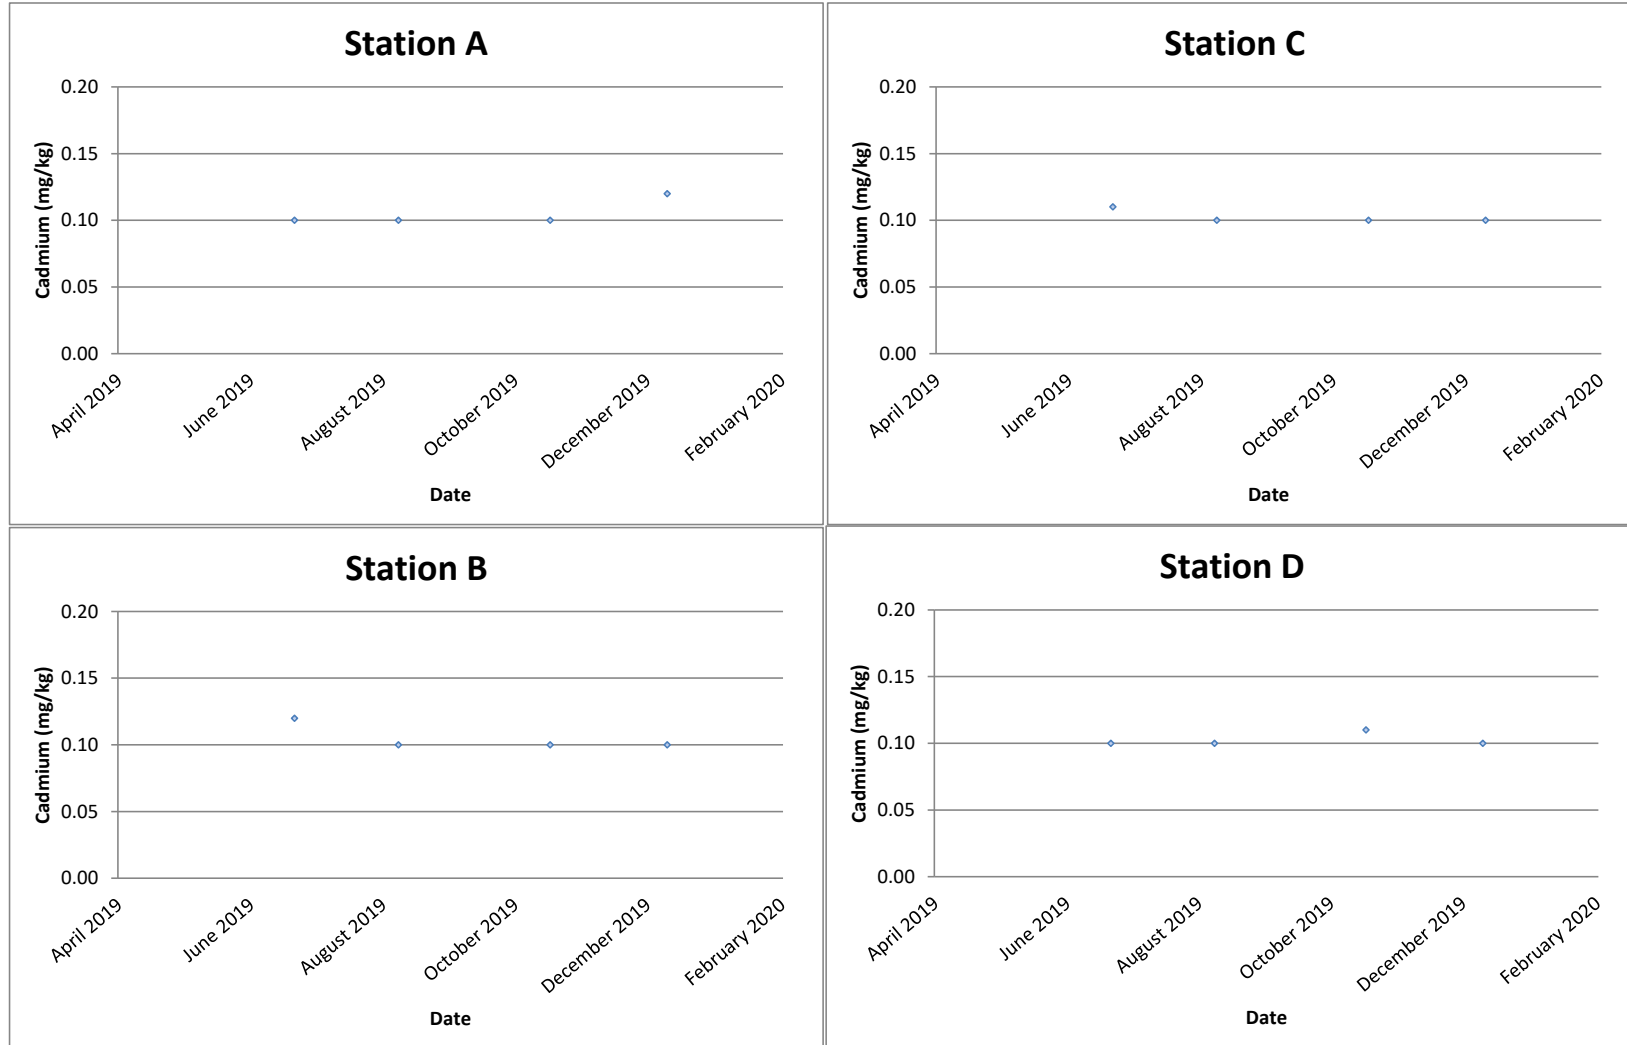
Cadmium (mg/kg)

Remark: All below the Limit of Report sample results (<0.1 mg/kg) for Cadmium is regarded as 0.1 mg/kg in graphical presentation.

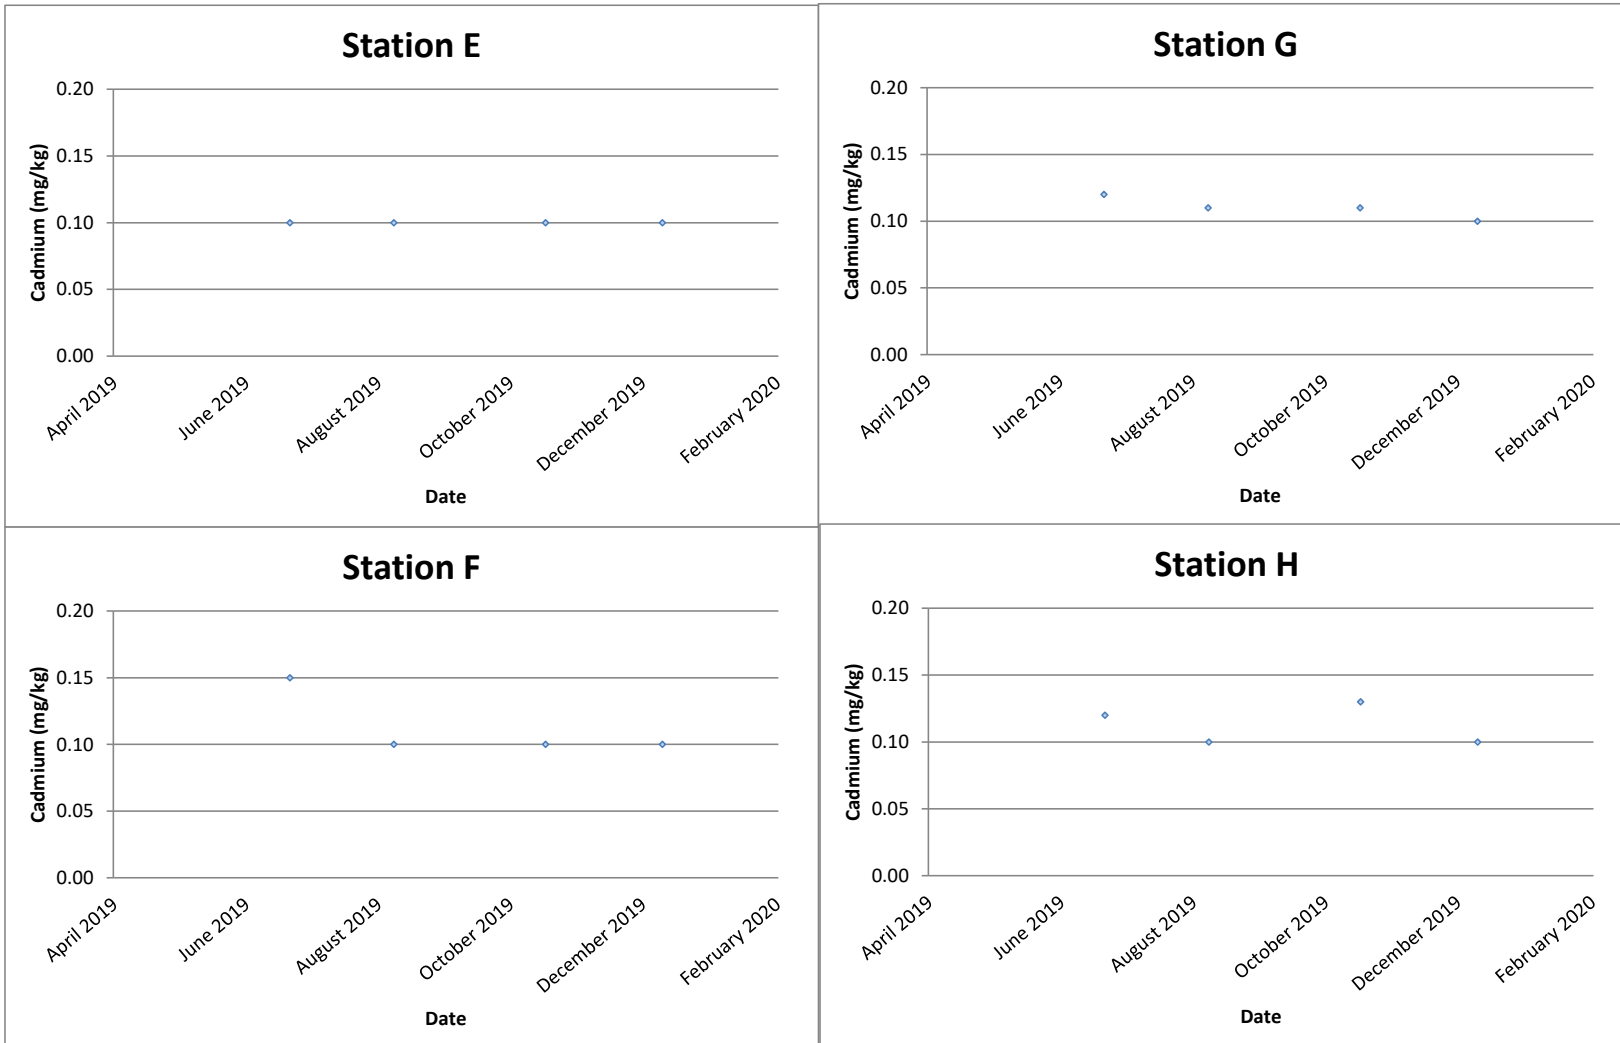
Cadmium (mg/kg)

Remark: All below the Limit of Report sample results (<0.1 mg/kg) for Cadmium is regarded as 0.1 mg/kg in graphical presentation.
