Report No.: 0041/17/ED/0536B

## Monthly EM&A Report March 2020

Project : Contract No. CM 14/2016  
Environmental Team for Operational  
Environmental Monitoring and Audit for Siu  
Ho Wan Sewage Treatment Works

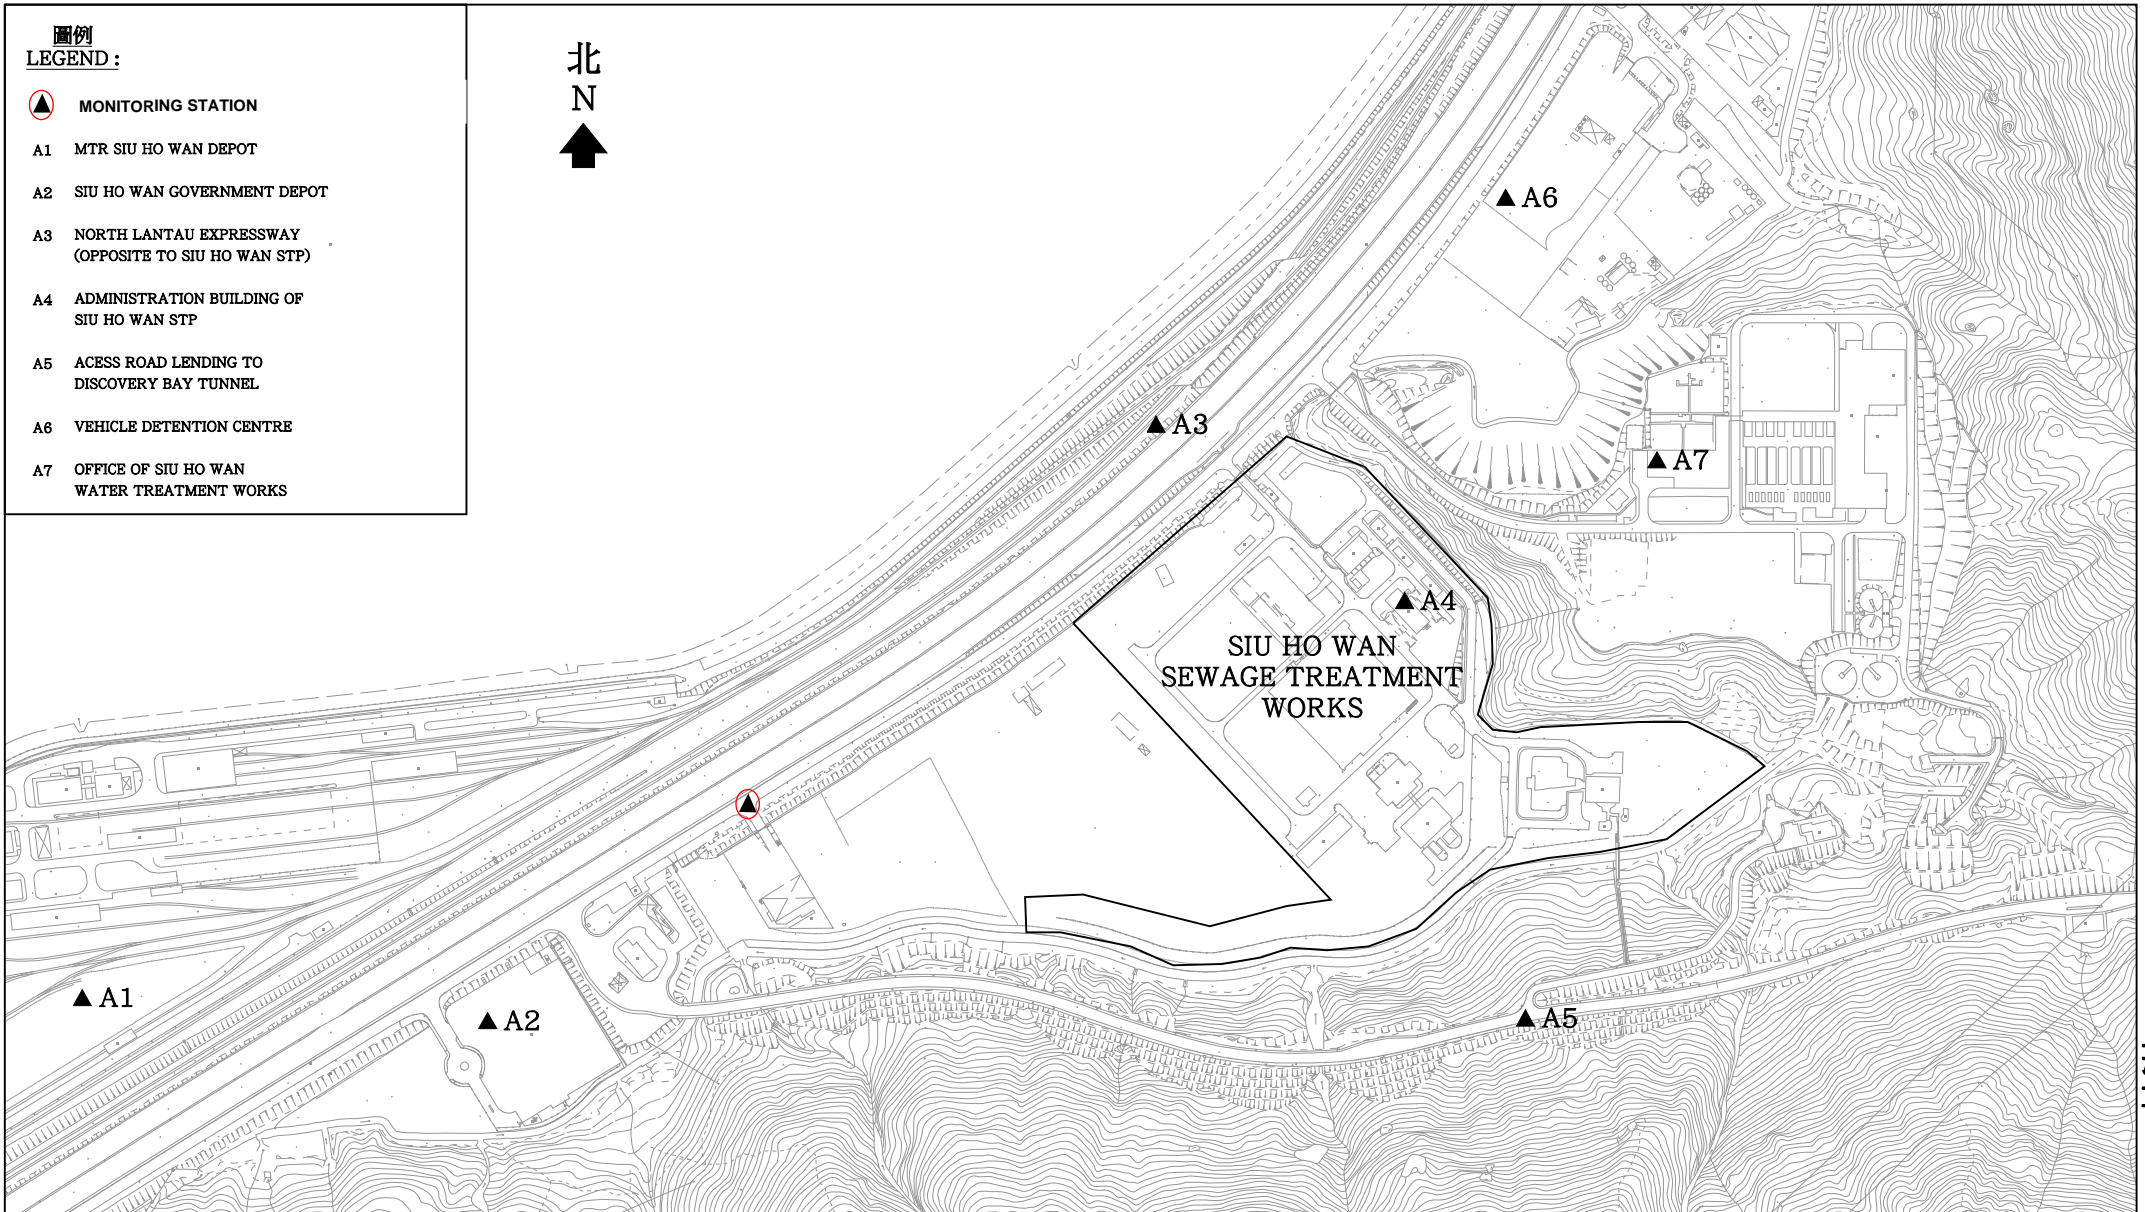
**MONITORING STATION**
- A1** MTR SIU HO WAN DEPOT
- A2** SIU HO WAN GOVERNMENT DEPOT
- A3** NORTH LANTAU EXPRESSWAY  
(OPPOSITE TO SIU HO WAN STP)
- A4** ADMINISTRATION BUILDING OF  
SIU HO WAN STP
- A5** ACCESS ROAD LENDING TO  
DISCOVERY BAY TUNNEL
- A6** VEHICLE DETENTION CENTRE
- A7** OFFICE OF SIU HO WAN  
WATER TREATMENT WORKS

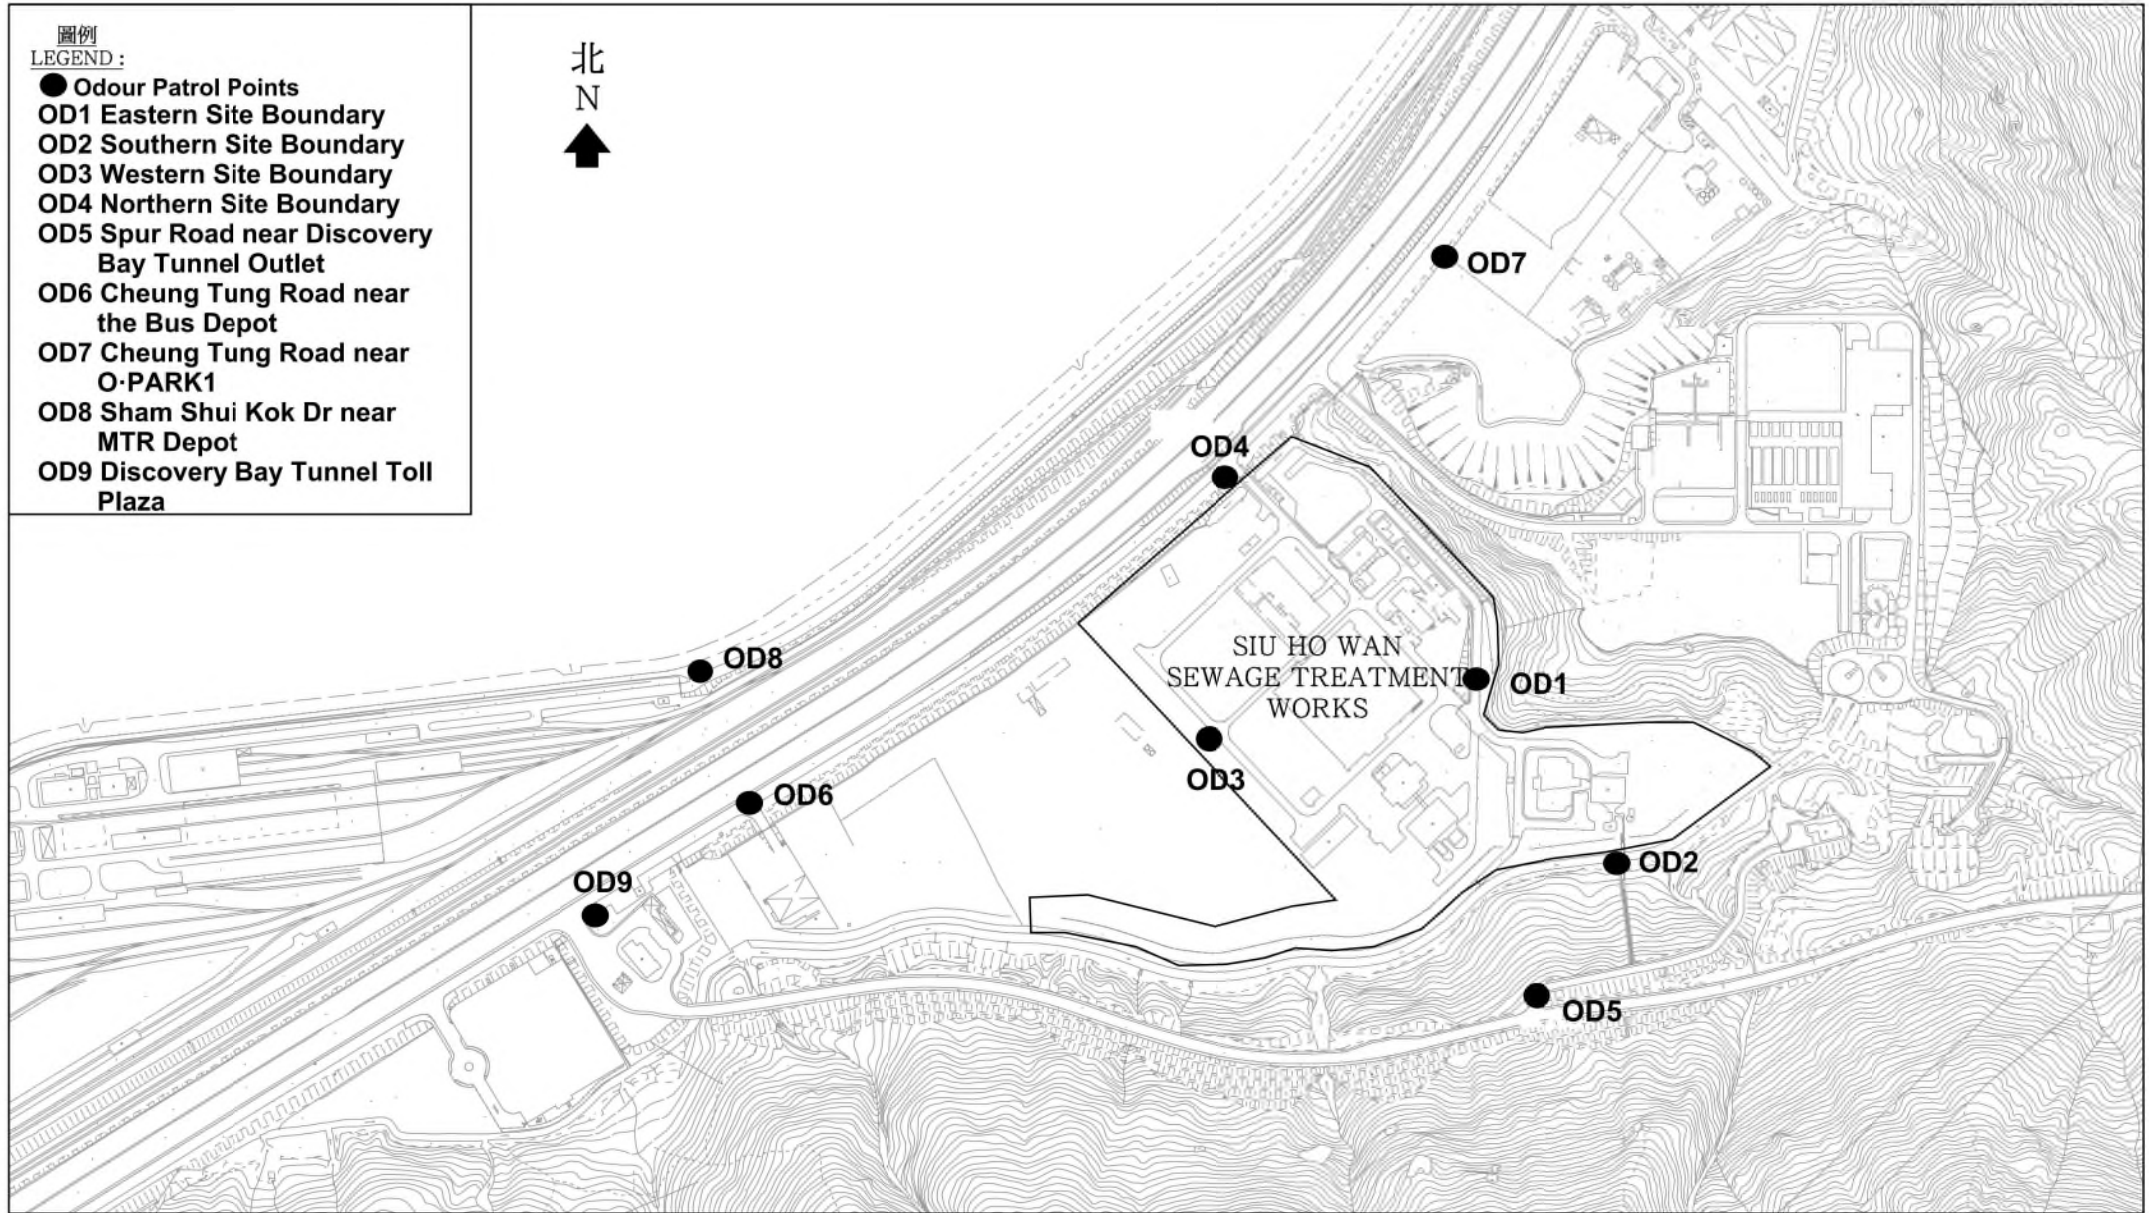
- Odour Patrol Points
- OD1 Eastern Site Boundary
- OD2 Southern Site Boundary
- OD3 Western Site Boundary
- OD4 Northern Site Boundary
- OD5 Spur Road near Discovery Bay Tunnel Outlet
- OD6 Cheung Tung Road near the Bus Depot
- OD7 Cheung Tung Road near O-PARK1
- OD8 Sham Shui Kok Dr near MTR Depot
- OD9 Discovery Bay Tunnel Toll Plaza

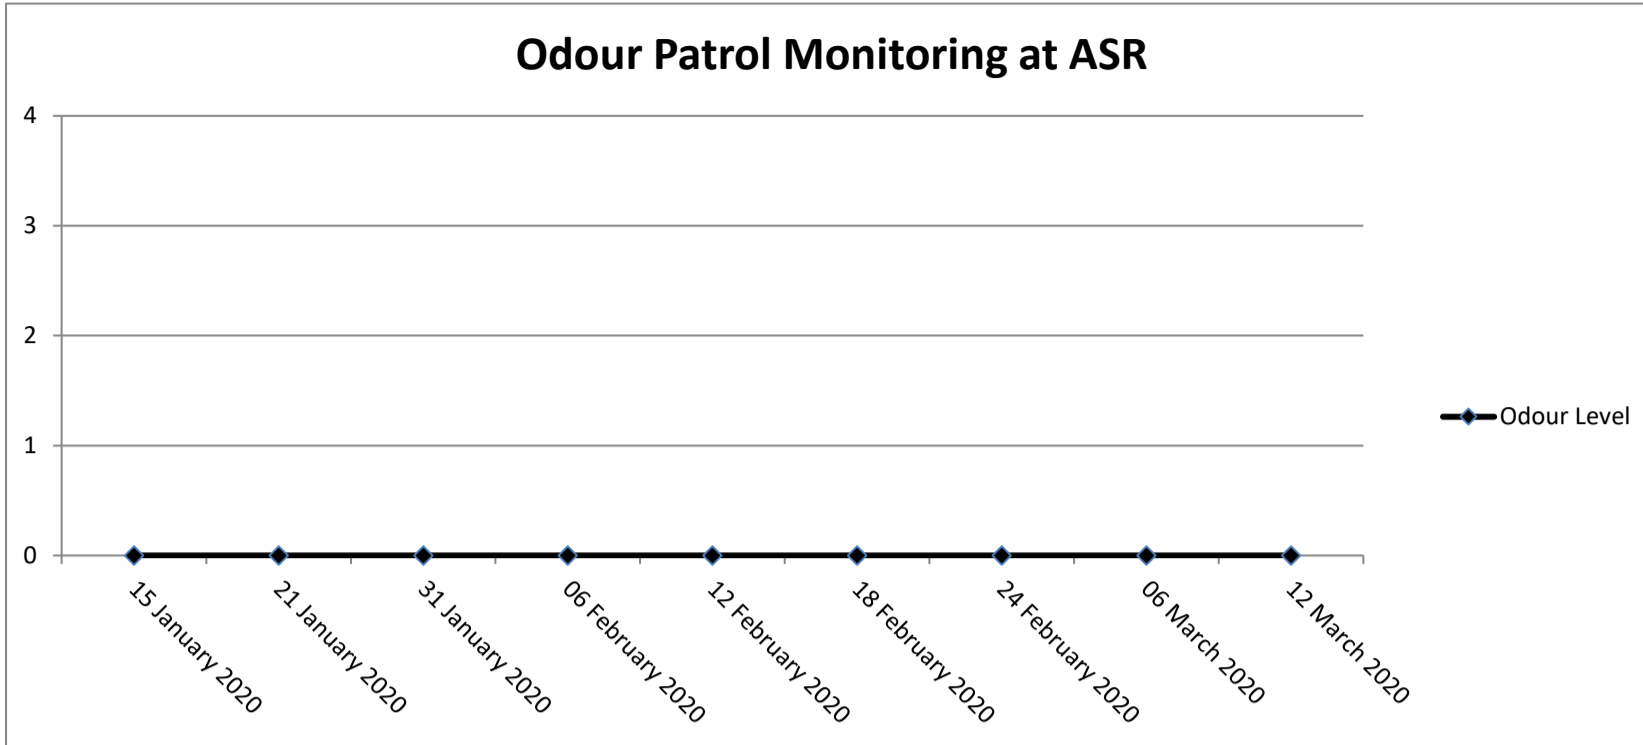
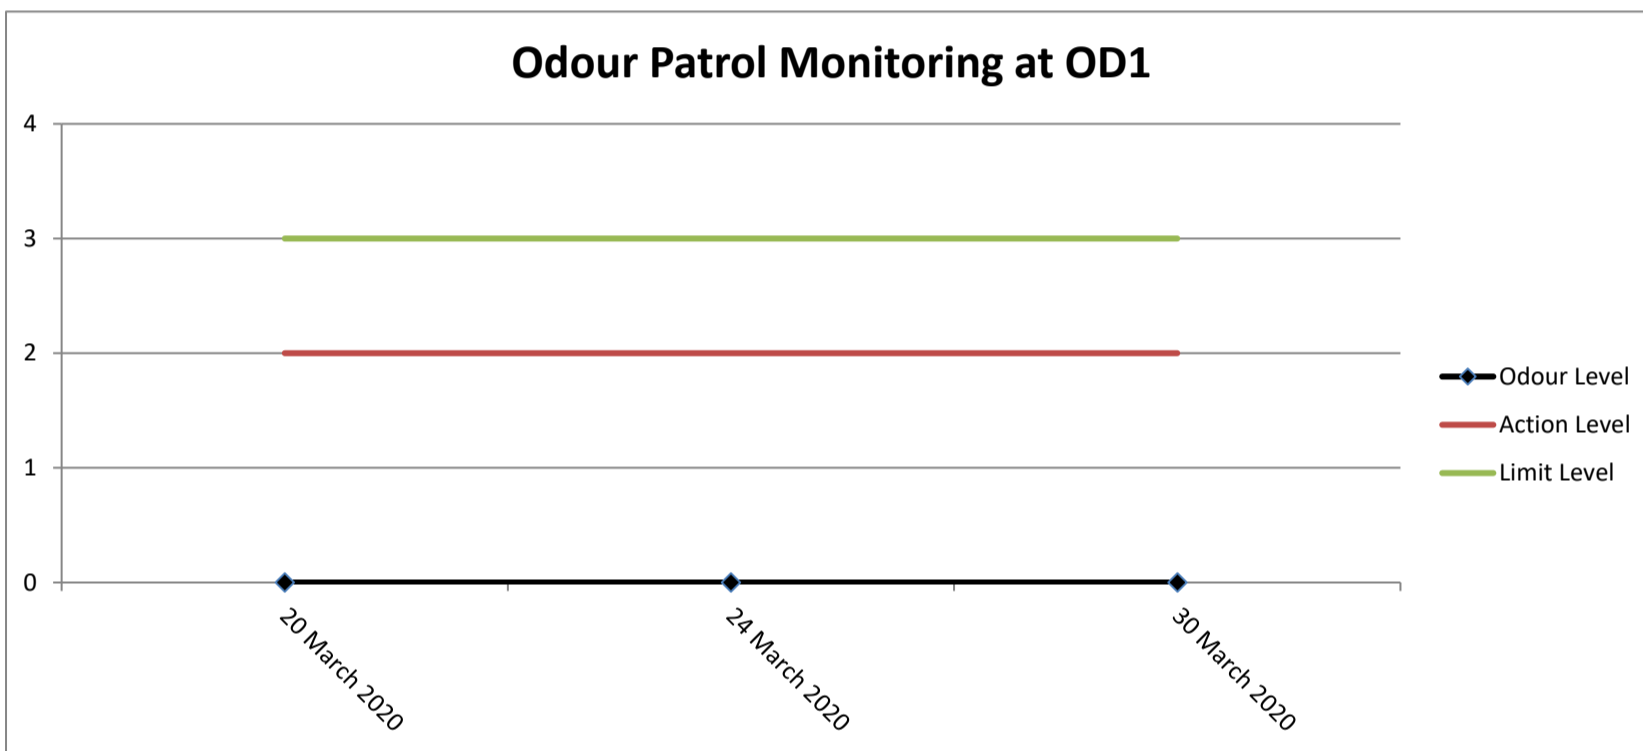
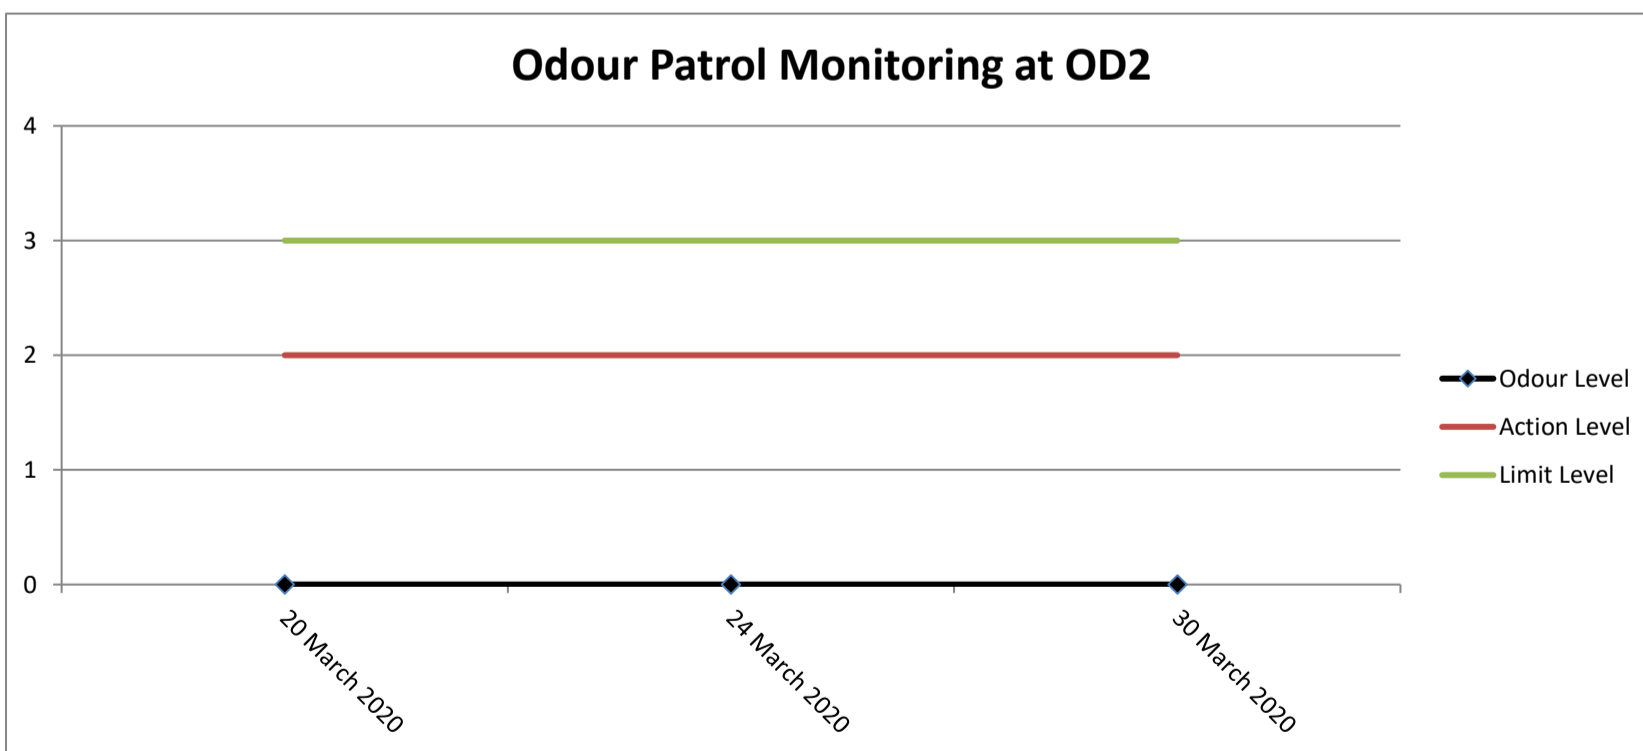
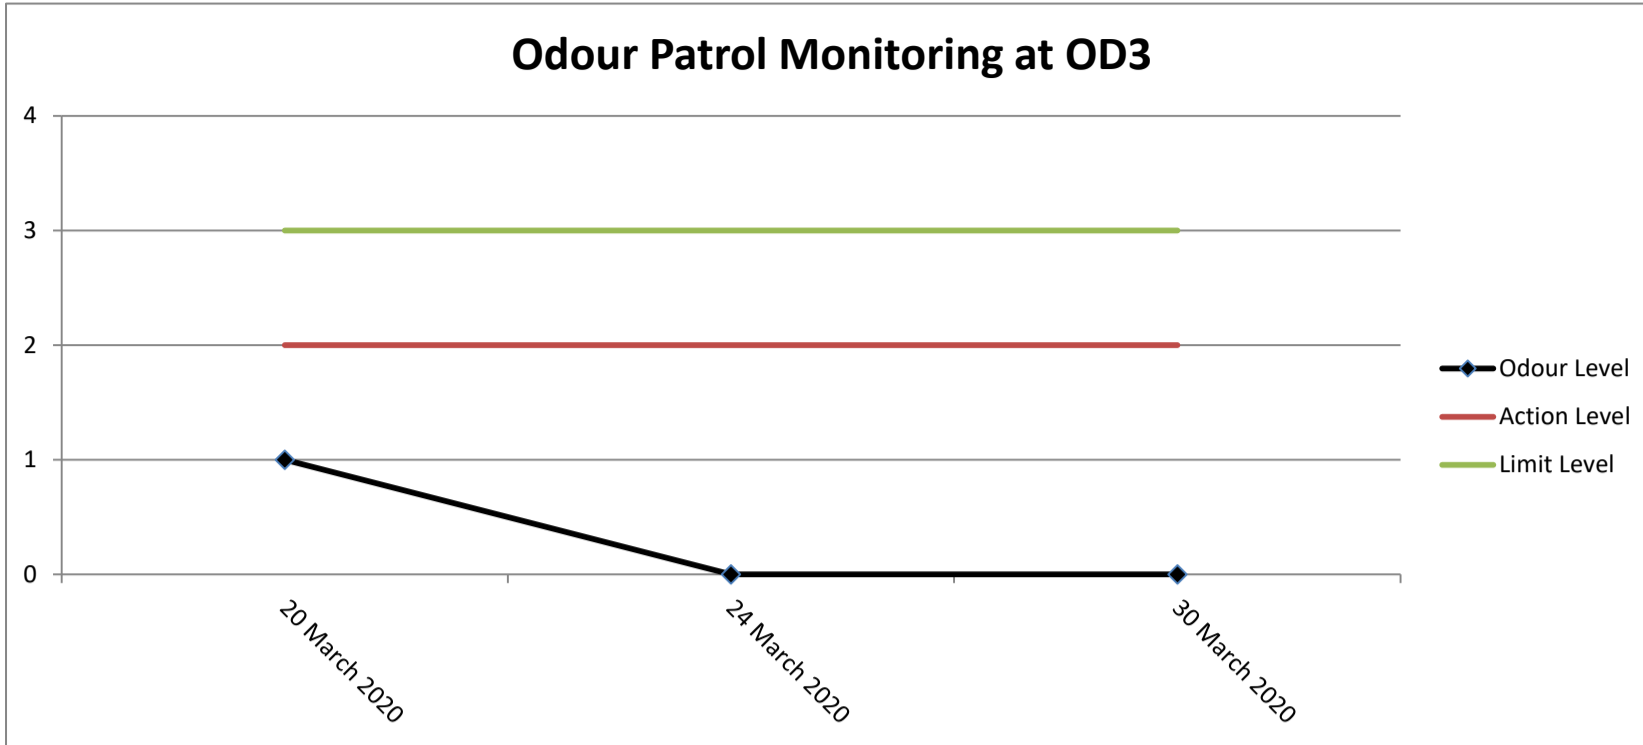
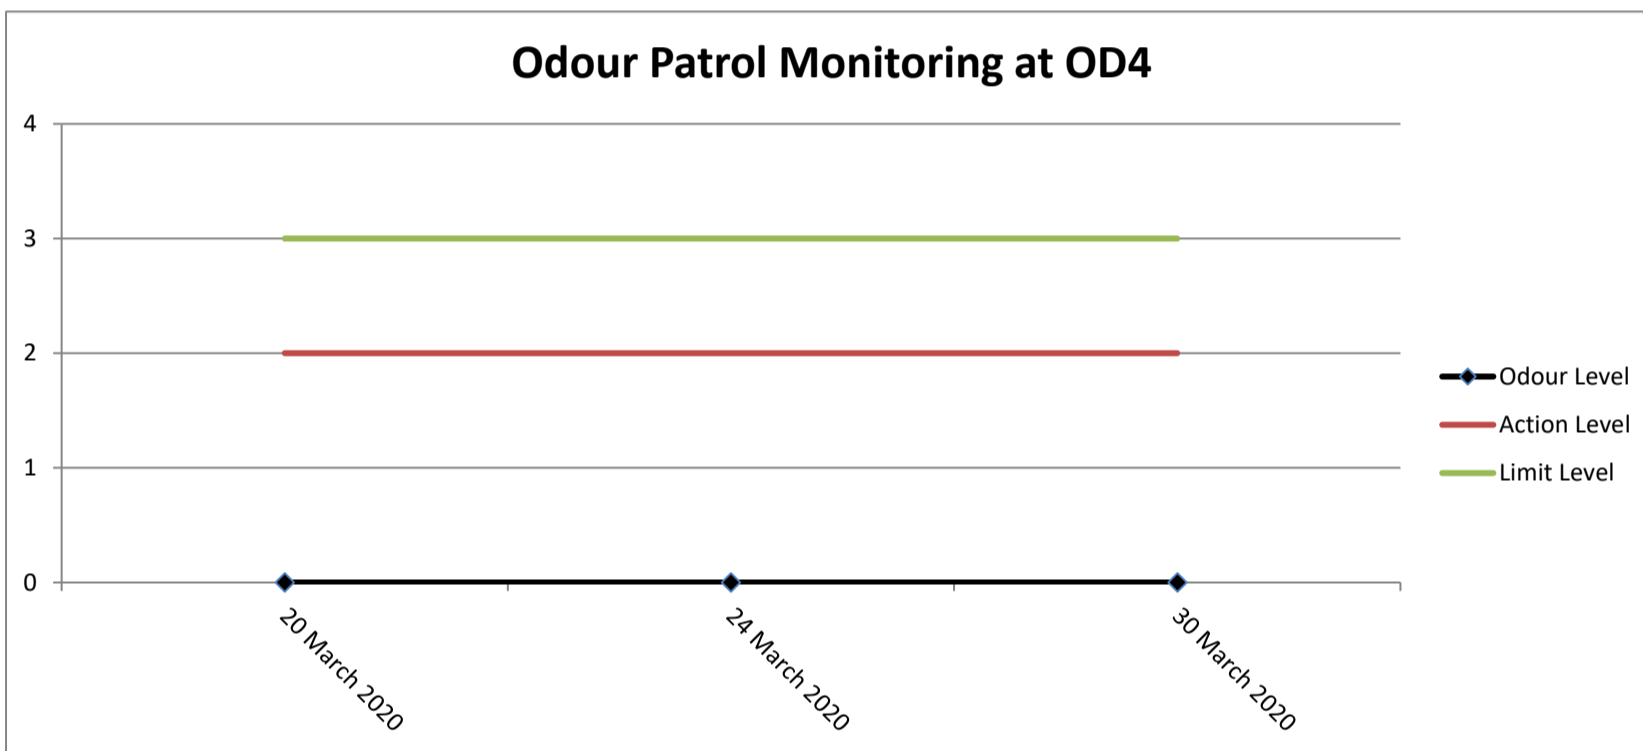
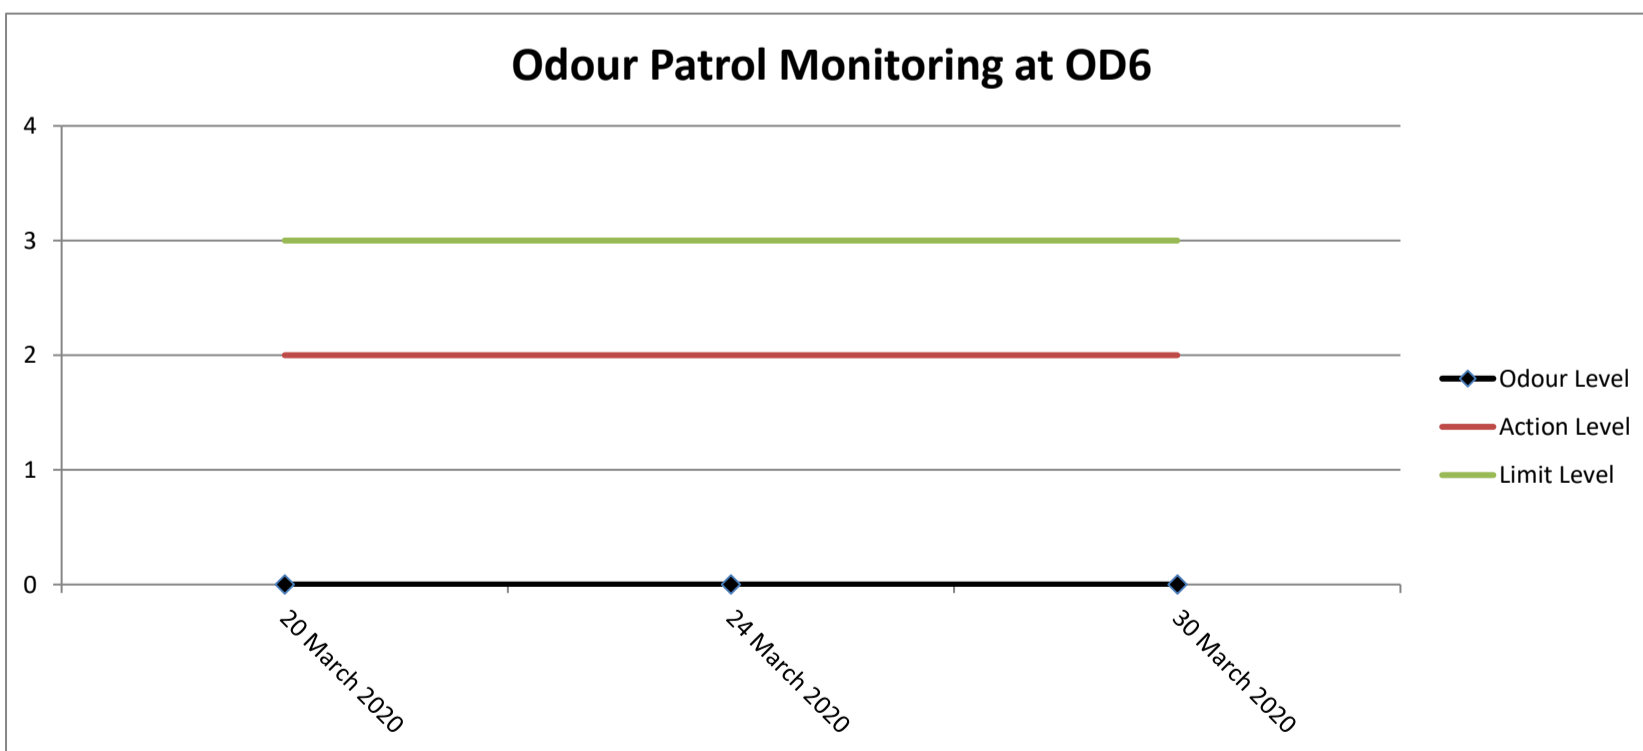
Note:  
Y-axis refers to the Odour Level: 0 - Not Detected; 1- Slight; 2 - Noticeable; 3 - Strong; 4 - Extreme

Note:  
Y-axis refers to the Odour Level: 0 - Not Detected; 1- Slight; 2 - Moderate; 3 - Strong; 4 - Extreme

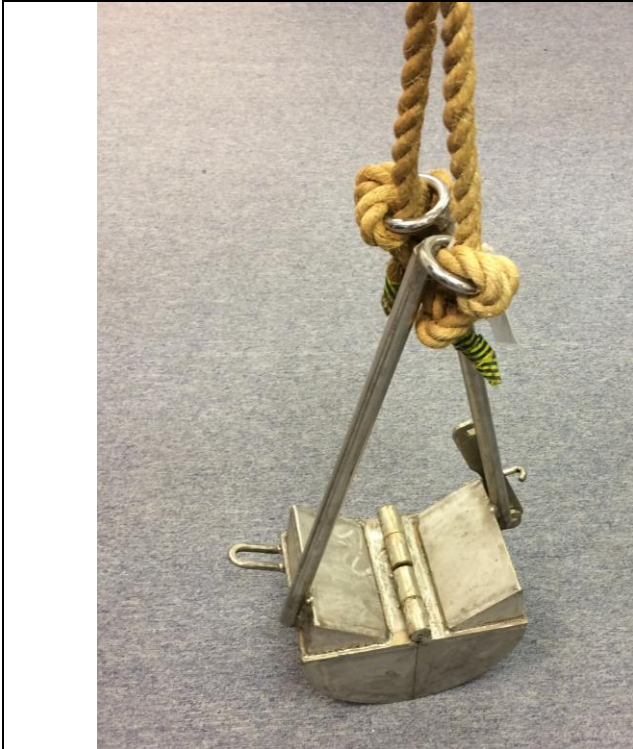
Photo 1. A ponar grab sampler

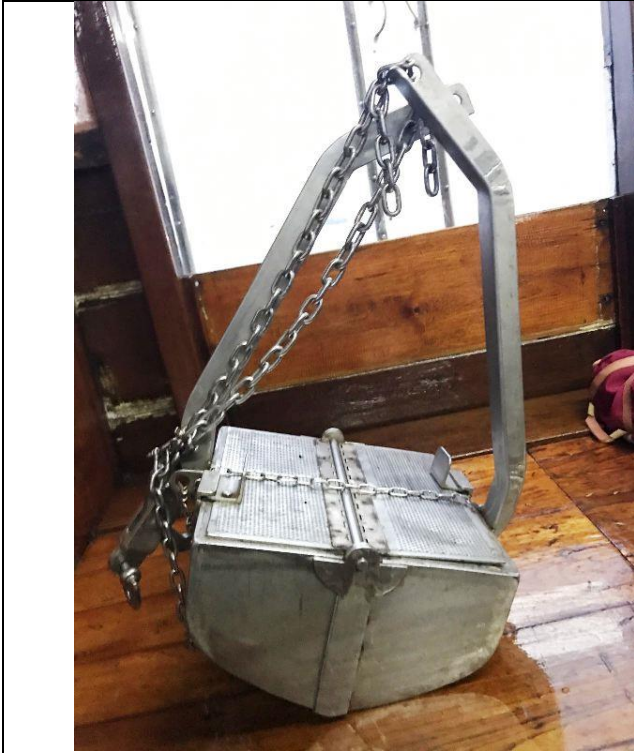
Photo 1. A modified Van Veen grab sampler

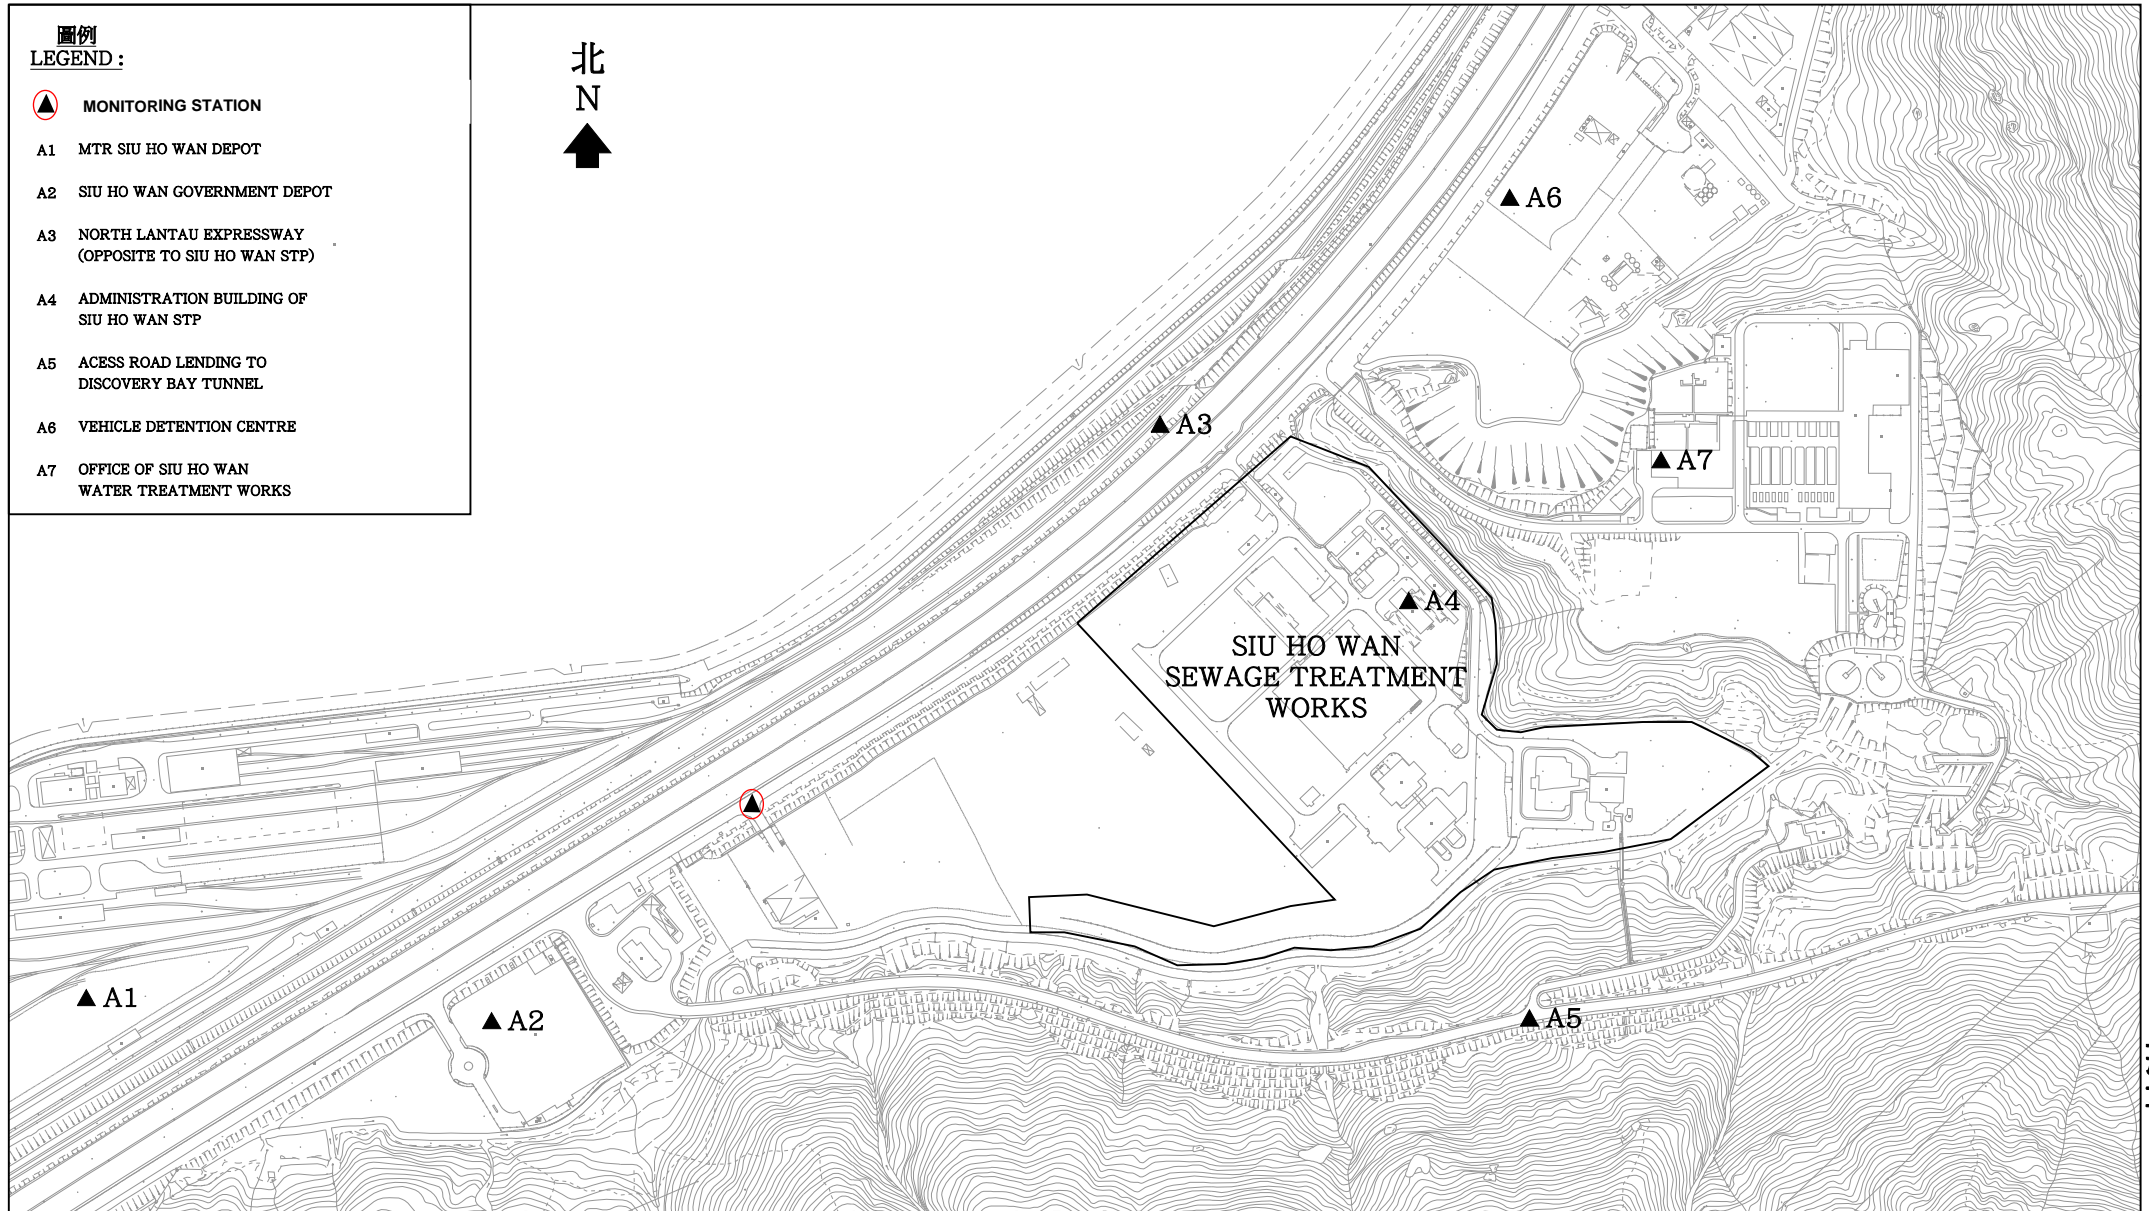
圖則名稱 drawing title

- ▲ MONITORING STATION
- A1 MTR SIU HO WAN DEPOT
- A2 SIU HO WAN GOVERNMENT DEPOT
- A3 NORTH LANTAU EXPRESSWAY  
(OPPOSITE TO SIU HO WAN STP)
- A4 ADMINISTRATION BUILDING OF  
SIU HO WAN STP
- A5 ACCESS ROAD LENDING TO  
DISCOVERY BAY TUNNEL
- A6 VEHICLE DETENTION CENTRE
- A7 OFFICE OF SIU HO WAN  
WATER TREATMENT WORKS
