Report No.: 0041/17/ED/0568A

Monthly EM&A Report July 2020

Project : Contract No. CM 14/2016
Environmental Team for Operational
Environmental Monitoring and Audit for Siu
Ho Wan Sewage Treatment Works

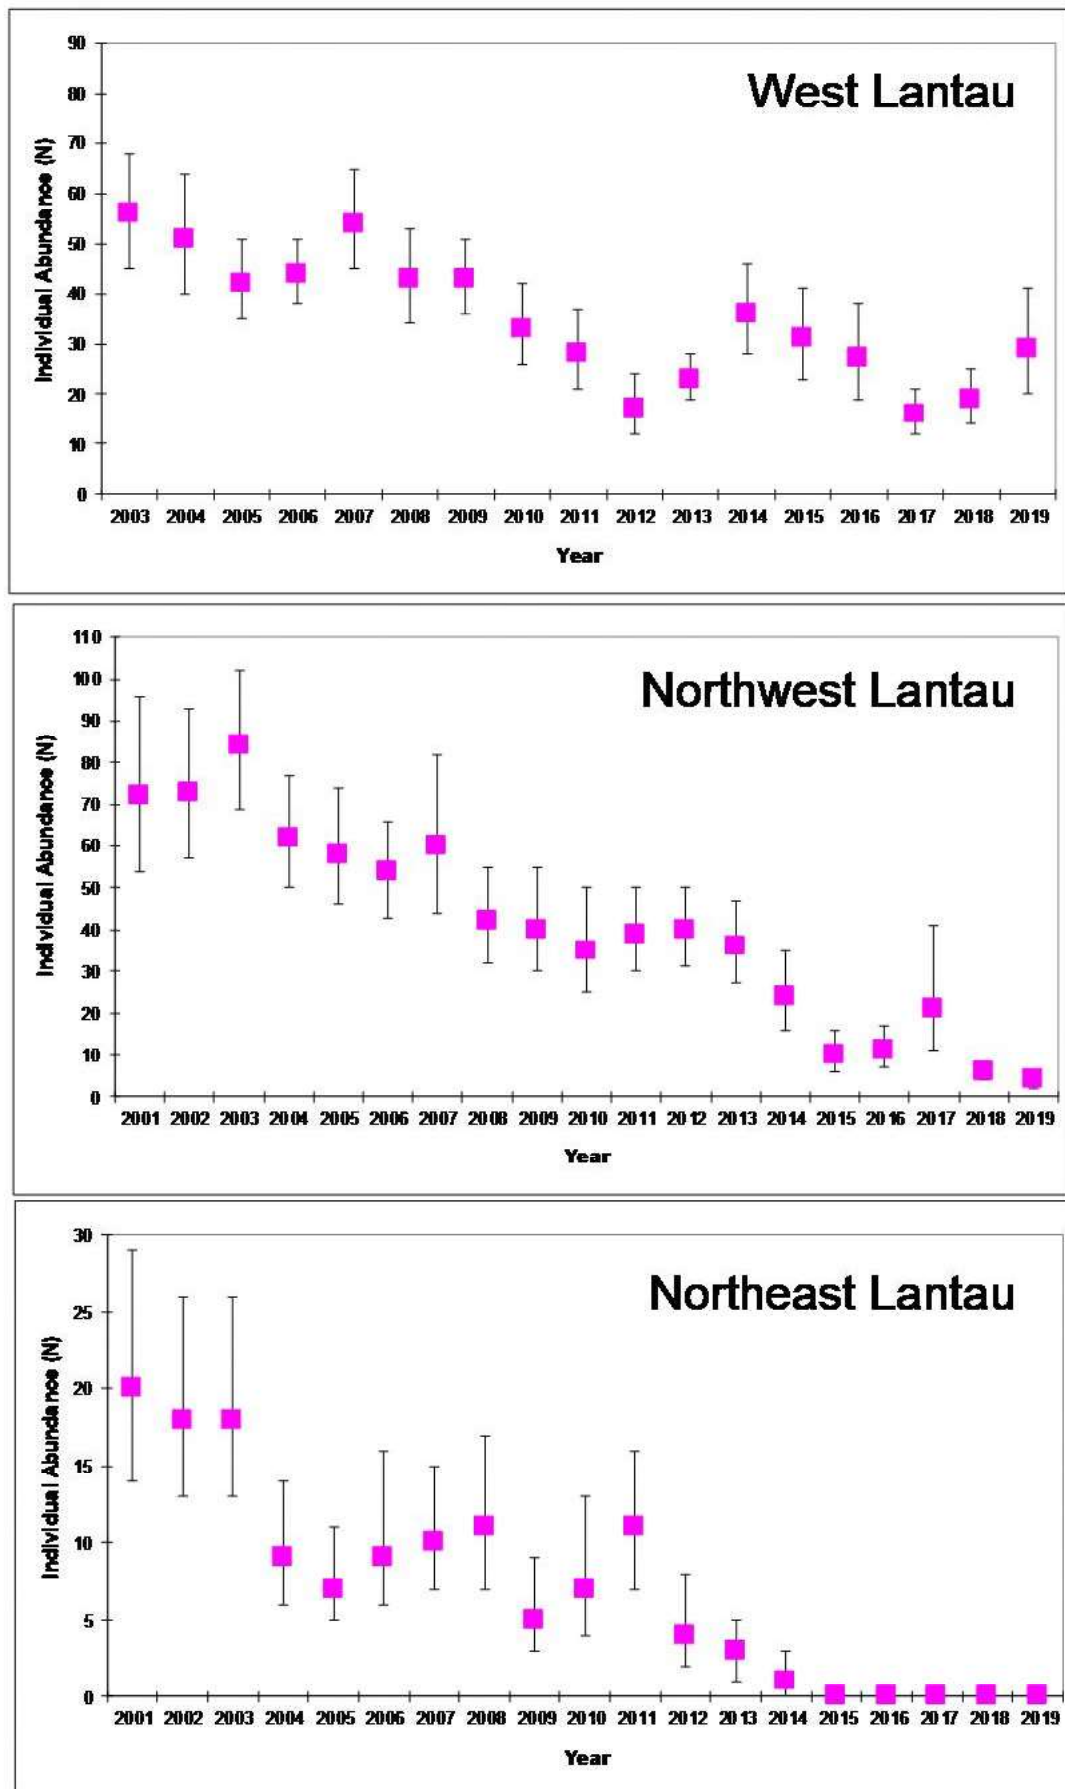
Figure 40. Temporal trends in annual abundance estimates of Chinese White Dolphins in WL, NWL & NEL from 2001-19 (error bars: 95% confidence interval of abundance estimates)
