Report No.: 0041/17/ED/0649

Quarterly EM&A Report August 2021 - October 2021

Project : Contract No. CM 14/2016
Environmental Team for Operational
Environmental Monitoring and Audit for Siu
Ho Wan Sewage Treatment Works

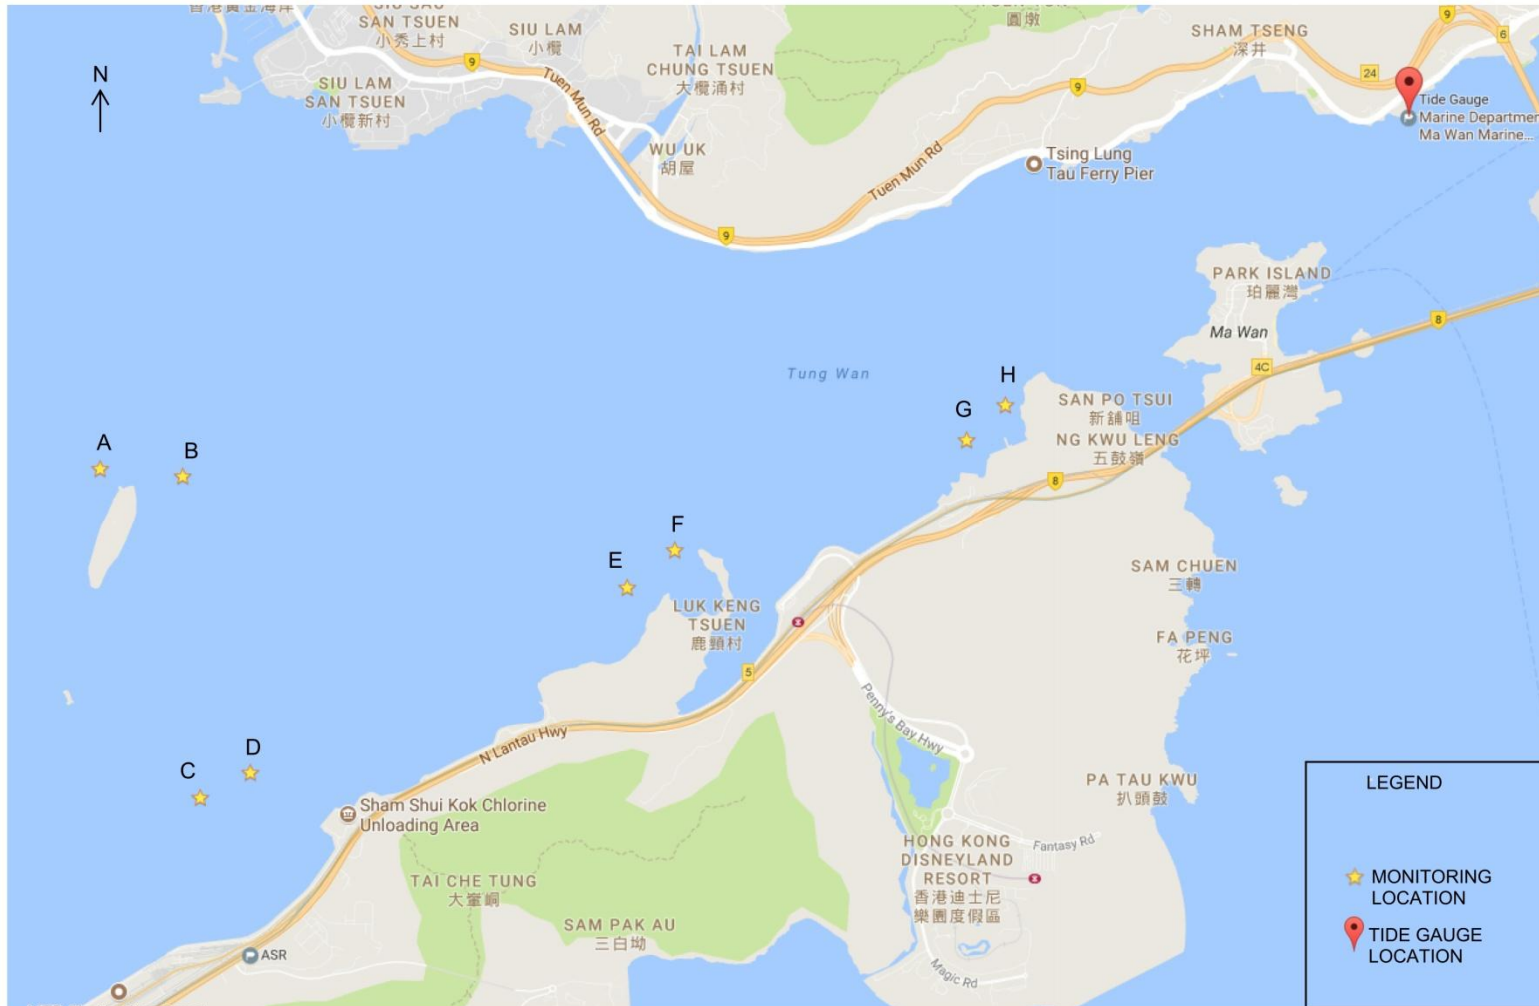
Location of the Tide Gauge

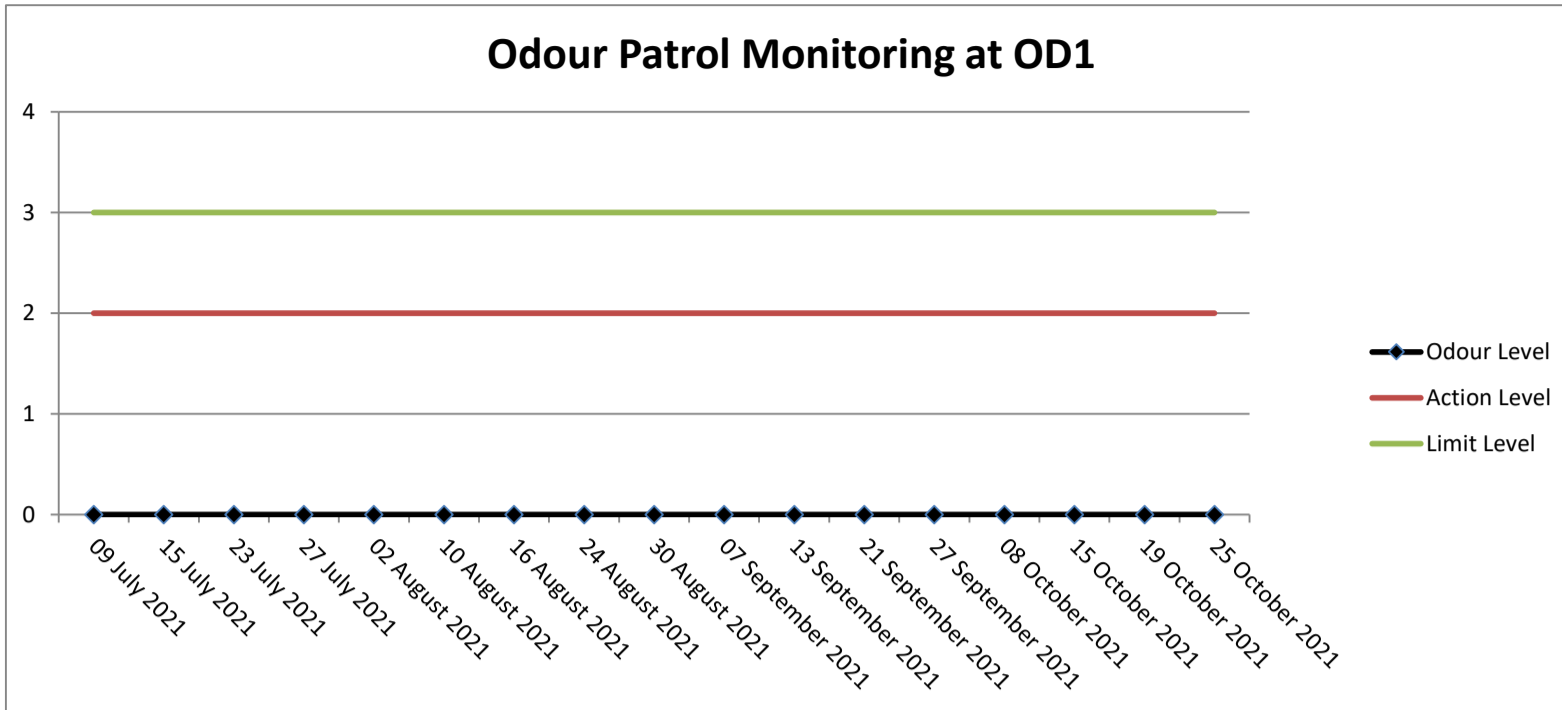
Note:
Y-axis refers to the Odour Level: 0 - Not Detected; 1- Slight; 2 - Moderate; 3 - Strong; 4 - Extreme
