# Monthly EM&A Report January 2022

:	Drainage Services Department
:	Contract No. CM 14/2016
	Environmental Team for Operational
	Environmental Monitoring and Audit for Siu
	Ho Wan Sewage Treatment Works
:	0041/17/ED/0658
	:

# INDEPENDENT ENVIRONMENTAL CHECKER FOR OPERATIONAL ENVIRONMENTAL MONITORING AND AUDIT FOR SIU HO WAN SEWAGE TREATMENT WORKS (SHWSTW) MONTHLY ENVIRONMENTAL MONITORING AND AUDIT (EM&A) REPORT (JANUARY 2022)

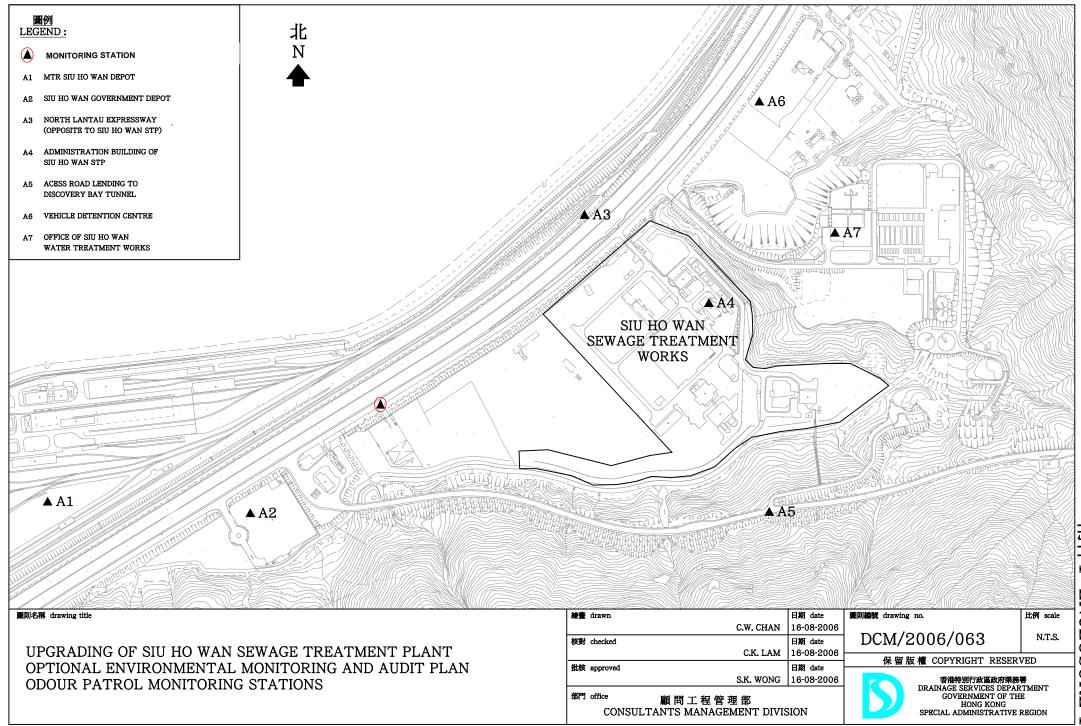
Figure 1

Monitoring Stations of Air Sensitive Receivers

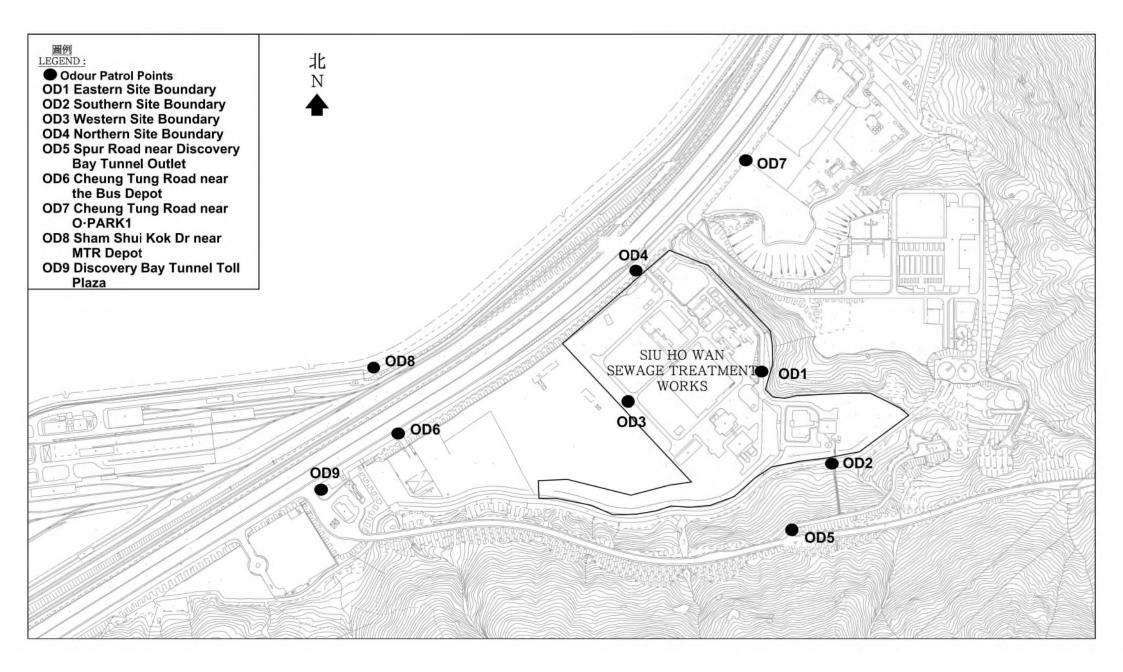
Figure 2

**2.4.3** The odour patrol points of modified odour patrol is shown in **Figure 2**.

Odour Patrol Points of Modified Odour Patrol

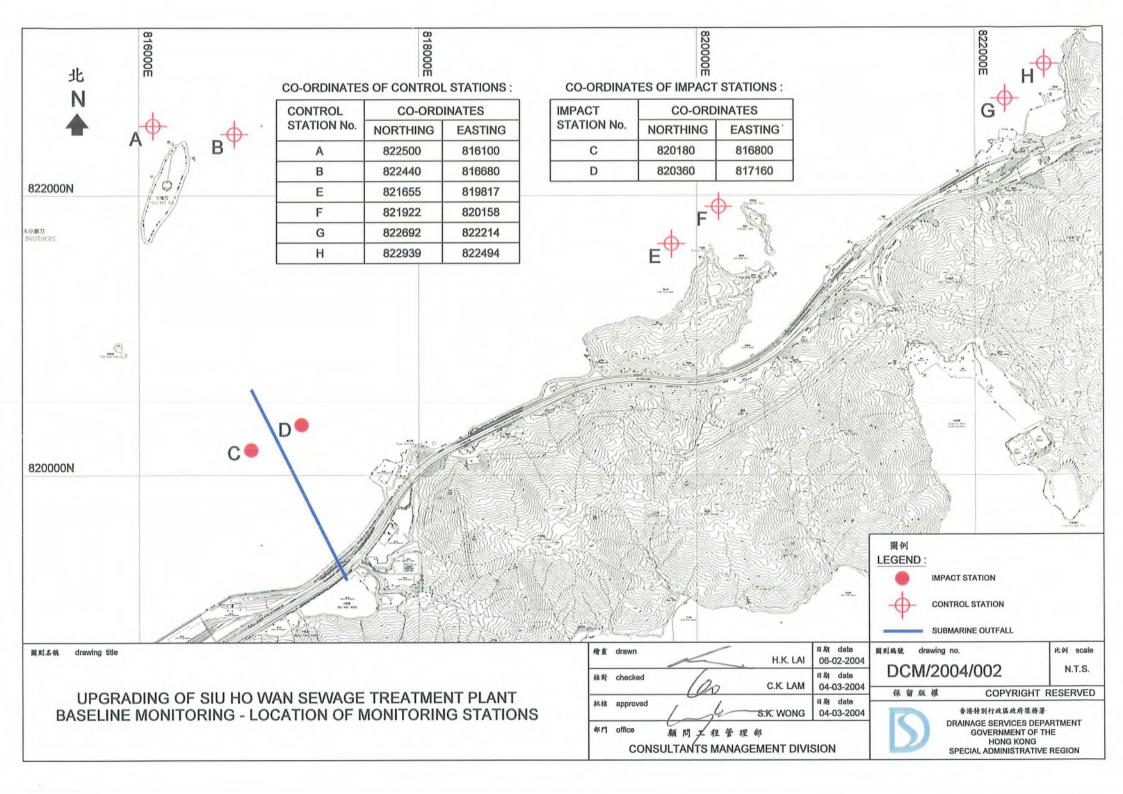
Figure 3

# Monitoring Stations of Water Quality Monitoring, Sediment Quality Monitoring and Benthic Survey

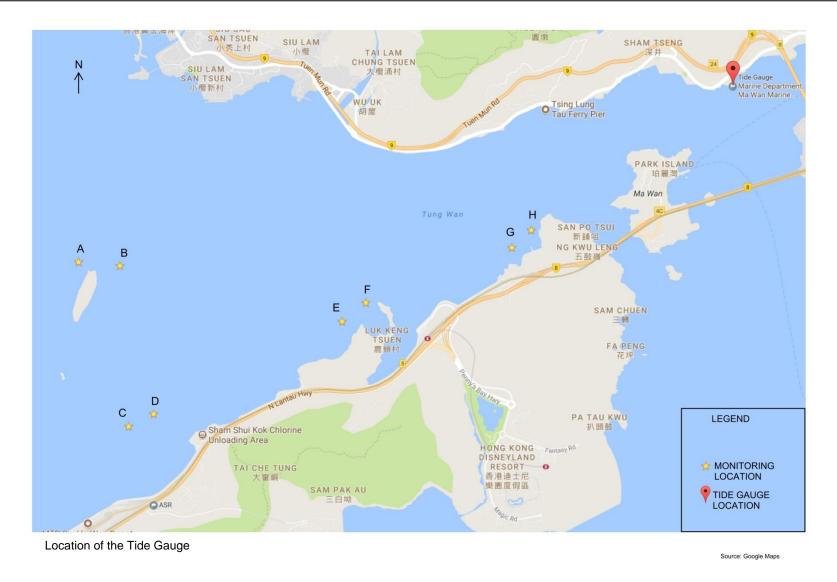
- **3.2.2** Apart from the parameters listed in the **Table 3.2**, other relevant supplementary information such as monitoring location, time, weather conditions and any special phenomena will be also recorded.
- **3.2.3** The tidal data will be obtained from the tide gauge installed in Ma Wan Marine Traffic Station, managed by the Hydrographic Office of Marine Department. Location of the tide gauge is shown in **Figure 4**.

- **4.2.2** Apart from the parameters listed in the Table 4.2, other relevant supplementary information such as monitoring location, time, weather conditions and any special phenomena will be also recorded.
- **4.2.3** The tidal data will be obtained from the tide gauge installed in Ma Wan Marine Traffic Station, managed by the Hydrographic Office of Marine Department. Location of the tide gauge is shown in **Figure 4**.

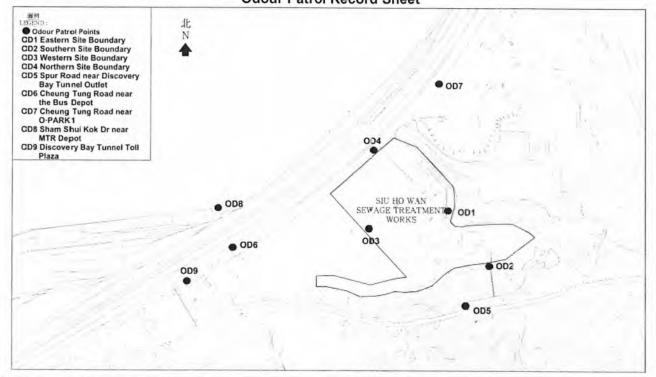
Date		3-1-22	Weather	Fine	Temperatur	e 19.	70C	Humidity	68%
ID	Locat	ion		Time	Wind Direction	Wind Speed (m/s)	Odour	1 Odour (	haracteristics
OD1	Easte	rn Site Boundar	у	10:29	N	1.7	6	/	
OD2	South	ern Site Bounda	ary	10:33	NW	0.5	1	E	Efluent
OD3	Weste	ern Site Boundar	ry	10:26	IVW	12.4	0	-	9
OD4	North	ern Site Bounda	ry	10:24	NW	0.0	0		1
OD5	Spur	Road near Disco	overy Bay Tunne			U.S.			
OD6	Cheu	ng Tung Road n	ear the Bus Dep	ot 10:08	NW	0.5	0		/
OD7	Cheu	ng Tung Road n	ear O·PARK1	10:10	1-	1.6	0		/
OD8	Sham	Shui Kok Dr ne	ar MTR Depot	10:02	NW	1.3	0		/
OD9	Disco	very Bay Tunnel	Toll Plaza	10:06		0.7	0		/

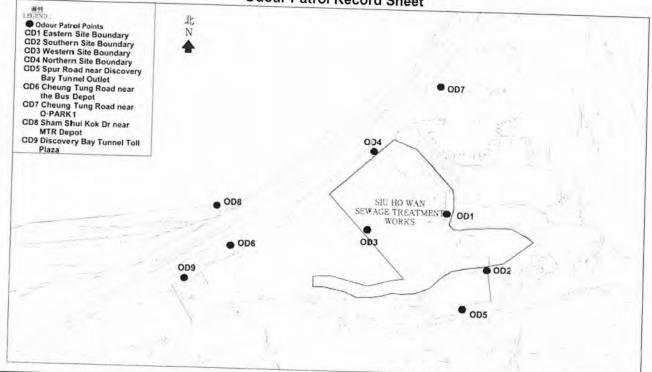
3 Jon 2021 Weather	ne	Temperatu	re 19.	7°( Hur	midity 62%
Location	Time	Wind Direction	Wind Speed	Odour	Odour Characteristics
Eastern Site Boundary	10.00	5/	(11/5)

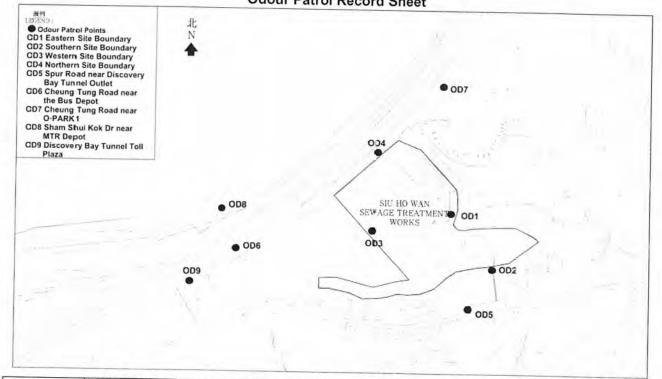
14 Jan 2022 Weather Clo	nely	Temperatu	re   6 4	, C Hur	midity 75%
Location	Time	Wind Direction	Wind Speed (m/s)	Odour intensity	Odour Characteristics
Eastern Site Boundary	1051	SU	1.5	D	1
Southern Site Boundary		N	17.9	10	
Western Site Boundary	6		- 1		
			11	0	/
	in it	/	1.6	0	- /,
	LOSK	NE	1.4	0	- /,
Cheung Tung Road near O.PARK1	1			-	1
Sham Shui Kok Dr near MTR Depot				0	-/,
Discovery Bay Tunnel Toll Plaza	1 1		12	5	- /,
	Eastern Site Boundary Southern Site Boundary Western Site Boundary Northern Site Boundary Spur Road near Discovery Bay Tunnel Outlet Cheung Tung Road near the Bus Depot Cheung Tung Road near O·PARK1 Sham Shui Kok Dr near MTR Depot	Eastern Site Boundary(c) [)Southern Site Boundary105 [)Western Site Boundary104 bNorthern Site Boundary104 bSpur Road near Discovery Bay Tunnel Outlet/Cheung Tung Road near the Bus Depot1035 bCheung Tung Road near O·PARK11027 bSham Shui Kok Dr near MTR Depot1023 bDiscovery Bay Tunnel Toll Plaza1023 b	Eastern Site Boundary       Iof J       SU         Southern Site Boundary       Iof J       SU         Southern Site Boundary       Iof J       N         Western Site Boundary       Iof J       NE         Northern Site Boundary       Iof V       NE         Northern Site Boundary       Iof V       NE         Spur Road near Discovery Bay Tunnel Outlet       Iof V       NE         Cheung Tung Road near the Bus Depot       Iof SK       NE         Cheung Tung Road near O·PARK1       Iof 21       NE         Sham Shui Kok Dr near MTR Depot       Iof 21       NE         Discovery Bay Tunnel Toll Plaza       Iof 23       NE	LocationTimeWind DirectionSpeed (m/s)Eastern Site Boundary(051)5001.5Southern Site Boundary105 bN0.9Western Site Boundary104 bNE0.9Northern Site Boundary104 bNE0.6Northern Site Boundary104 bNE0.6Spur Road near Discovery Bay Tunnel Outlet//Cheung Tung Road near the Bus Depot1035NE1.4Cheung Tung Road near OPARK11037NE0.9Sham Shui Kok Dr near MTR Depot(021)NE1.0Discovery Bay Tunnel Toll Plaza1033NE1.3	LocationTimeWind DirectionSpeed (m/s)Odour intensityEastern Site Boundary(0) 15001.50Southern Site Boundary1056N0.90Western Site Boundary1040NE0.00Northern Site Boundary1044NE1.60Spur Road near Discovery Bay Tunnel Outlet////Cheung Tung Road near the Bus Depot1035NE1.40Cheung Tung Road near O'PARK11037NE0.90Sham Shui Kok Dr near MTR Depot1033NE1.00Discovery Bay Tunnel Toll Plaza1033NE1.30

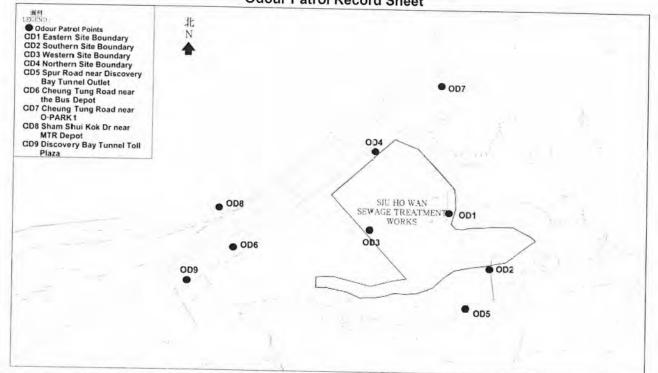
Date	14/1/2022 Weather Clou	dy	Temperature 16,5°C Humidity			midity 75 %
ID	Location	/ Time	Wind Direction	Wind Speed (m/s)	Odour intensity	Odour Characteristics
OD1	Eastern Site Boundary	1051	SW	115	0	/
OD2	Southern Site Boundary	1056	N	0.9	0	
OD3	Western Site Boundary	1048	NE	0.8	-	
OD4	Northern Site Boundary	10 44	NE	1.6	0	/
OD5	Spur Road near Discovery Bay Tunnel Outlet		100	110	0	/
OD6	Cheung Tung Road near the Bus Depot	1035	NE	1.4	-	/
OD7	Cheung Tung Road near O·PARK1	1037	NE	0.8	0	/
OD8	Sham Shui Kok Dr near MTR Depot	1027	NE		0	
OD9	Discovery Bay Tunnel Toll Plaza	1033	NE	1.0.		
Classi	fication Criteria:	103/	IV L	112	0

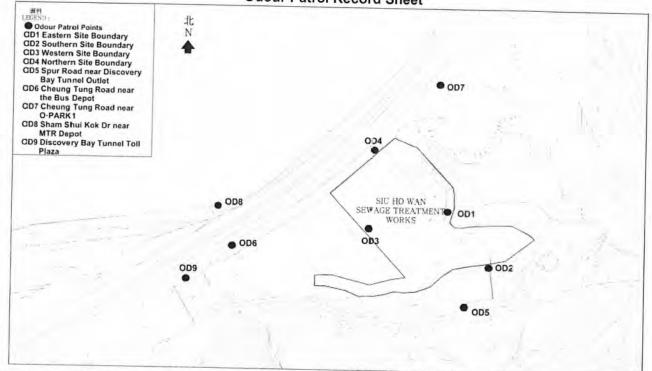
20/1/2022 Weather Fine	2	Temperatu	re 17,5	°C Hu	midity 61 %
Location	Time	Wind Direction	Wind Speed (m/s)	Odour intensity	Odour Characteristics
Eastern Site Boundary	1052	N	1	0	1
Southern Site Boundary	1056			. 1	2811 4
Western Site Boundary			0.5	1	Efflorent
		NE	0		1
		IVE	015	0	- /

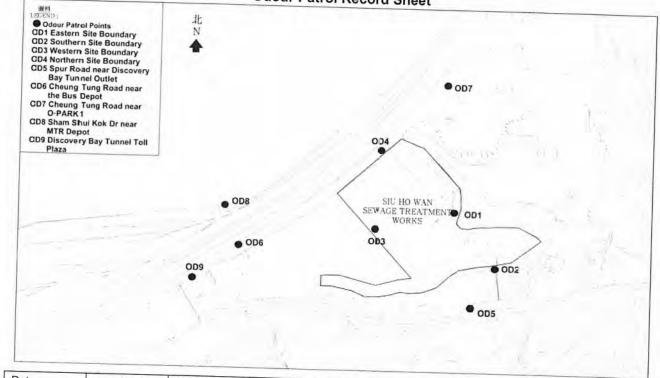
Date	20/1/2012 Weather Fin	e	Temperatu	re 175	"( Hur	midity	61%
ID	Location	Time	Wind Direction	Wind Speed (m/s)	Odour intensity	Odour Cha	
OD1	Eastern Site Boundary	10:52	N		D		
OD2	Southern Site Boundary	10.56		0.2	U	/	
OD3	Western Site Boundary		N	0.3	0 /		
OD4	Northern Site Boundary	10:48	-	0	0	/	
OD5	Spur Road near Discovery Bay Tunnel Outlet	10:44	NE	0.3	0	/	
OD6	Chause T	1	/	/	/	/	
0.01	Cheung Tung Road near the Bus Depot	10:31	1	0	D	-	
OD7	Cheung Tung Road near O·PARK1	10:33	01	0	U	/	
OD8	Sham Shui Kok Dr near MTR Depot	10:21	N	0.2	0	/	
OD9	D9 Discovery Bay Tunnel Toll Plaza		IVE	0.2	0	/	
Classif	fication Criteria:	10.28	/	V	O	/

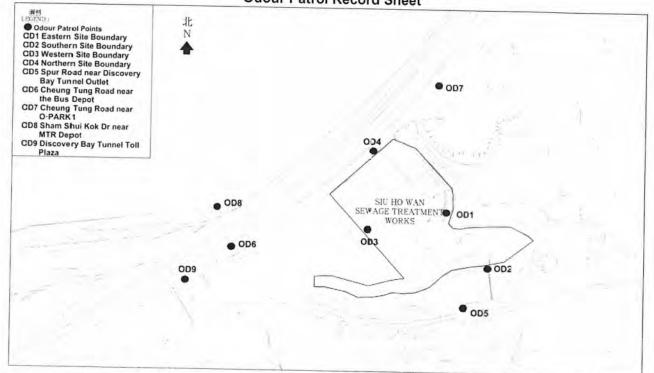
Date	26-1-2027 Weather Find	2	Temperatu	re 21.6	C Hu	midity 70%			
ID	Location	Time	Wind Direction	Wind Speed (m/s)	Odour intensity	Odour Characteristics			
OD1	Eastern Site Boundary	1521	N	0:4	0	/			
OD2	Southern Site Boundary	1524	/	0	-				
OD3	Western Site Boundary		Western Site Boundary	1519	1	0.7	0		
OD4	Northern Site Boundary	15/6	E	0.6	0	/			
OD5	Spur Road near Discovery Bay Tunnel Outlet	1542		0	0	/			
OD6	Cheung Tung Road near the Bus Depot	1502	N	-	0	/			
OD7	Cheung Tung Road near O·PARK1	1504	10	0.3	0				
OD8	Sham Shui Kok Dr near MTR Depot	1455	NE	-	0				
OD9	Discovery Bay Tunnel Toll Plaza	1500	IVL	0.5	0				
Classi	fication Criteria:	1,200	-

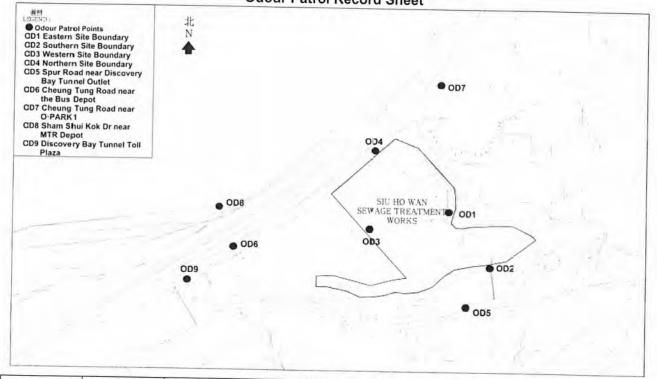
Date	-	26/1/ 3022 Weather	Fine	Temperatu	re 21	C Hur	midity 70%	
ID	D Location		Time	Wind Direction	Wind Speed (m/s)	Odour intensity	Odour Characteristics	
OD1	Easte	rn Site Boundary	1521	N	0.4	0	1	
OD2	South	ern Site Boundary	1524	/	C	1	C111 +	
OD3	Weste	ern Site Boundary	1519	. 1	-	1	Effluent	
OD4	-	ern Site Boundary	1516	NE	VI	C	/	
OD5		Road near Discovery Bay Tunnel Ou	tlet 1542		0.6	0		
OD6		ng Tung Road near the Bus Depot	1502	N	0.3	0	-	
OD7	Cheung Tung Road near O·PARK1		1404		0.7	0	1	
OD8	Sham Shui Kok Dr near MTR Depot		1455	NE	0.5	0	1	
OD9			1500	/	0.7	0		
Classification Criteria:					0	0

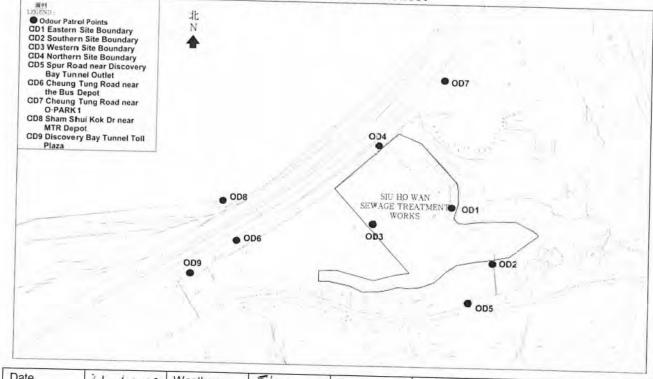
Date	31-1-2022 Weather Fin	e	Temperatu	re 13,2	2°C Hu	midity 6/01
ID	Location	Time	Wind Direction	Wind Speed (m/s)	Odour intensity	Odour Characteristics
OD1	Eastern Site Boundary	1045	N	0.4	0	
OD2	Southern Site Boundary	1048	//	D	1	FAIL
OD3	Western Site Boundary	1043	-	-	1	Eff elent
OD4	Northern Site Boundary	1041	E	1.0	0	/
OD5	Spur Road near Discovery Bay Tunnel Outlet		N	0.4	6	/
OD6	Cheung Tung Road near the Bus Depot	1-	1-	/	/	/
OD7	Cheung Tung Road near O.PARK1	1033	NE	0.5	0	/
OD8		1035	NE	0.4	0	/
2.202	Sham Shui Kok Dr near MTR Depot	1028	/	0	0	/
OD9	Discovery Bay Tunnel Toll Plaza	1031	N	0.2	0	
Classi	fication Criteria:			0.0	0

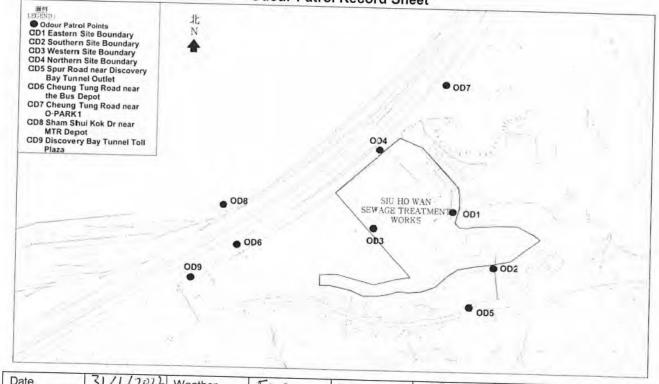
Date	ST/1/2022 Weather Fin	e	Temperatu	re 13.	2°C Hur	midity 61%
ID	Location	Time	Wind Direction	Wind Speed (m/s)	Odour intensity	Odour Characteristics
OD1	Eastern Site Boundary	10:45	N	0.4	D	
OD2	Southern Site Boundary			0.4	-	
OD3	Western Site Boundary	10:4A	-	0	U	/
OD4	Northern Site Boundary	10:43	E	1.0	0	/
OD5	Spur Road near Discovery Bay Tunnel Outlet	10:41	N	0.4	0	/
OD6	Cheung Tung Road near the Bus Depot		1-	/	/	/
OD7	Cheung Tung Road near O·PARK1	10:33	NE	0.5	0	(
OD8	Sham Shui Kok Dr near MTR Depot	10:35	NE	0.4	0	/
OD9	Discovery Bay Tunnel Toll Plaza	10:22	/	0	6	/
Classi	fication Criteria:	10:31	N	0.2	D	/

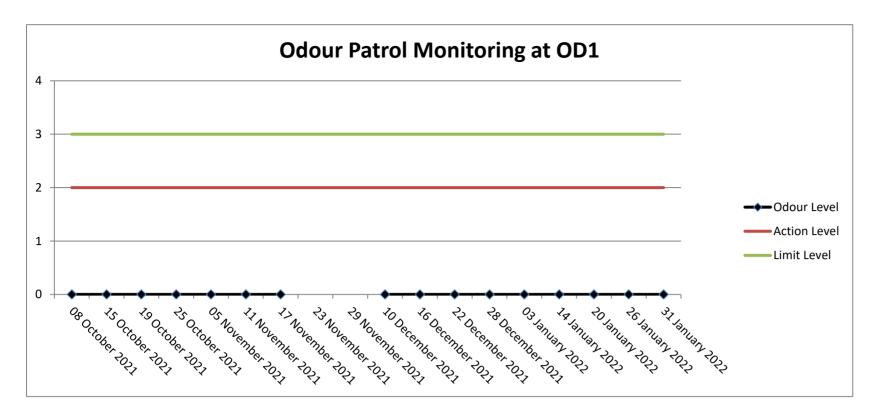
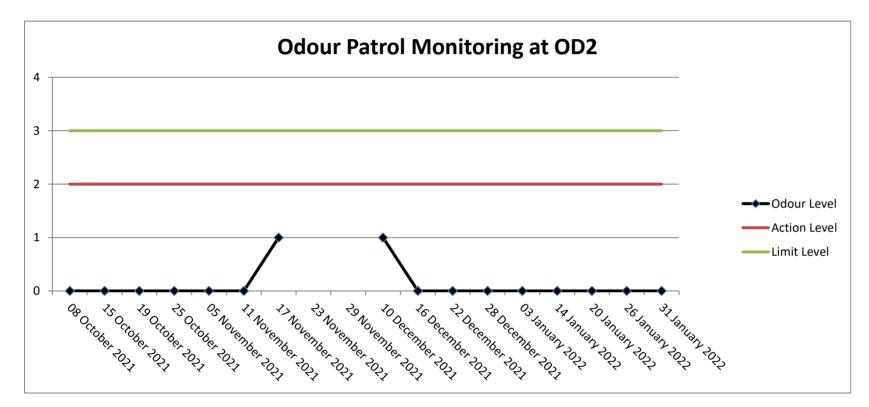
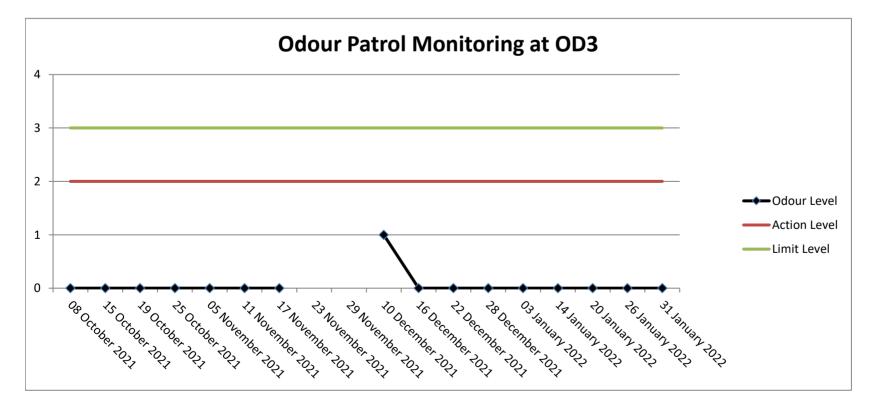
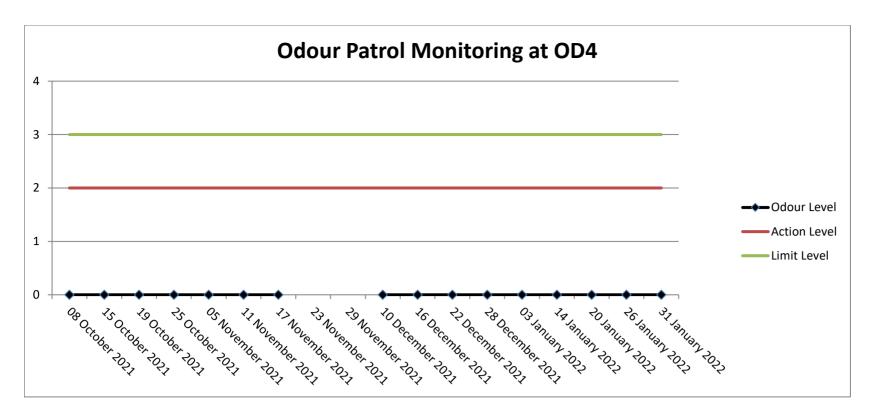
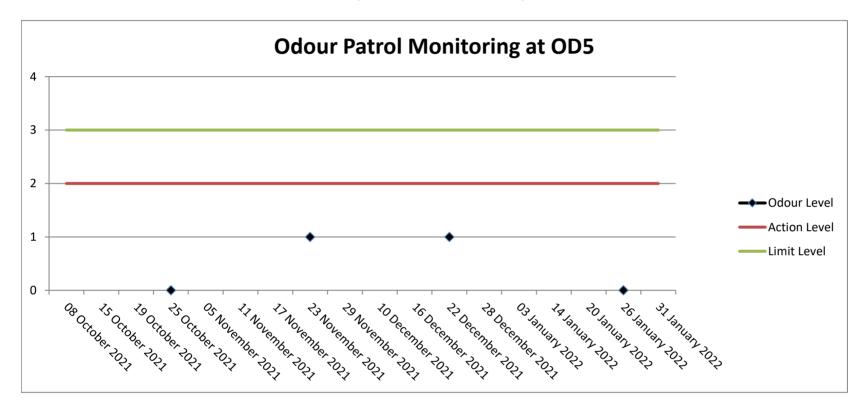
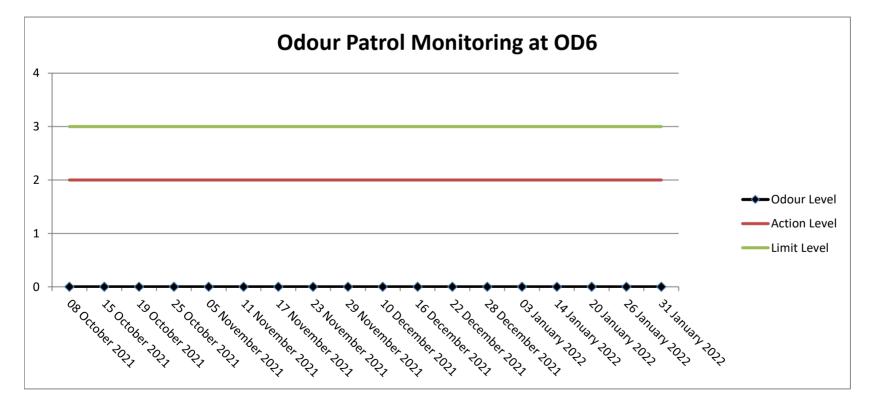
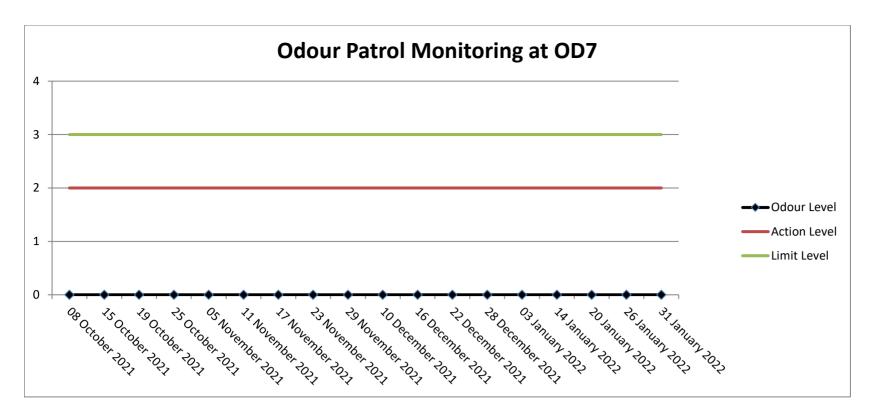
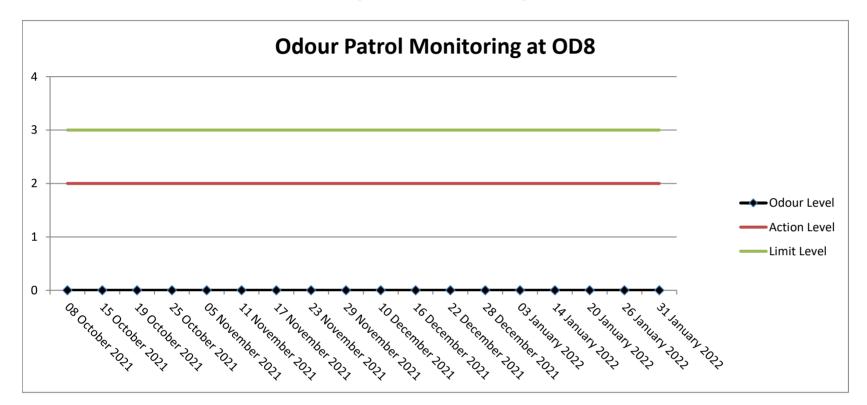
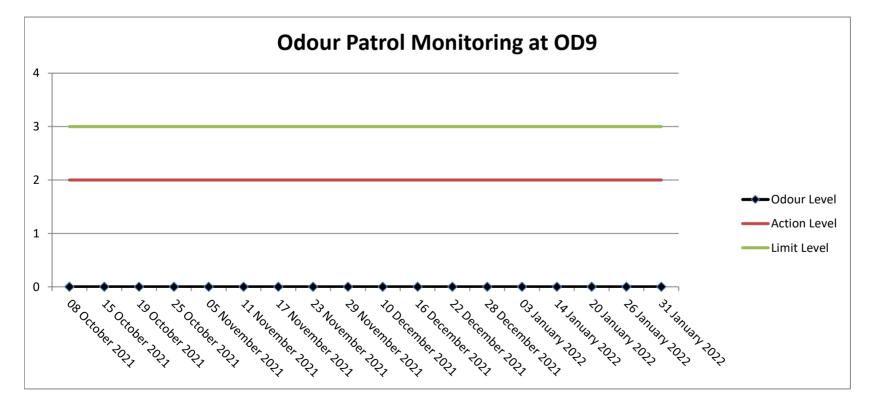
Y-axis refers to the Odour Level: 0 - Not Detected; 1- Slight; 2 - Moderate; 3 - Strong; 4 - Extreme
