**Castle Peak Road
Improvement Between
Sham Tseng and Ka
Loon Tsuen,
Tsuen Wan
West Contract No.
HY/99/18**

Monthly Environmental
Monitoring and Audit
Report
October 2004

Monthly Environmental Monitoring and Audit Report – October 2004

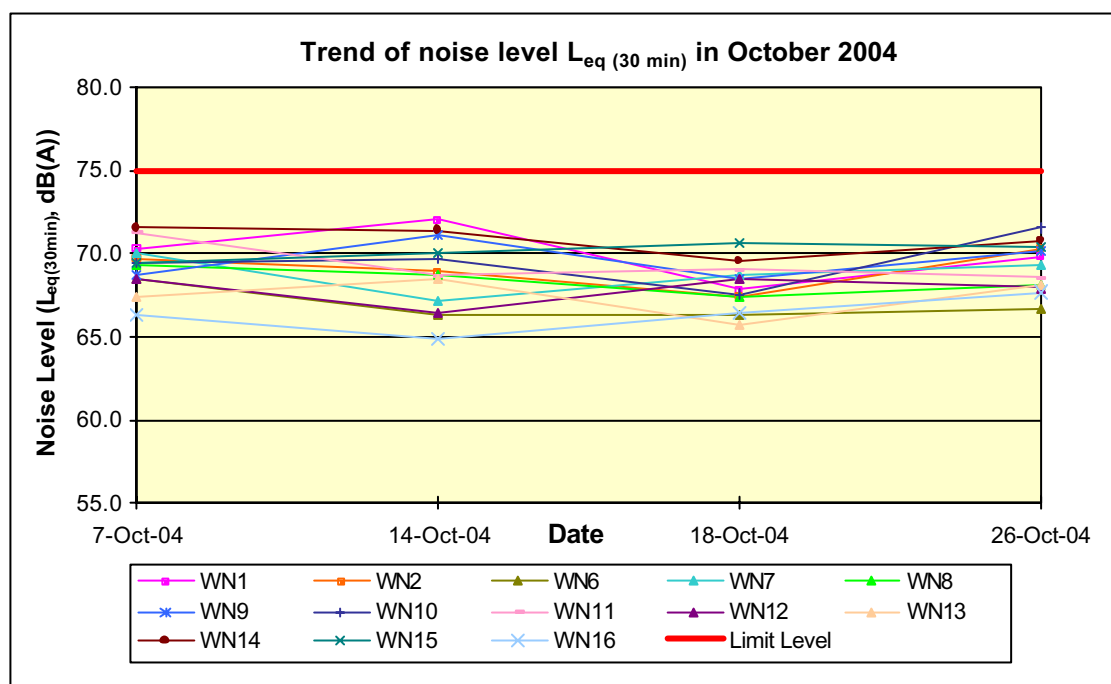
Figure 5-1 Graphical presentation of daytime noise levels for October 2004

The highest noise level was 72dB(A) recorded at House No.3, Ka Loon Tsuen (WN1) on 14 October 2004 while the lowest noise level was 65dB(A) recorded at G/F, Carpark of Lido Garden (WN16) on 14 October 2004. There was no exceedance of the AL Levels during the monitoring period. The noise levels at each monitoring location are plotted and presented in Figure 5-1.
