ENVIRONMENTAL MONITORING AND AUDIT REPORT

CONTRACT No. CV/2002/L3

FILL BANK AT TUEN MUN AREA 38

OCTOBER 2004

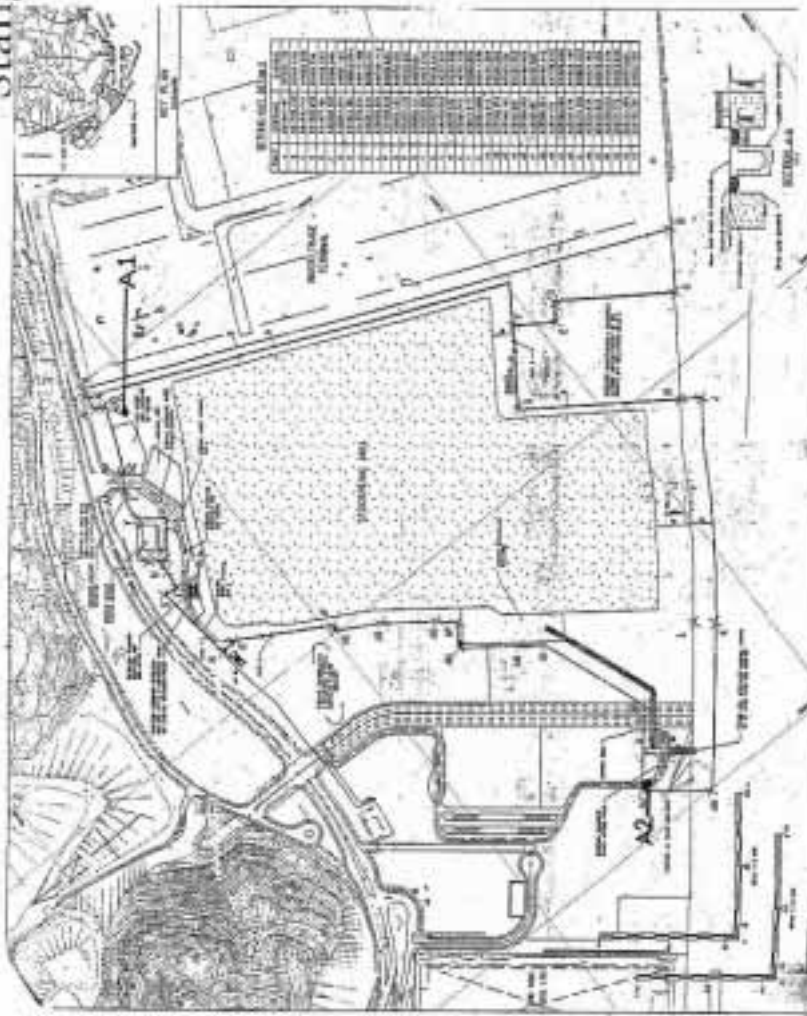
Figure 4.1 – Air Quality Monitoring Stations

The project has two designated locations (A1 & A2) for the monitoring of air quality. A1 is a fixed location in the vicinity of the site office to monitor the TSP levels at River Trade Terminal and A2 is a movable location to the western boundary of the site that is designed to move as works progress. The air monitoring locations are shown in Figure 4.1.

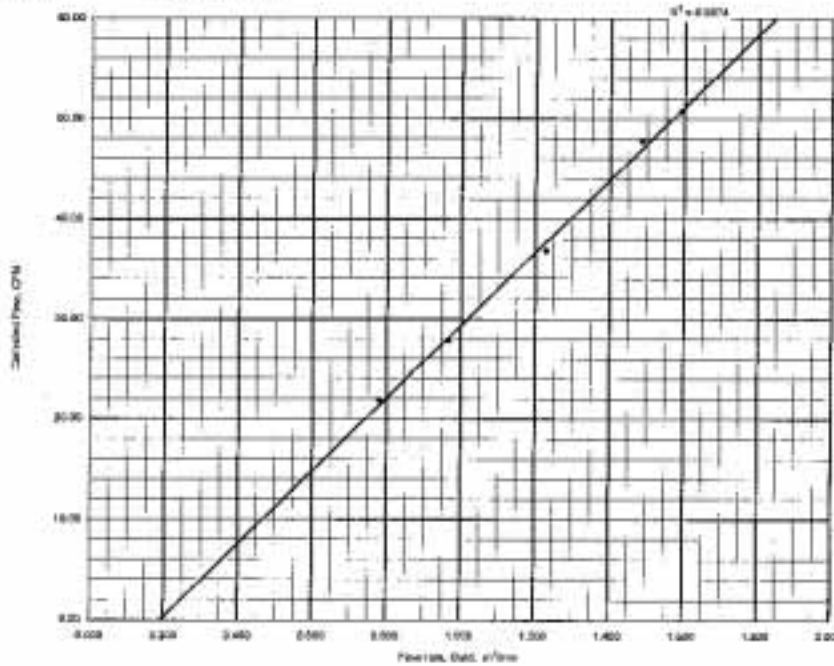
Location: Tuen Mun Area 30 - 01

Remarks: The correlation coefficient is larger than 0.99 indicates the calibration is linear.
 Slope= 30.320028
 Intercept= -6.903426

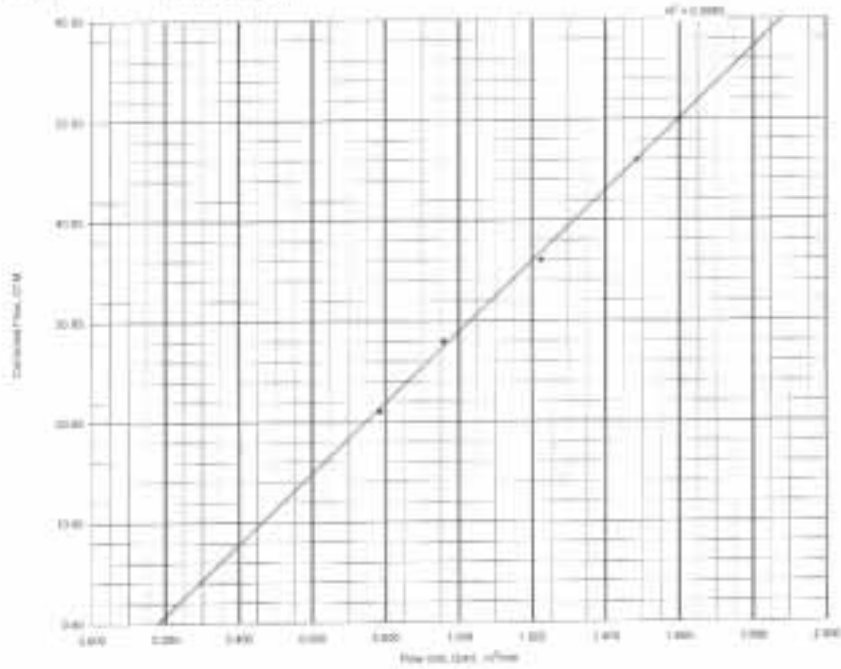
Location: Tuan Man Area 30 - A1

Remarks: The correlation coefficient is larger than 0.99 indicates the calibration is linear.
 Station: SD 152424
 Inspector: G200198

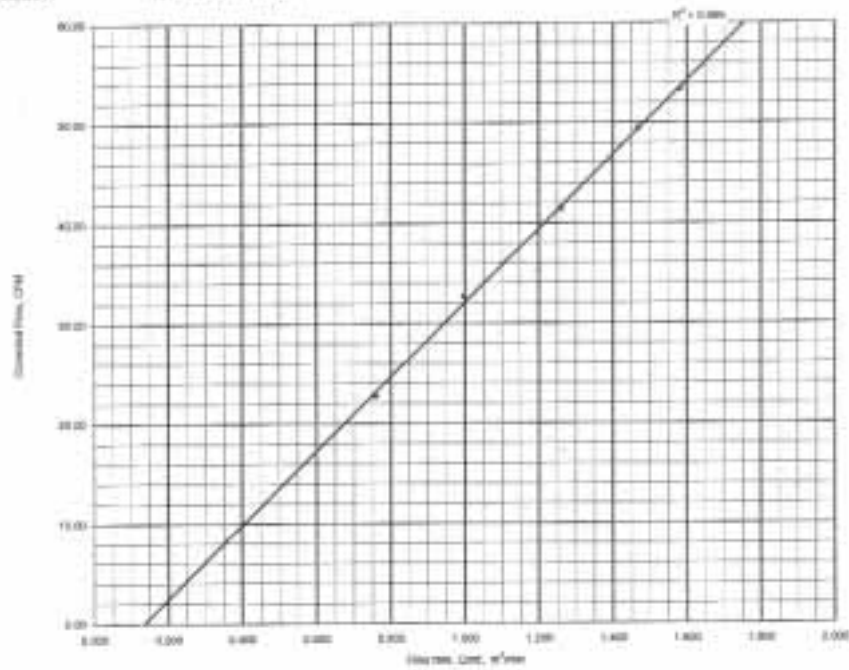
Location: Tuas Man Area 38 - A2

Remarks: The correlation coefficient is larger than 0.99 indicates the calibration is linear.
 Slope = 36.86674
 Intercept = -4.95797

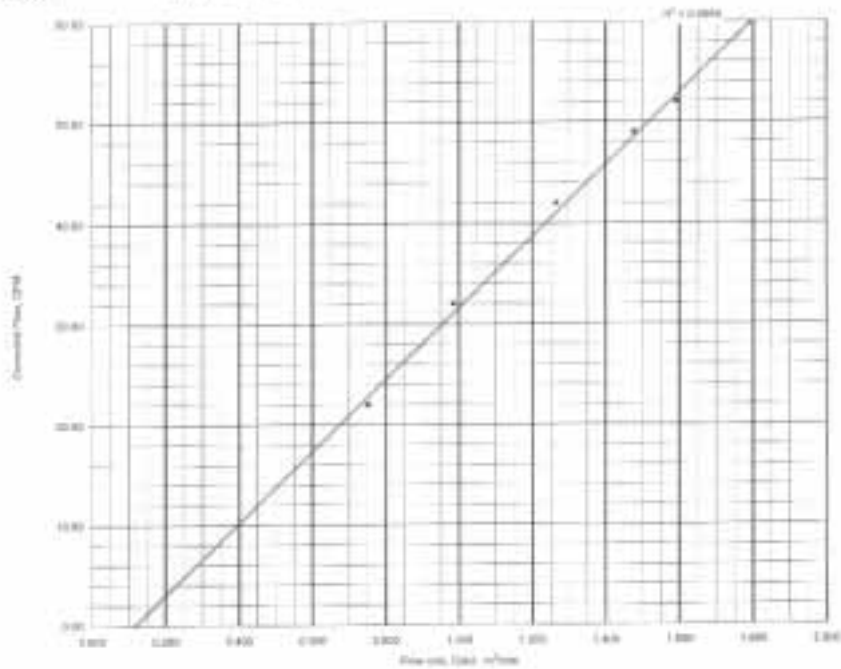
Location: Tuas Man Area 7B - A2

Remarks: The correlation coefficient is larger than 0.99 indicates the calibration is fine.
 Skiper: 00.072877
 Microchip: -3.920422
