ENVIRONMENTAL MONITORING AND AUDIT REPORT

CONTRACT No. CV/2002/13

FILL BANK AT TUEN MUN AREA 38

DECEMBER 2004

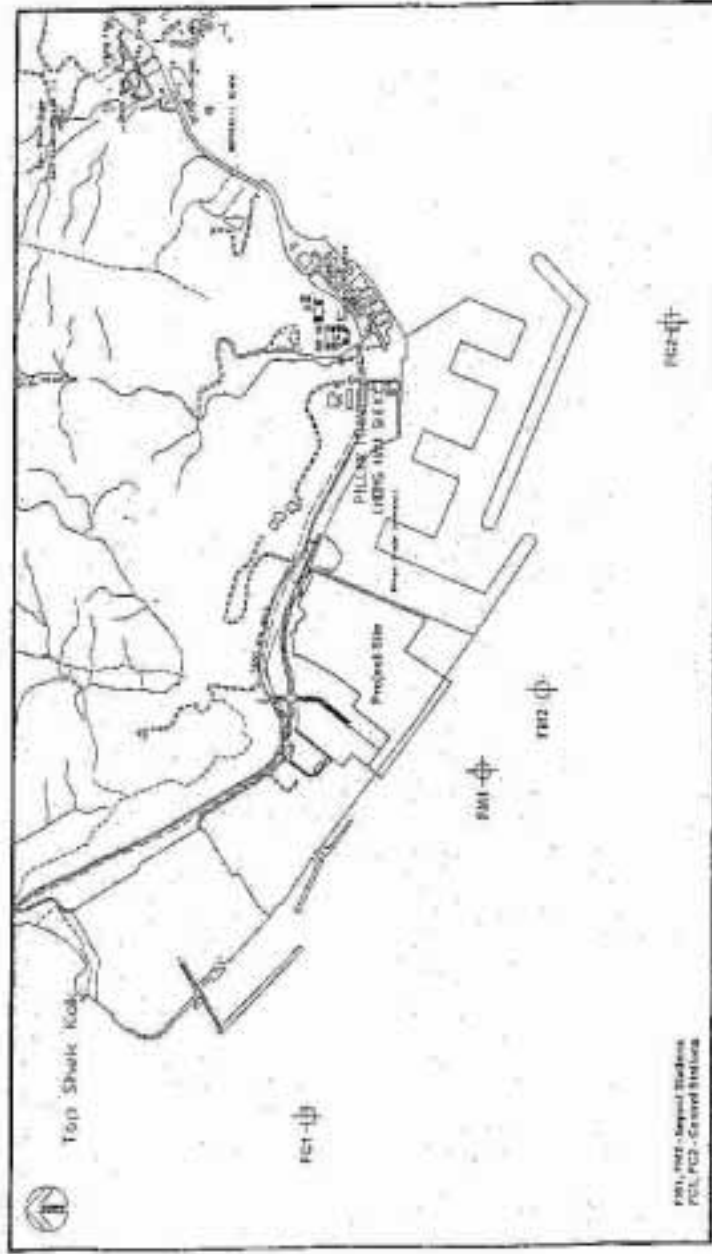
Figure 4.2 – Water Quality Monitoring Stations

Water quality in terms of turbidity, dissolved oxygen, suspended solids, temperature, and salinity, was carried out on fourteen occasions during flood tide and ebb tide at FM1, FM2, FC1 and FC2 in this reporting period. There was no exceedance to the set action or limit level for all parameters at all stations.
