**Development at Former Marine Police
Headquarters KIL 11161
Environmental Monitoring & Audit Report
for June 2008**

(Ref No. 3.12/050/2006)

July 2008

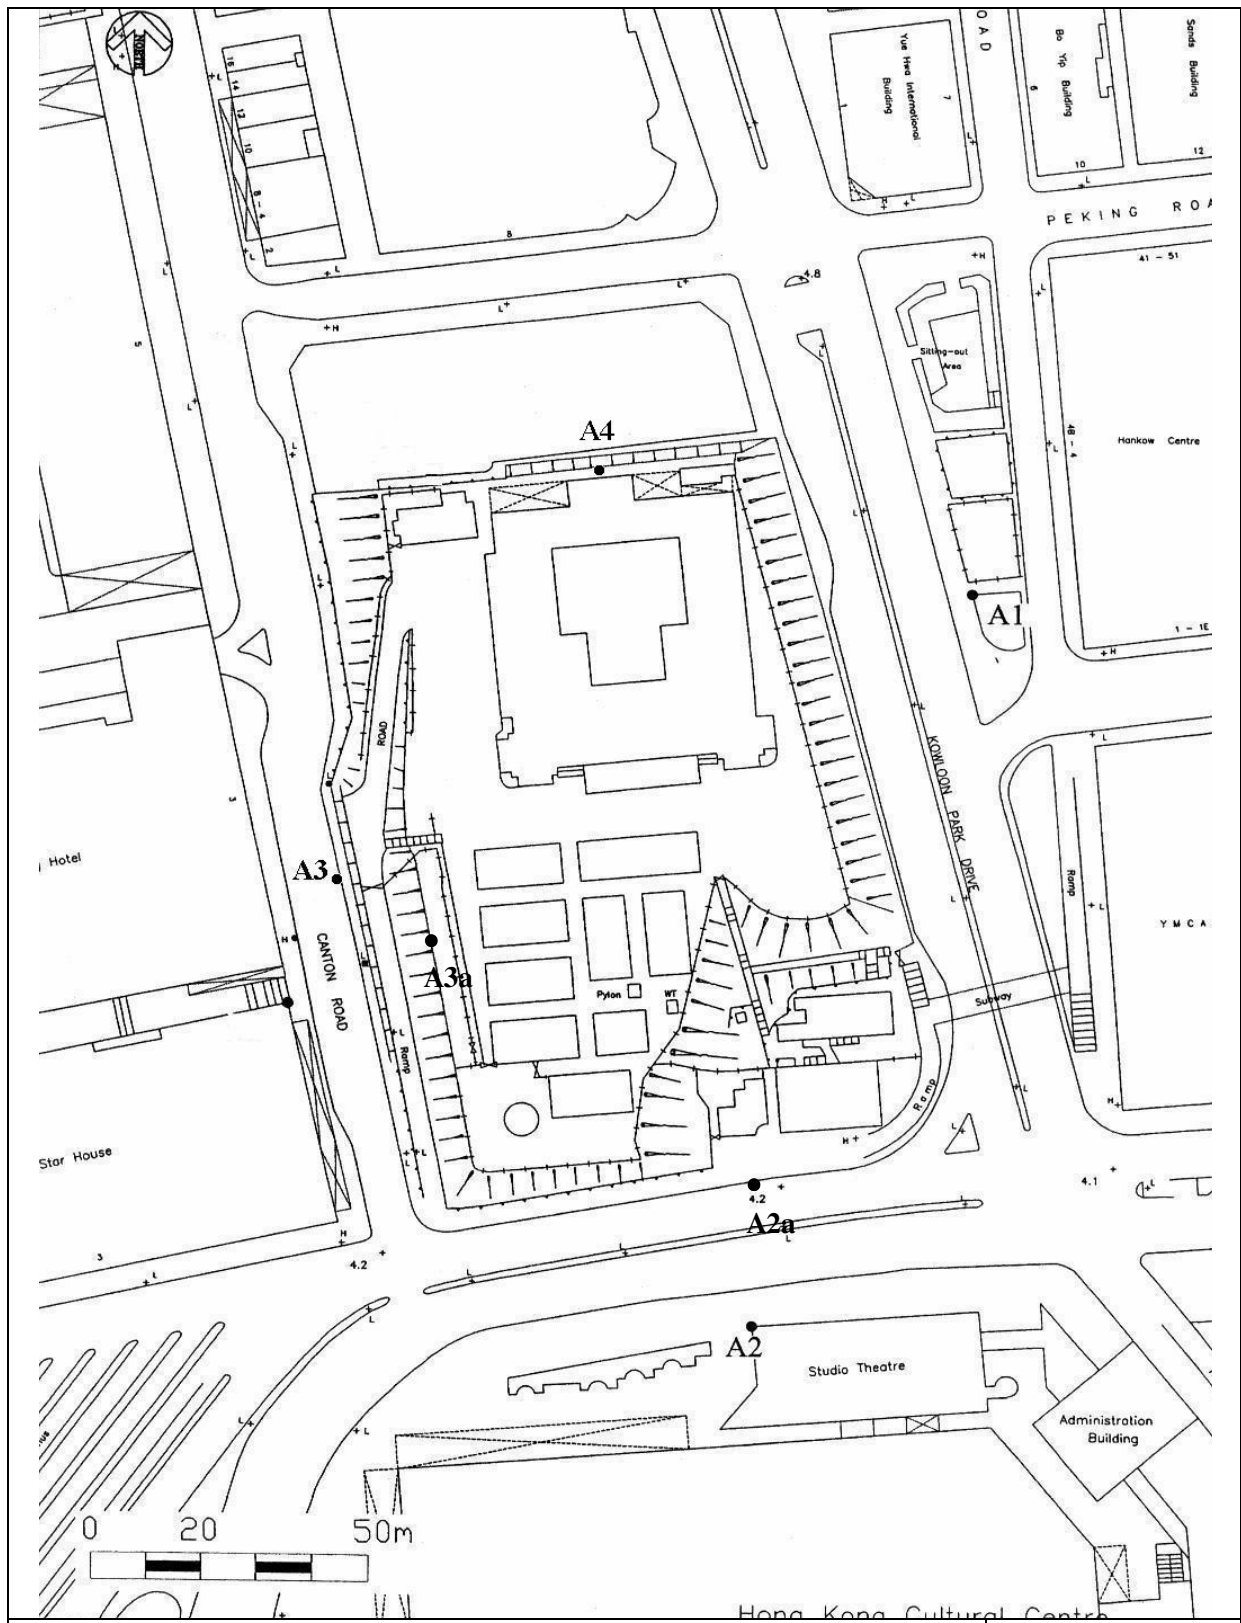
Figure 3.1 Dust Monitoring Locations (A1 is on building rooftop about 11m above ground, A2, on podium level about 5m above ground, A2a, A3a and A4 on hoarding top about 6m, 6m and 13m above ground respectively)

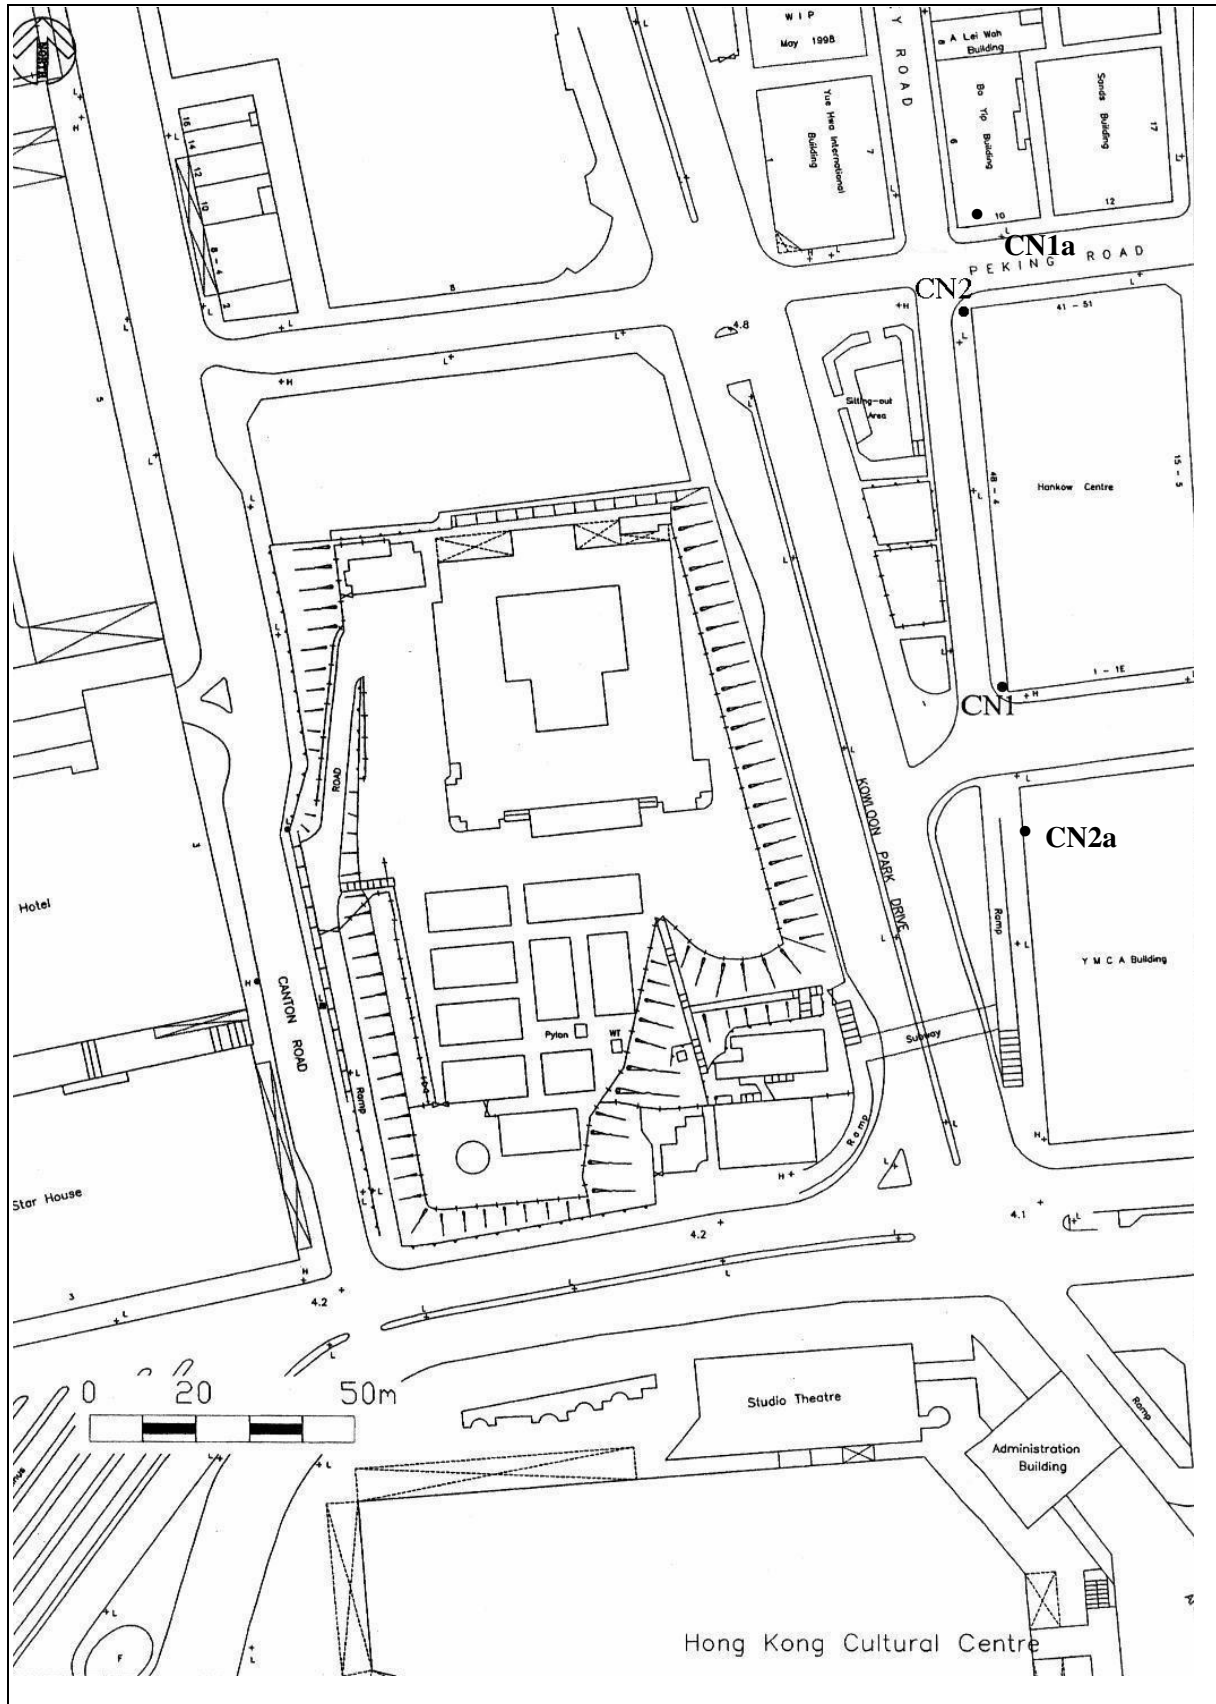
Figure 4.1 Proposed Noise Monitoring Stations (CN1 and CN2 are at podium level, about 15m above ground). Alternative measurement stations (CN1a and CN2a are about 33m and 11m above ground respectively).

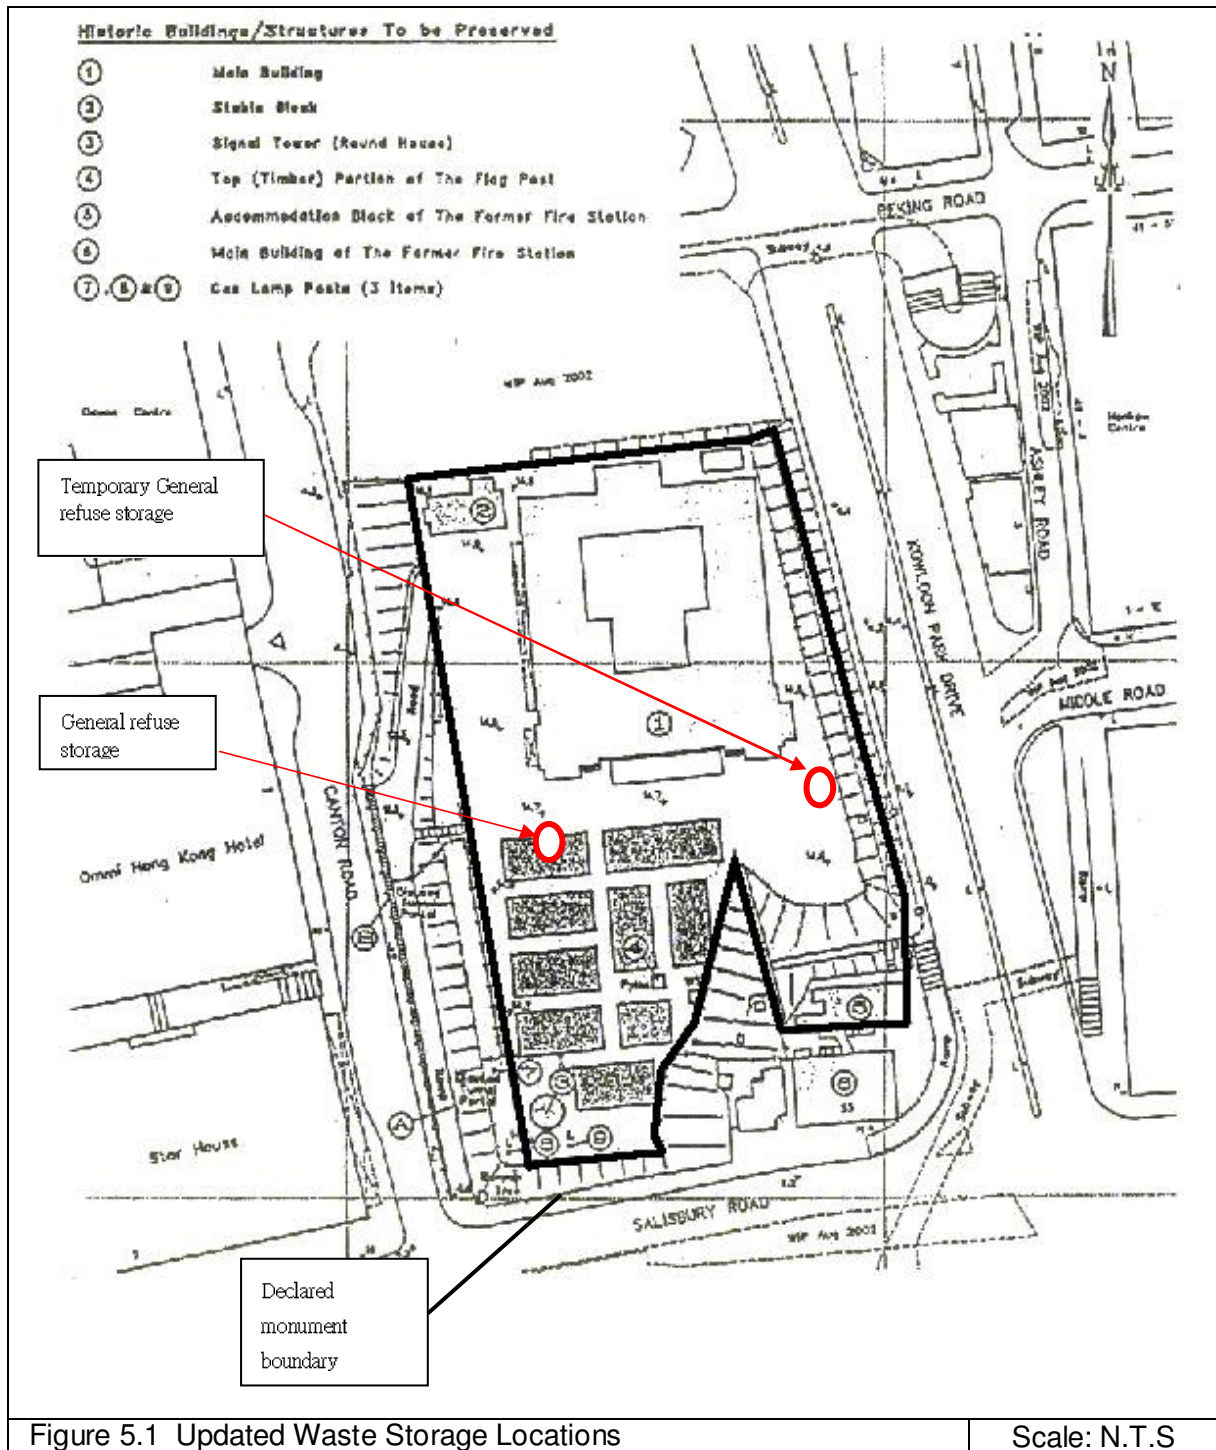
Figure 5.1 Updated Waste Storage Locations

- 5.4. Updated records on waste disposal should be made available promptly to allow better monitoring of waste management performance. Waste recycling should be more actively promoted on site. In particular, the Contractor is reminded to maintain proper documentation on the return of chemical containers to suppliers for reuse.
- 5.5. Temporary waste storage location has been shifted to the west closer to the present site entrance to suit for the site progress. As per paragraph 4.33 of the Waste Management Plan of May 2007, Figure 5.1 gives the updated waste storage locations. Proper covering and storage of general refuse should be carried out.
- 5.6. Chemical waste storage area is now removed due to the lack of chemical waste produced. Contractor is reminded to reinstate the proper chemical waste storage area if there is chemical waste produced.
