**Development at Former Marine Police
Headquarters KIL 11161
Environmental Monitoring & Audit Report
for July 2008**

(Ref No. 3.12/050/2006)

August 2008

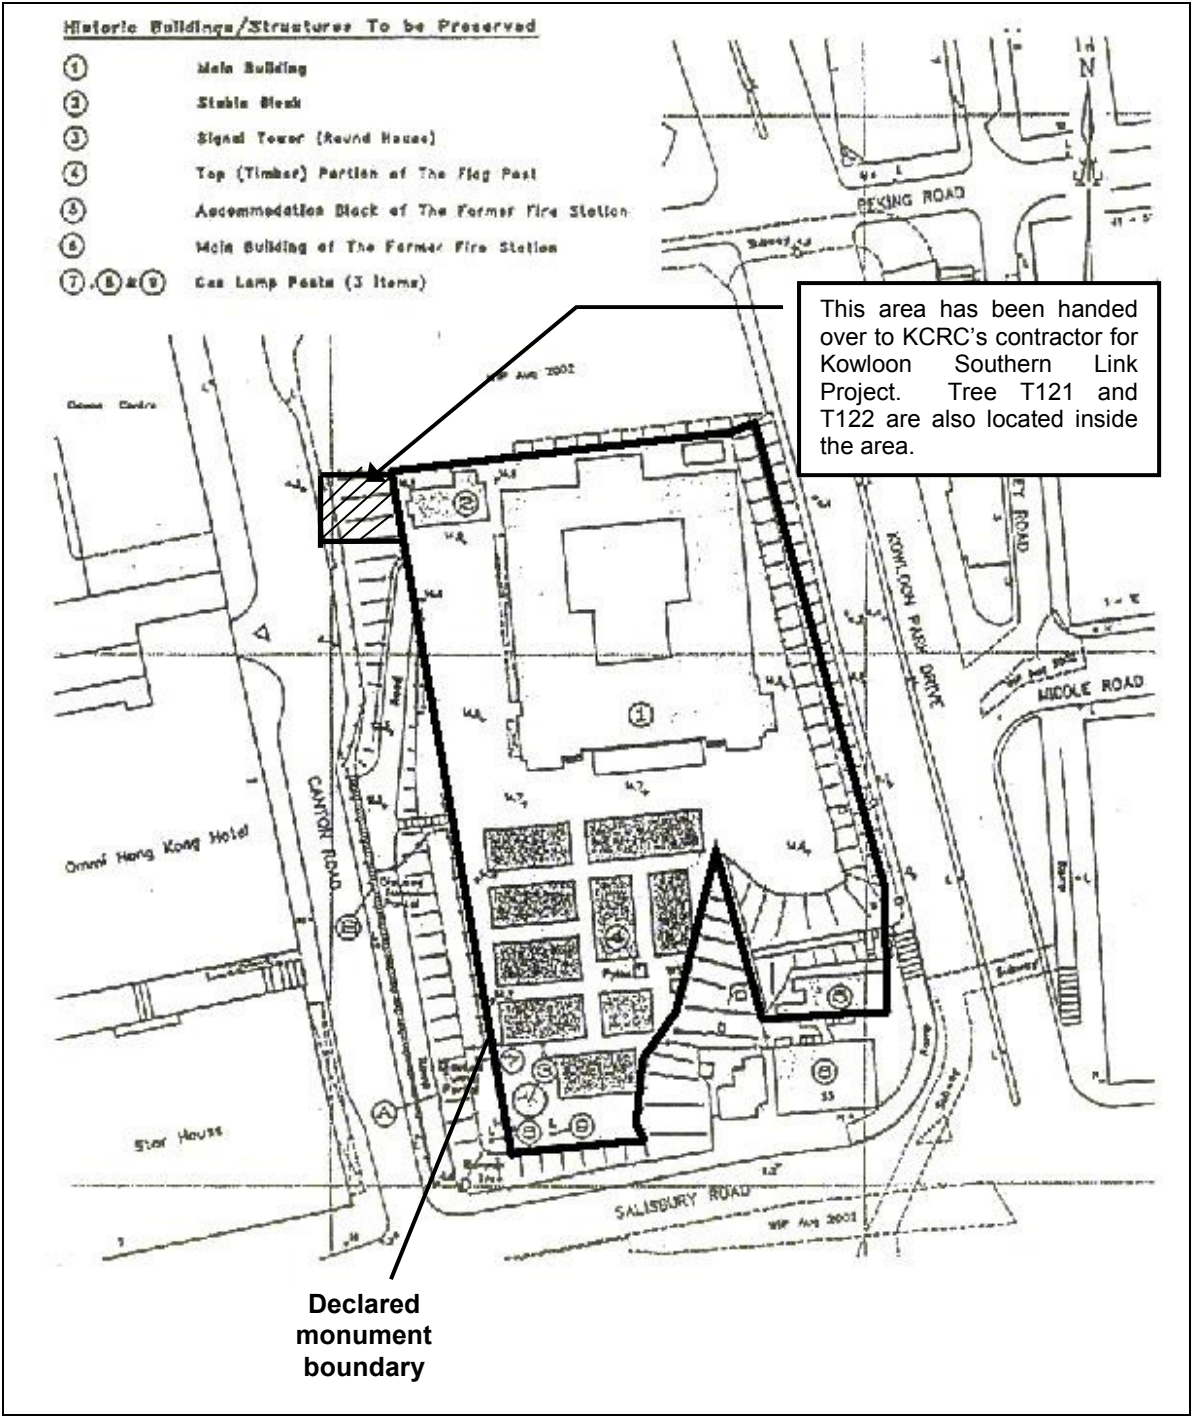
Figure 2.1 Location, site layout with the location of site where it was handed over to KCRC's Contractor for KSL Project, historic buildings and structures to be preserved Scale: N.T.S

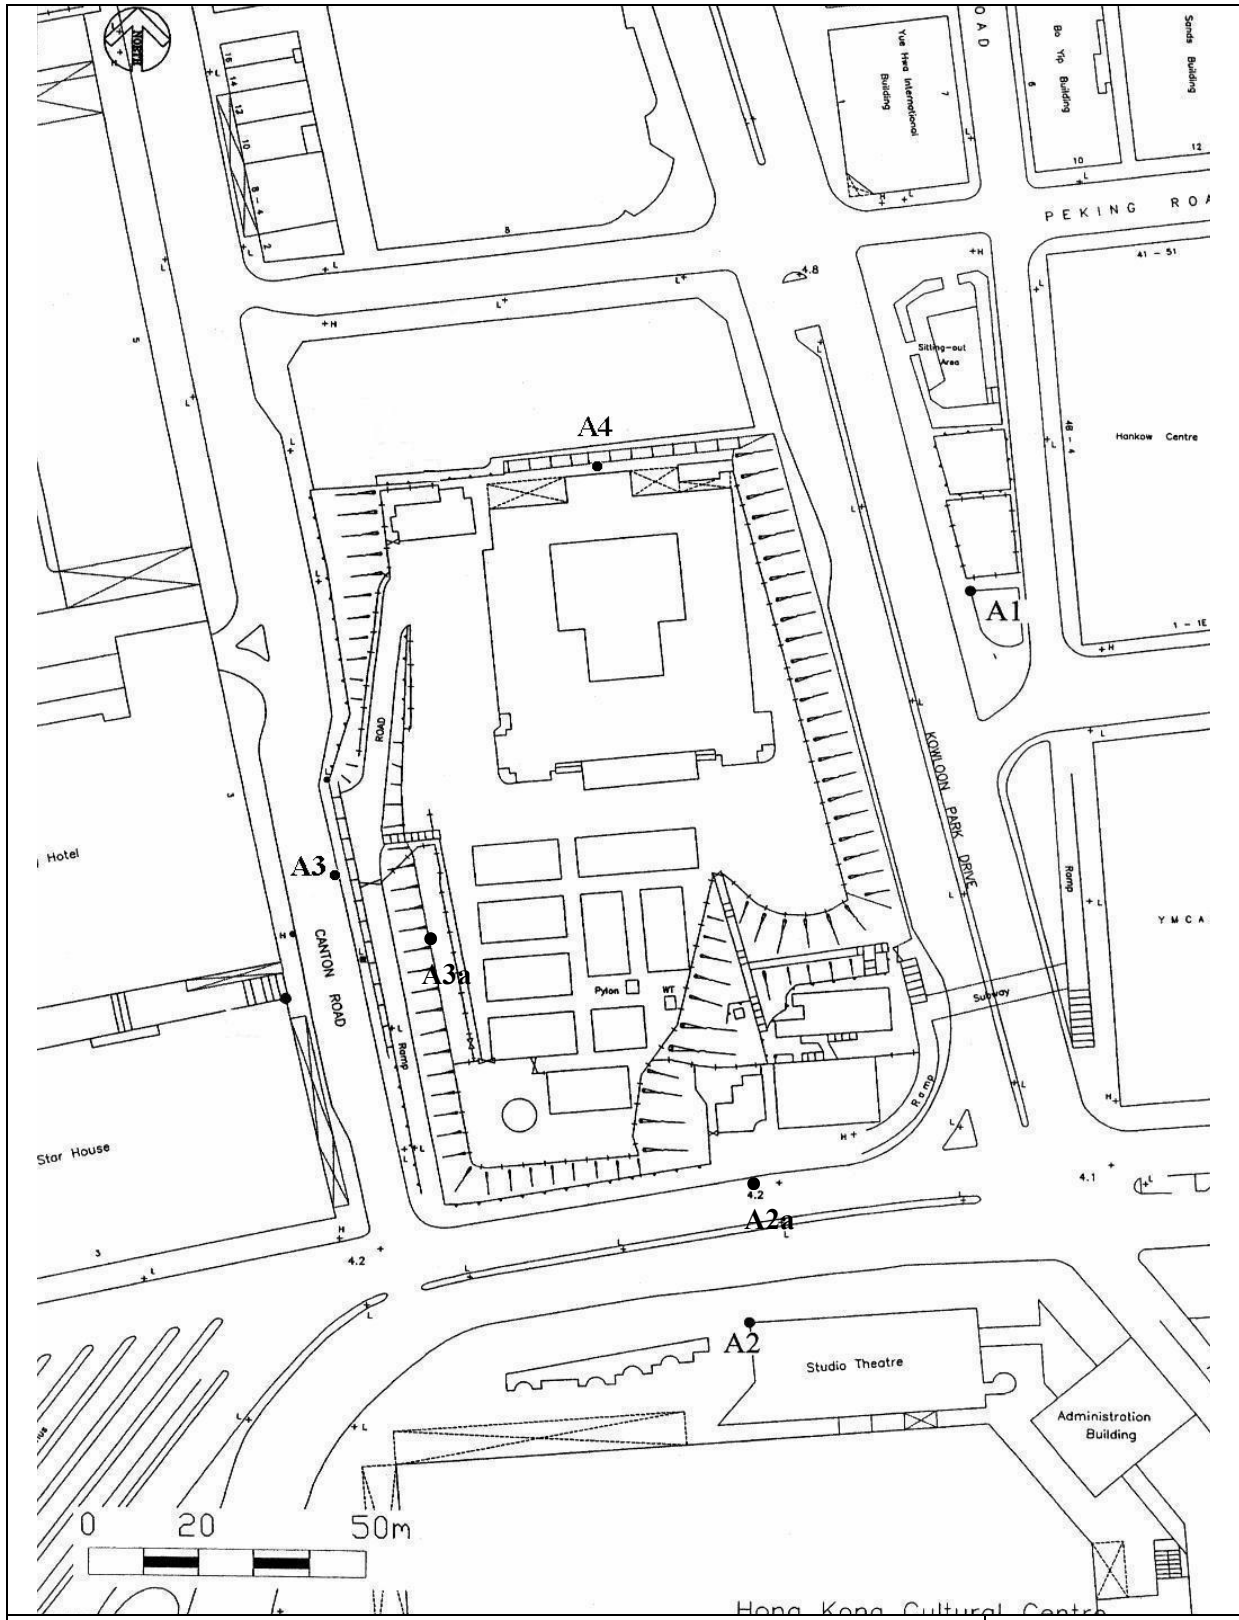
Figure 3.1 Dust Monitoring Locations (A1 is on building rooftop about 11m above ground, A2, on podium level about 5m above ground, A2a, A3a and A4 on hoarding top about 6m, 6m and 13m above ground respectively)

- A3a is situated just outside of the cordon area of the tree T96, positioned as close to Canton Road as possible and is about 20m south-east of the earlier station A3. The replacement of A3 with A3a was required due to the dismantling of west hoardings hence the removal of platform that host the air sampler. Approval for the replacement was granted by EPD on 14 May 2008 and monitoring at A3a was commenced on 21 May 2008 after installation completion.

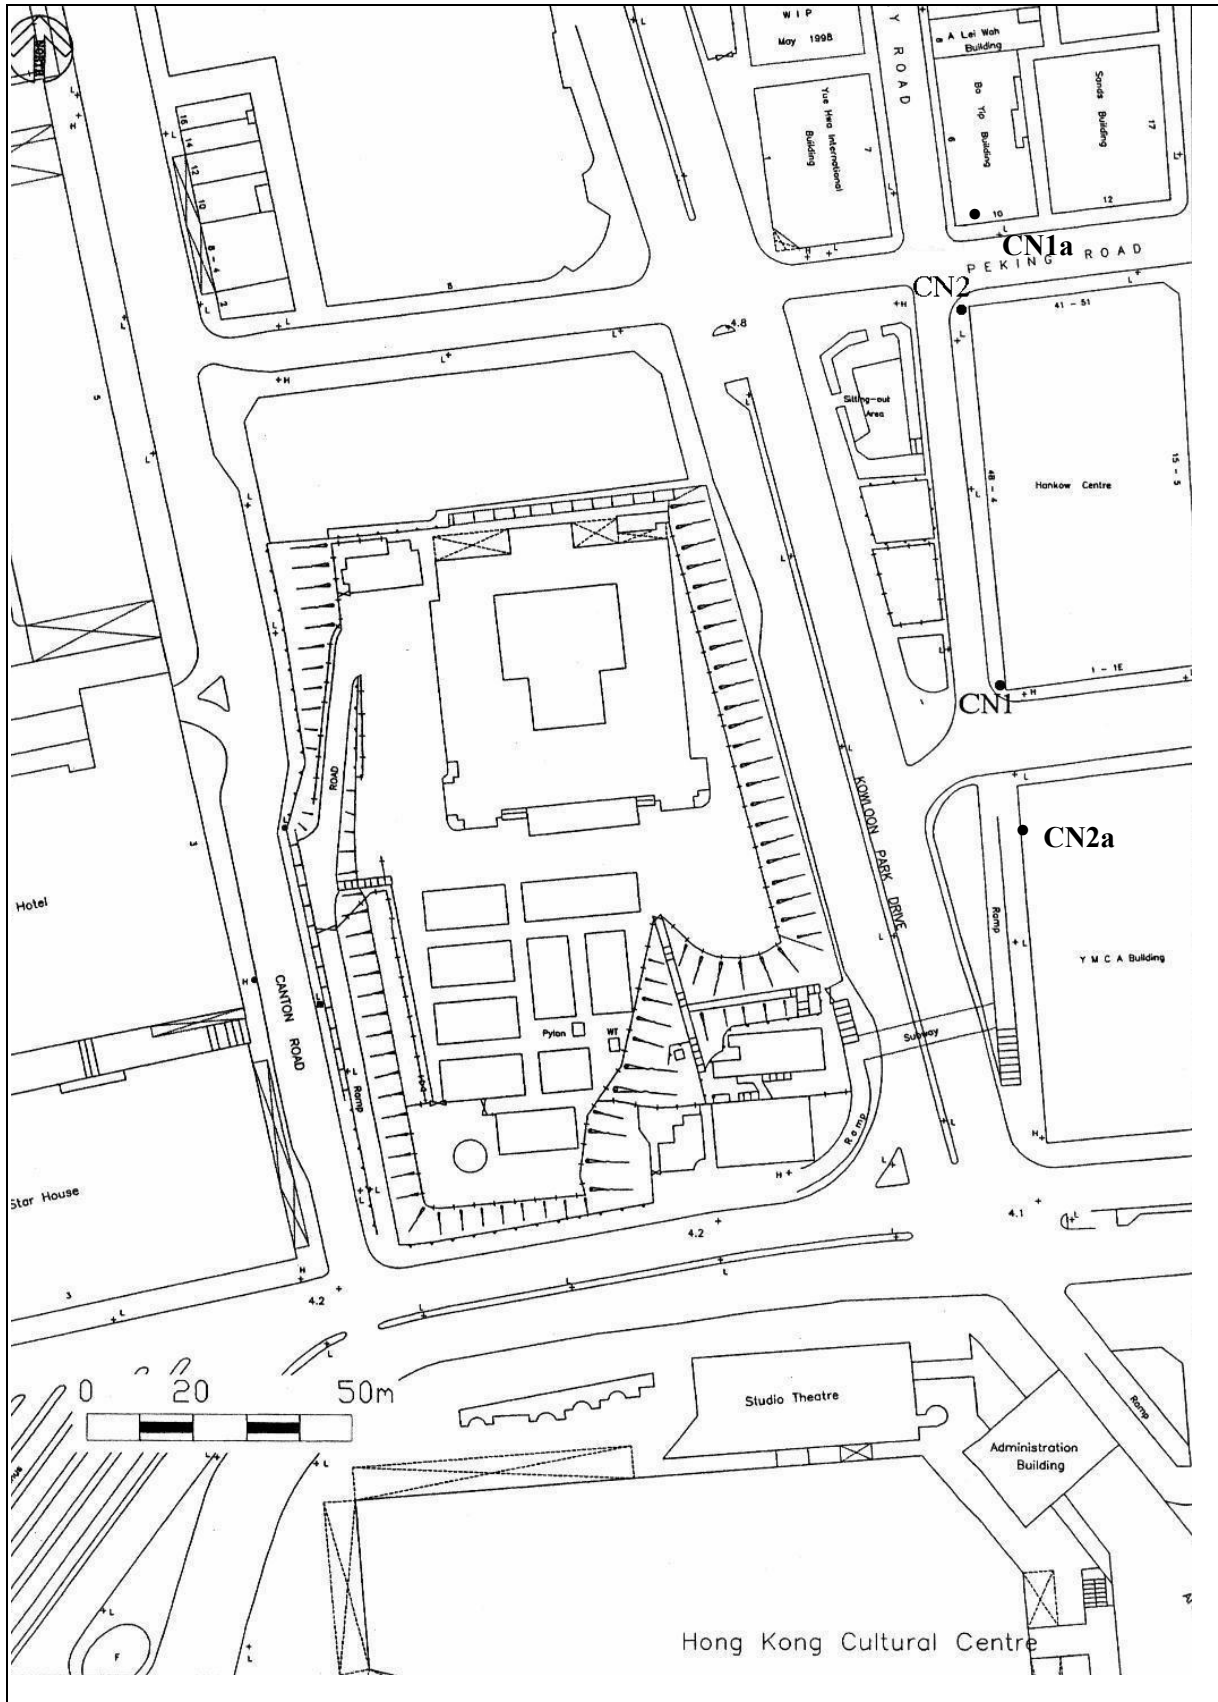
Figure 4.1 Proposed Noise Monitoring Stations (CN1 and CN2 are at podium level, about 15m above ground). Alternative measurement stations (CN1a and CN2a are about 33m and 11m above ground respectively).

- 4.13. The monitoring location at CN1a was at free field condition. The meter was fixed on a stand with the microphone at position 1.2m above the reflecting ground and hence façade correction of +3dB(A) was applied. The other monitoring location at CN2a was at a point 1m from the exterior of the building façade.
- 4.14. Before and after each noise measurement, the meter was calibrated using the Calibrator for 94 dB at 1000 Hz.
- 4.15. The wind speed was checked with the portable wind speed meter to be within 5m/s during measurement.
- 4.16. Site conditions and possible noise sources affecting the measurement were recorded on the noise monitoring field record sheet. Extraneous noise was avoided as far as possible.

- 4.18. There were four Limit Level exceedances in July 2008. The limit level exceedances were all found at CN2a and were not due to the site construction works as there was no noisy construction activity during the period of measurements.

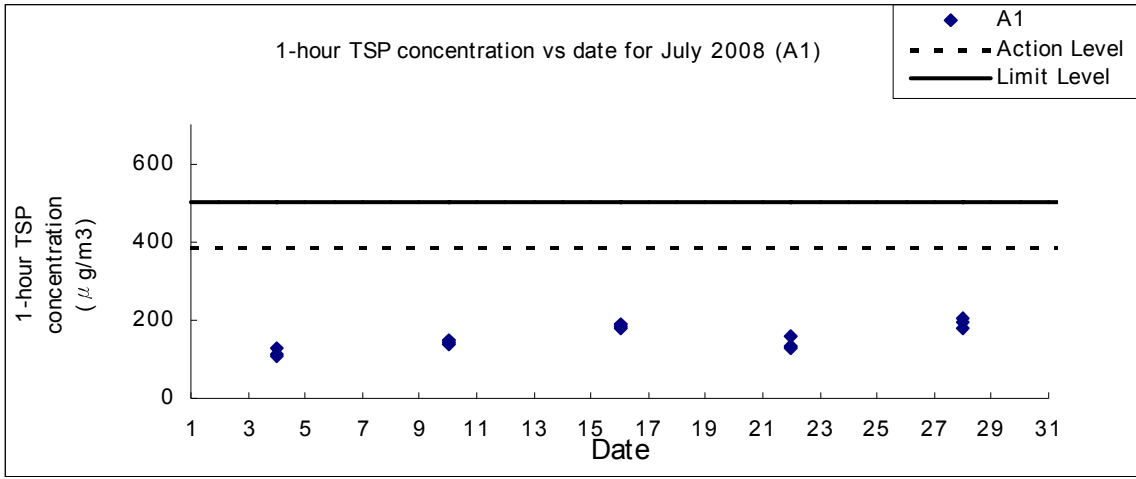
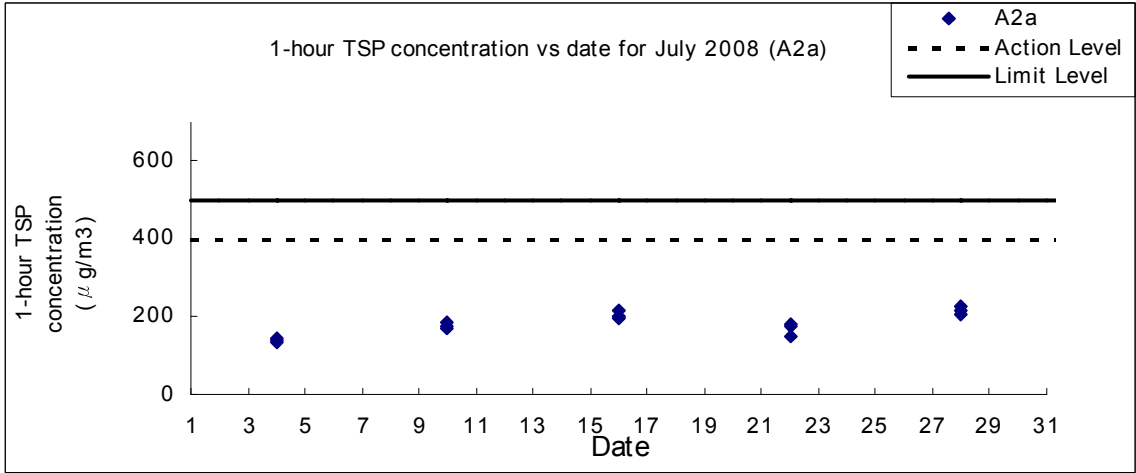
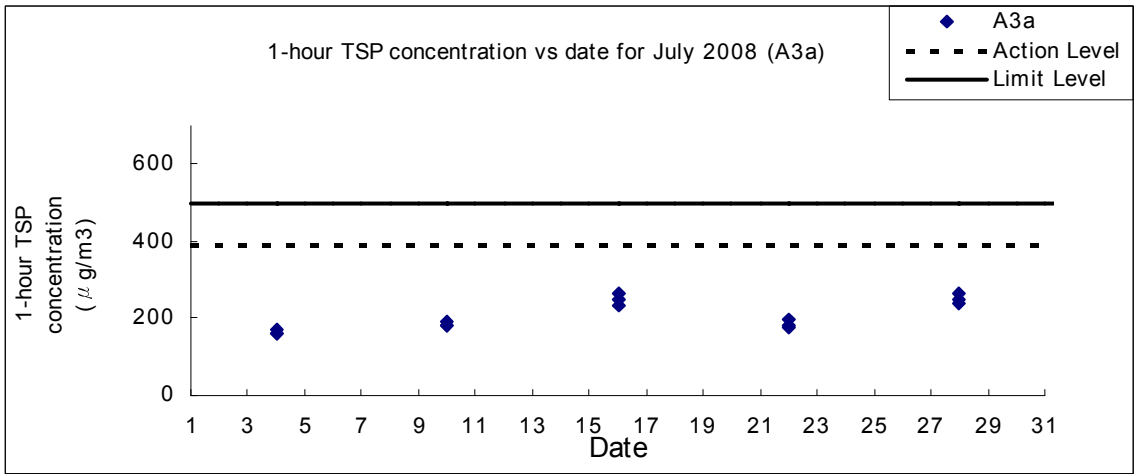
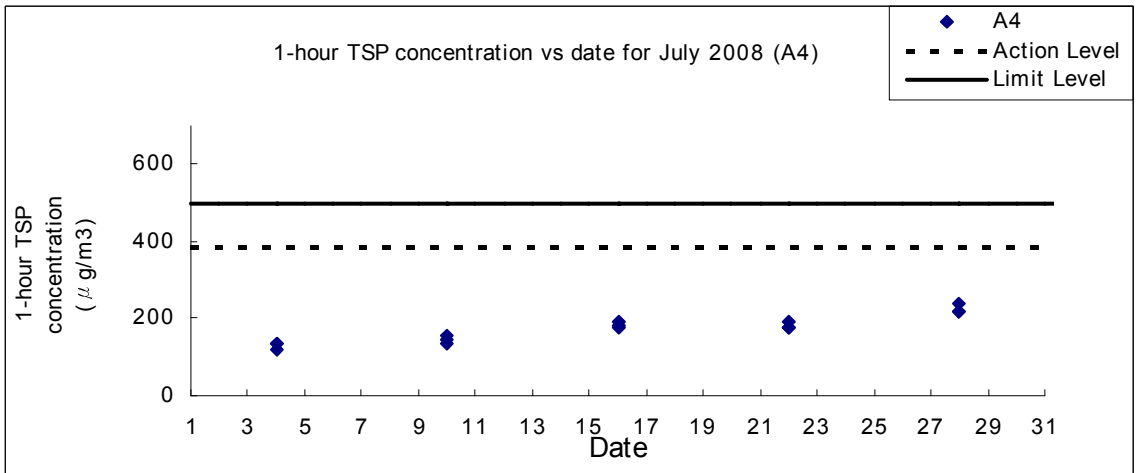
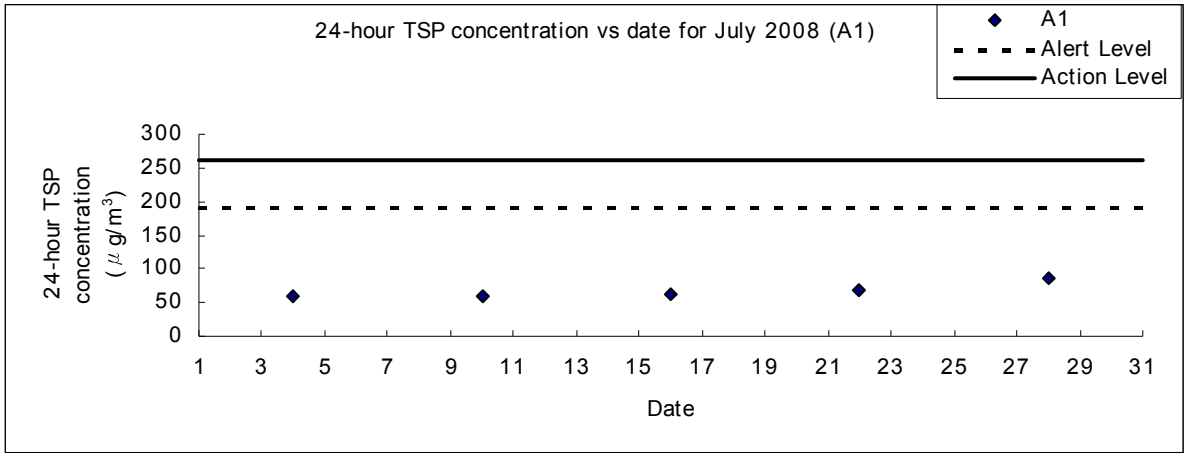
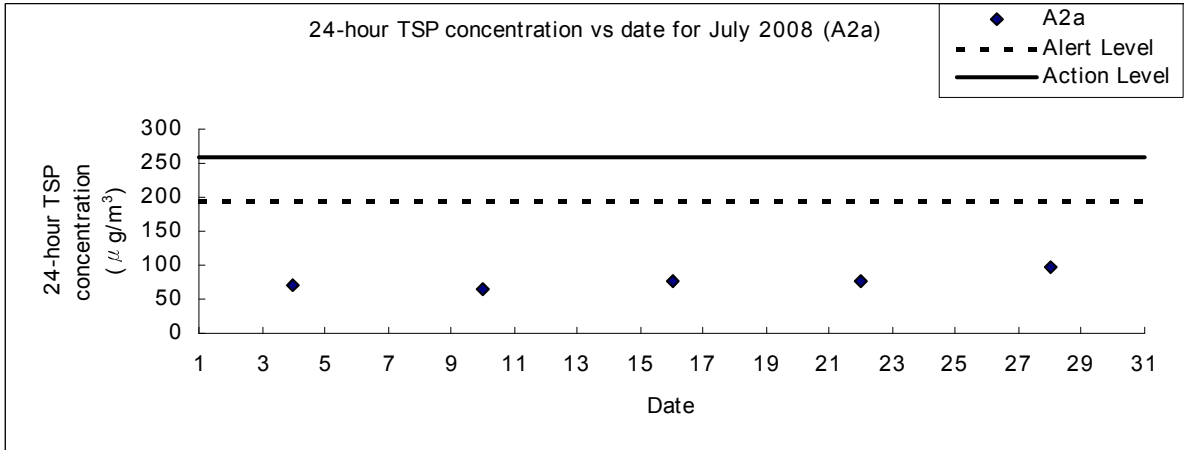
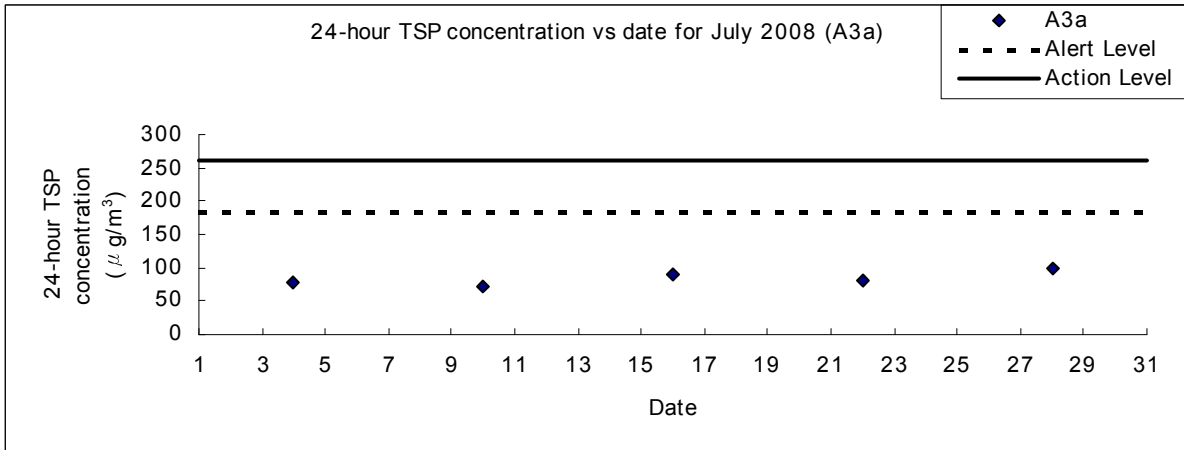
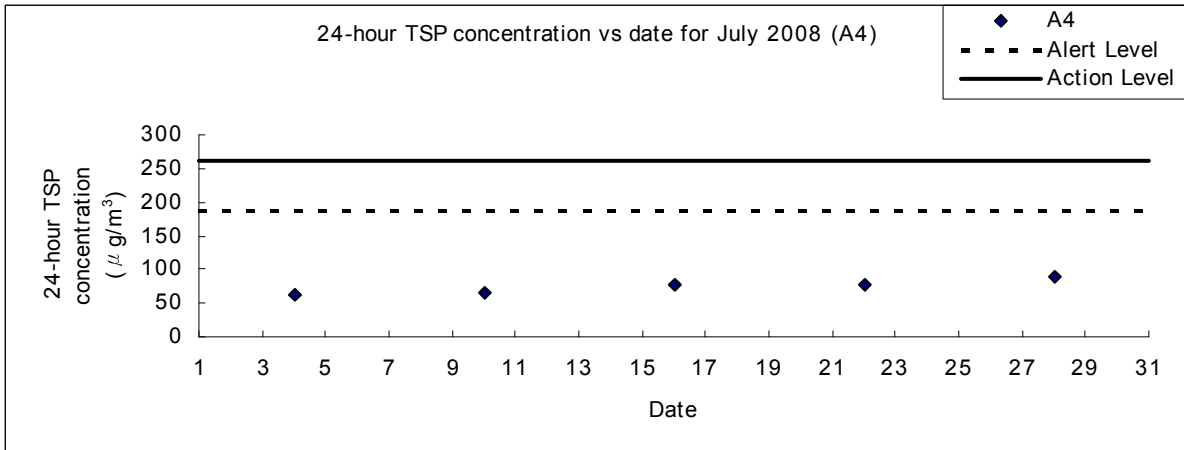
Appendix F: Graphical presentations of the air impact monitoring results

Parameter	Location	Monitoring Period	No. of Exceedance(s)	
			Action Level	Limit Level
Air (1-hour TSP)	A1	01/7/2008 – 31/7/2008	0	0
	A2a	01/7/2008 – 31/7/2008	0	0
	A3a	01/7/2008 – 31/7/2008	0	0
	A4	01/7/2008 – 31/7/2008	0	0
Air (24-hour TSP)	A1	01/7/2008 – 31/7/2008	0	0
	A2a	01/7/2008 – 31/7/2008	0	0
	A3a	01/7/2008 – 31/7/2008	0	0
	A4	01/7/2008 – 31/7/2008	0	0
Noise	CN1a	01/7/2008 – 31/7/2008	0	0
	CN2a	01/7/2008 – 31/7/2008	0	4
Ground-Borne Noise	HKSM	--	0	0
	HKCC	--	0	0

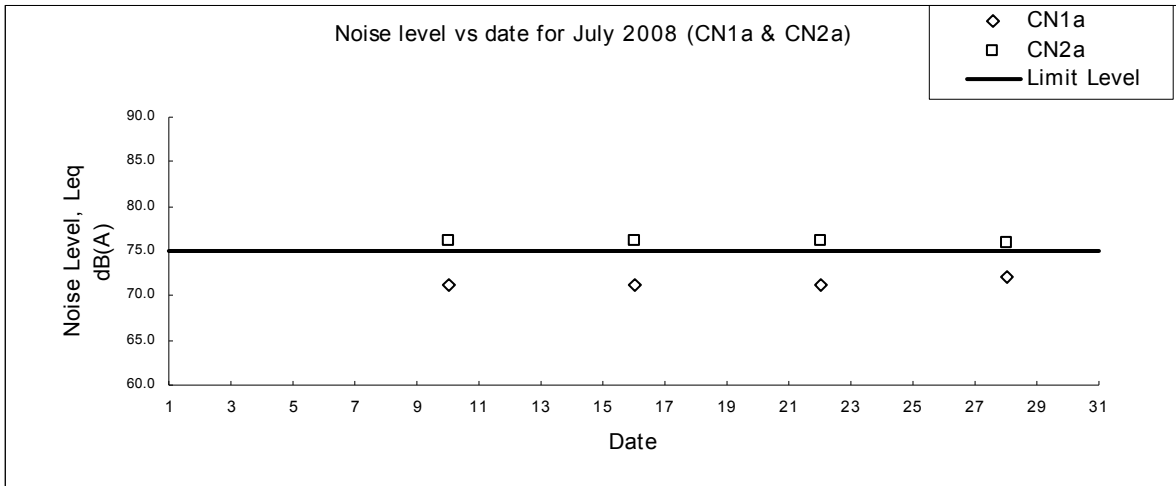
Appendix J: Graphical presentations of the noise impact monitoring results

- 9.1. EM&A work for July 2008 has been successfully completed. Four limit level exceedances were found.
- 9.2. Four limit level exceedances on noise level were recorded. The exceedances were due to other activities not related to the site construction works.

Date	Time	Weather	CN2a (YMCA)		
			Noise Level, dB(A)		
			L _{eq}	L ₉₀	L ₁₀
10-Jul-08	13:20	Cloudy	76.1	73.6	78.5
16-Jul-08	11:15	Sunny	76.2	73.9	78.8
22-Jul-08	11:00	Sunny	76.2	73.2	78.6
28-Jul-08	11:08	Sunny	75.9	72.6	77.9
