**Development at Former Marine Police  
Headquarters KIL 11161  
Environmental Monitoring & Audit Report  
for November 2008**

**(Ref No. 3.12/050/2006)**

**December 2008**

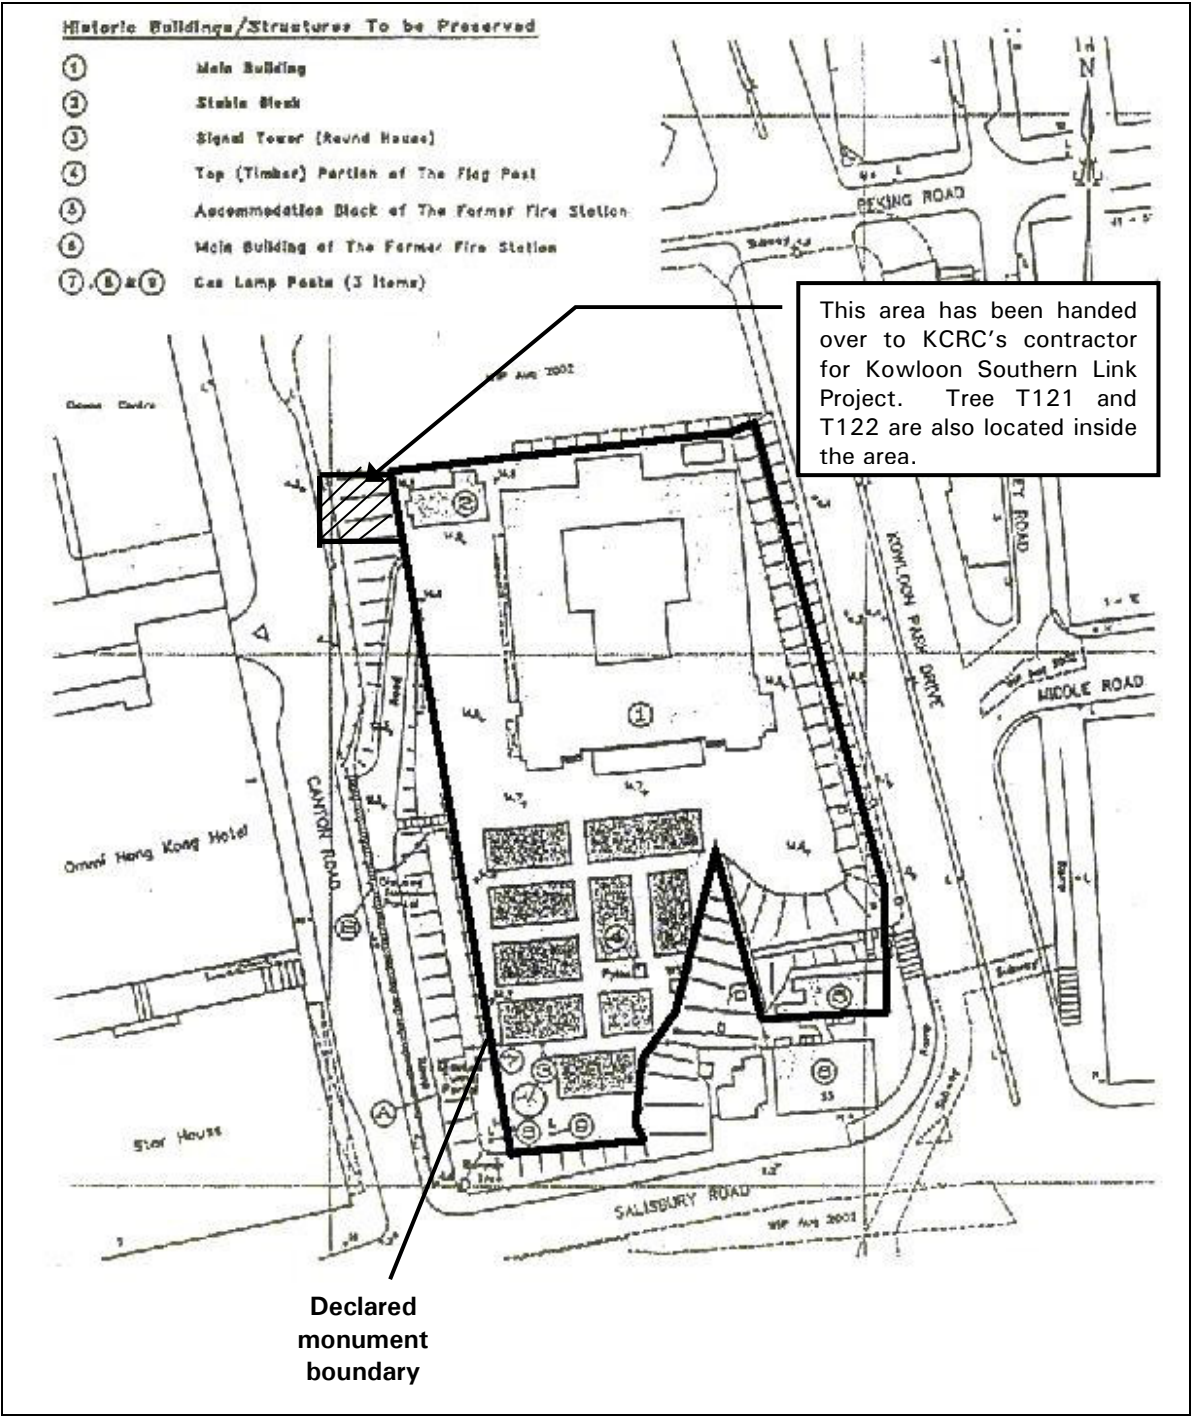
Figure 2.1 Location, site layout with the location of site where it was handed over to KCRC's Contractor for KSL Project, historic buildings and structures to be preserved Scale: N.T.S

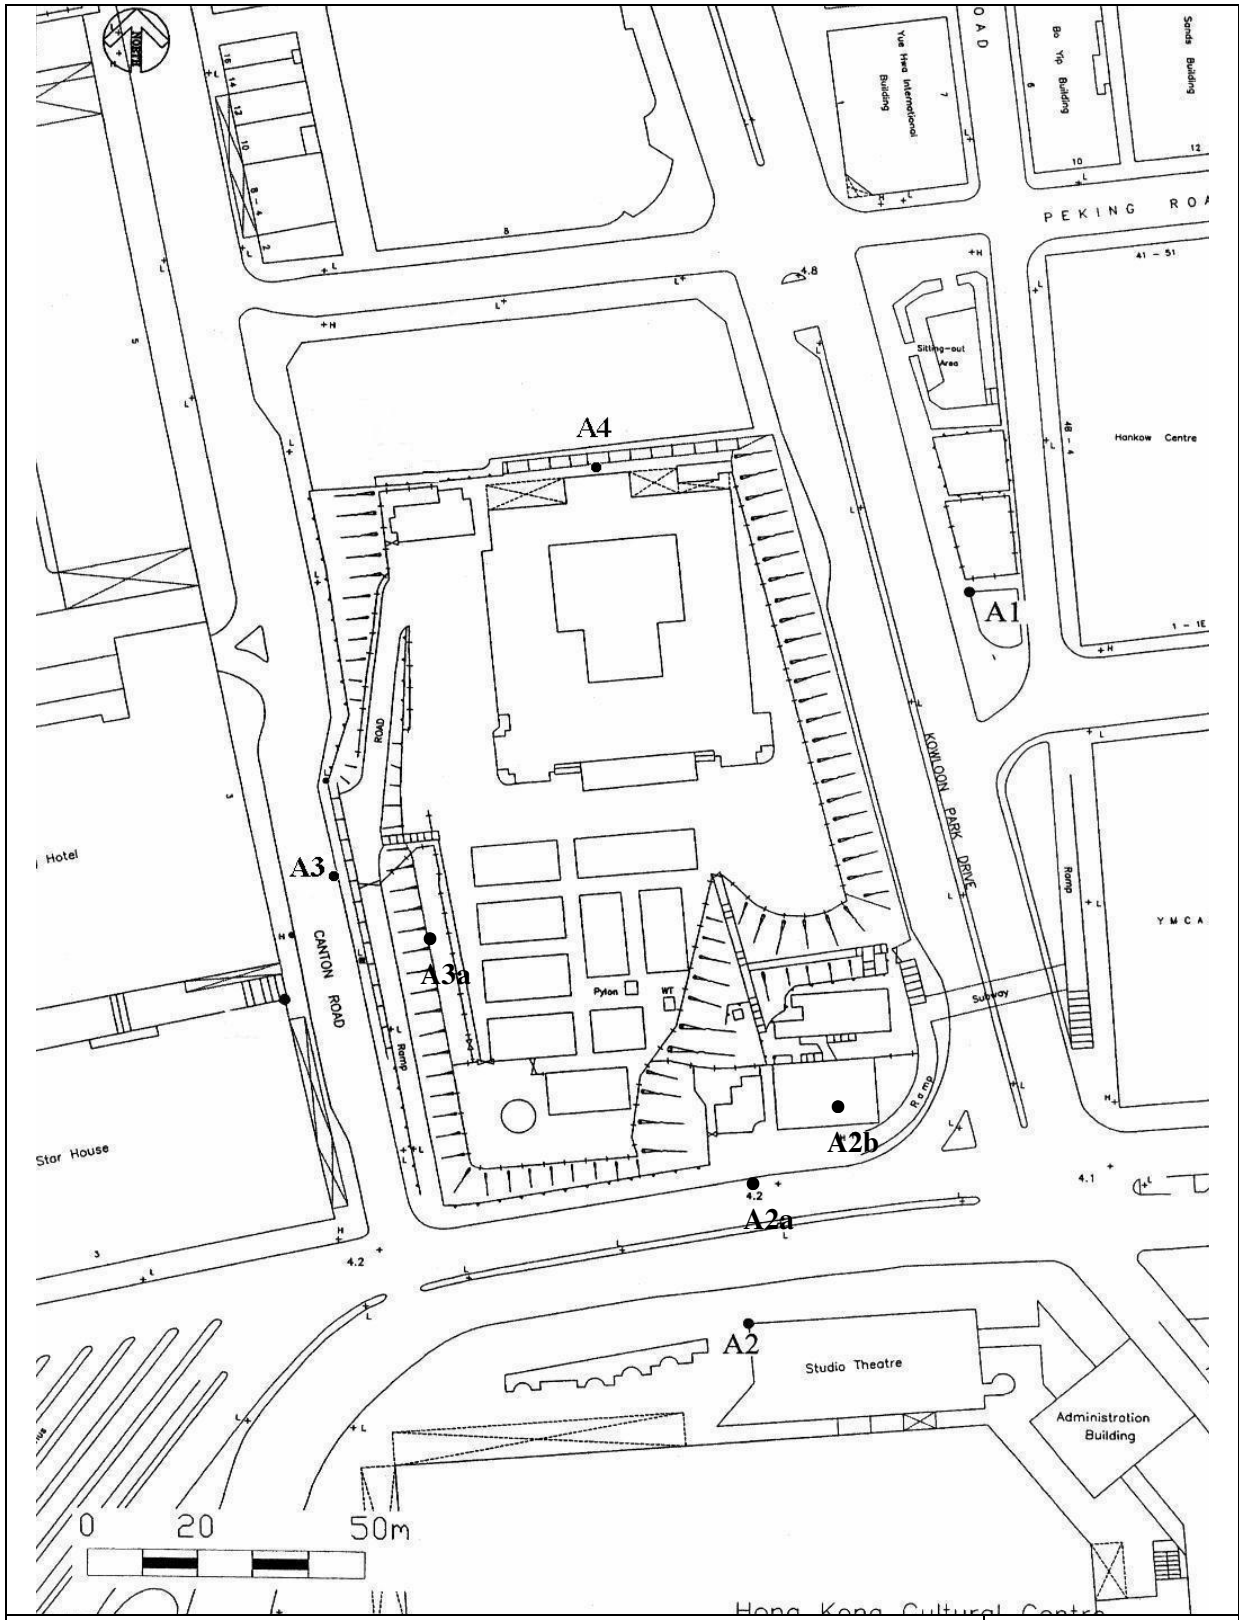
Figure 3.1 Dust Monitoring Locations (A1 is on building rooftop about 11m above ground, A2, on podium level about 5m above ground, A2a, A3a and A4 on hoarding top about 6m, 6m and 13m above ground respectively, A2b is on a building rooftop about 6m above ground)

- A3a is situated just outside of the cordon area of the tree T96, positioned as close to Canton Road as possible and is about 20m south-east of the earlier station A3. The replacement of A3 with A3a was required due to the dismantling of west hoardings hence the removal of platform that host the air sampler. Approval for the replacement was granted by EPD on 14 May 2008 and monitoring at A3a was commenced on 21 May 2008 after installation completion.

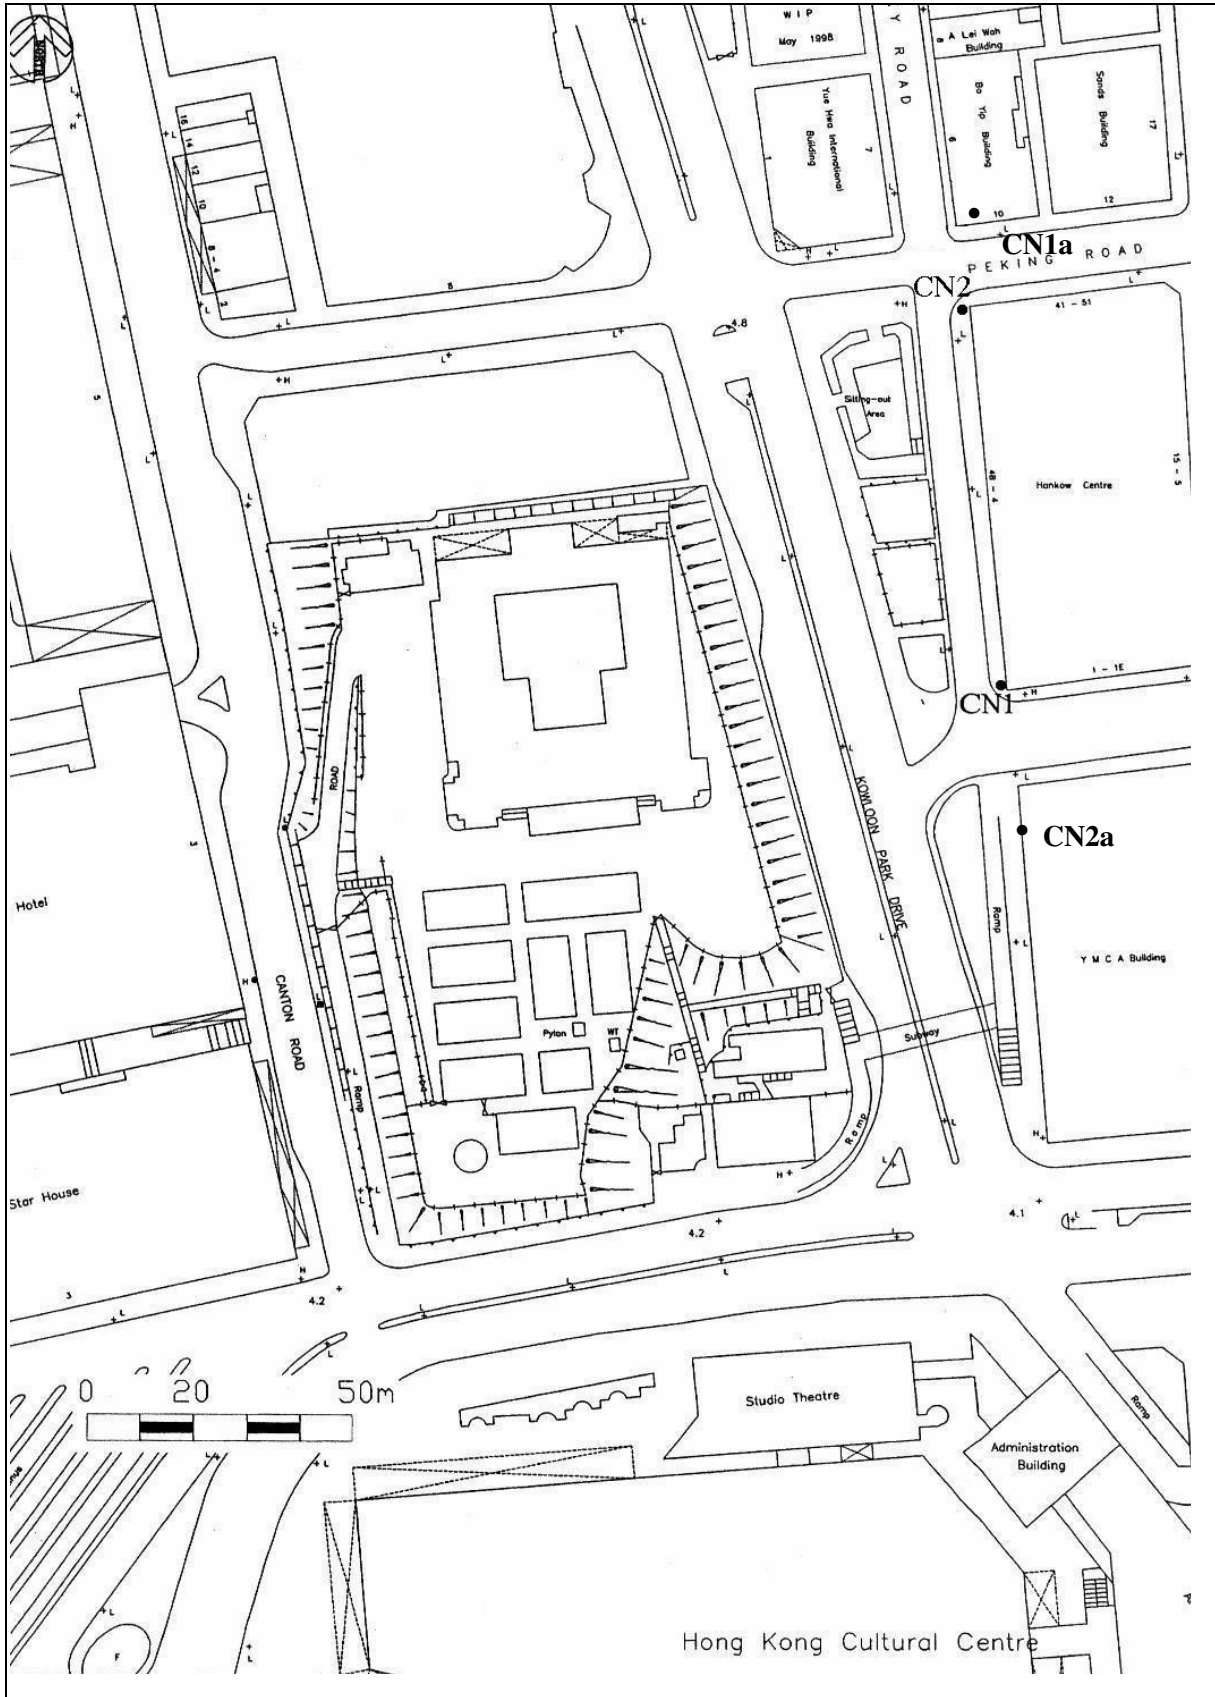
Figure 4.1 Proposed Noise Monitoring Stations (CN1 and CN2 are at podium level, about 15m above ground). Alternative measurement stations (CN1a and CN2a are about 33m and 11m above ground respectively).

- 4.13. The monitoring location at CN1a was at free field condition. The meter was fixed on a stand with the microphone at position 1.2m above the reflecting ground and hence façade correction of +3dB(A) was applied. The other monitoring location at CN2a was at a point 1m from the exterior of the building façade.
- 4.14. Before and after each noise measurement, the meter was calibrated using the Calibrator for 94 dB at 1000 Hz.
- 4.15. The wind speed was checked with the portable wind speed meter to be within 5m/s during measurement.
- 4.16. Site conditions and possible noise sources affecting the measurement were recorded on the noise monitoring field record sheet. Extraneous noise was avoided as far as possible.
