Chun Wo Construction &
Engineering Co Ltd

**Contract No HY/2005/06
Castle Peak Road
Improvement – West of
Tsing Lung Tau**

Monthly Environmental
Monitoring and Audit
Report for Construction
Works other than
Reclamation – November
2006

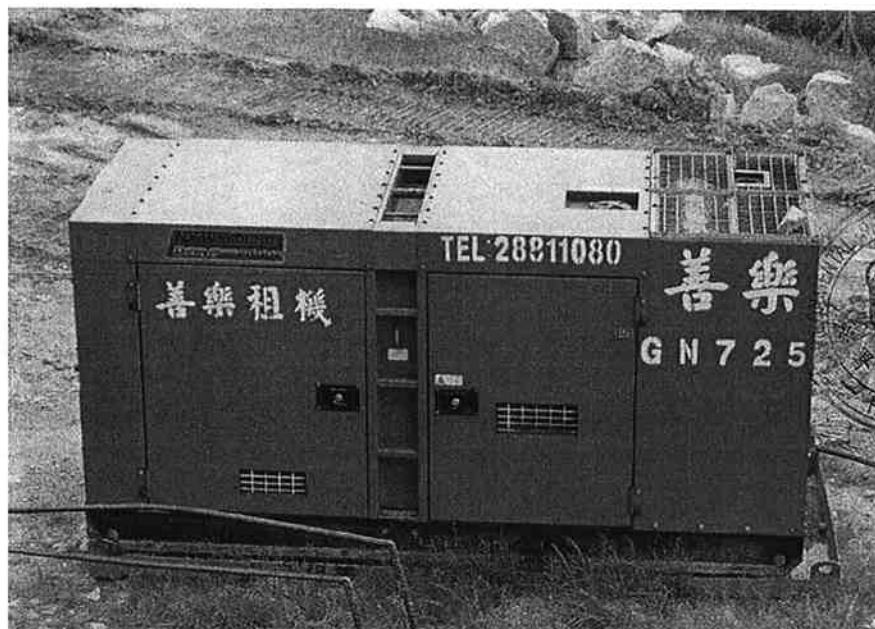
發電機，在距離發電機中心點的 7 米所量度的聲壓級 (A) ≤ 75 分貝(A)
Generator, with sound pressure level of ≤ 75 dB(A) measured at 7 m
from the centre of the generator

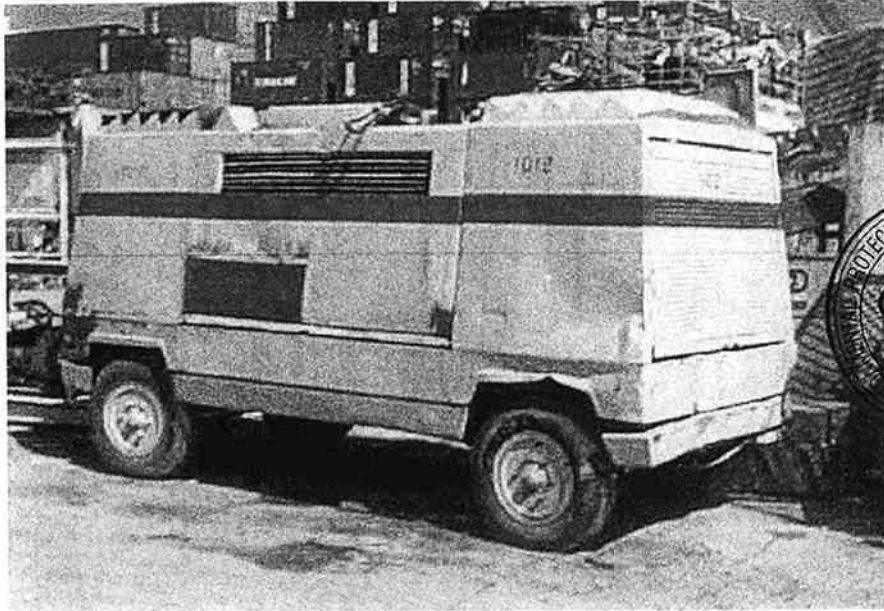
空氣壓縮機，備有噪音標籤顯示聲功率級 ≤ 102 分貝(A)
Air Compressor, with Noise Emission Label showing
a sound power level of ≤ 102 dB(A)

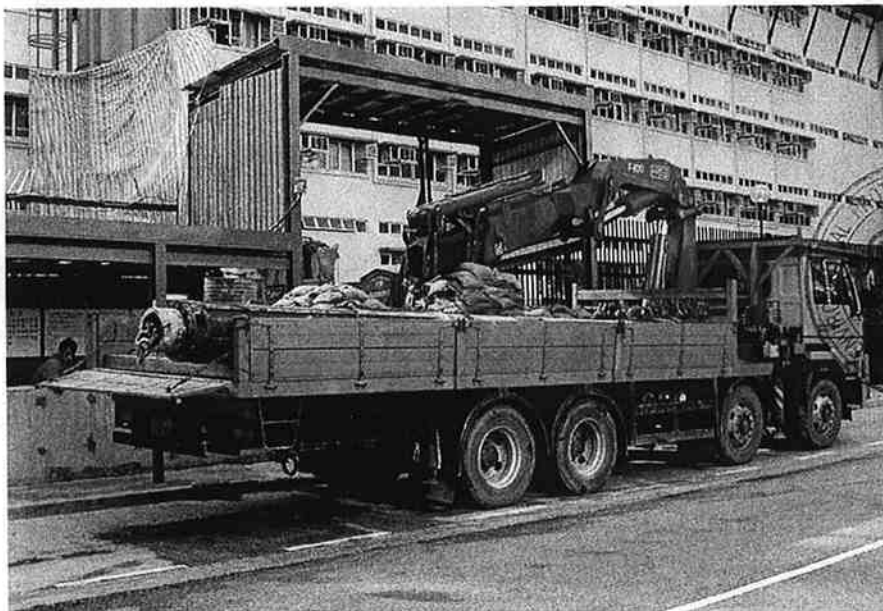
吊臂貨車，總重量 ≤ 38 噸
Lorry, with crane, gross vehicle weight ≤ 38 tonnes
