**Land Contamination Study  
for the Extension of Public Golf Course  
at Kau Sai Chau, Sai Kung**

**Contamination Assessment Plan**

Reference : R420-5.05  
Client : China Harbour Engineering Company (Group)  
Prepared by : CH2M-IDC Hong Kong Limited  
Date : January 2006

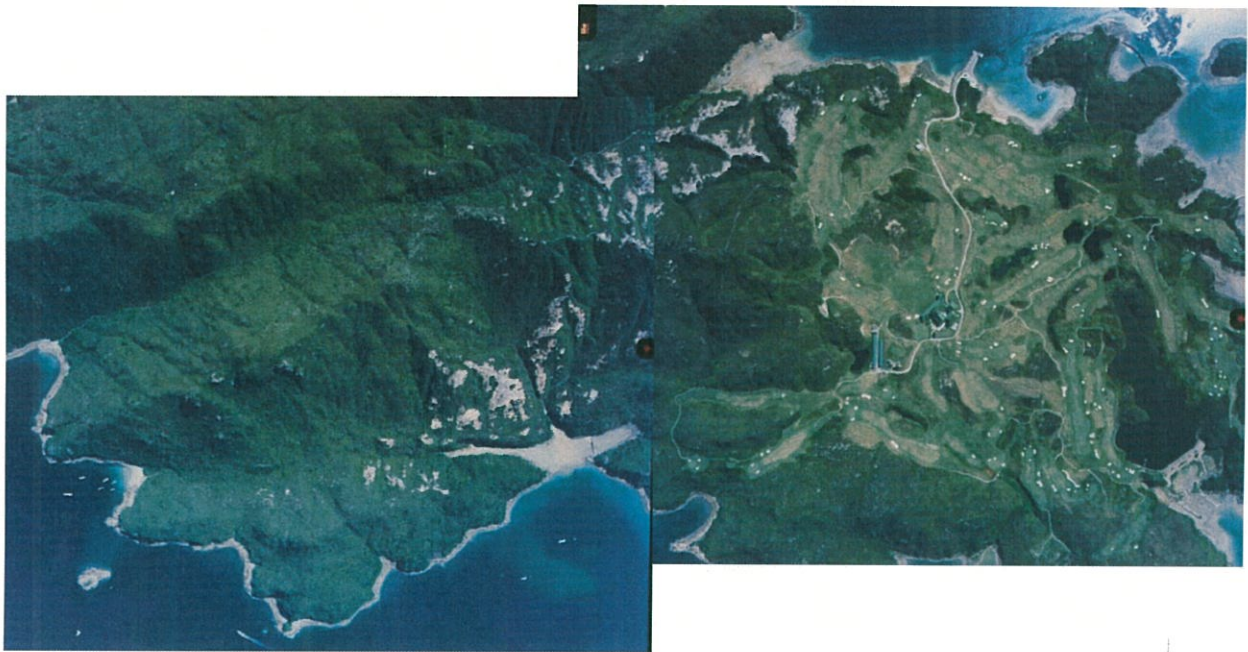
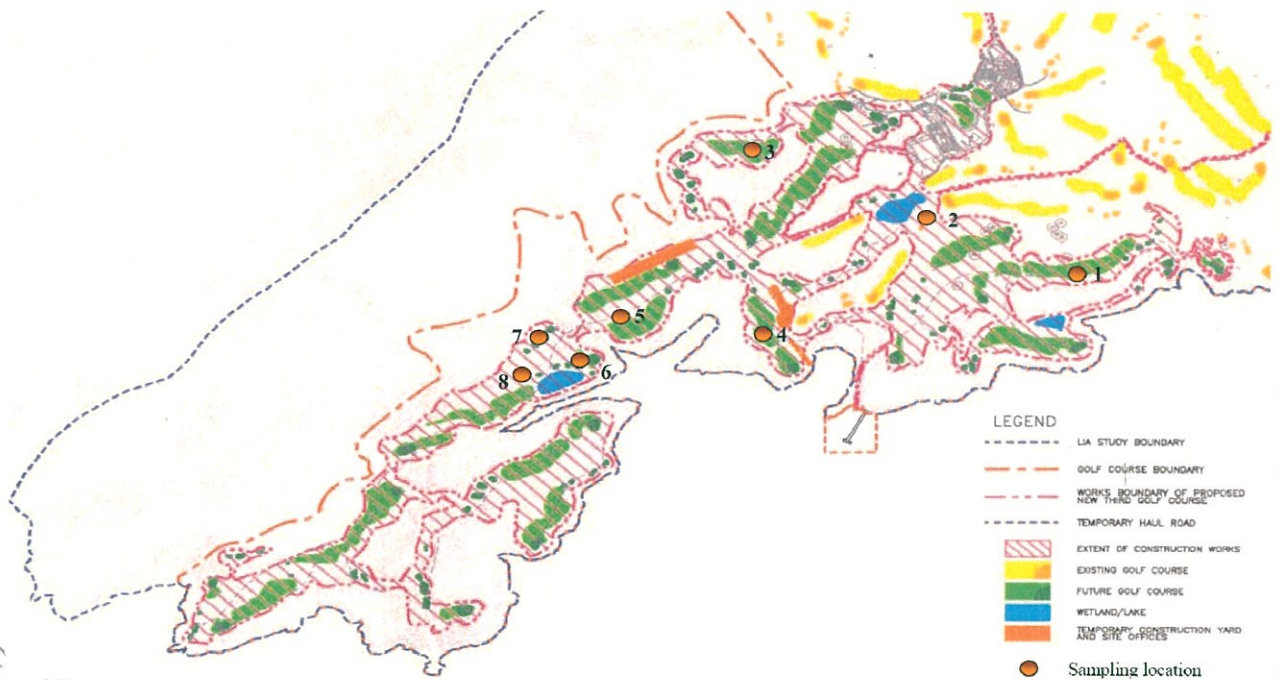
Figure: 2-1

2.2.5 During the preliminary site investigation conducted on 12 July 2005, eight sampling locations (1 to 8) were identified within the Study Area as shown in Figure 2-1. Surface soil samples (soil of 5cm to 10cm below ground surface) were collected by means of shovel or hoe from seven out of the eight sampling locations, with the exception of Sampling Location 2 which was inaccessible during the preliminary SI.

Title: Preliminary Land Contamination Sampling Locations

2.2.7 It has been indicated in the Approved EIA Report that the lead contamination is possibly a discrete exceedance at Sampling Location 3, while the exceedance of total sulphur at Sampling Locations 6 to 8 might have identified a contaminated spot, possibly due to the landuse of an artillery firing range. It has also been commented that sulphur contamination is not spatially continuous and is confined within the area near Sampling Locations 6 to 8.
