**Proposed Extension of Public Golf Course
at Kau Sai Chau Island, Sai Kung**

**Monthly Environmental Monitoring & Audit (EM&A) Report
for March 2006**

(Report No. 382210/003)

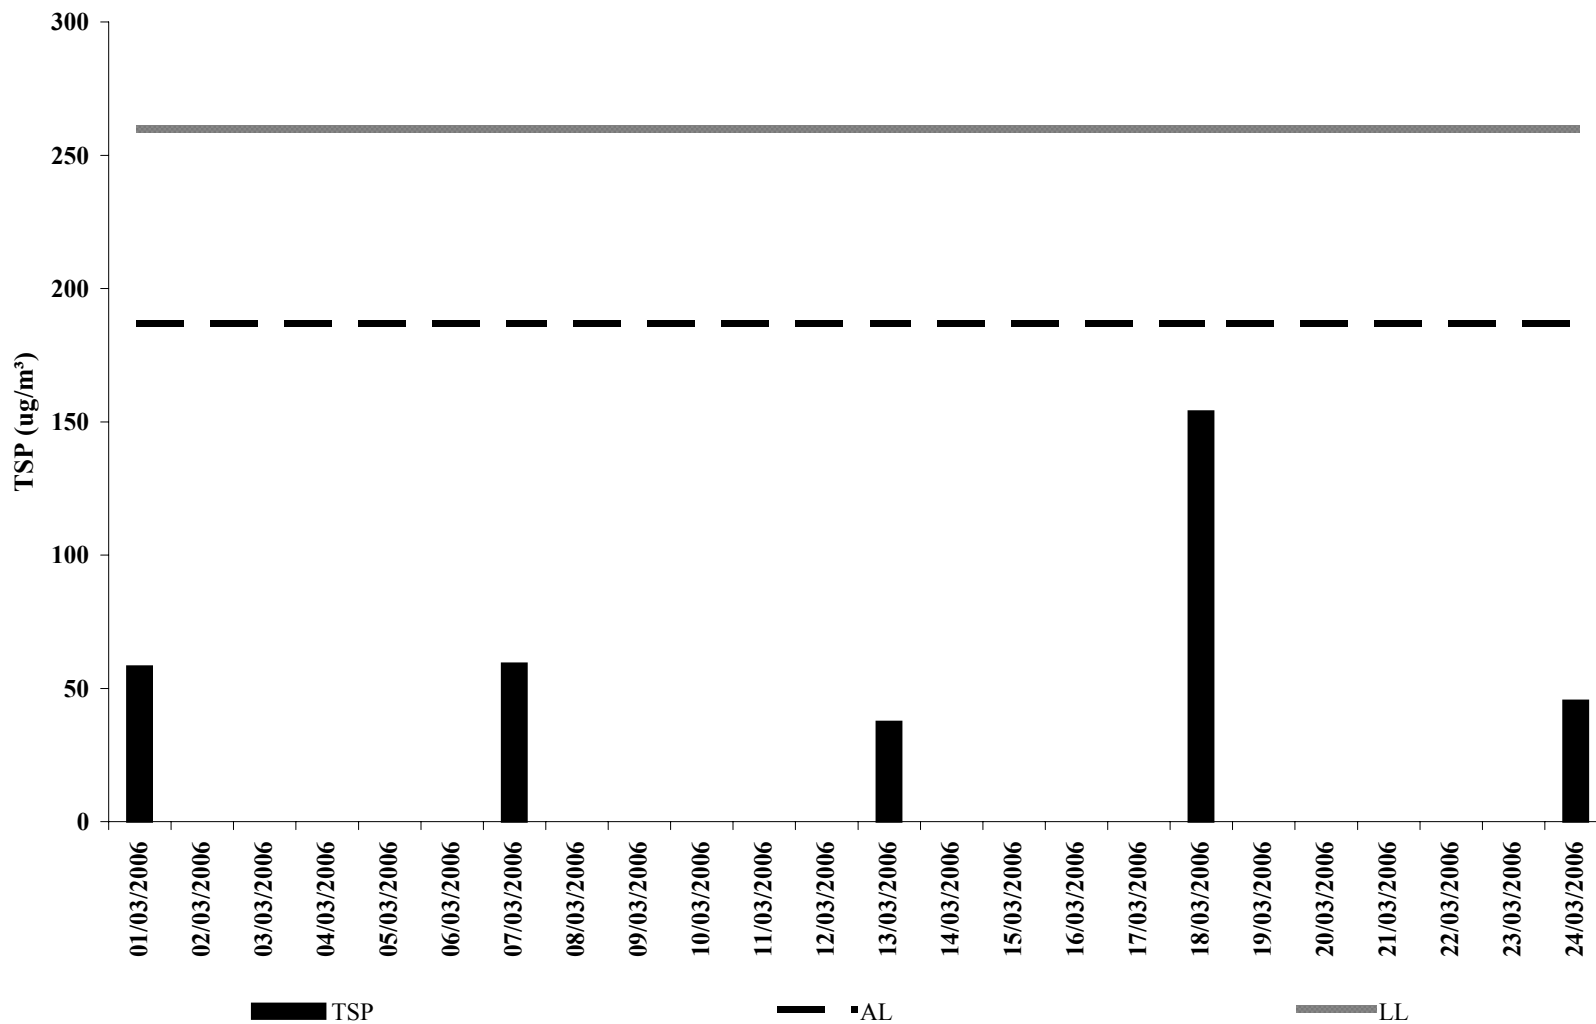
24-hour TSP Monitoring Results at Station GCA B1

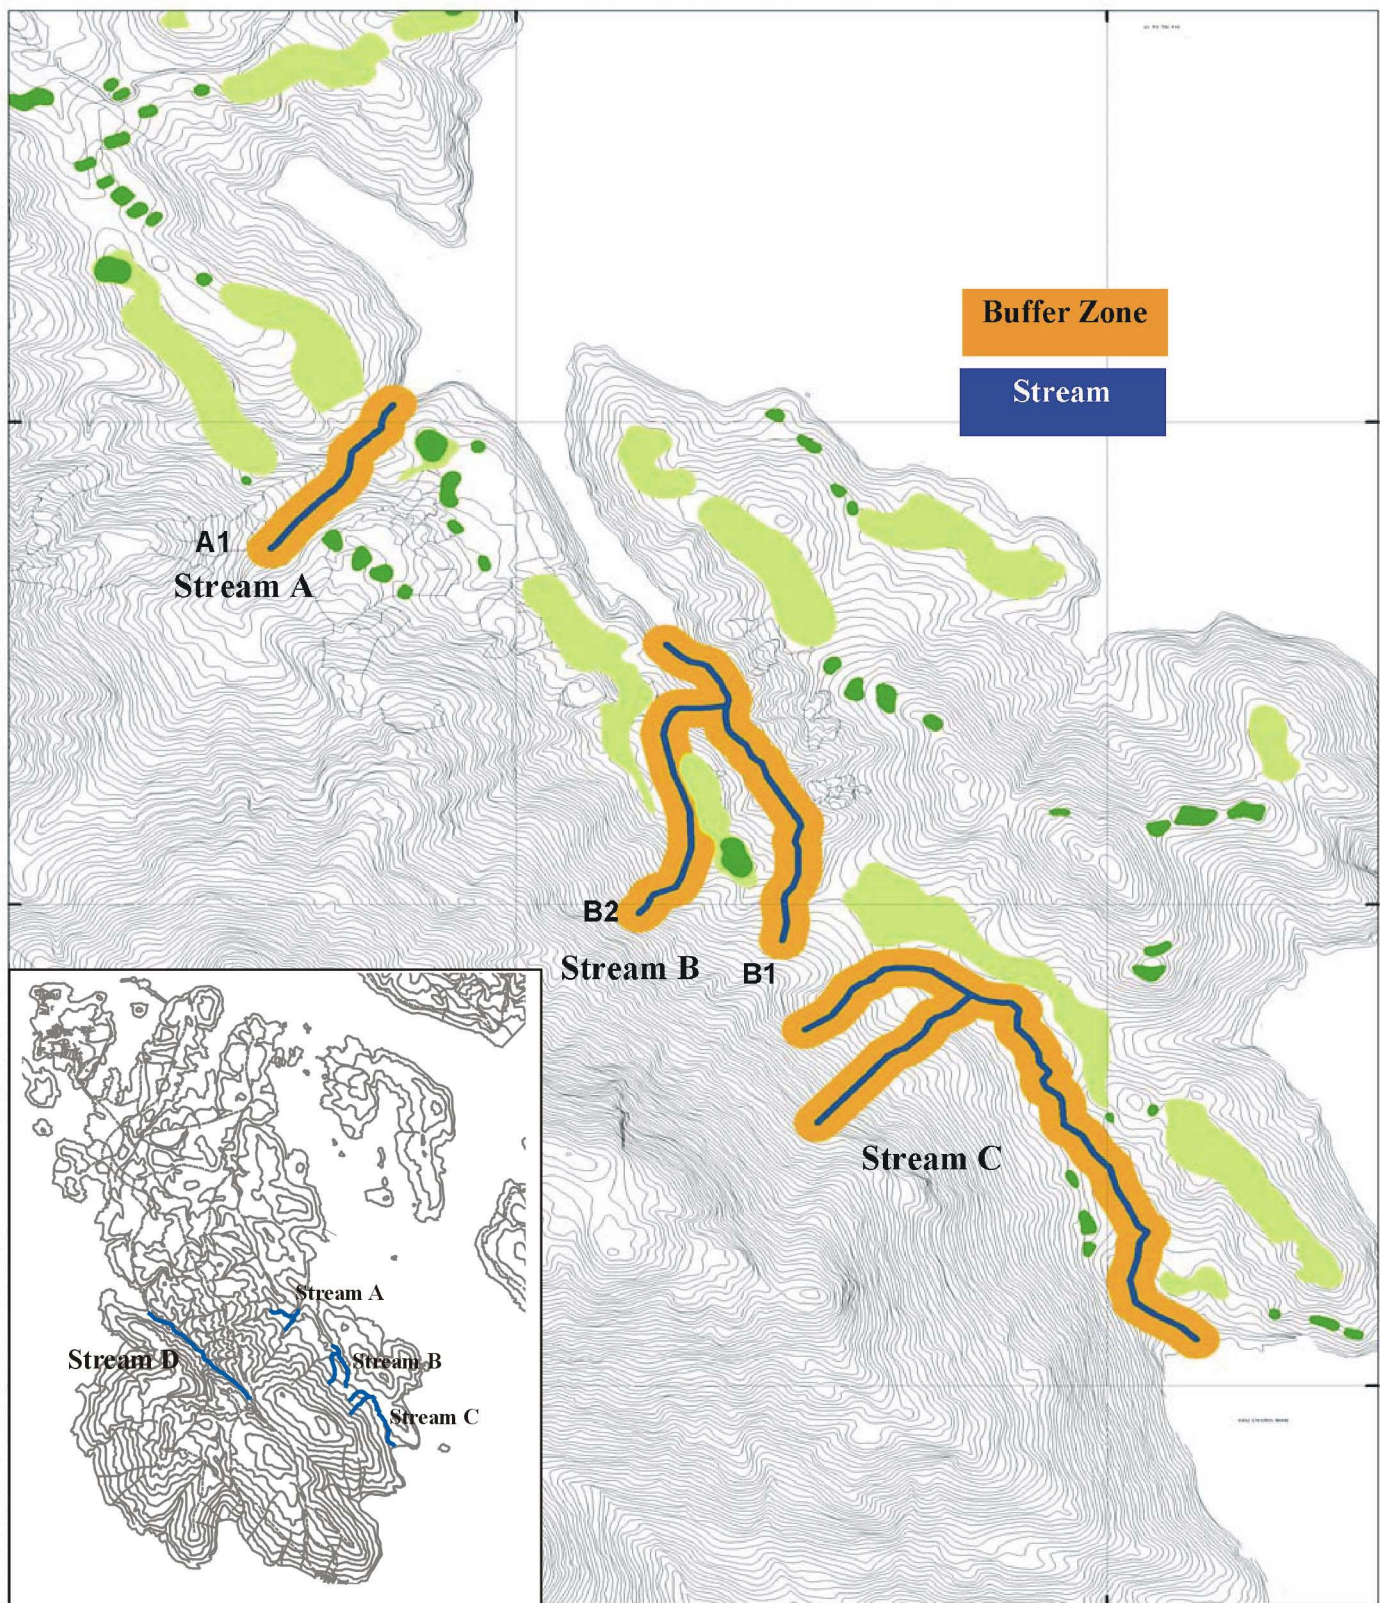
Fig 3.3

Proposed Extension of Public Golf Course at Kau Sai
Chau Island, Sai Kung
Proposed Ecological Monitoring Location
(Streams Buffer Zone)

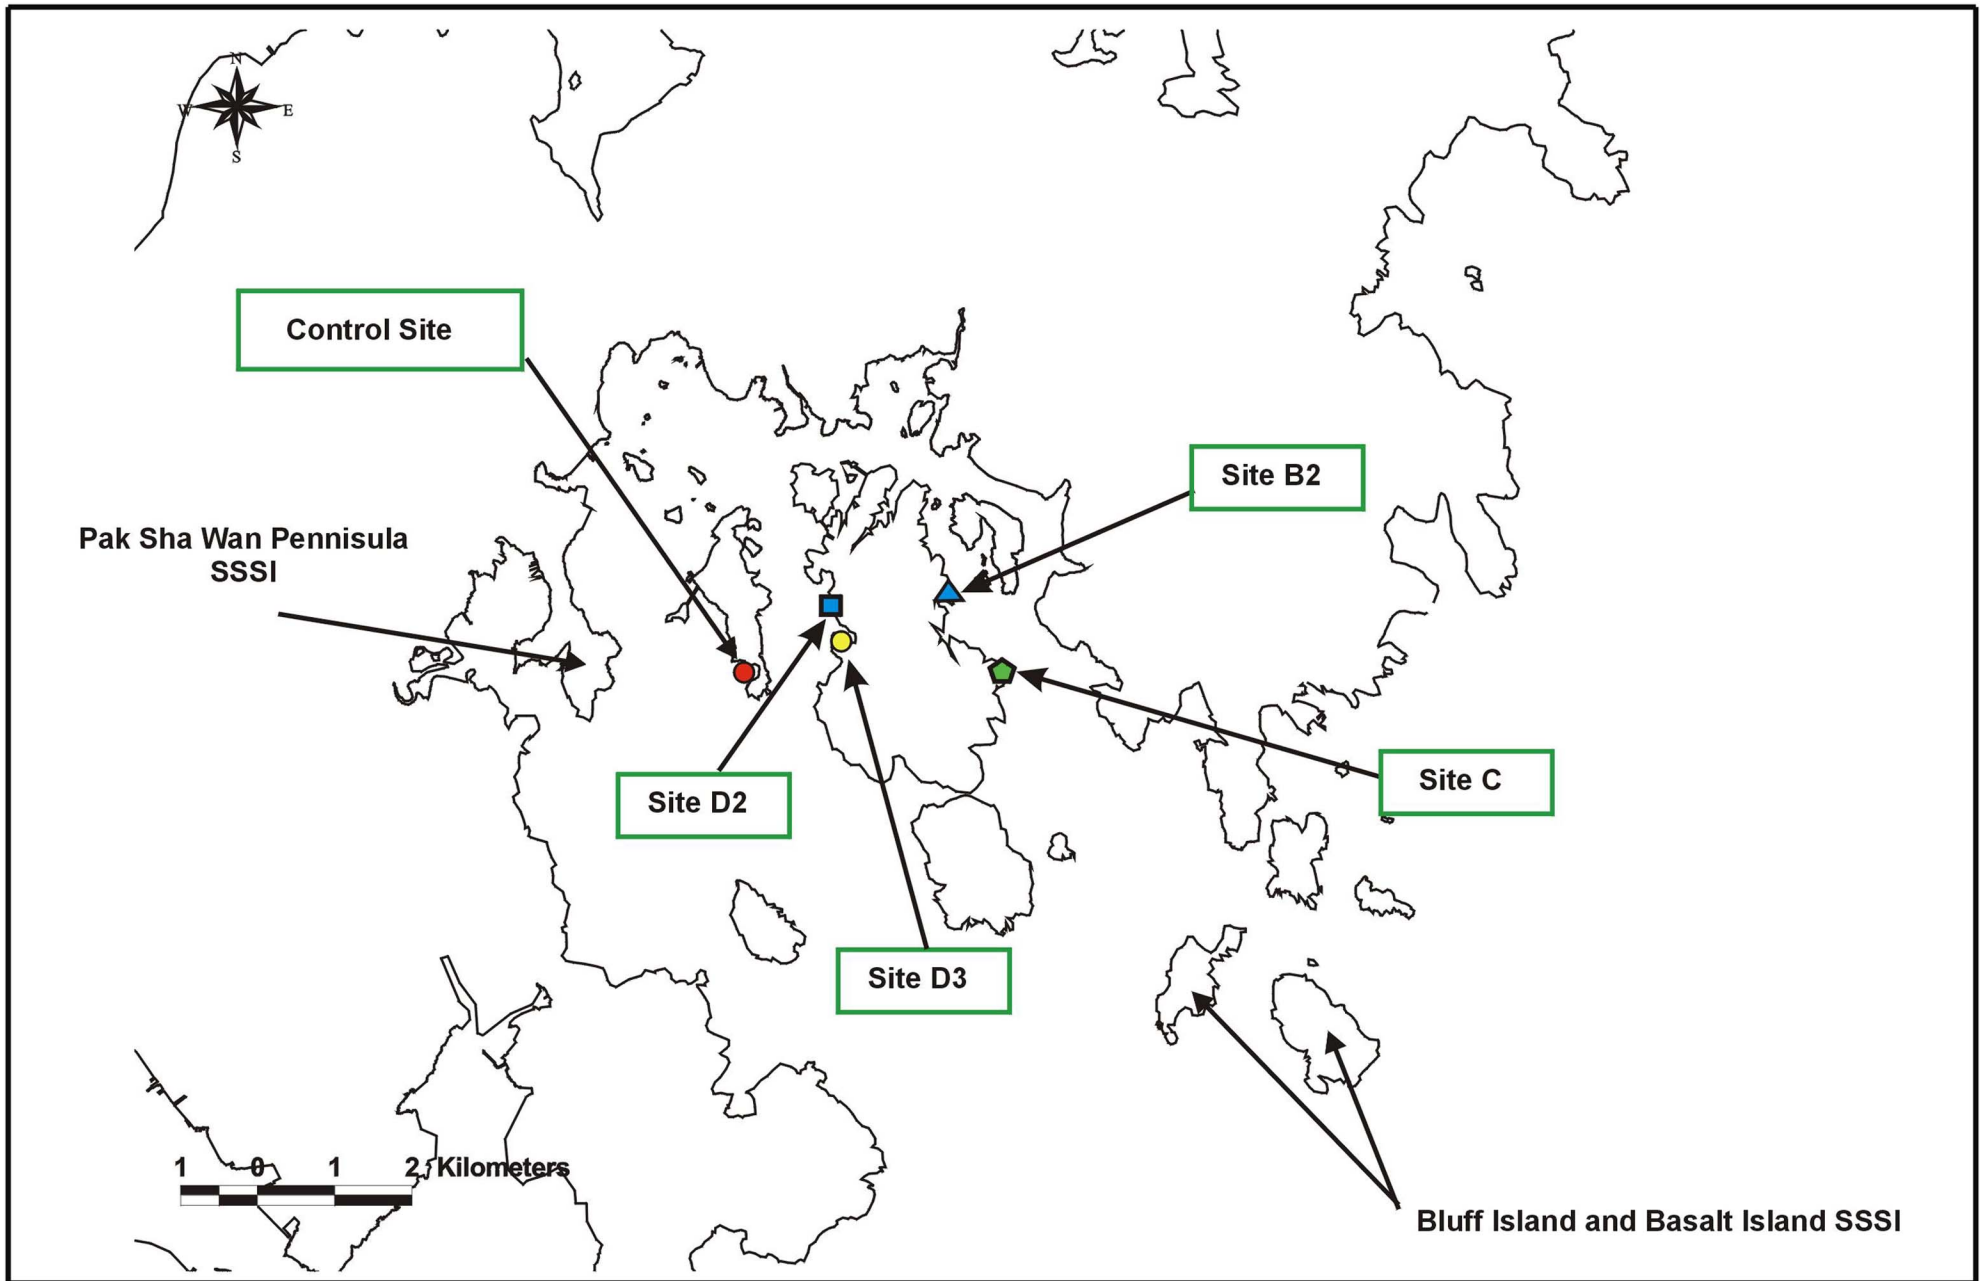
Figure 3.4 Site C, Site B2, Site D2 and a Control Site near the AFCD's Coral Buoy at Sharp Island

- 3.3.7 As required in the EM&A Manual, prior to the commencement of all construction works, a baseline survey of natural corals were conducted in December 2005. At each of the Site C, Site B2, Site D2 and a Control Site near the AFCD's Coral Buoy at Sharp Island (**Figure 3.4**), 20 natural coral colonies in good conditions (i.e. generally intact and no sign of bleaching) and significant sizes (over 20 cm in diameter) were selected and tagged. Each of the tagged coral colonies was identified to species level and their conditions, in terms of percentages of survival, sedimentation and bleaching, were recorded. Each coral was attached with a plastic label with assigned number and then photographed. The species and the size of each tagged corals were also recorded. The species of corals to have been tagged included the following 15 species: *Cyphastrea serailia*, *Favia speciosa*, *Favites abdita*, *Favites pentagona*, *Goniastrea aspera*, *Goniopora columna*, *Hydnophora exesa*, *Leptastrea pruinosa*, *Lithophyllon undulatum*, *Pavona decussate*, *Platygyra acuta*, *Platygyra carnosus*, *Plesiastrea versipora*, *Psammocora superficialis*, and *Turbinaria peltata*. All tagged corals were in good conditions, without significant sign of bleaching or being covered by sediments. The seagrass beds in Site D3 were also surveyed for their extent, coverage percentage and health conditions. The results of the baseline survey were presented in the Baseline Report.
