**Proposed Extension of Public Golf Course  
at Kau Sai Chau Island, Sai Kung**

**Monthly Environmental Monitoring & Audit (EM&A) Report  
for April 2006**

**(Report No. 382210/004)**

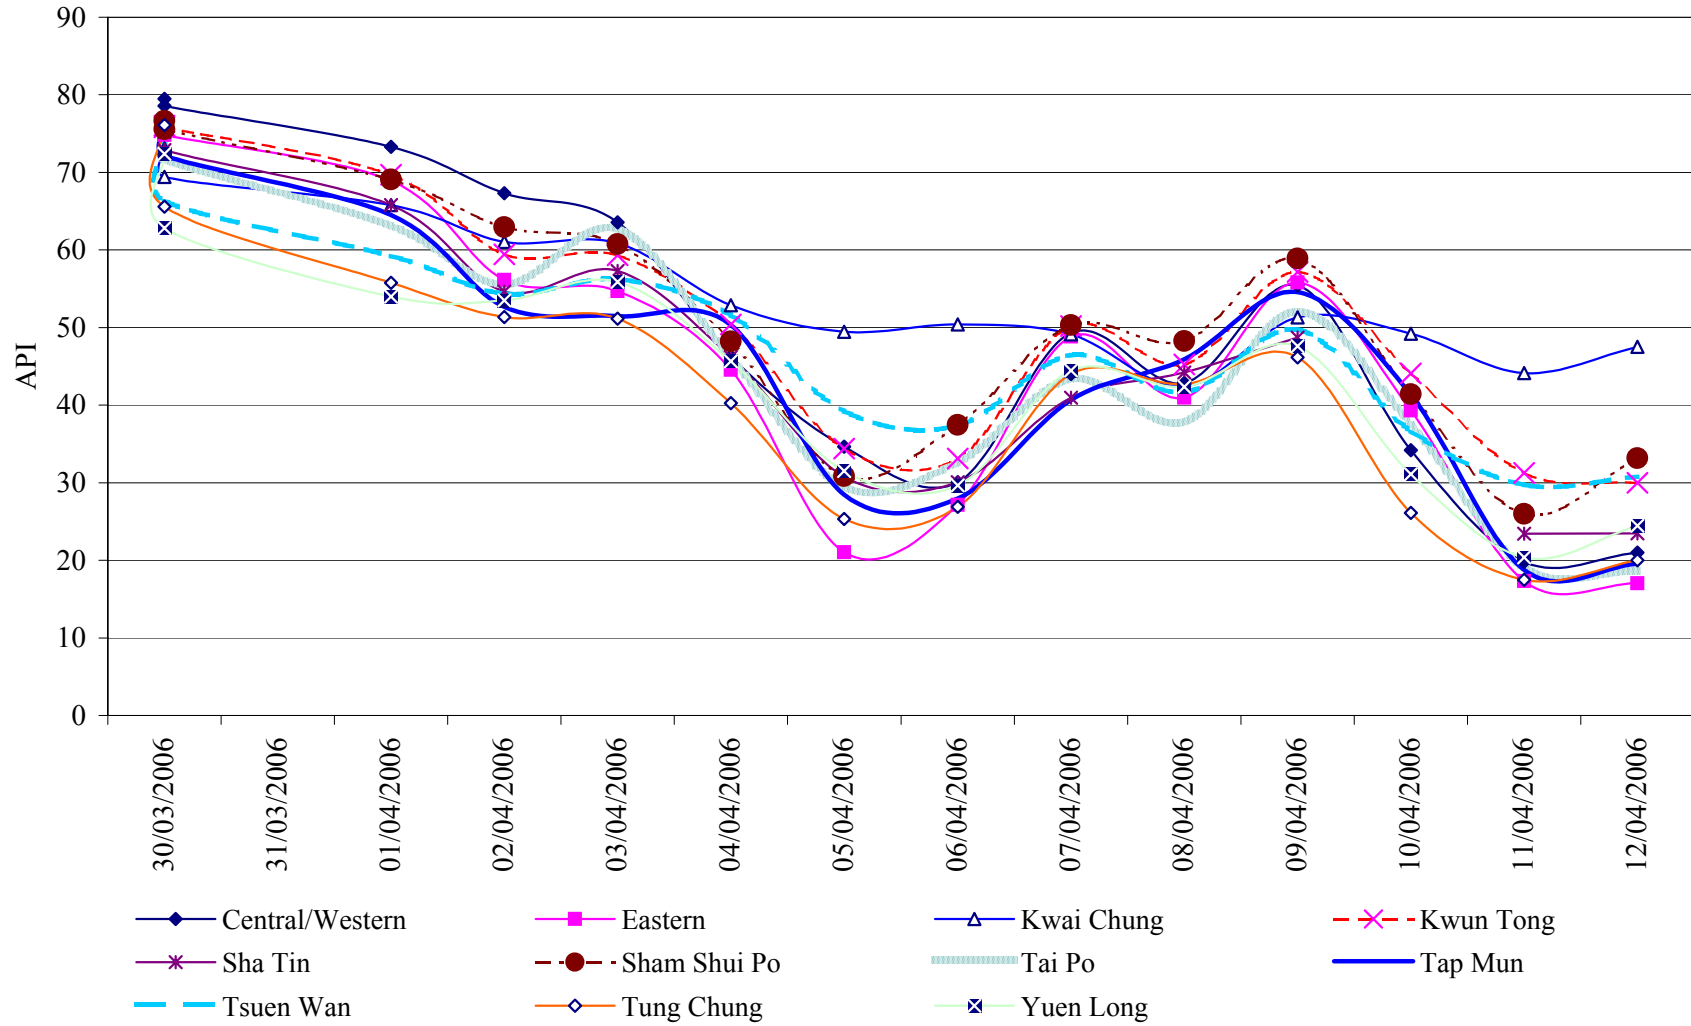
Air Pollutant Index - API (source: EPD)

- 5.1.3 ET reviewed the Air Pollutant Index (API) for all air quality monitoring stations in Hong Kong during the reporting month. There was a decreasing trend of API recorded from 30<sup>th</sup> March 2006 to 5<sup>th</sup> April 2006. The average API was ranging from 52-63 (medium to high) (**Annex E**). The 24-hr TSP monitoring results at GCA B1 on 30<sup>th</sup> Apr 2006 and 4<sup>th</sup> April 2006 were 36.9 µg/m<sup>3</sup> and 235 µg/m<sup>3</sup> respectively. During the monitoring period, the wind directions were dominated by East and Southeast which could cause a direct dust impact to the monitoring station at Bungalow A. In addition, the cut-and-fill area and exposed area was also increased during the reporting month. The exceedance was considered attributed to the works. The Contractor was reminded to provide sufficient dust suppression mitigation measures on site.

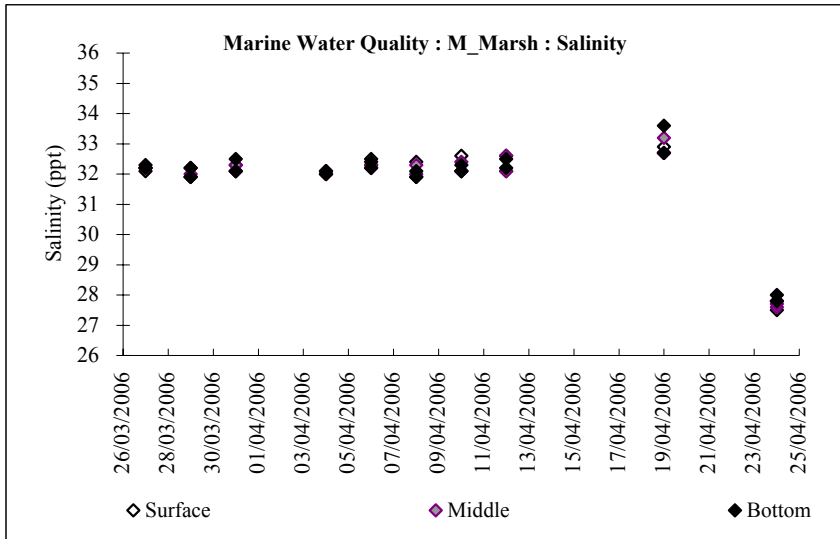
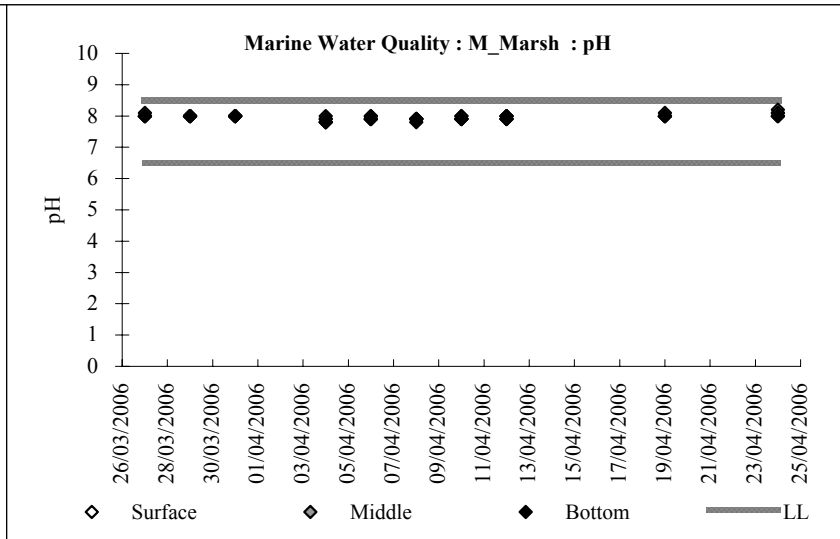
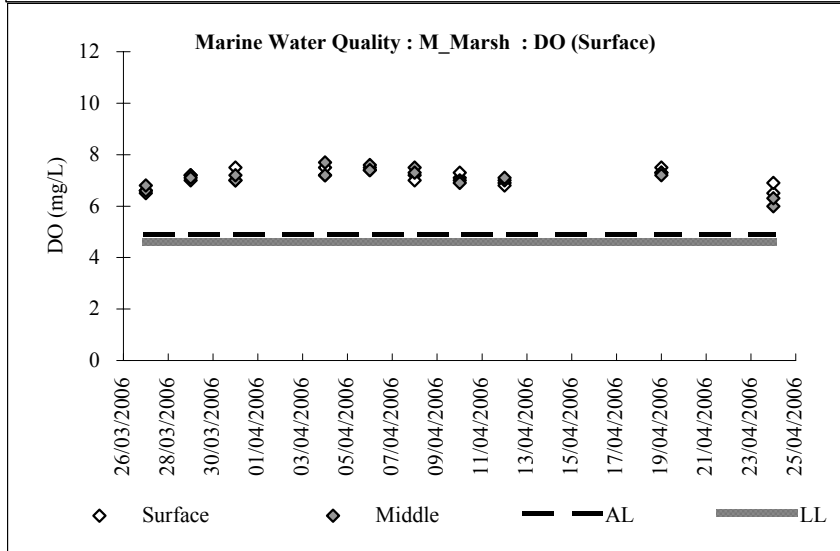
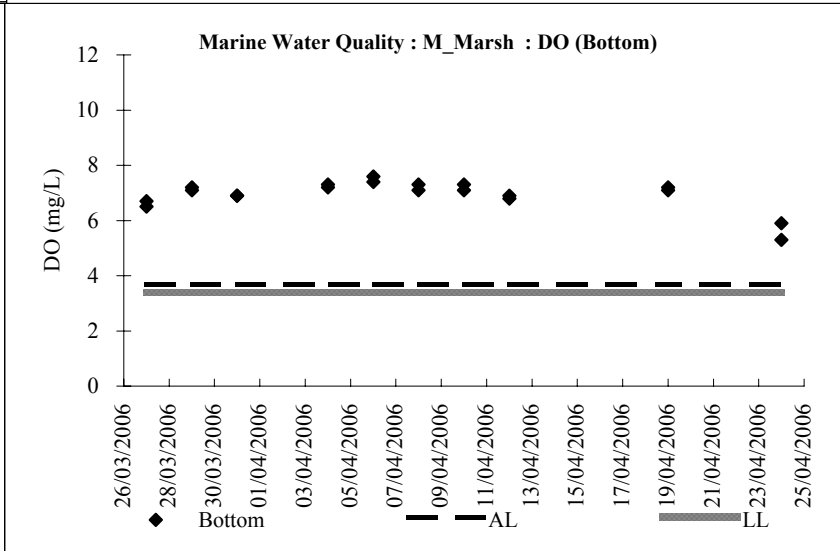
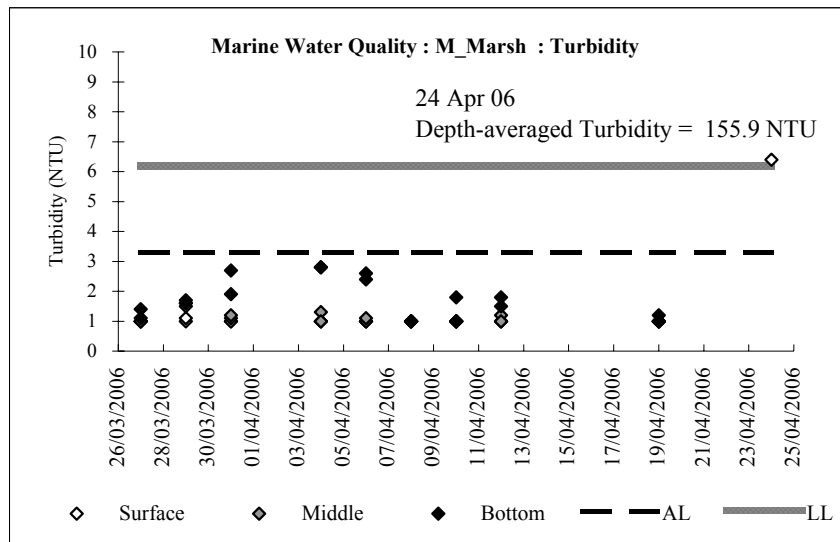
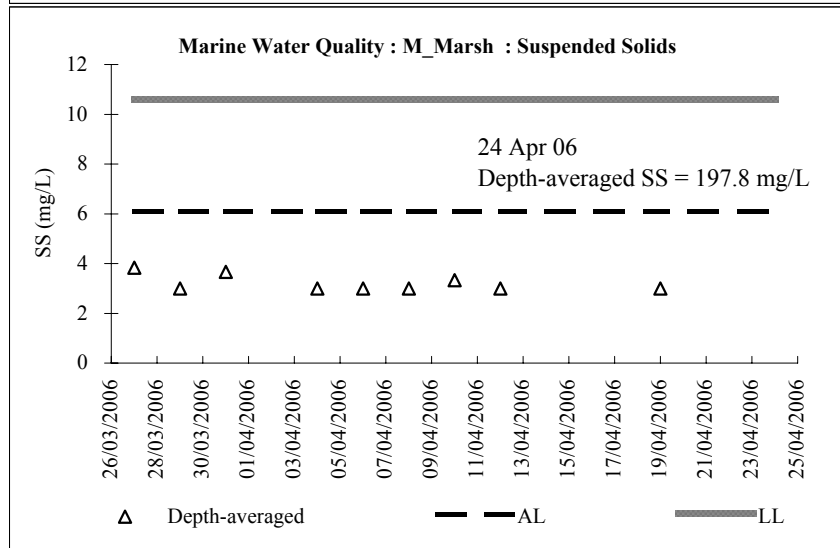
5.2.5 However, silty runoff was observed during the site investigation on 24<sup>th</sup> April 2006 after the heavy rainstorm event from Stream A, haul road near temporary barging point and existing freshwater inland marsh. Six SS and turbidity exceedances at M\_Marsh, TTC and M\_BP were considered project-related.

M_Marsh	Mid-Ebb			Mid-Flood			Depth-averaged
	Surface	Middle	Bottom	Surface	Middle	Bottom	SS (mg/L)
27/03/2006	2.0	3.0	4.0	3.0	5.0	6.0	3.8
29/03/2006	2.0	3.0	3.0	4.0	3.0	3.0	3.0
31/03/2006	3.0	3.0	6.0	3.0	3.0	4.0	3.7
04/04/2006	2.0	3.0	5.0	<del>2.0</del>	<del>2.0</del>	4.0	3.0
06/04/2006	<del>2.0</del>	<del>2.0</del>	6.0	3.0	<del>2.0</del>	3.0	3.0
08/04/2006	3.0	5.0	3.0	3.0	<del>2.0</del>	<del>2.0</del>	3.0
10/04/2006	2.0	3.0	4.0	4.0	<del>2.0</del>	5.0	3.3
12/04/2006	<del>2.0</del>	4.0	4.0	3.0	2.0	3.0	3.0
19/04/2006	2.0	3.0	4.0	2.0	3.0	4.0	3.0
24/04/2006	40.0	183.0	479.0	7.0	120.0	358.0	<b>197.8</b>

- 4.1.9 The Contractor was reminded to implement proper temporary drainage measures and critically reviewed the temporary drainage measures. We recommended the Contractor shall urgently further discuss with the Engineer on the effectiveness and site-specific mitigation measures if necessary to prevent runoff to marine water and stream courses.

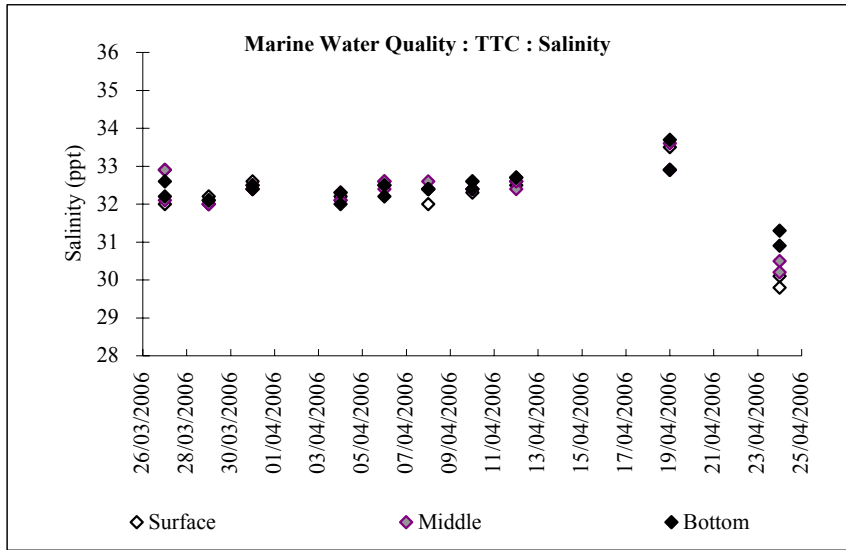
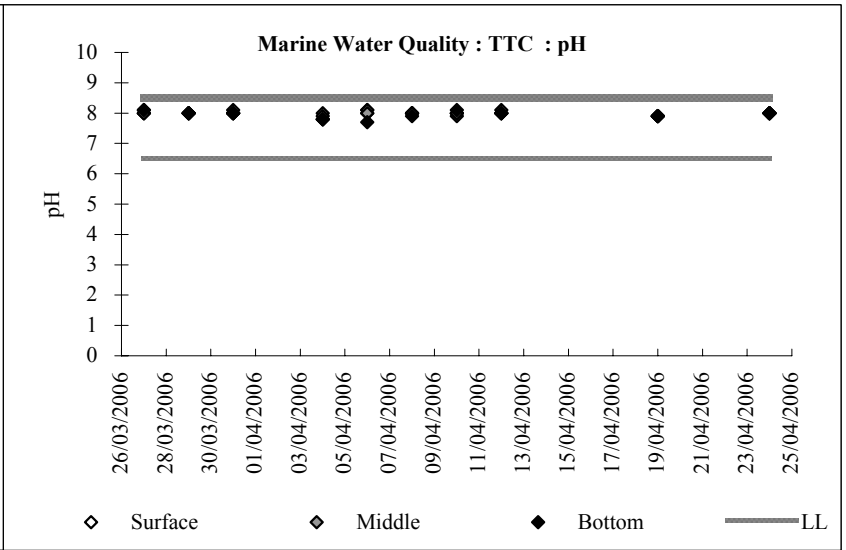
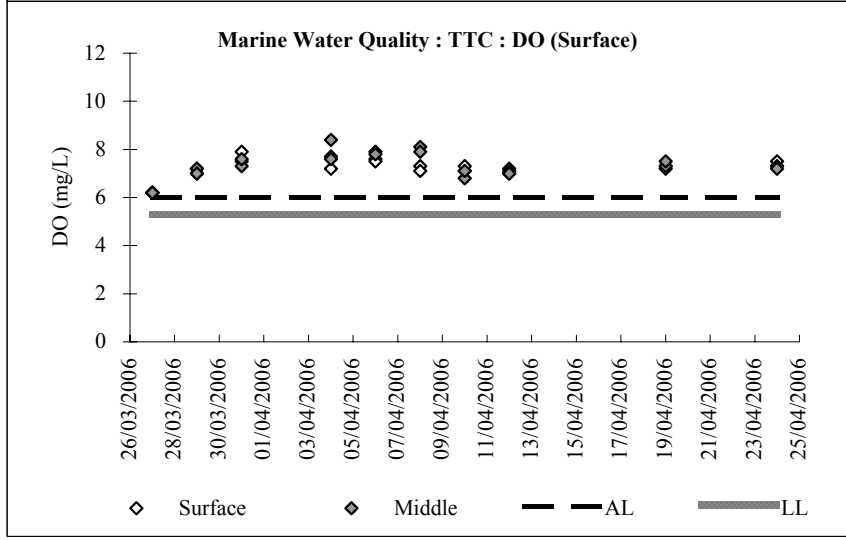
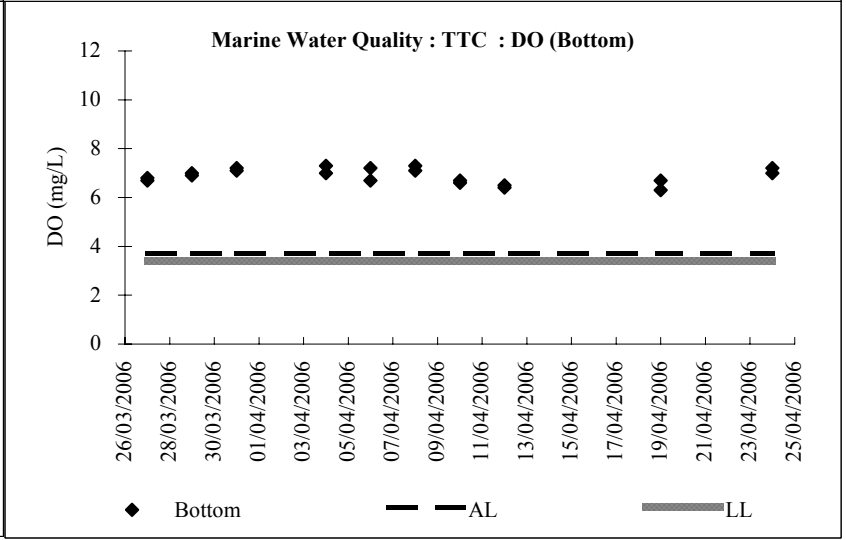
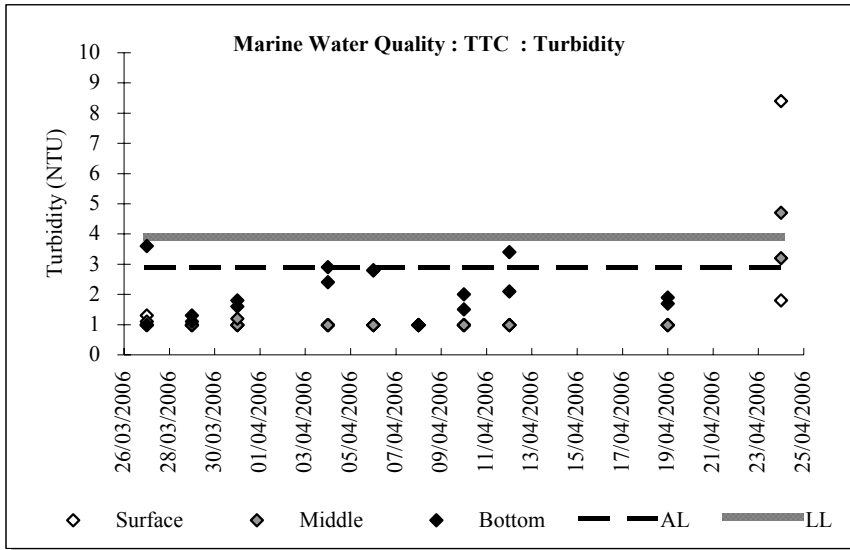
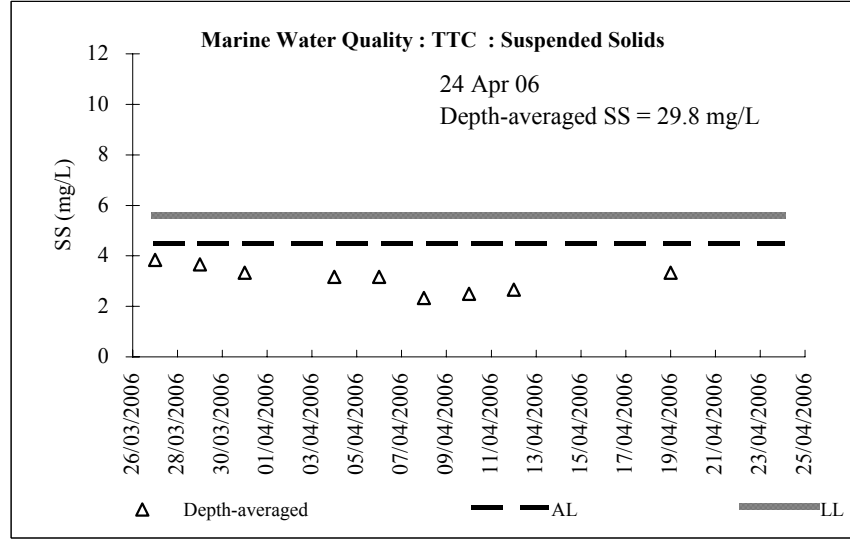
TTC	Mid-Ebb			Mid-Flood			Depth-averaged
	Surface	Middle	Bottom	Surface	Middle	Bottom	SS (mg/L)
27/03/2006	2.0	2.0	5.0	3.0	5.0	6.0	3.8
29/03/2006	3.0	5.0	5.0	2.0	4.0	3.0	3.7
31/03/2006	3.0	3.0	3.0	3.0	4.0	4.0	3.3
04/04/2006	2.0	3.0	6.0	3.0	2.0	3.0	3.2
06/04/2006	2.0	3.0	2.0	5.0	5.0	2.0	3.2
08/04/2006	2.0	2.0	4.0	2.0	2.0	2.0	2.3
10/04/2006	3.0	2.0	2.0	2.0	4.0	2.0	2.5
12/04/2006	2.0	4.0	3.0	2.0	2.0	3.0	2.7
19/04/2006	4.0	3.0	4.0	2.0	3.0	4.0	3.3
24/04/2006	20.0	38.0	55.0	6.0	20.0	40.0	<b>29.8</b>

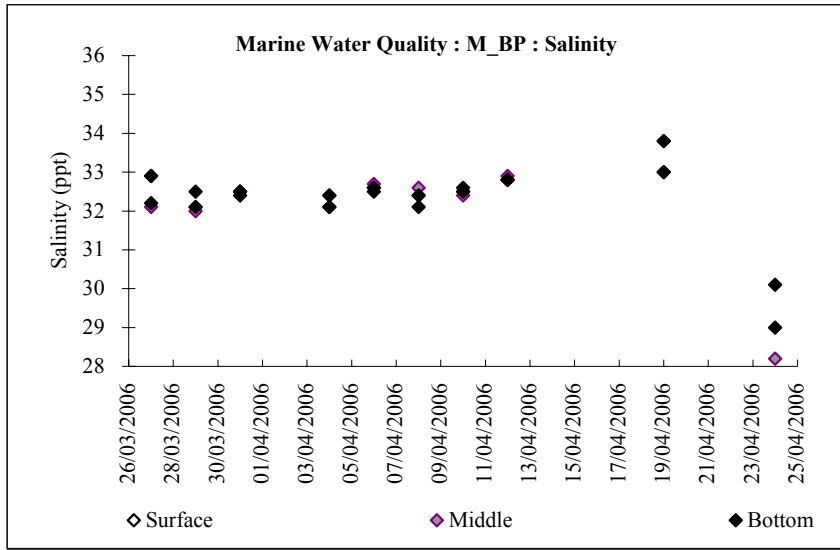
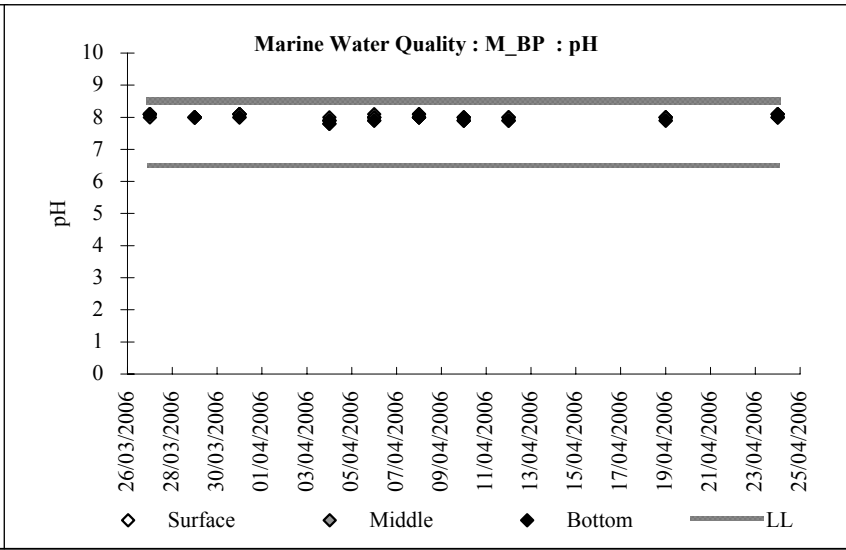
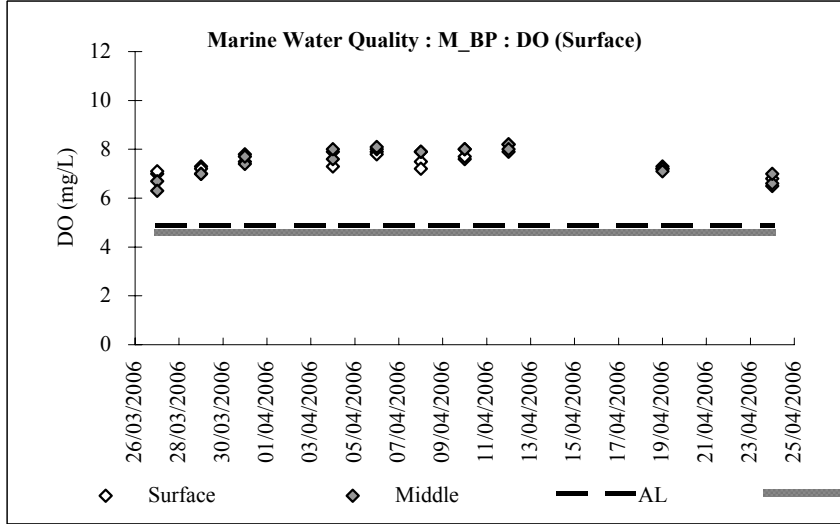
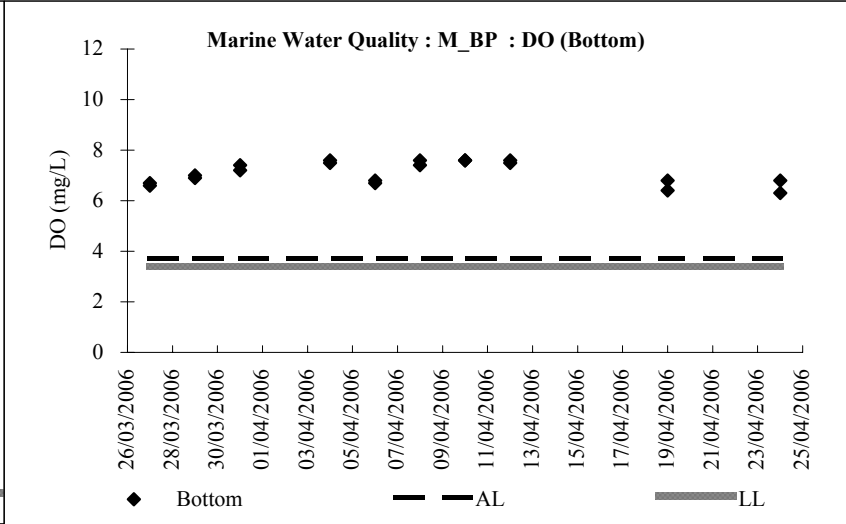
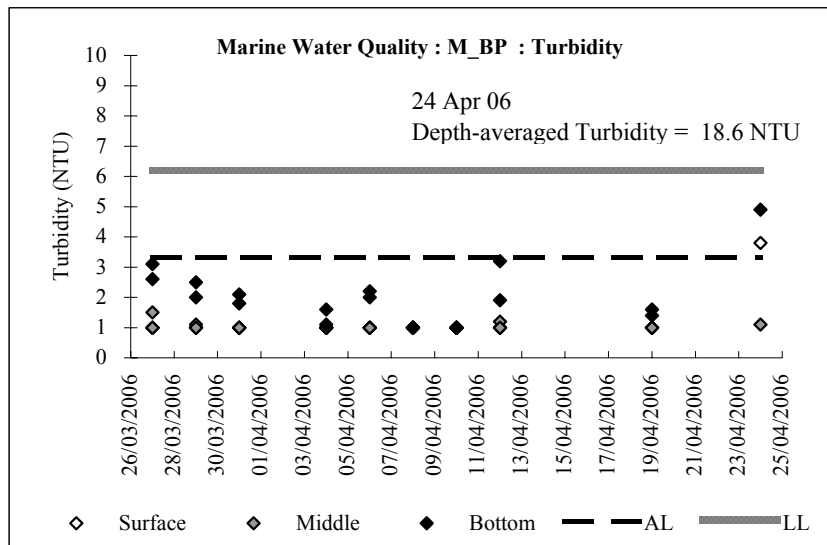
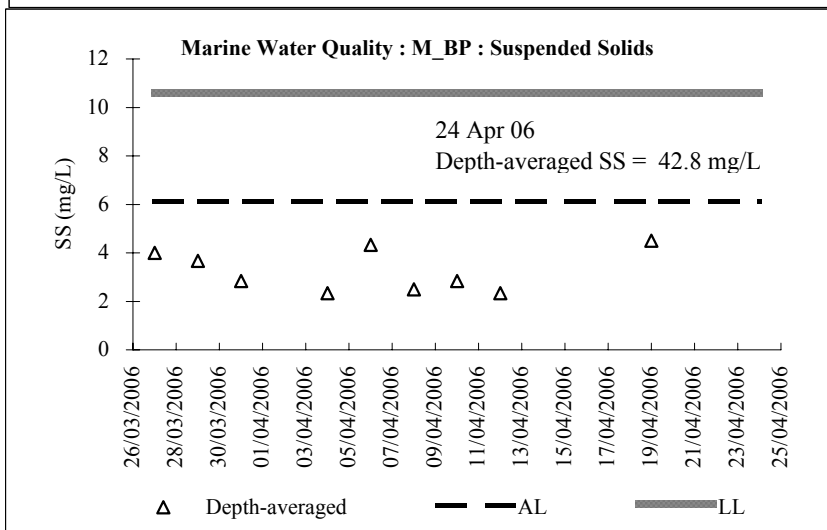
M_BP	Mid-Ebb			Mid-Flood			Depth-averaged
	Surface	Middle	Bottom	Surface	Middle	Bottom	SS (mg/L)
27/03/2006	3.0	4.0	4.0	3.0	4.0	6.0	4.0
29/03/2006	6.0	3.0	4.0	2.0	4.0	3.0	3.7
31/03/2006	2.0	3.0	<del>2.0</del>	3.0	4.0	3.0	2.8
04/04/2006	3.0	2.0	3.0	2.0	<del>2.0</del>	<del>2.0</del>	2.3
06/04/2006	<del>2.0</del>	3.0	6.0	5.0	3.0	7.0	4.3
08/04/2006	<del>2.0</del>	2.0	2.0	4.0	<del>2.0</del>	3.0	2.5
10/04/2006	<del>2.0</del>	2.0	<del>2.0</del>	2.0	4.0	5.0	2.8
12/04/2006	<del>2.0</del>	<del>2.0</del>	3.0	<del>2.0</del>	3.0	<del>2.0</del>	2.3
19/04/2006	5.0	3.0	3.0	6.0	5.0	5.0	4.5
24/04/2006	48.0	63.0	123.0	7.0	5.0	11.0	<b>42.8</b>

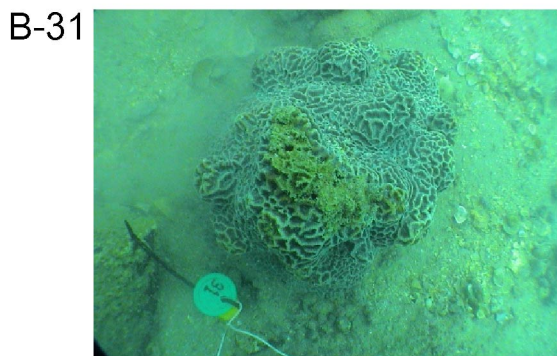
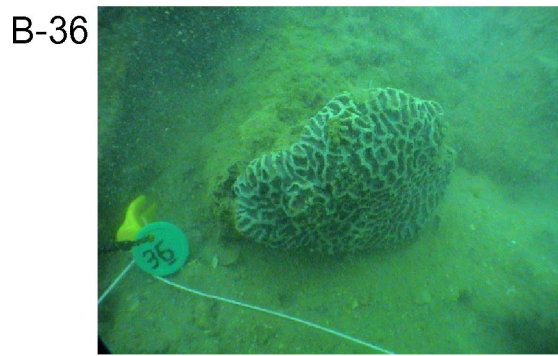
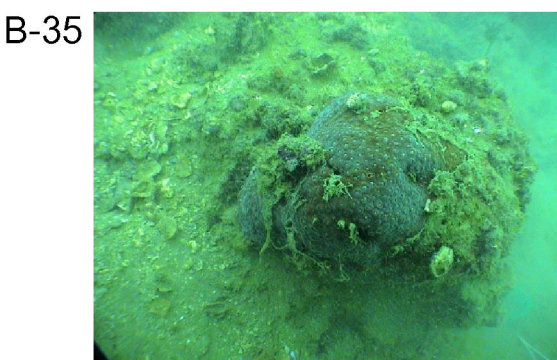
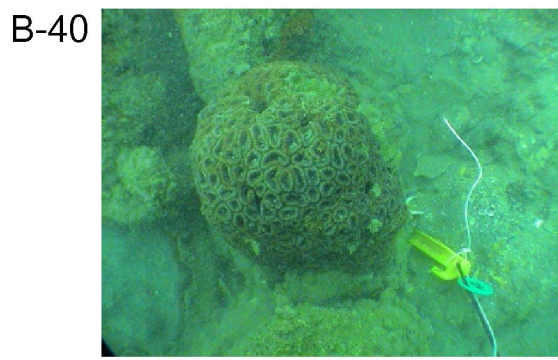
Baseline conditions of additional tagged corals in April 2006

- 3.3.8 The coral monitoring regime at Site B2 was adjusted at the present survey due to the damages on tagged corals reported in the last monitoring report (March 2006). The tagged corals B-11 to B-20, which were distributed in linear formation parallel to the seawall and within the area covered by the temporary barging point, would be retained for monitoring purpose, while another 40 additional corals would be tagged, 20 on each side of the temporary barging point. The total number of tagged corals at Site B2 was thus increased from 20 to 50, and included corals within and outside the sea area covered by the temporary barging point. The indicative locations of the 50 tagged corals were shown in **Figure 3.4b**.
