**Proposed Extension of Public Golf Course
at Kau Sai Chau Island, Sai Kung**

**Monthly Environmental Monitoring & Audit (EM&A) Report
for June 2006**

(Report No. 382210/006)

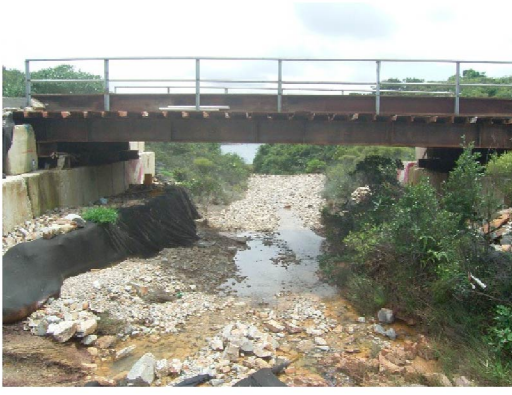
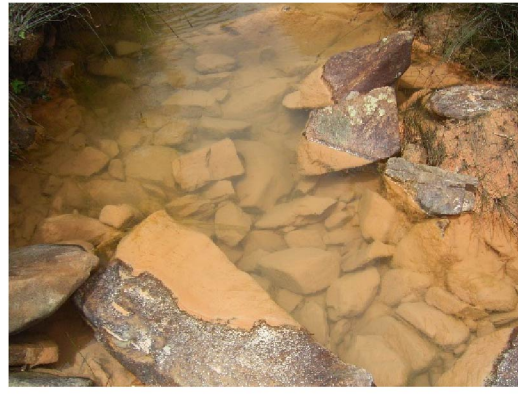
5.3.8 In the present monitoring survey, the main stream course of Stream A (the section downstream to the confluence of tributaries A1 and A2) was found to be filled up by rubbles to the level of the weir at its downstream end (see **Photo Plate 5.3-1**). The rubbles were reported to be washed down from the upper Tributary A2 which was under pipe culvert construction. Although the riparian vegetation was not affected by the rubbles, this section of stream channel was temporarily lost. Stream A was of the lowest ecological value among the four natural streams as it was heavily silted with sediments from eroded hillsides all year round. No stream fish and only very limited aquatic fauna were recorded in Stream A before. The impact from this

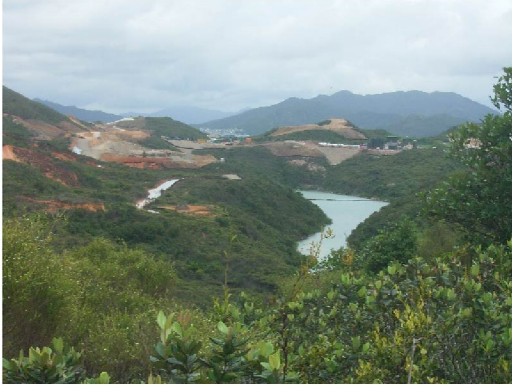
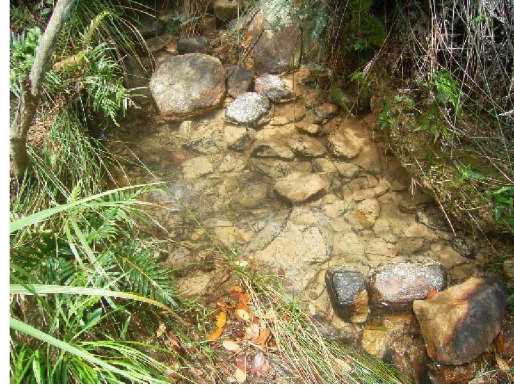
Stream B

- 5.3.9 Water levels in the 4 streams were much higher than in previous monitoring surveys during dry season. For the two tributaries in Stream B, the flow in B2 tributary was similar and flow in B1 tributary was also observed at its lower reach. The majority of Stream C had been found dry in previous monitoring surveys, but in the present survey surface flow was present in even upstream section. Stream D had surface flow even at the most upper reach. Photos of Streams A to D were shown in **Photo Plate 5.3-1 (Annex E)**.

- 5.3.11 Aquatic fauna communities were checked during the monitoring survey. Atyid shrimp *Caridina trifasciata* were found in Stream B, Stream C & Stream D during the present monitoring survey (**Annex E - Photo Plate 5.3-1**). The recent heavy rainfall had significantly increased the flow in the streams, but also increased the sediment inside the streams. It was observed that there were sediments (e.g. silts) covering some boulders inside the channels. But the stream flow was still clear.

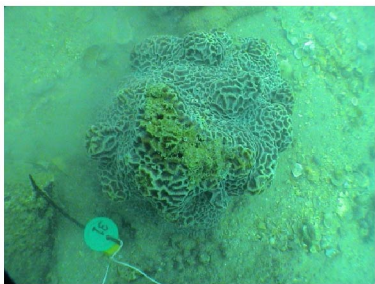
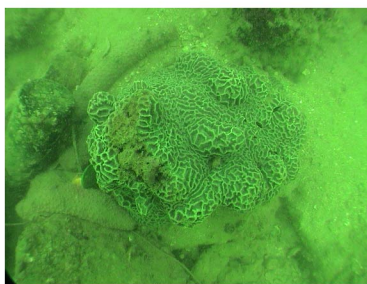
B-31

- 5.3.16 The conditions of the tagged corals during the present survey were compared with the conditions during the Baseline Survey (for B-11 to B-20) or in April 2006 (for B-21 to B-60) (**Annex E - Photo Plates 5.3-2 to 5.3-6**). All 50 tagged corals were recovered. B-19 was found toppled in the last monitoring survey (May 2006) and was then restored to the original posture. In the present monitoring, the mortality of this colony was found about 70%, but the partial mortality of this colony should not be considered as a consequence of the operation of the temporary barging point. Another coral colony (B-58) had significant mortality was B-58 which was 60% mortality. Two more coral colonies also had minor mortality, i.e. B-52 and B-53 and both of them were recorded in 10% mortality. As there was no other coral showing significant mortality, it was unlikely that the mortality of B-58 was caused by the barging point operation or the construction of the golf course. One possibility was that B-58 also experienced toppled since the last monitoring, but the wave action turned it back to normal posture again. The partial mortality of this colony should also not be considered as a consequence of the operation of the temporary barging point.

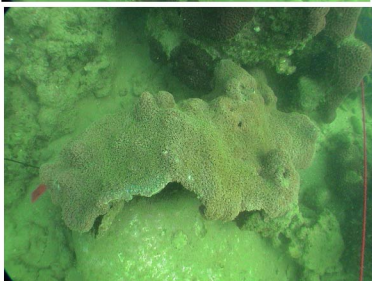
X-05

Lost

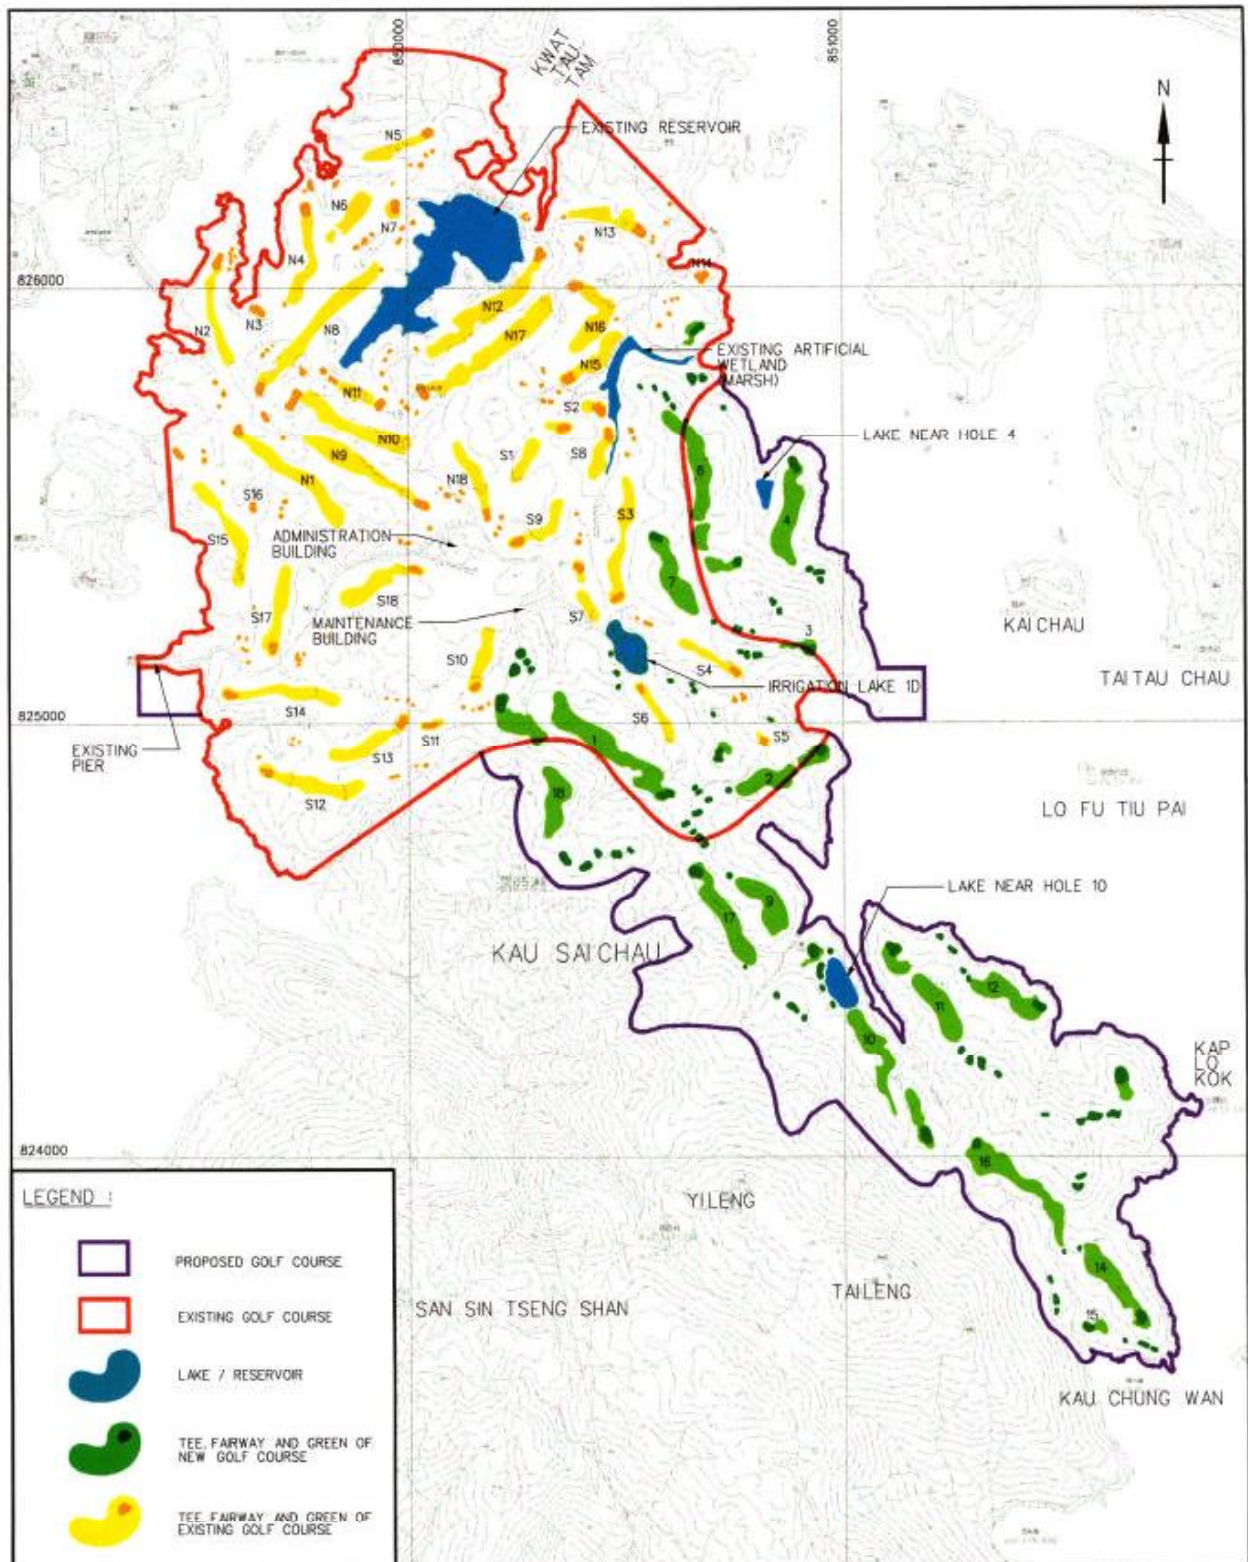
-   PROPOSED GOLF COURSE
-   EXISTING GOLF COURSE
-   LAKE / RESERVOIR
-   TEE, FAIRWAY AND GREEN OF NEW GOLF COURSE
-   TEE, FAIRWAY AND GREEN OF EXISTING GOLF COURSE

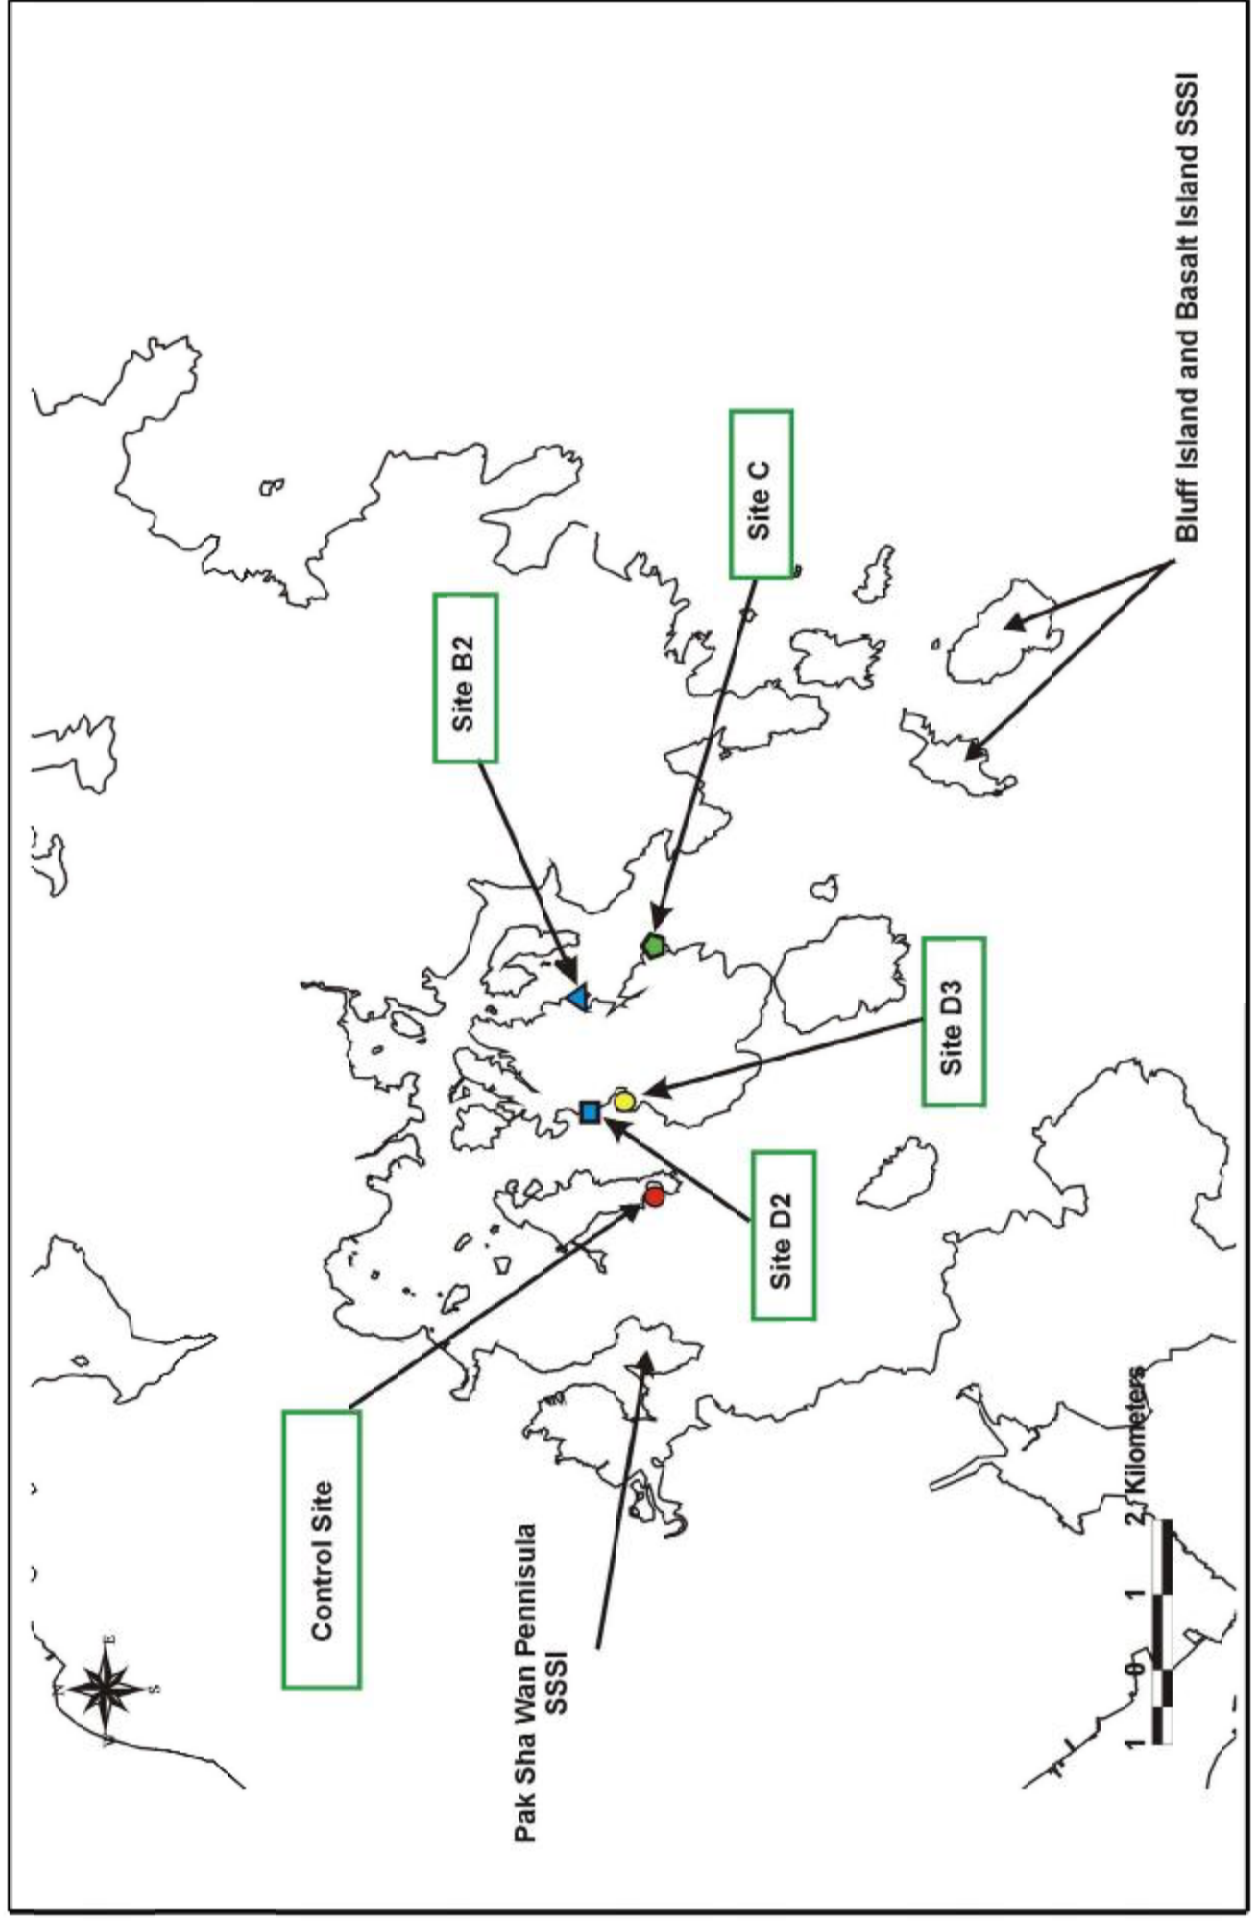
Figure 3.4 Site C, Site B2, Site D2 and a Control Site near the AFCD's Coral Buoy at Sharp Island

- 3.3.7 As required in the EM&A Manual, prior to the commencement of all construction works, a baseline survey of natural corals were conducted in December 2005. At each of the Site C, Site B2, Site D2 and a Control Site near the AFCD's Coral Buoy at Sharp Island (**Figure 3.4**), 20 natural coral colonies in good conditions (i.e. generally intact and no sign of bleaching) and significant sizes (preferably over 20 cm in diameter) were selected and tagged. Each of the tagged coral colonies was identified to species level and their conditions, in terms of percentages of survival, sedimentation and bleaching, were recorded. Each coral was attached with a plastic label with assigned number and then photographed. The species and the size of each tagged corals were also recorded. The species of corals to have been tagged included the following 15 species: *Cyphastrea serailia*, *Favia speciosa*, *Favites abdita*, *Favites pentagona*, *Goniastrea aspera*, *Goniopora columna*, *Hydnophora exesa*, *Leptastrea pruinosa*, *Lithophyllon undulatum*, *Pavona decussate*, *Platygyra acuta*, *Platygyra carnosus*, *Plesiastrea versipora*, *Psammocora superficialis*, and *Turbinaria peltata*. All tagged corals were in good conditions during the baseline survey, without significant sign of bleaching or being covered by sediments, and therefore were all recommended as the monitored coral colonies (all 80 tagged corals, 20 from each site). The seagrass beds in Site D3 were also surveyed for their extent, coverage percentage and health conditions during the baseline survey. The results of the baseline survey has presented in the Baseline Monitoring Report. The original 20 tagged corals at Site B2 were re-organised in April 2006, with B-11 to B-20 retained, but 40 new tagged corals (B-21 to B-60) were established. The number of tagged corals at Site B2 was therefore increased from 20 nos. to 50 nos. The baseline conditions of these newly tagged corals (40 nos.) were presented in the monthly monitoring report of April 2006.

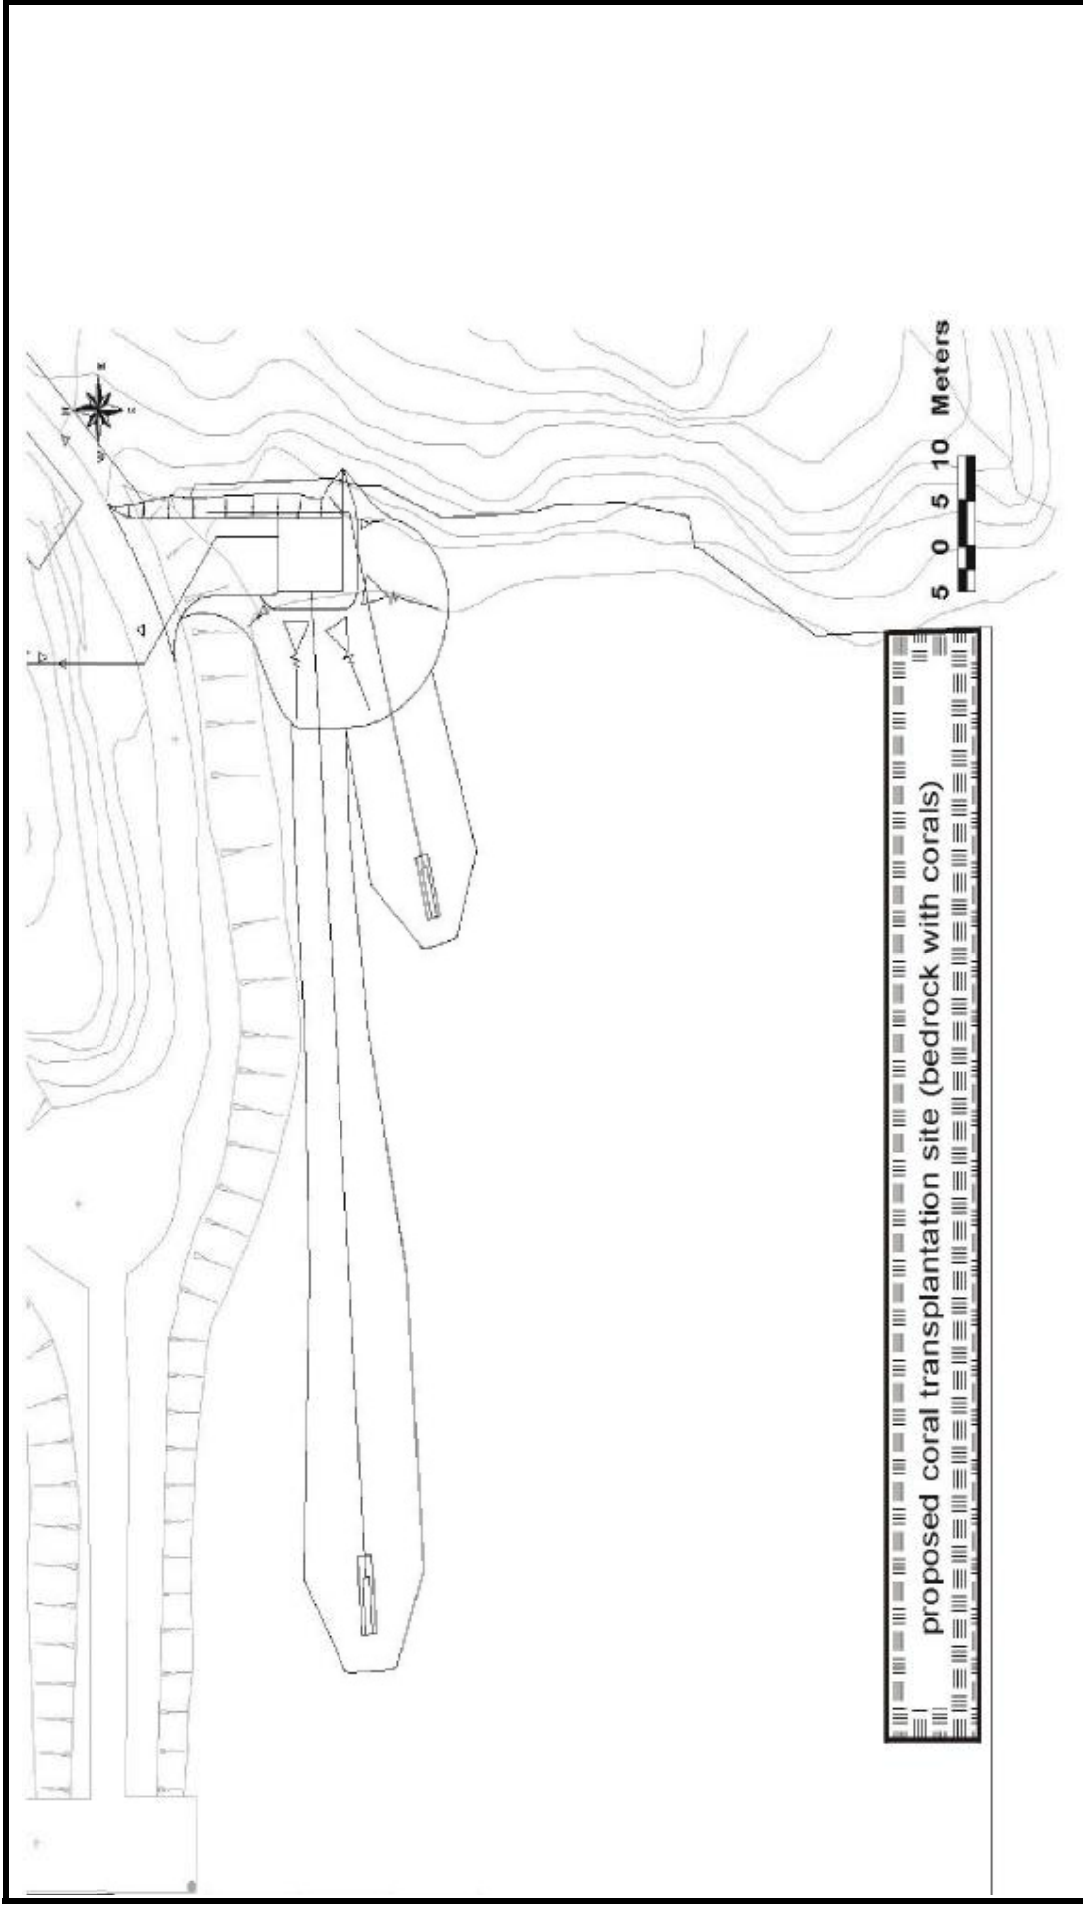
Fig 3.5

3.3.10 During the weekly site inspection, ET also monitored and audited the implementation of the recommended mitigation measures for terrestrial and marine ecology. Monitoring locations for ecology are shown in **Figures 3.3 – 3.5**. The monitoring programme for the reporting period is shown in **Annex B**.

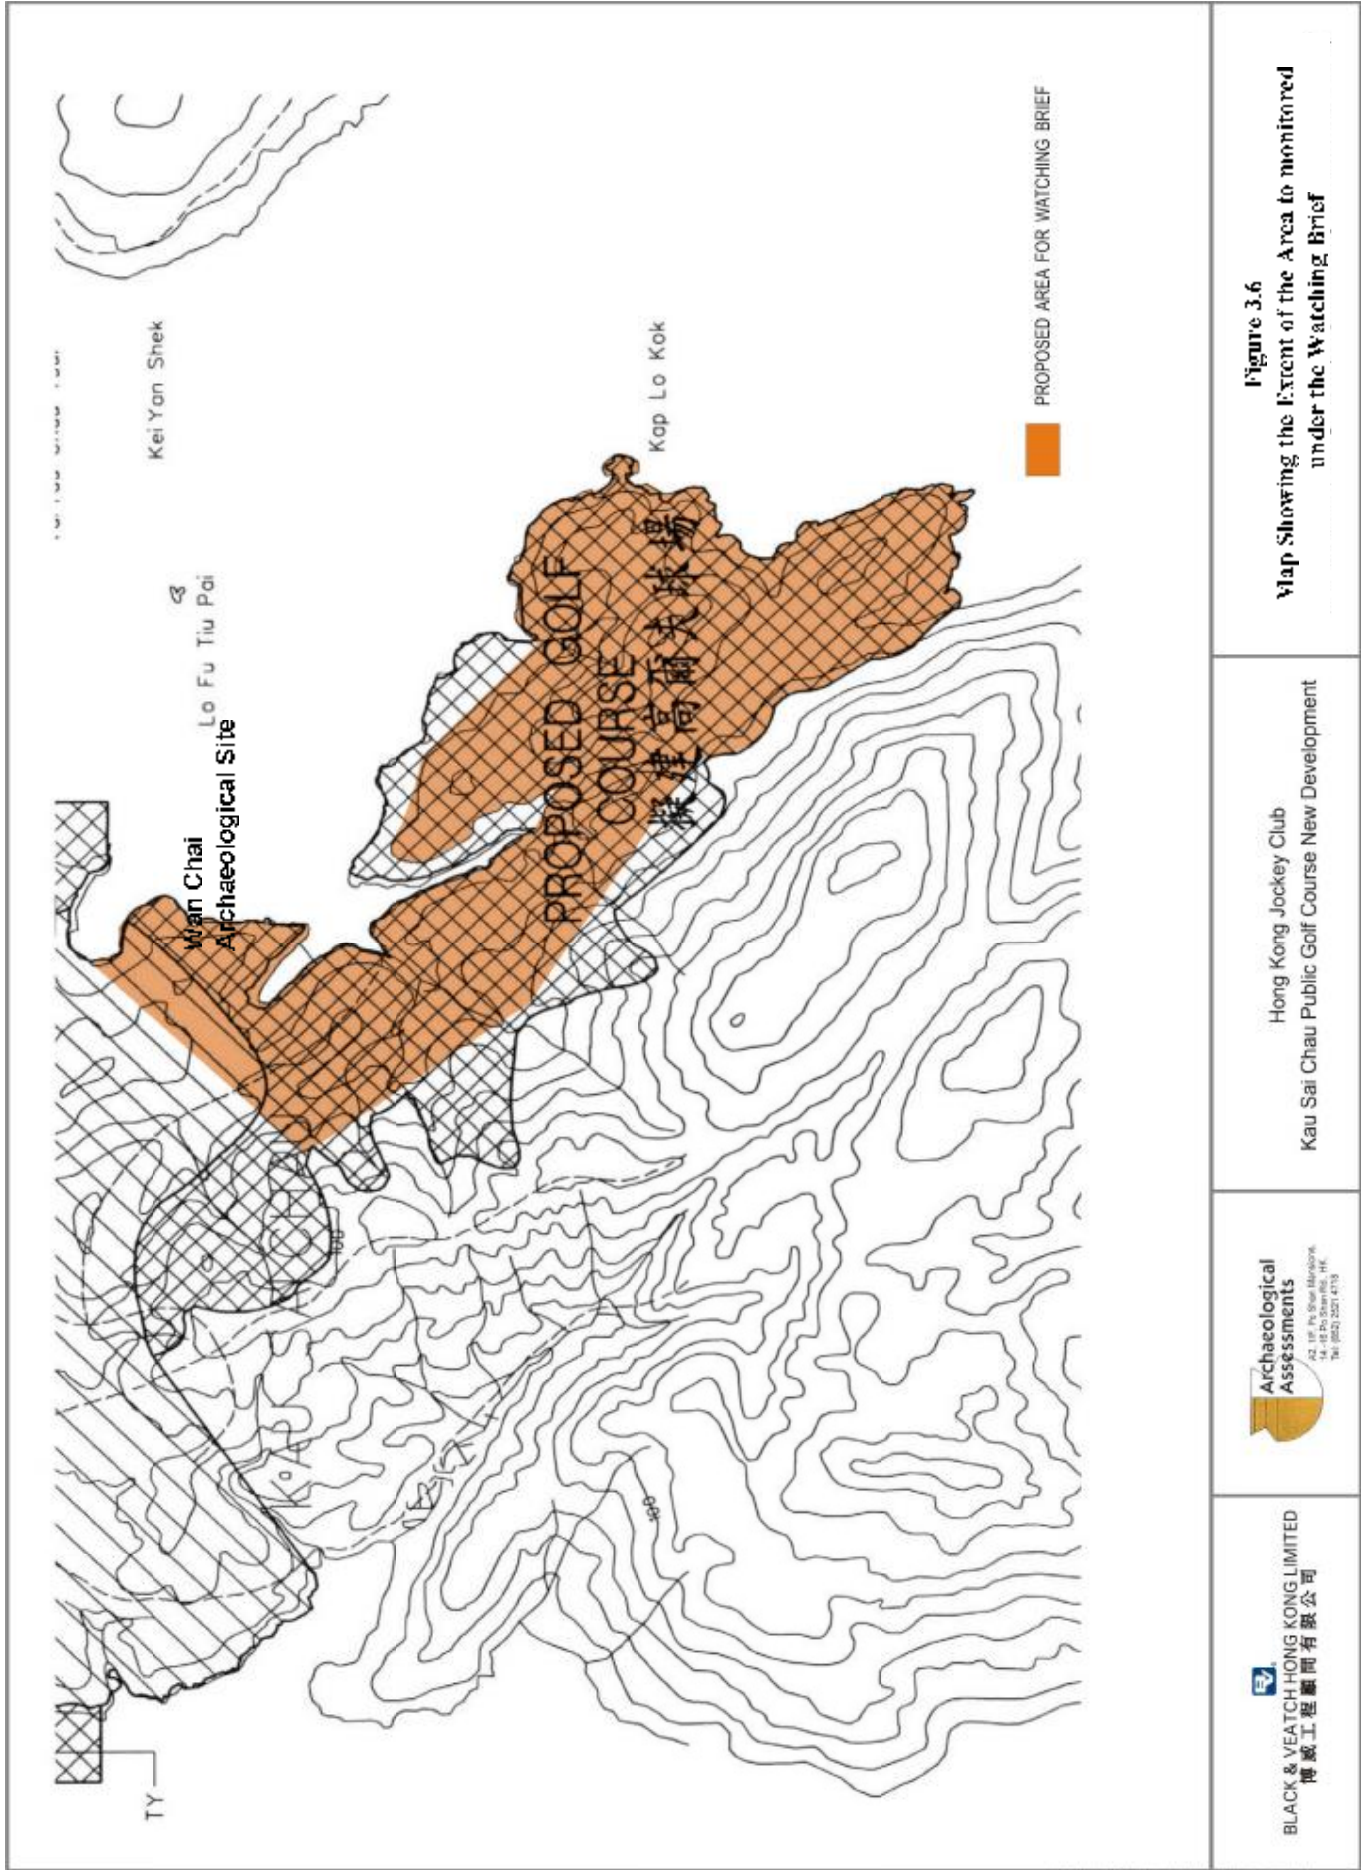
Figure 3.6
Map Showing the Extent of the Area to be monitored
under the Watching Brief

3.5.1 The archeological impact assessment conducted in the EIA concluded that some potential for archaeological material remains at the Wan Chai Archaeological Site and a watching brief is recommended during the construction phase.
