SkyCity Golf Course EM&A Monthly Compliance Report

April 2007

Report no: 01332R0171

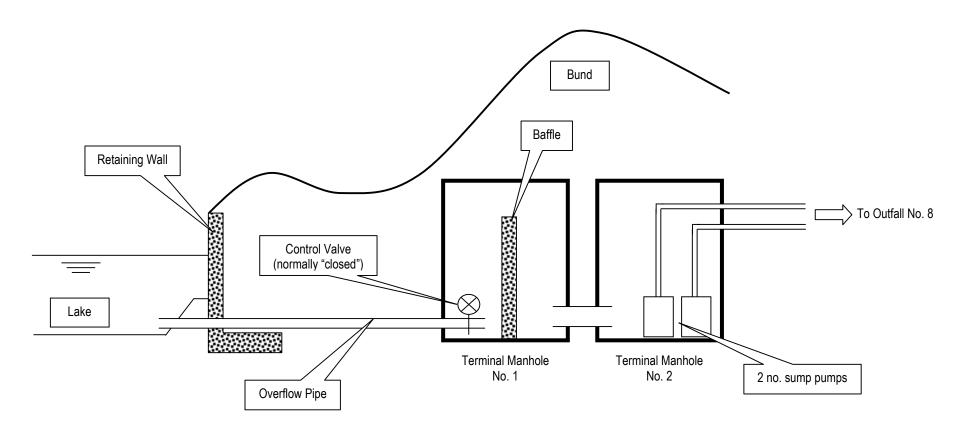
Figure 2-2 Schematic of Lake Water Control System

During operation, the Golf Course has been designed to contain water within two artificial lakes. The two lakes are linked together by two underwater pipes, which means that they can be considered as a single water body in terms of water quality and hydrology. Because of the sloping topography of the site, all rainwater collected within the Golf Course will drain into the lakes through a subsoil drainage system. The lakes provide a source of freshwater for irrigation, from which surplus water will then flow back into the lakes.

Lake water is sampled on a regular basis to ensure that, should it need to be discharged, it will meet the relevant discharge standards. If more than 20,000m³ of water flows into the lakes, then the Golf Course may flood. To avoid this, the Golf Course Supervisor can authorise the opening of a control valve to allow the water to overflow from the lake and into off-site storm drains that discharge via Outfall No. 8. However, the valve can only be opened if the latest lake water monitoring results indicate that water is of an acceptable quality. In normal circumstances, the control valve remains closed and discharge off-site is not possible. All opening and closing of the control valve will be logged on site.

If the latest lake water monitoring results indicate that water is not of an acceptable quality, then the valve cannot be opened, the lake water cannot overflow and the Golf Course will begin to flood. This is part of the mitigation design to prevent off-site discharge of water that does not meet the required standard. The bund that surrounds the site is at least 1.5m high and up to $90,000\text{m}^3$ of floodwater can be retained within the Golf Course, in addition to the $20,000\text{m}^3$ lake capacity. In this situation, water samples from the flooded Golf Course will be taken more frequently. Only when water has returned to an acceptable quality will the control valve be opened to allow water to overflow from the lake and into off-site storm drains that discharge via Outfall No. 8, thereby allowing the flood to recede.

The system by which this water control is achieved is shown in Figure 2-2.

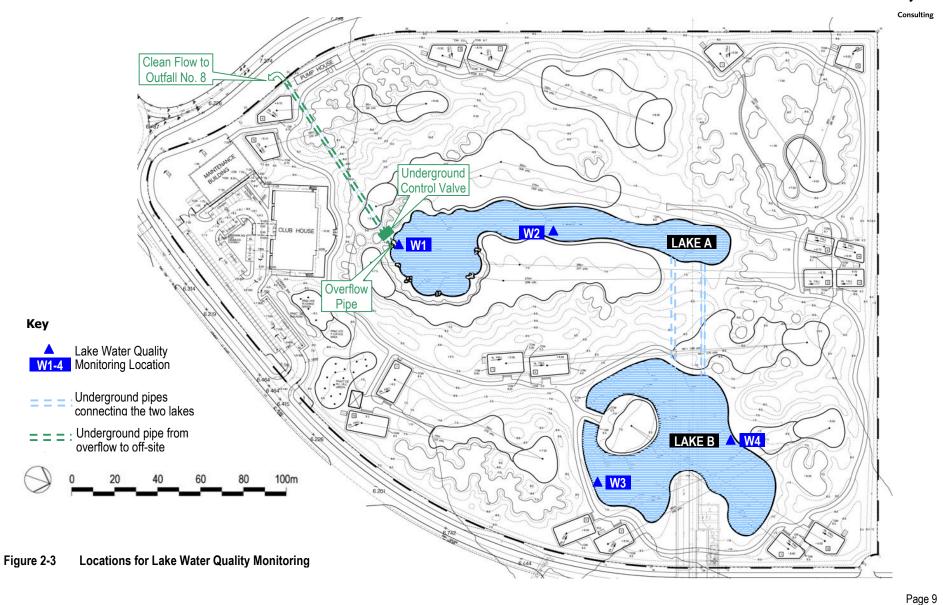
Monitoring locations together with grid references are shown in Figure 2-3. Monitoring Stations are designated as W1, W2, W3 and W4.
