SkyCity Nine Eagles Golf Course

Quarterly EM&A Compliance Report

May to July 2010

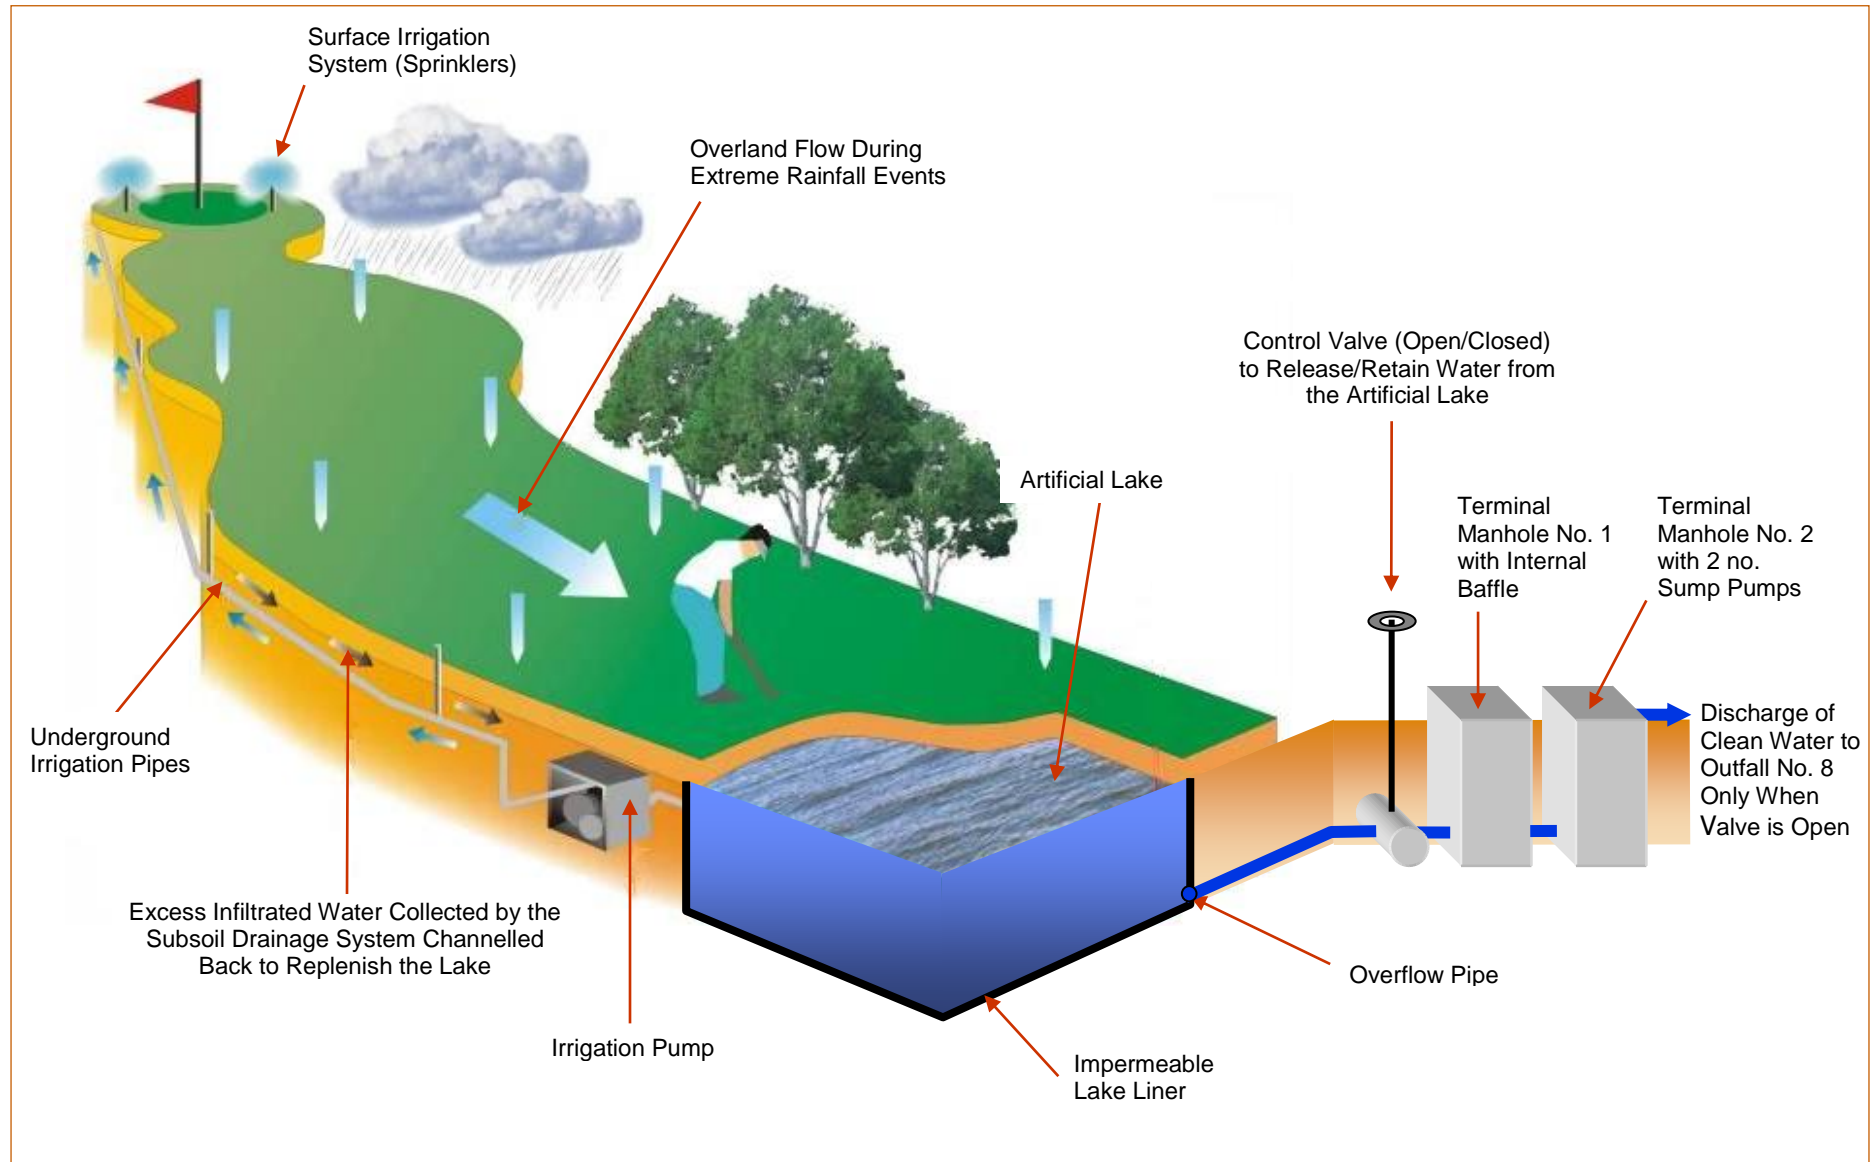
Figure 1-2 Schematic of Lake Water Control System

The Golf Course has been designed to contain water within two artificial lakes, which are linked together by two underwater pipes. The lakes provide a source of freshwater for irrigation. All rainwater and surplus irrigation water collected within the Golf Course will drain back into the lakes for reuse, through a sub-soil drainage system.

If the capacity of the lakes exceeds 20,000m³, then the Golf Course may flood. To avoid this, the Golf Course Supervisor can authorise the opening of a control valve to allow the water to overflow from the lakes into storm drains that discharge off-site via Outfall No. 8. However, the valve can only be opened if the lake water monitoring results indicate that water is of an acceptable quality. Under normal circumstances, the control valve remains closed and discharge off-site is not possible. All opening/closing of the control valve is logged on site.

If the latest lake water monitoring results indicate that water is not of an acceptable quality, then the valve cannot be opened, the lake water cannot overflow and the Golf Course may begin to flood. This is part of the mitigation design to prevent off-site discharge of water that does not meet the required standard.

The bund that surrounds the site is at least 1.5m high and up to 90,000m³ of floodwater can be retained within the Golf Course in addition to the 20,000m³ lake capacity. In this situation, water samples from the flooded Golf Course will be taken more frequently. Only when water has returned to an acceptable quality will the control valve be opened to allow water to overflow from the lake and into off-site storm drains that discharge via Outfall No. 8, thereby allowing the flood to recede.

The system by which this water control is achieved is shown in *Figure 1-2*.

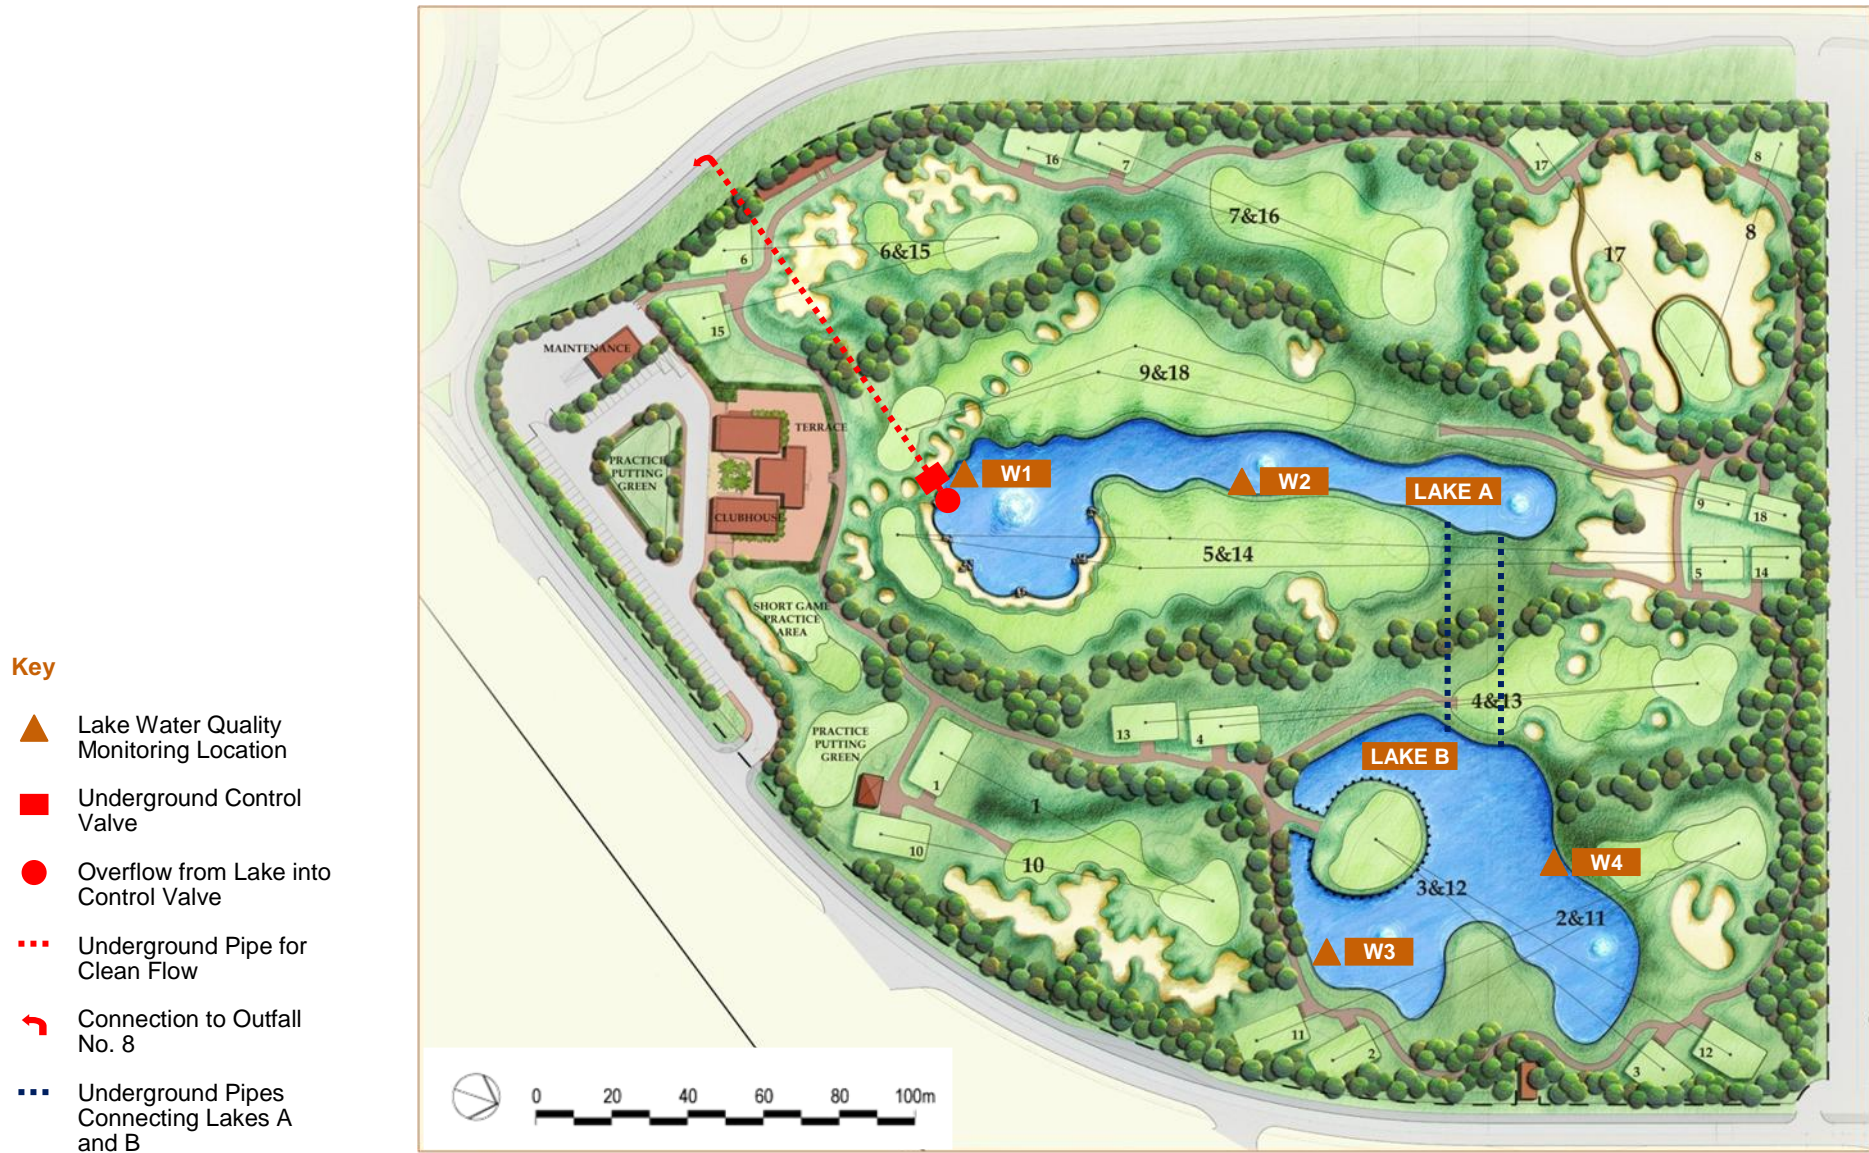
Figure 2-1 Locations for Lake Water Quality Monitoring

Monitoring locations together with grid references are shown in **Figure 2-1**. Monitoring Stations are designated as W1, W2, W3 and W4.

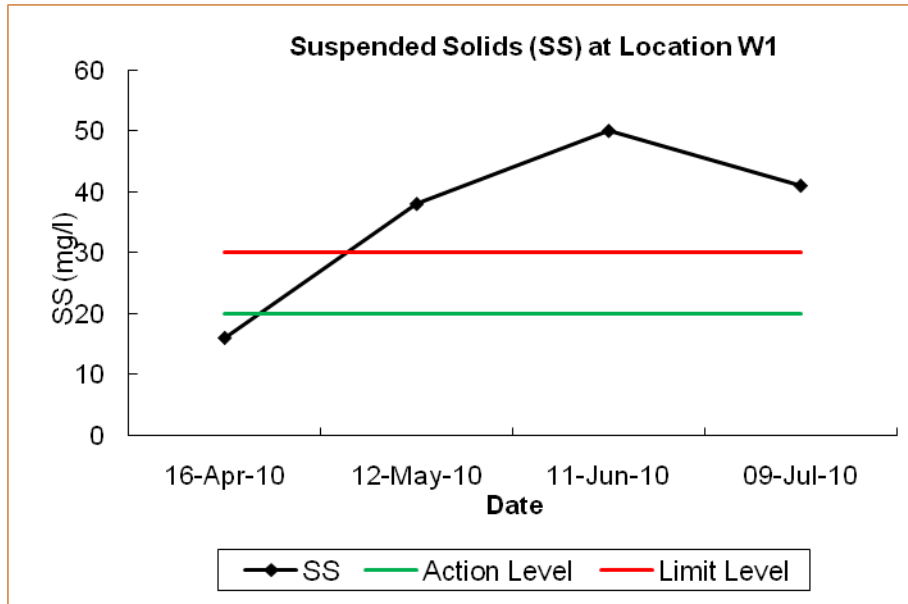
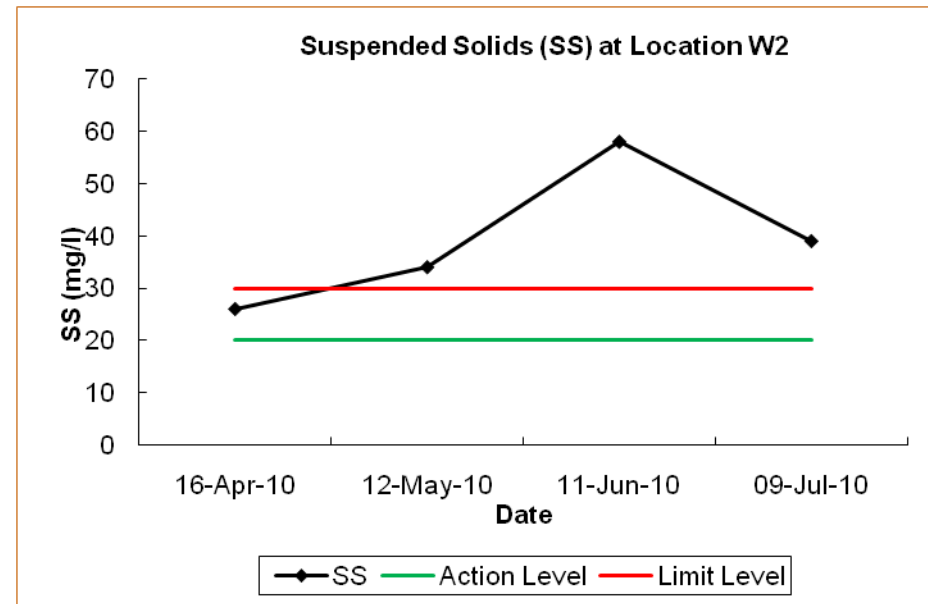
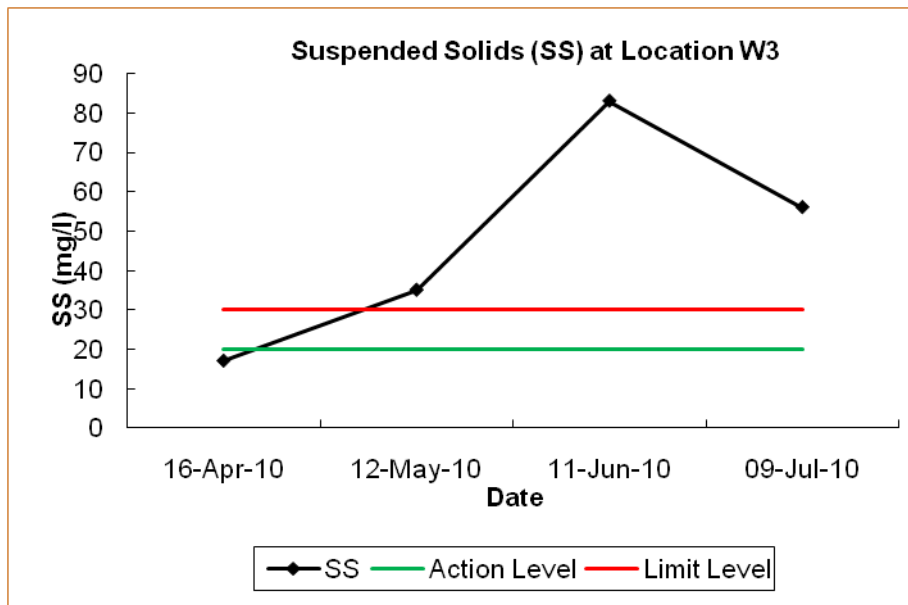
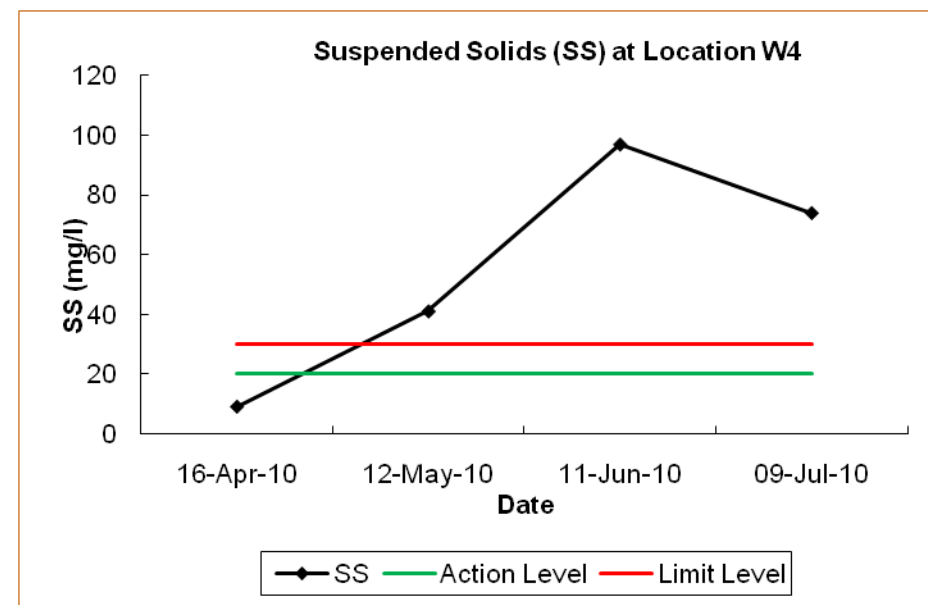
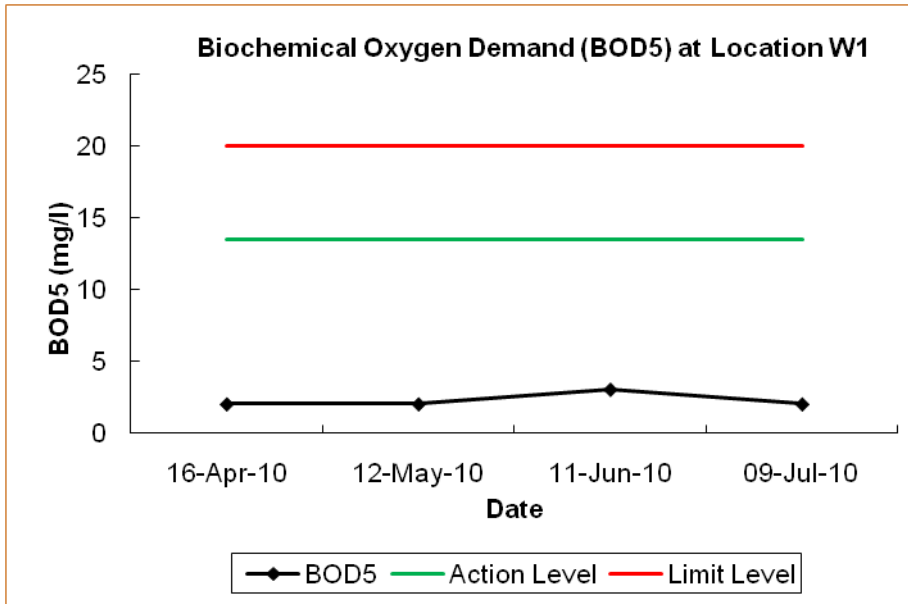
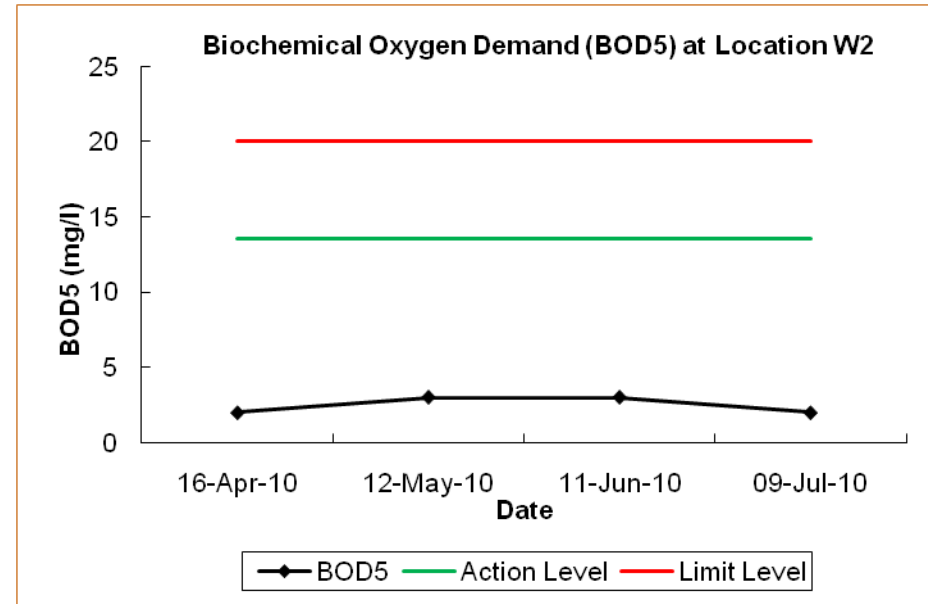
Graphical Plots of Monitoring Data for the Past Four Months

A summary of scheduled lake water monitoring results for the reporting quarter is provided in **Table 3-1**, below. Detailed results are provided in **Appendix 2** and graphical plots since commencement of the second phase of Operation are given in **Appendix 3**.

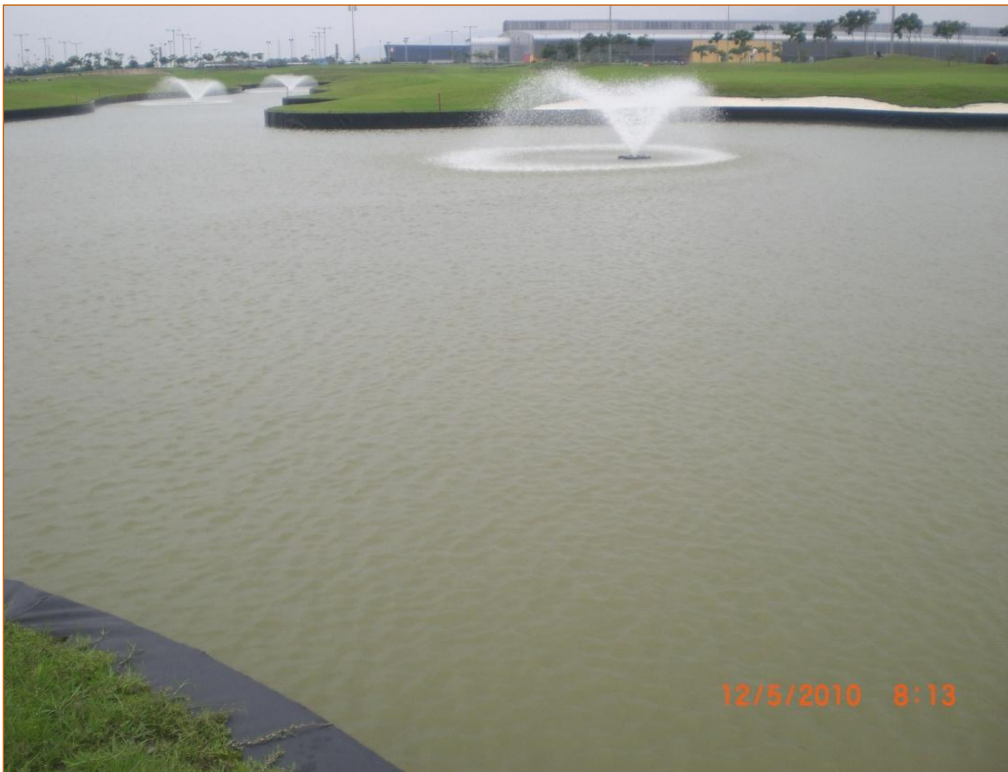
Location W1 (Lake A)

In May, there were exceedances of Target Level for SS at all four monitoring locations. Based on observations, we consider that the high SS concentrations are due to algal growth in the lakes – the water in the lakes was visibly green and clouded with algae during sampling, as shown in the photographs in [Appendix 4](#).

To address the water quality problem caused by excessive algal growth, “Aqua Bio-Trol Liquid” was added to lake water on 16 July. This is a liquid microbial pond clarifier, comprising a proprietary blend of 58 strains of aerobic and facultative beneficial bacteria, and is a safe, natural way to establish and maintain cleaner pond and lake water without the addition of chemicals. Further details of “Aqua Bio-Trol Liquid” are provided in [Appendix 5](#). However, being a biological agent, no immediate improvement in water quality is expected – it will likely take a couple of weeks for an effect to be observed.
