# SkyCity Nine Eagles Golf Course

## Quarterly EM&A Compliance Report

August to October 2010

Project/Deliverable Number:	J481A   D01/02
Project Name:	SkyCity Nine Eagles Golf Course
Report Name:	Quarterly EM&A Compliance Report – August to October 2010
Report Date:	31 October 2010
Report for:	Sky City Nine Eagles Golf Course

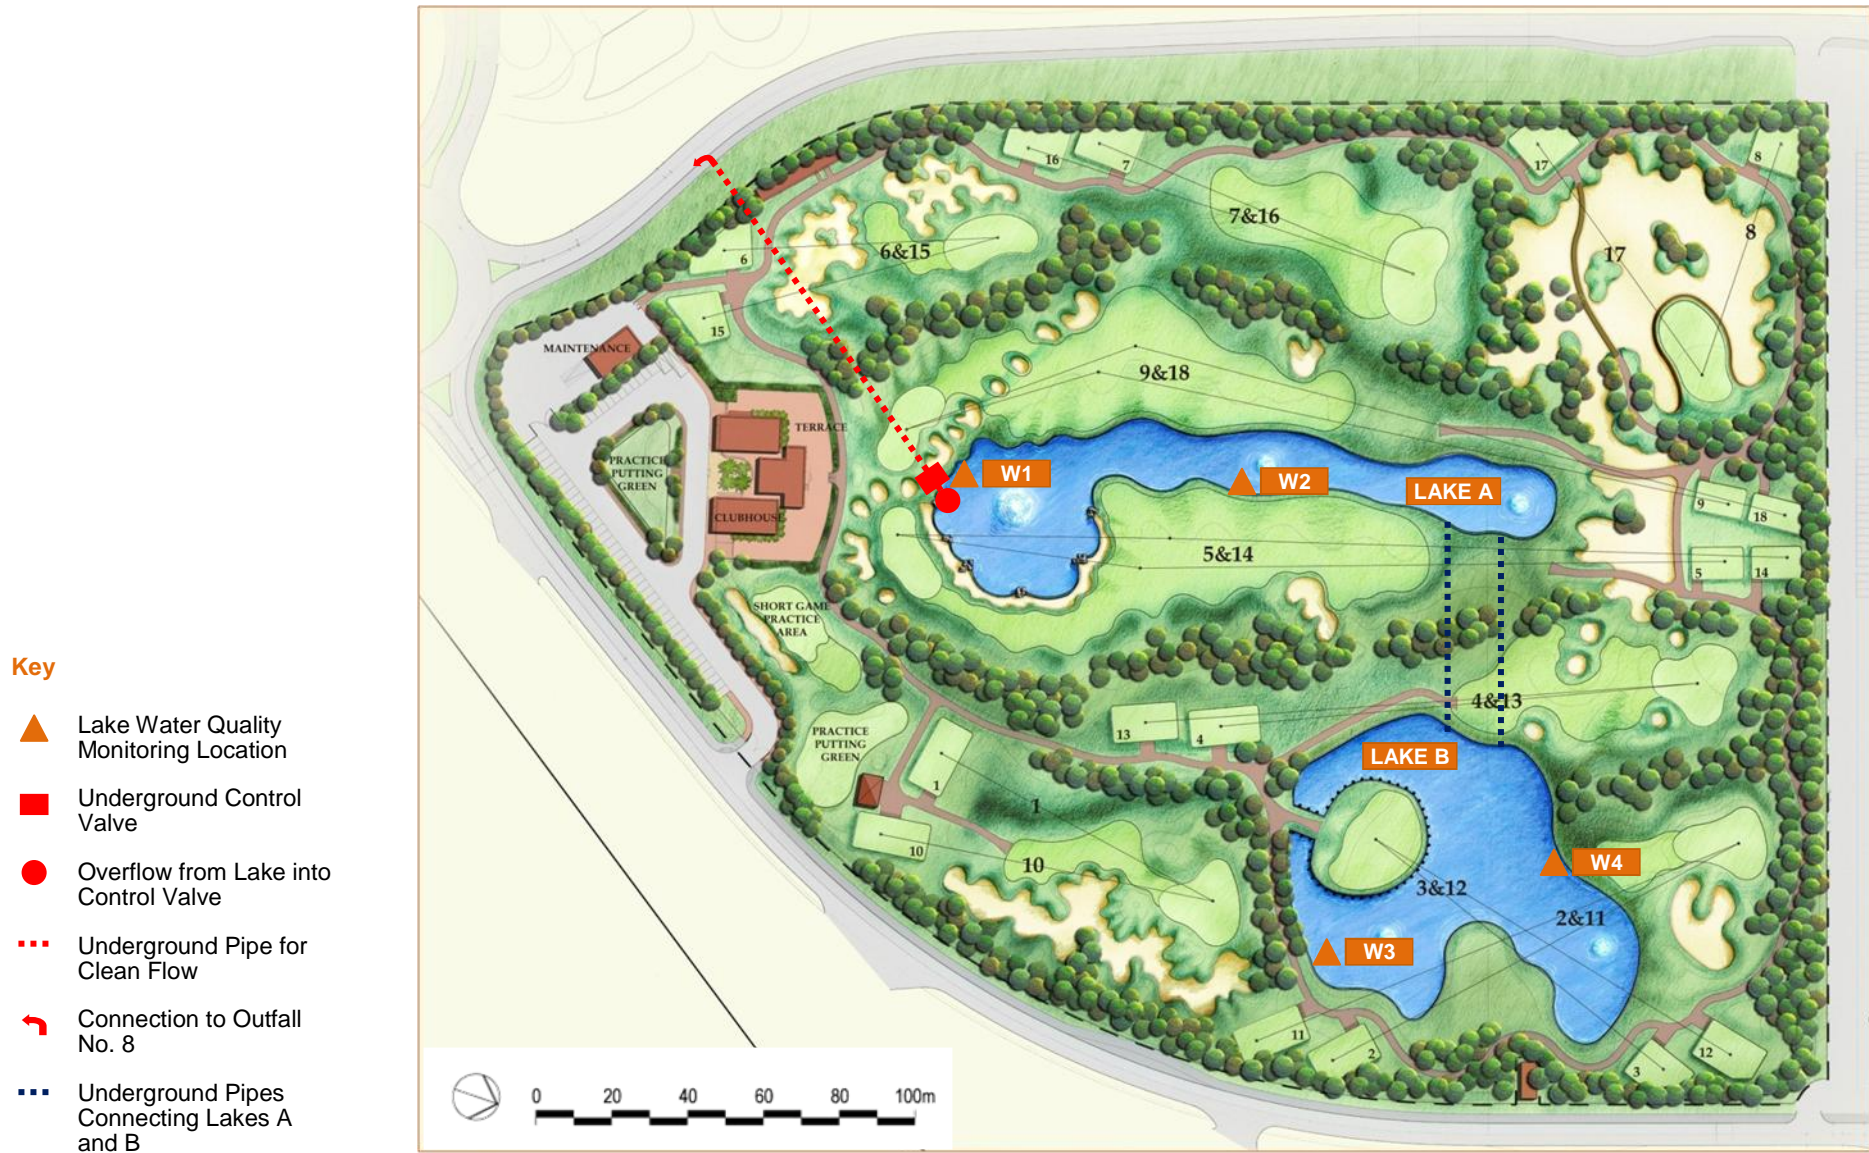
**Figure 2-1** Locations for Lake Water Quality Monitoring

Monitoring locations together with grid references are shown in [Figure 2-1](#). Monitoring Stations are designated as W1, W2, W3 and W4.

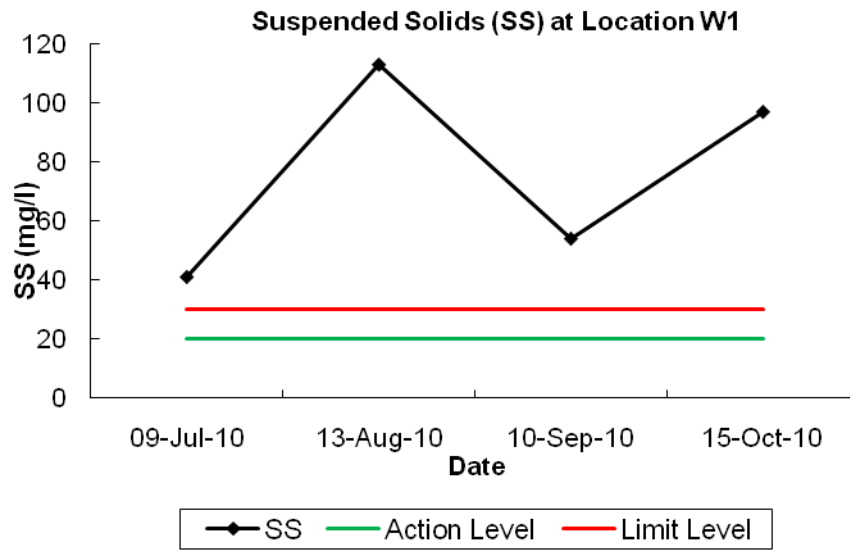
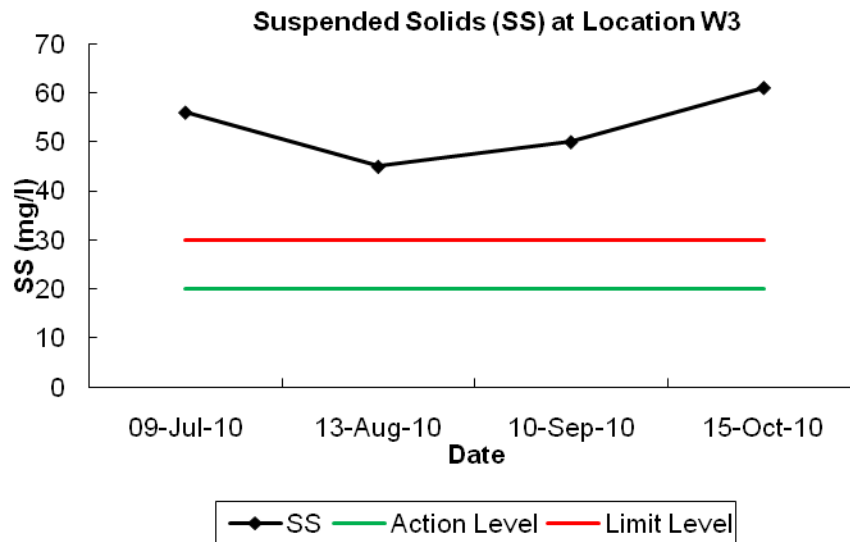
### Graphical Plots of Monitoring Data for the Past Four Months

A summary of scheduled lake water monitoring results for the reporting quarter is provided in **Table 3-1**, below. Detailed results are provided in **Appendix 2** and graphical plots since commencement of the second phase of Operation are given in **Appendix 3**.
