SkyCity Nine Eagles Golf Course

Quarterly EM&A Compliance Report

May to July 2011

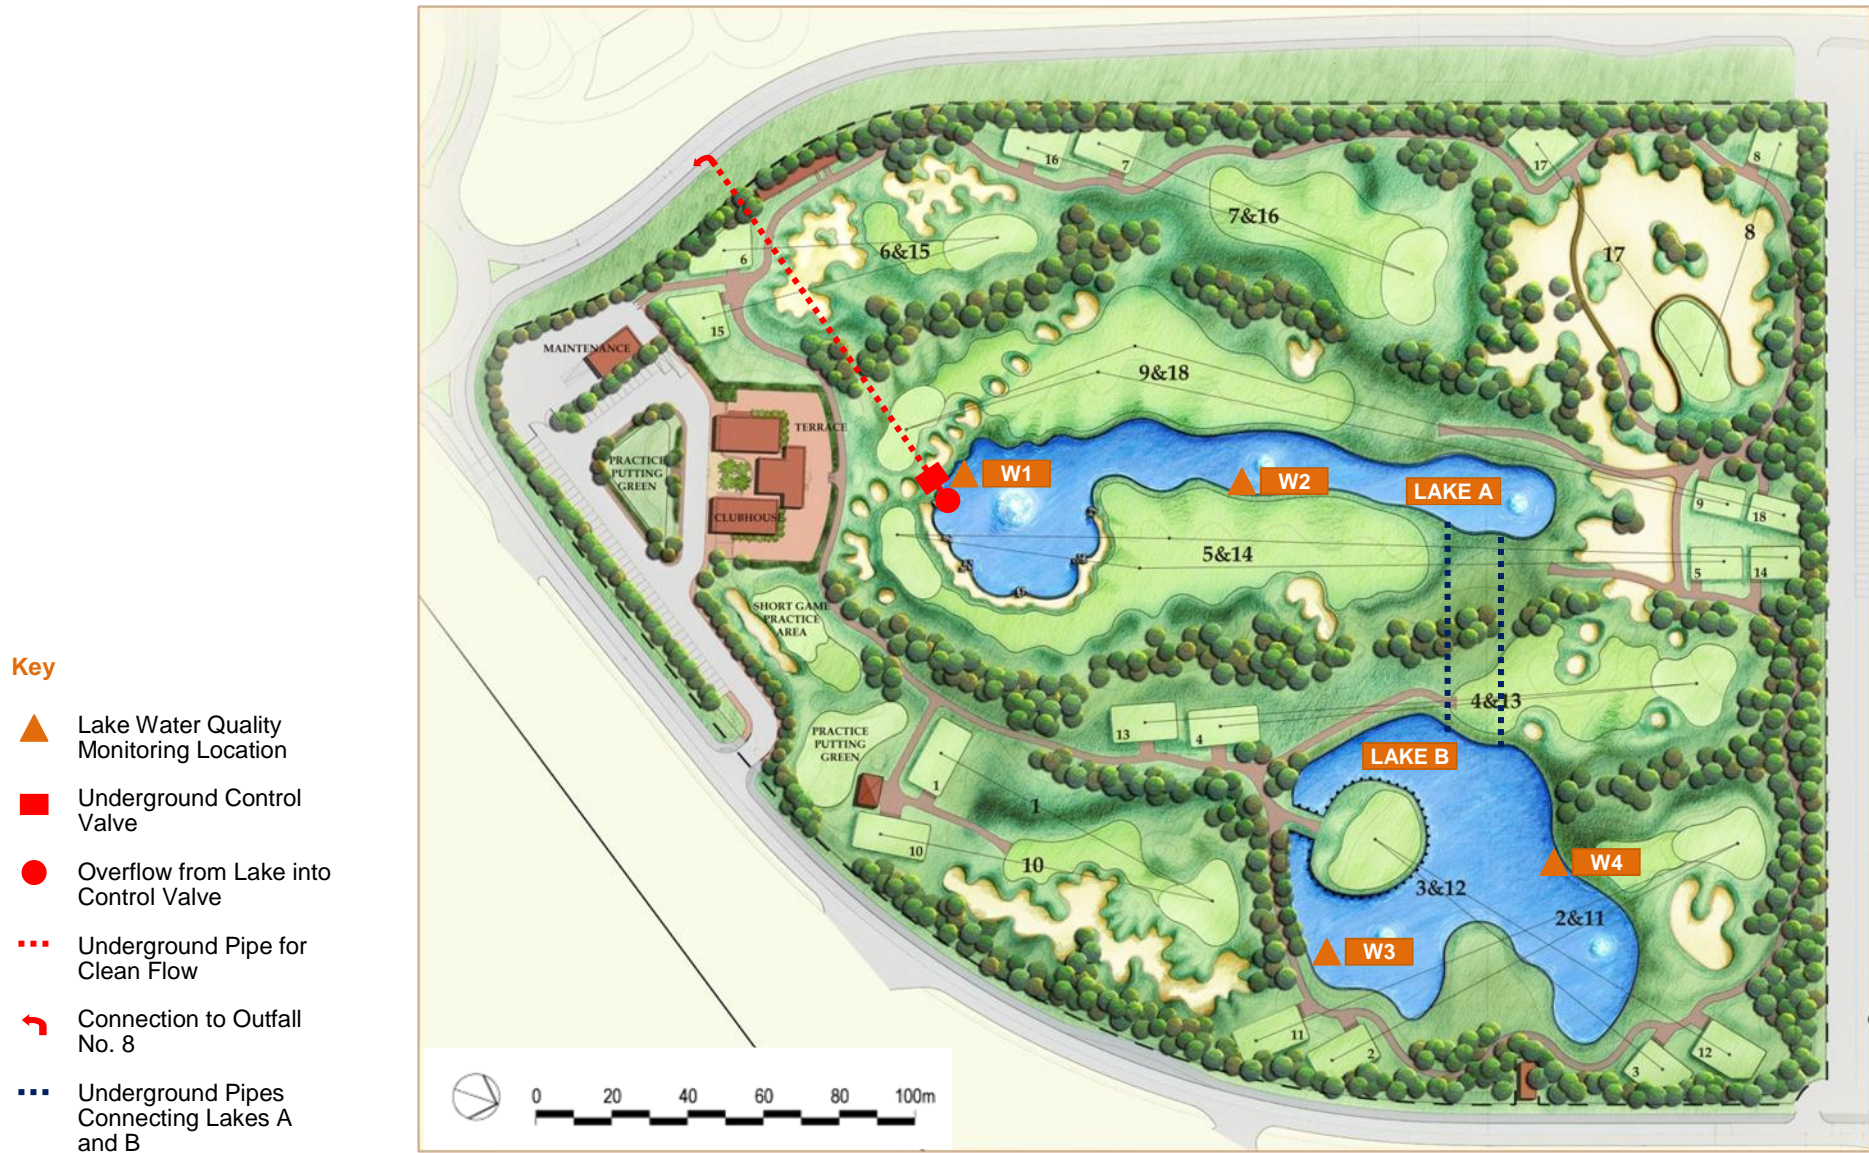
Figure 2-1 Locations for Lake Water Quality Monitoring

Monitoring locations together with grid references are shown in [Figure 2-1](#). Monitoring Stations are designated as W1, W2, W3 and W4.
