Quarterly EM&A Compliance Report

# SkyCity Nine Eagles Golf Course

November 2013 to January 2014

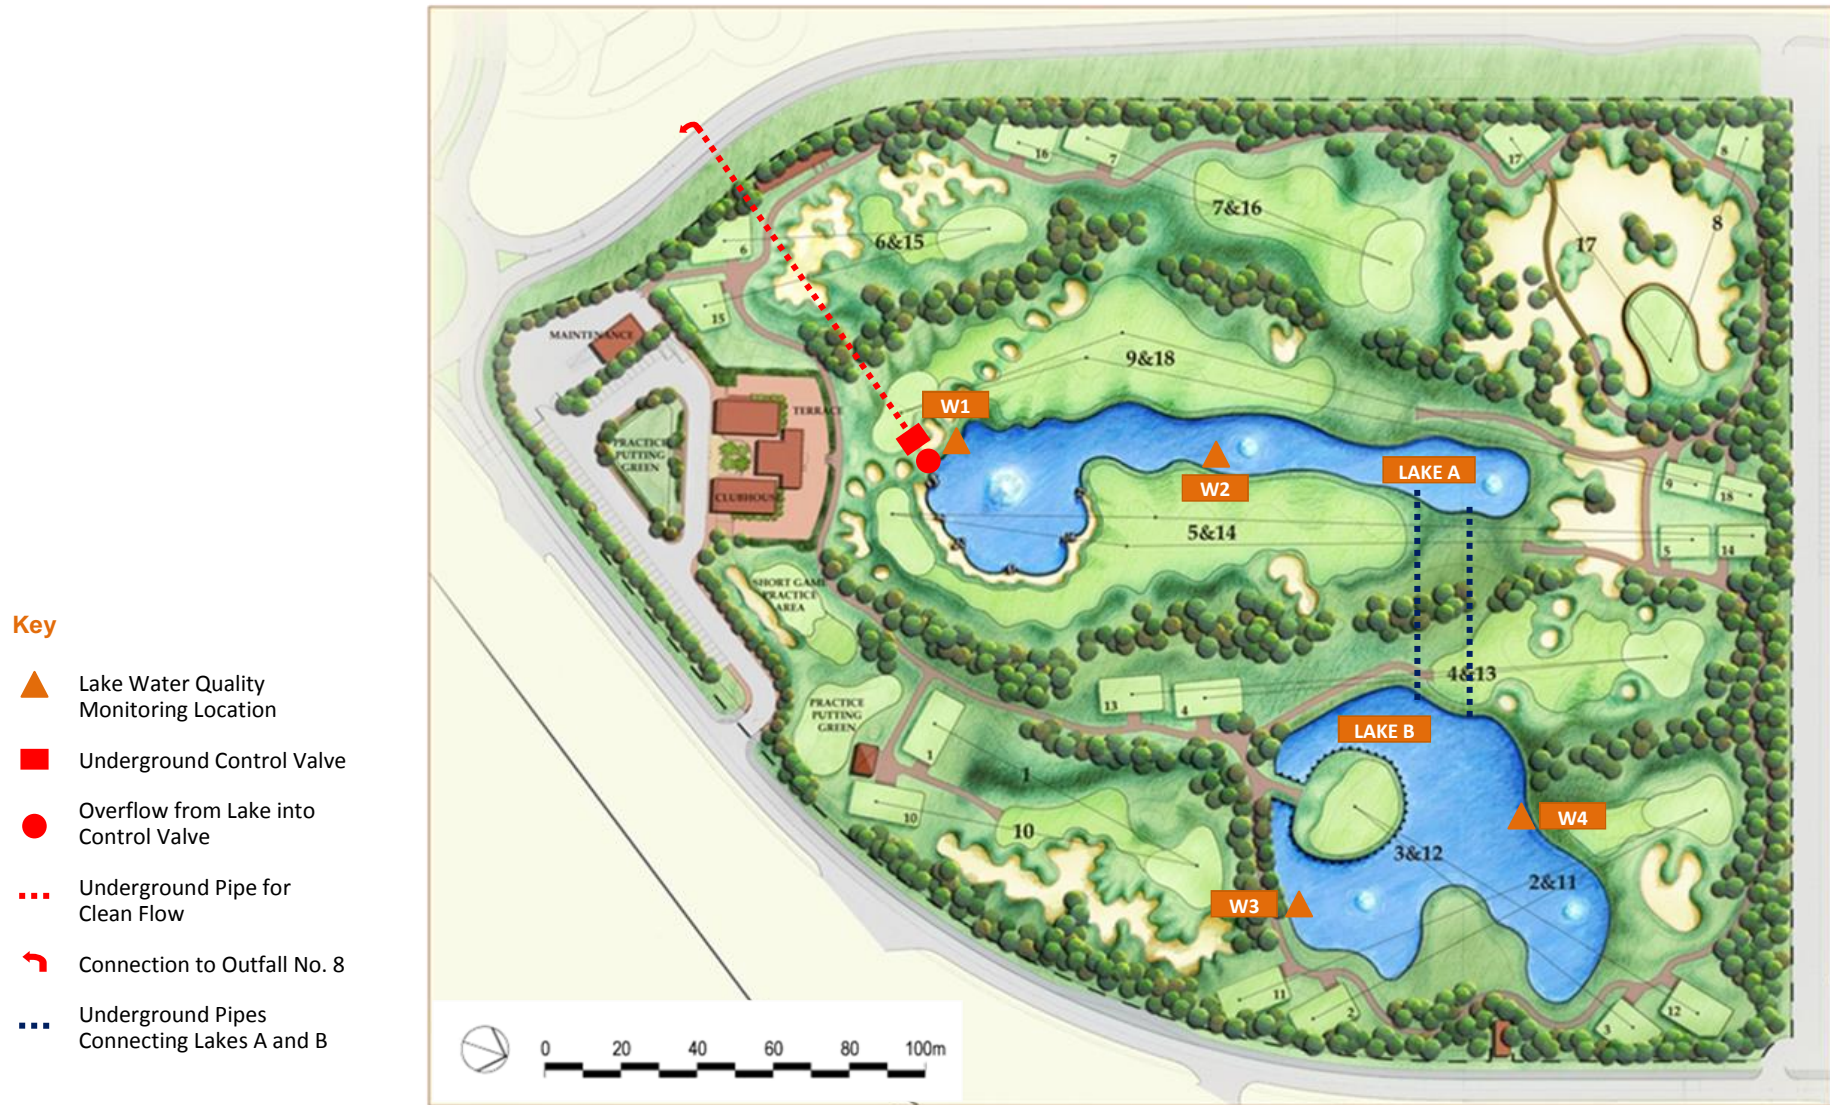
**Figure 2-1**      **Locations for Lake Water Quality Monitoring**

Monitoring locations together with grid references are shown in *Figure 2-1*. Monitoring Stations are designated as W1, W2, W3 and W4.

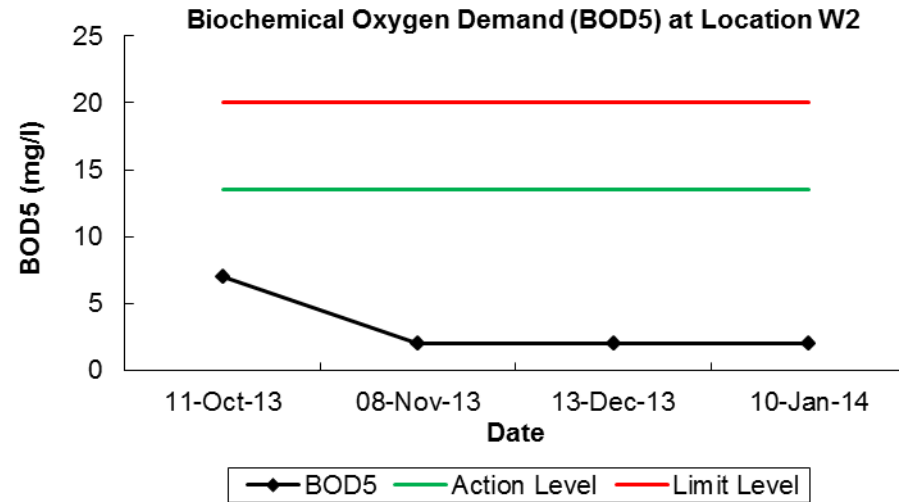
### Graphical Plots of Monitoring Data for the Past Four Months

A summary of scheduled lake water monitoring results for the reporting quarter is provided in **Table 3-1**, below. Detailed results are provided in **Appendix 2** and graphical plots since commencement of the second phase of Operation are given in **Appendix 3**.
