**Emission Control Project at Castle Peak Power Station "B" Units**

**Environmental Monitoring  
and Audit Monthly Report**

October 2009

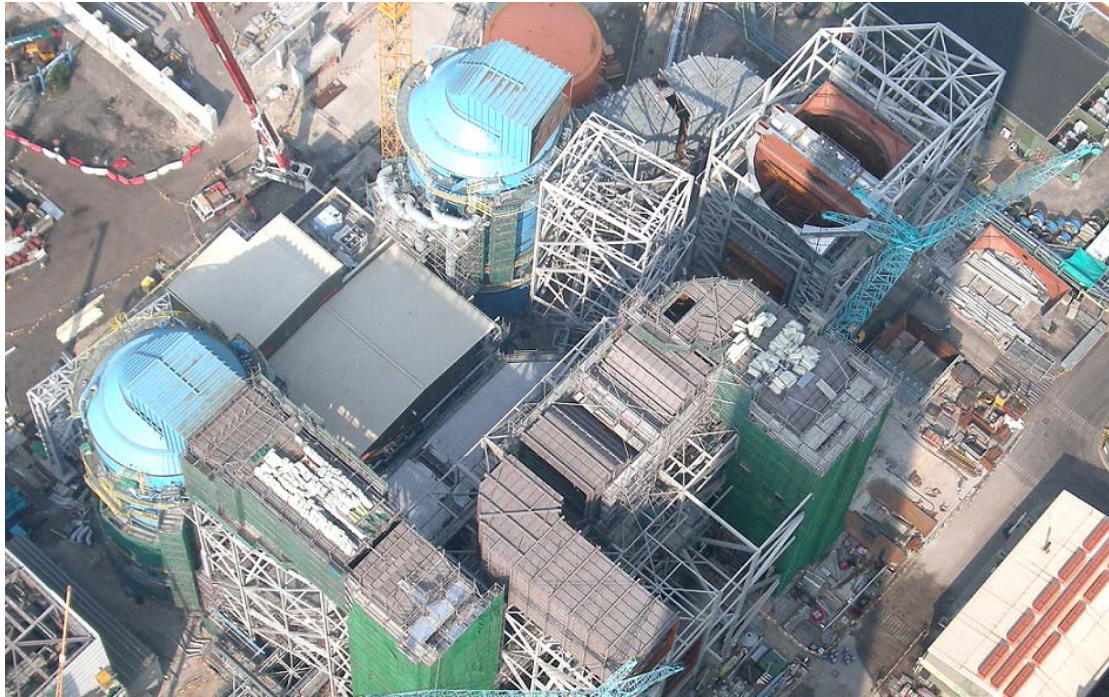
E. 1 Unit B1 and Unit B2 FGD Areas

- Flue Gas Desulphurization Absorbers
  - Mechanical erection works of Unit B1 – B4 FGD Absorbers. (*Photo E.1*)
  - Plant erection works at the Unit B1 and Unit B2 Gas-to-Gas Heater Area, Common Limestone Preparation and Gypsum Dewatering Areas (*Photo E.2*), Limestone Handling Area, Gypsum Handling Area (*Photo E.3*) and Waste Water Treatment Plant Area (*Photo E.4*).
