**DSD CONTRACT NO. DC/2007/17
DRAINAGE IMPROVEMENT WORKS IN CHEUNG PO,
MA ON KONG, YUEN KONG SAN TSUEN AND TIN SAM
TSUEN OF YUEN LONG DISTRICT AND SEWERAGE AT
TSENG TAU CHUNG TSUEN, TUEN MUN**

**BASELINE ECOLOGICAL MONITORING REPORT
- KT13**

PREPARED FOR
CHINA ROAD & BRIDGE CORPORATION

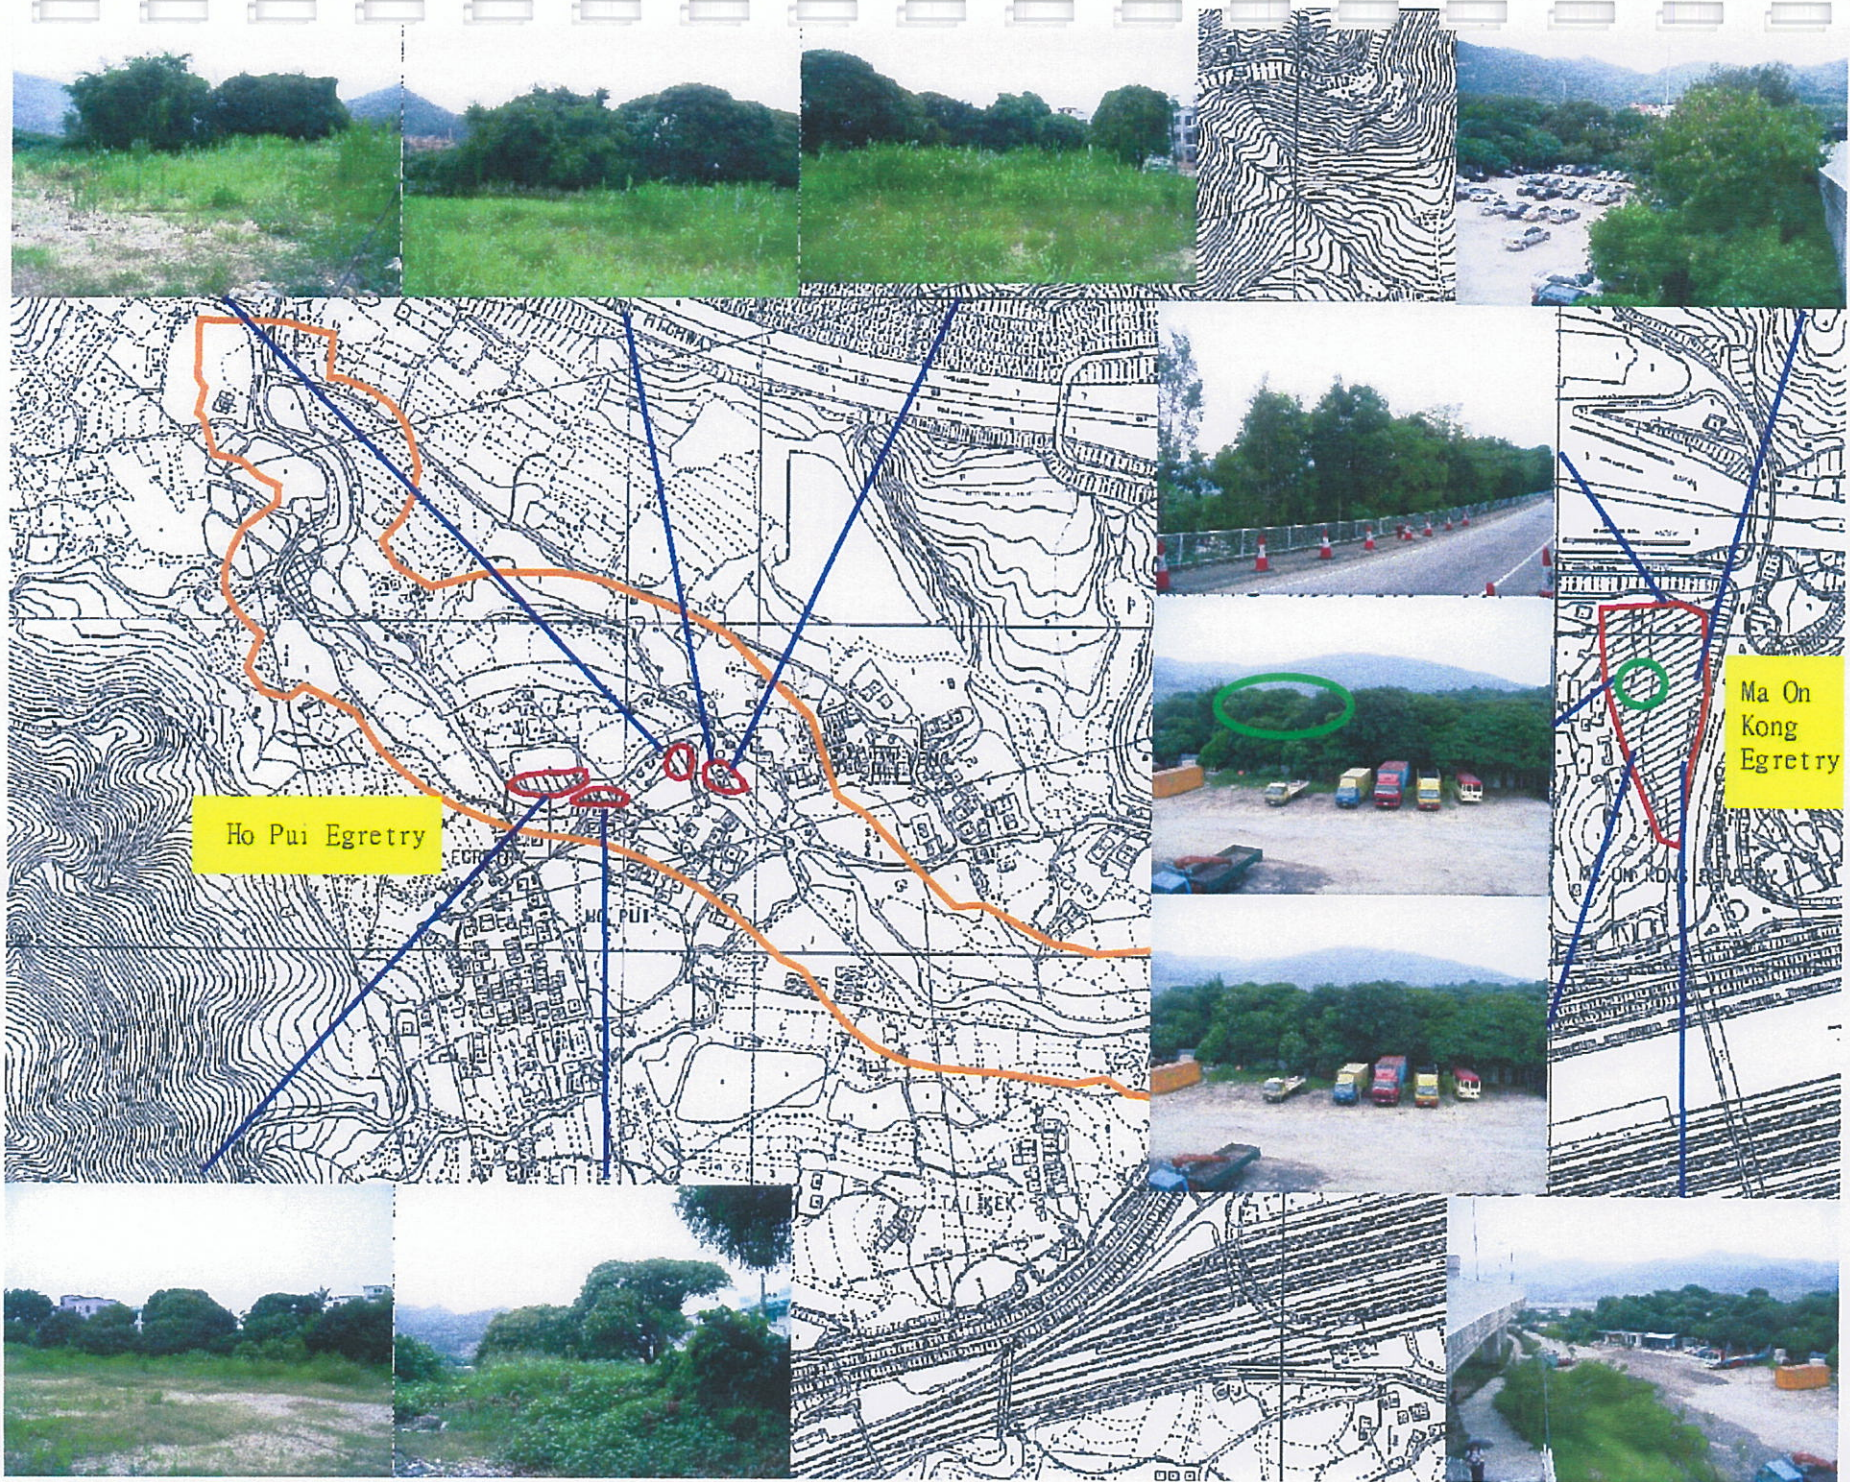
Egretty Photos

Conditions of the two egrettries (the green circles indicate the locations of the nests in Ma On Kong Egretty)

The two egrettries were also checked during the baseline monitoring survey for KT13. During which, however, no nesting egrets were found in Ho Pui egrettry and Ma On Kong egrettry.
