PROJECT No.: TCS/00408/08

**DSD CONTRACT NO. DC/2007/17  
 DRAINAGE IMPROVEMENT WORKS IN CHEUNG PO,  
 MA ON KONG, YUEN KONG SAN TSUEN AND TIN SAM  
 TSUEN OF YUEN LONG DISTRICT AND SEWERAGE AT  
 TSENG TAU CHUNG TSUEN, TUEN MUN**

**FIRST MONTHLY EM&A REPORT – OCTOBER 2008  
 - KT13**

PREPARED FOR  
**CHINA ROAD & BRIDGE CORPORATION**

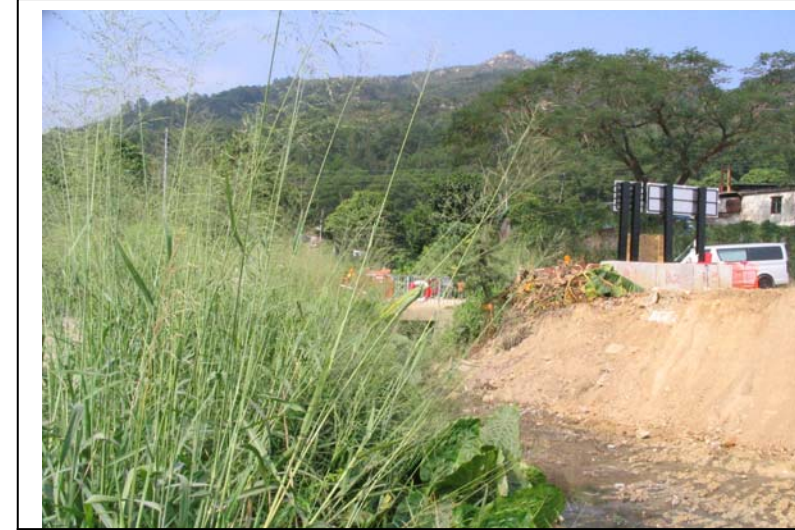
Photo No. A6 – LR2.1

10.7.4	LR2.1 (Fish Pond) within site boundary LR2.2 (Fish Pond) outside site boundary	A6 A7	There are 4 numbers of fallowed fish ponds at the upstream of the Ma On Kong Channel. A chain of fish ponds near downstream but distant from the Channel is noted. The fish ponds cover area of in total 23,000 m2. Most of them are heavily colonized by aquatic plants, which attribute to their low visual quality as a water landscape element. They have low landscape value and sensitive to change.	Minor change due to site clearance and preparation work within site boundary

Fish Pond within site boundary

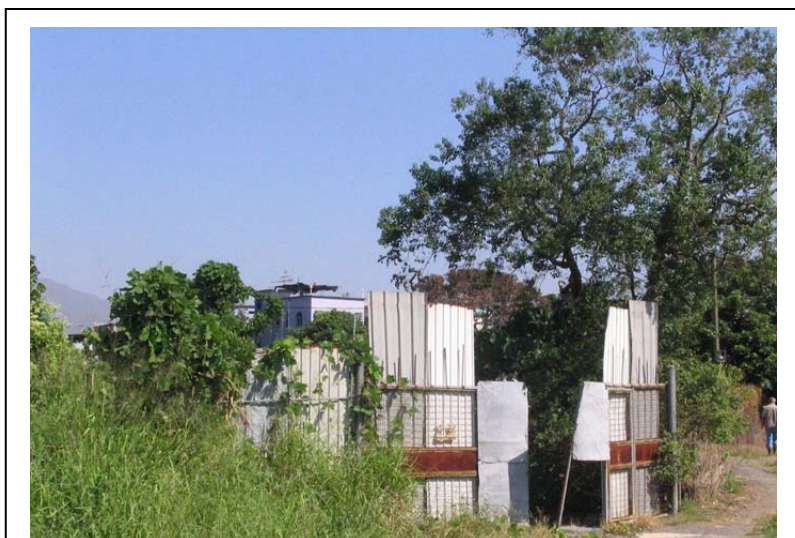
Photo No. B11—LCA 6 Industrial Landscape Character Area

10.7.17	LCA6 (Industrial Landscape Character Area)	B11 & B12	This comprise collection of slummy-built temporary structure and open storage uses land, which are characterized with metallic hoarding and used for poultry, recycling, vehicle repairing etc. The sensitivity to change of this area is low.	Remain the same as the baseline
