**DSD CONTRACT NO. DC/2007/17  
DRAINAGE IMPROVEMENT WORKS IN CHEUNG PO,  
MA ON KONG, YUEN KONG SAN TSUEN AND TIN SAM  
TSUEN OF YUEN LONG DISTRICT AND SEWERAGE AT  
TSENG TAU CHUNG TSUEN, TUEN MUN**

**MONTHLY EM&A REPORT FOR KT13  
(DECEMBER 2008)**  
PREPARED FOR  
**CHINA ROAD & BRIDGE CORPORATION**

ES01 This is the third monthly EM&A report for KT13, covering the construction period from 26 November to 25 December 2008.

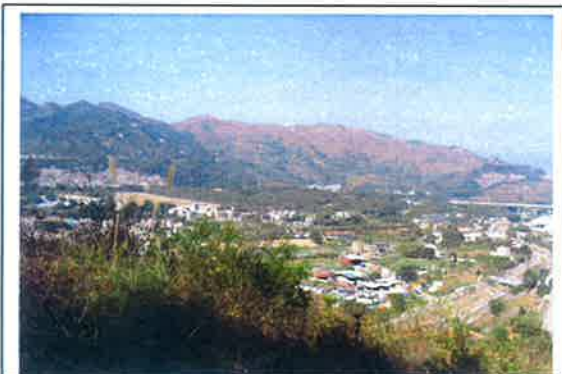
Photo No. A6 – LR2.1

10.7.4	LR2.1 (Fish Pond) within site boundary LR2.2 (Fish Pond) outside site boundary	A6 A7	There are 4 numbers of fallowed fish ponds at the upstream of the Ma On Kong Channel. A chain of fish ponds near downstream but distant from the Channel is noted. The fish ponds cover area of in total 23,000 m2. Most of them are heavily colonized by aquatic plants, which attribute to their low visual quality as a water landscape element. They have low landscape value and sensitive to change.	Minor change due to site clearance and preparation work within site boundary

Fish Pond within site boundary

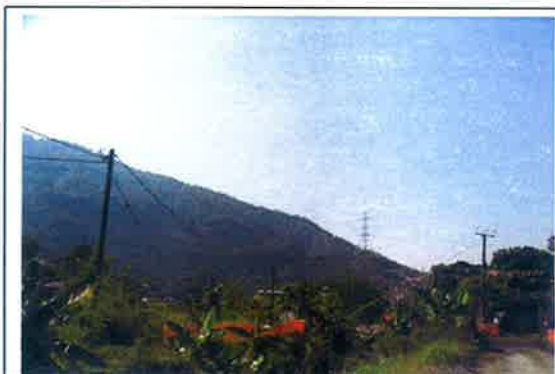
Photo No. A7 – LR2.2

River/Stream

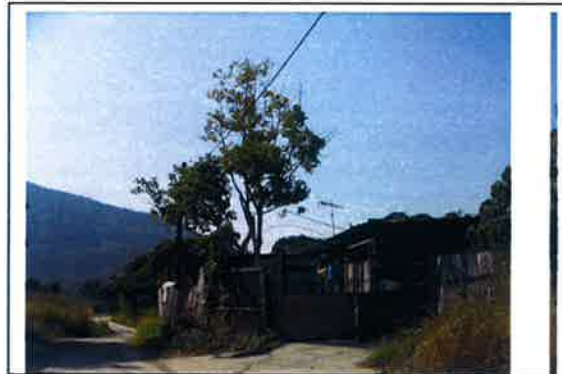
Photo No. B11—LCA 6 Industrial Landscape Character Area

10.7.17	LCA6 (Industrial Landscape Character Area)	B11 & B12	This comprise collection of slummy-built temporary structure and open storage uses land, which are characterized with metallic hoarding and used for poultry, recycling, vehicle repairing etc. The sensitivity to change of this area is low.	Remain the same as the baseline
