PROJECT No.: TCS/00408/08

DSD CONTRACT NO. DC/2007/17
DRAINAGE IMPROVEMENT WORKS IN CHEUNG PO, MA
ON KONG, YUEN KONG SAN TSUEN AND TIN SAM
TSUEN OF YUEN LONG DISTRICT AND SEWERAGE AT
TSENG TAU CHUNG TSUEN, TUEN MUN

MONTHLY EM&A REPORT FOR KT13
(MARCH 2009)

PREPARED FOR
CHINA ROAD & BRIDGE CORPORATION

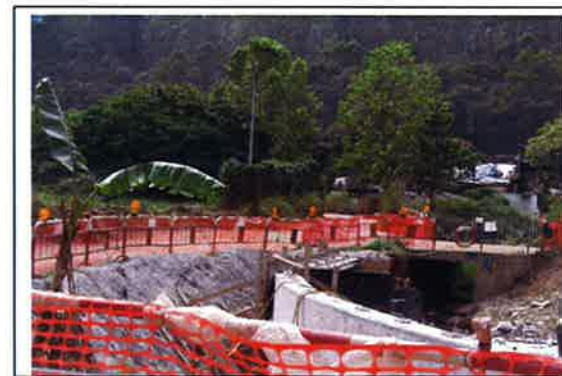
Photo No. A6 – LR2.1

| Section in EIA Report | Identify number – Landscape Resources | Photo No | Baseline Study, Environmental Impact Assessment Final Report [382047/E/EIA/Issue 9] | Current Situation |
|---|---|---|---|---|
| 10.7.4 | LR2.1 (Fish Pond) within site boundary LR2.2 (Fish Pond) outside site boundary | A6 A7 | There are 4 numbers of fallowed fish ponds at the upstream of the Ma On Kong Channel. A chain of fish ponds near downstream but distant from the Channel is noted. The fish ponds cover area of in total 23,000 m ² . Most of them are heavily colonized by aquatic plants, which attribute to their low visual quality as a water landscape element. They have low landscape value and sensitive to change. | Minor change due to construction of structures within site boundary. A soil platform was |

| | | | | created outside site boundary due to other project was noted. |

Fish Pond within site boundary

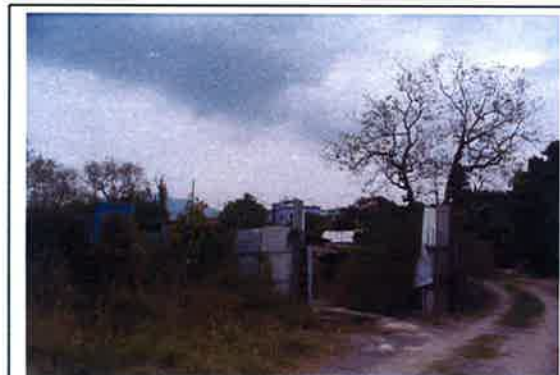
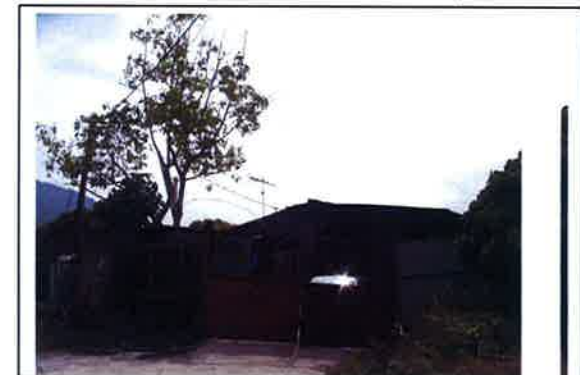
Photo No. B11—LCA 6 Industrial Landscape Character Area

| 10.7.17 | LCA6 (Industrial Landscape Character Area) | B11 & B12 | This comprise collection of slummy-built temporary structure and open storage uses land, which are characterized with metallic hoarding and used for poultry, recycling, vehicle repairing etc. The sensitivity to change of this area is low. | Remain the same as the baseline |
