DSD CONTRACT NO. DC/2007/17  
DRAINAGE IMPROVEMENT WORKS IN  
CHEUNG PO, MA ON KONG, YUEN KONG SAN TSUEN  
AND TIN SAM TSUEN OF YUEN LONG DISTRICT AND  
SEWERAGE AT TSENG TAU CHUNG TSUEN, TUEN MUN

MONTHLY EM&A REPORT FOR KT13  
(APRIL 2009)

PREPARED FOR  
CHINA ROAD & BRIDGE CORPORATION

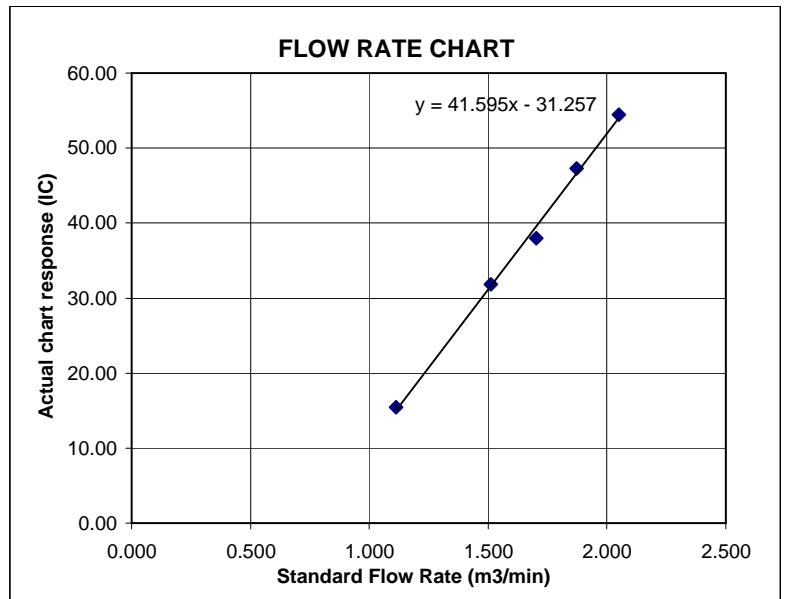
## TSP SAMPLER CALIBRATION CALCULATION SPREADSHEET

Location :	No.1 Ma On Kong Village	Date of Calibration: 3-Feb-09
Location ID :	ASR15 (A2)	Next Calibration Date: 3-Apr-09
		Technician: Mr. Ben Tam

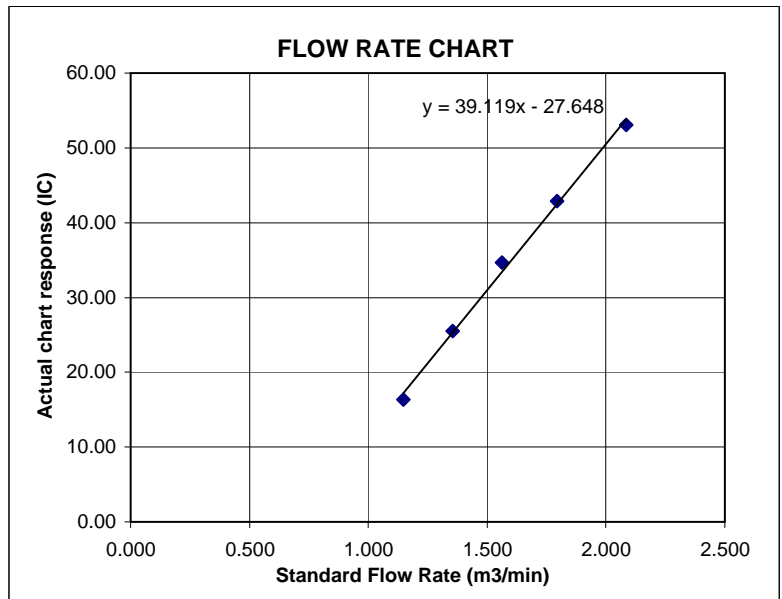
## TSP SAMPLER CALIBRATION CALCULATION SPREADSHEET

Location :	No.68 Ho Pui Village	Date of Calibration:	3-Apr-09
Location ID :	ASR14 (A1(a))	Next Calibration Date:	3-Jun-09
		Technician: Mr. Ben Tam

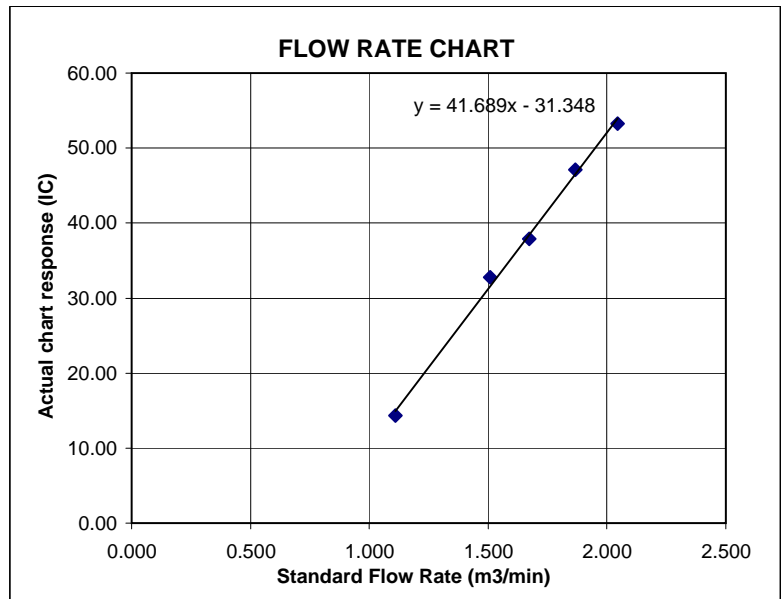
## TSP SAMPLER CALIBRATION CALCULATION SPREADSHEET

Location :	No.1 Ma On Kong Village	Date of Calibration:	3-Apr-09
Location ID :	ASR15 (A2)	Next Calibration Date:	3-Jun-09
		Technician: Mr. Ben Tam

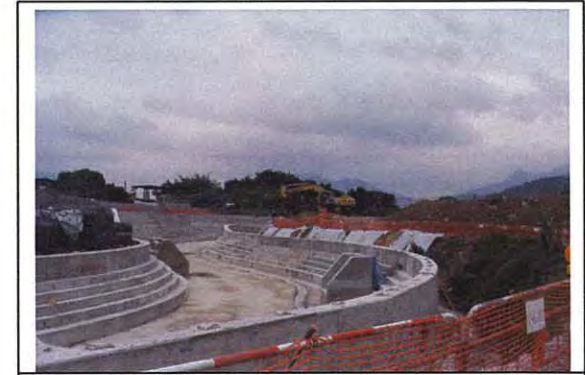
Photo No. A6 – LR2.1

10.7.4	LR2.1 (Fish Pond) within site boundary LR2.2 (Fish Pond) outside site boundary	A6 A7	There are 4 numbers of fallowed fish ponds at the upstream of the Ma On Kong Channel. A chain of fish ponds near downstream but distant from the Channel is noted. The fish ponds cover area of in total 23,000 m2. Most of them are heavily colonized by aquatic plants, which attribute to their low visual quality as a water landscape element. They have low landscape value and sensitive to change.	Minor change due to site clearance and preparation work within site boundary

Fish Pond within site boundary

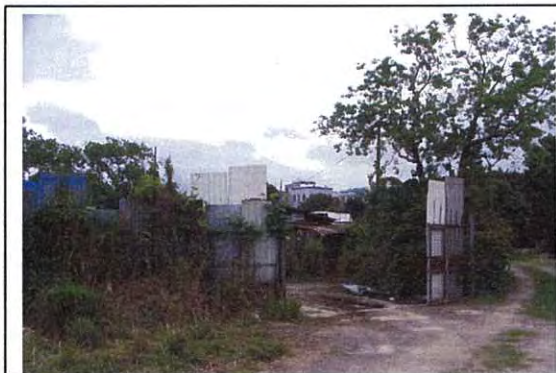
Photo No. B11—LCA 6 Industrial Landscape Character Area

10.7.17	LCA6 (Industrial Landscape Character Area)	B11 & B12	This comprise collection of slummy-built temporary structure and open storage uses land, which are characterized with metallic hoarding and used for poultry, recycling, vehicle repairing etc. The sensitivity to change of this area is low.	Remain the same as the baseline
