DSD CONTRACT NO. DC/2007/17
DRAINAGE IMPROVEMENT WORKS IN
CHEUNG PO, MA ON KONG, YUEN KONG SAN TSUEN
AND TIN SAM TSUEN OF YUEN LONG DISTRICT AND
SEWERAGE AT TSENG TAU CHUNG TSUEN, TUEN MUN

MONTHLY EM&A REPORT FOR KT13
(JULY 2009)

PREPARED FOR
CHINA ROAD & BRIDGE CORPORATION

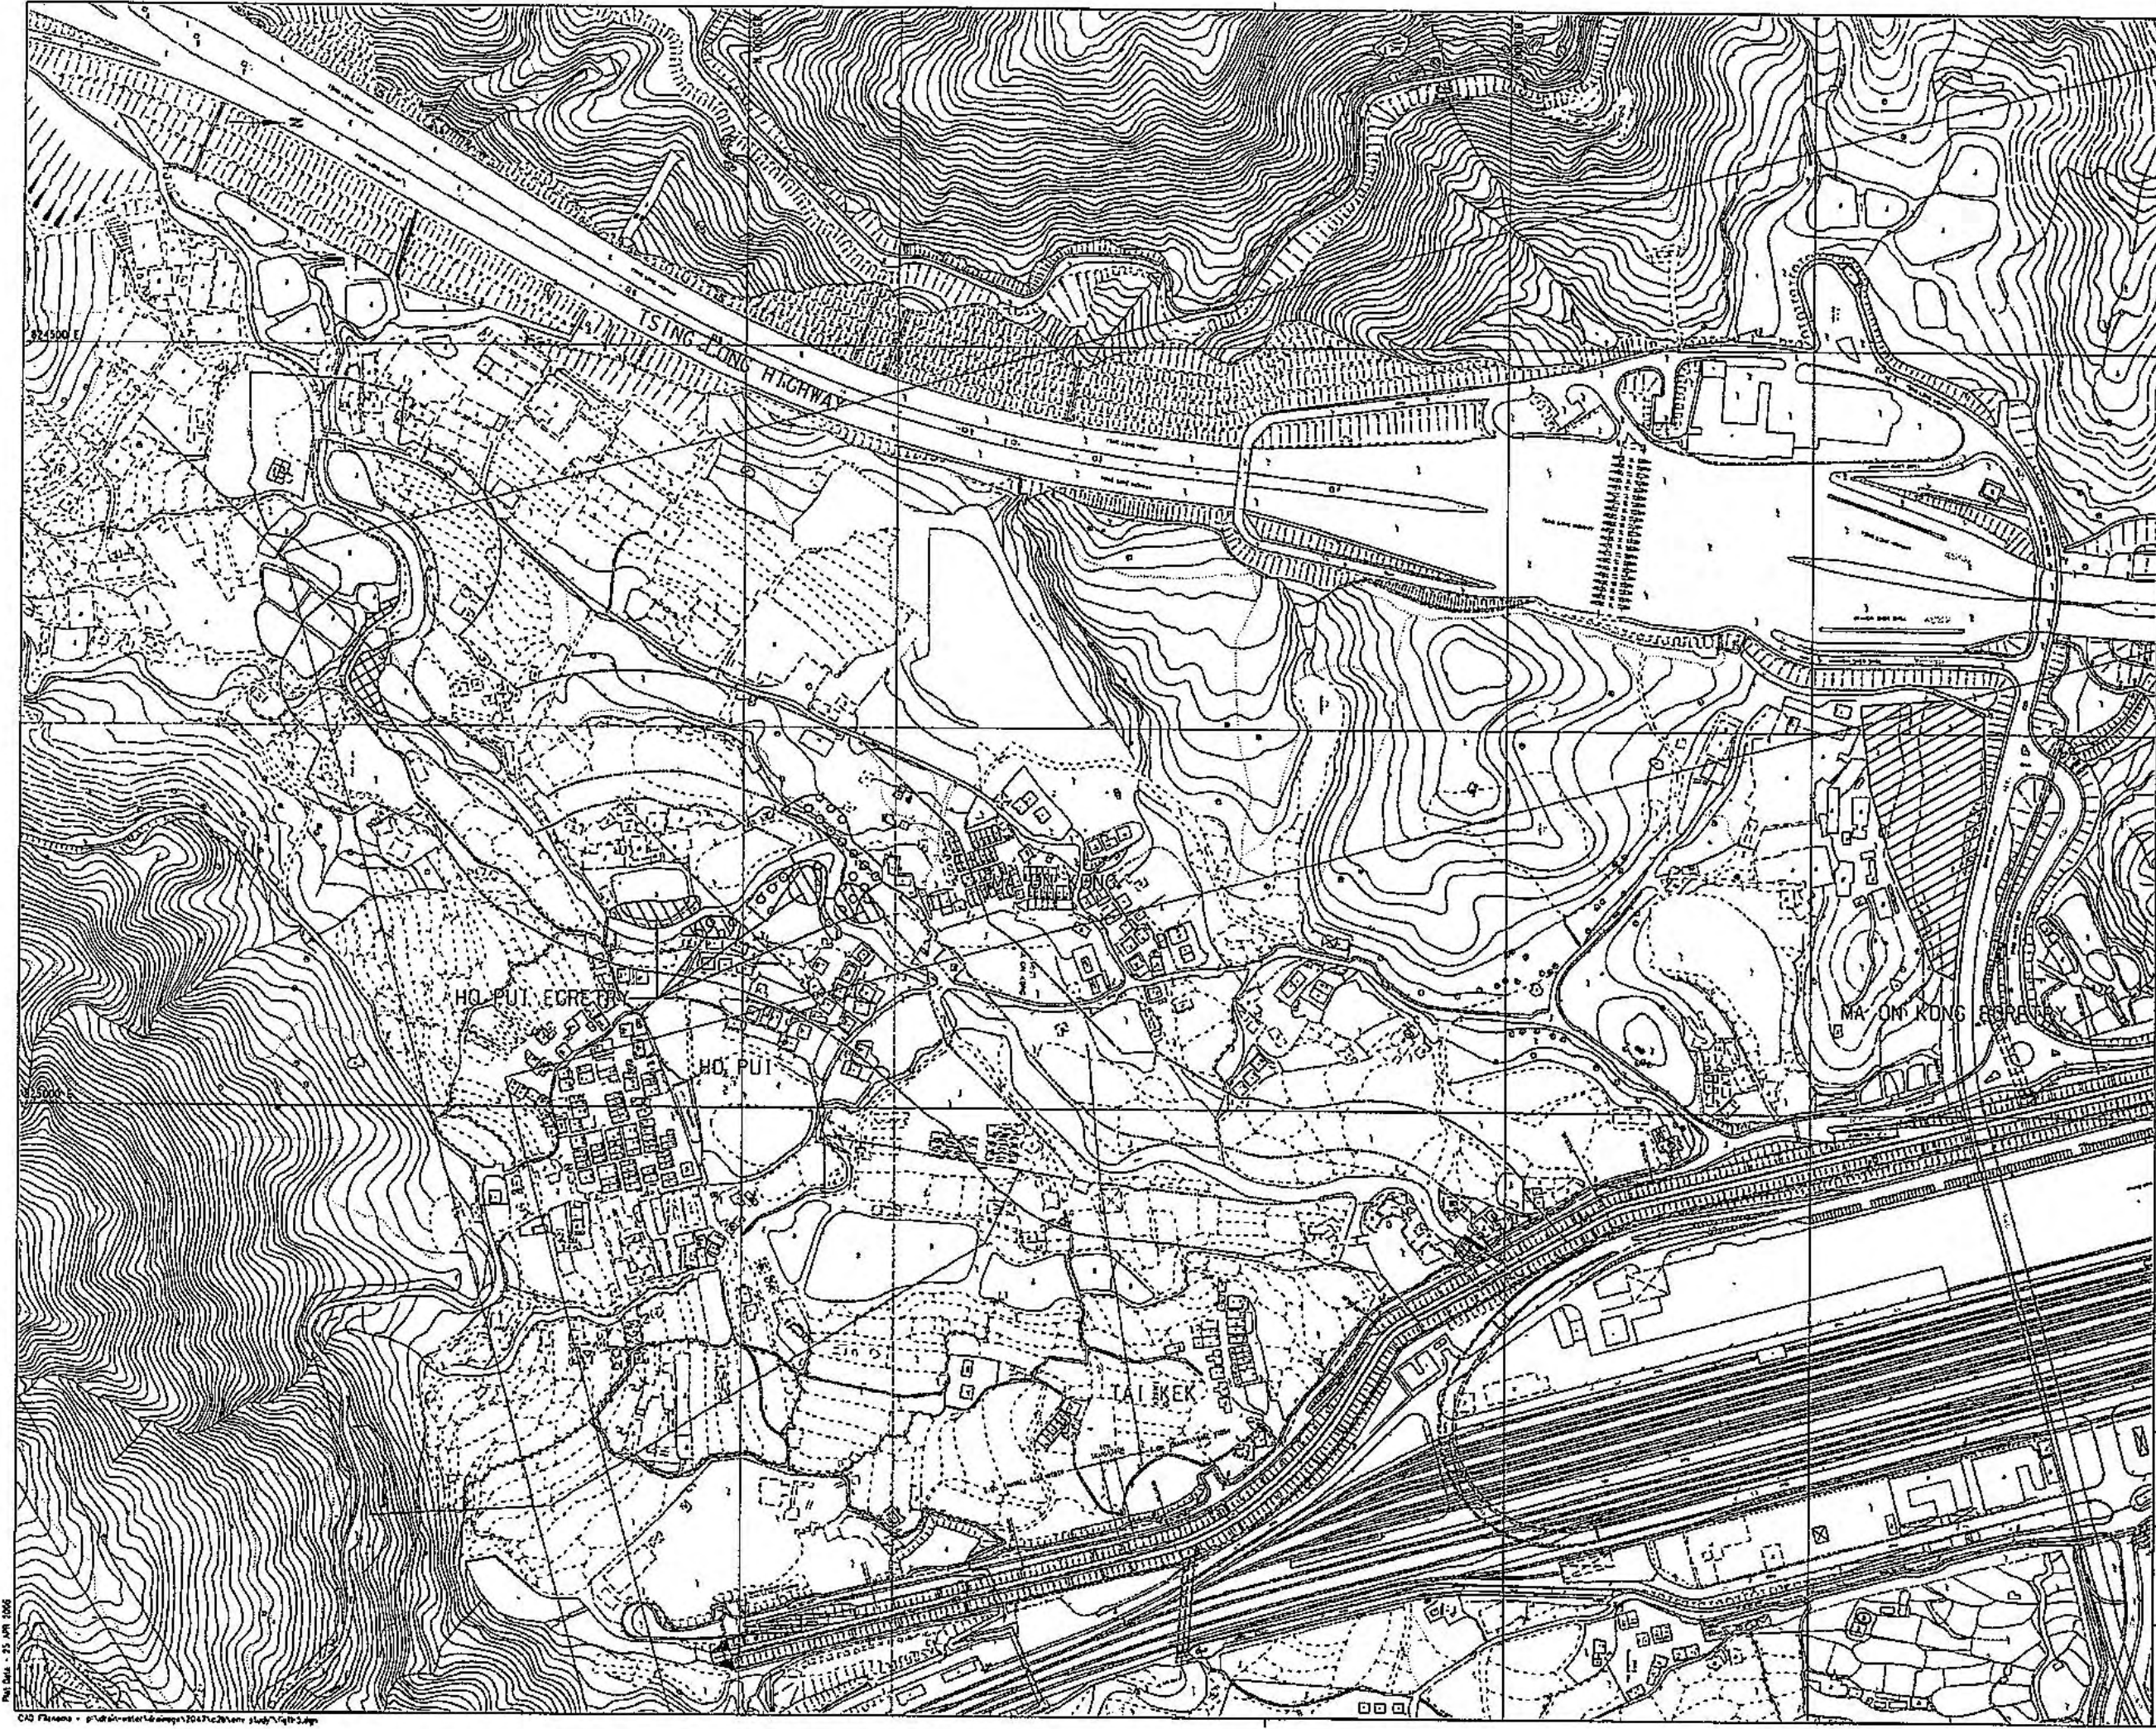
Drawing:
Air, Noise and Stream Water Monitoring Location at KT-13

Air monitoring location A1 has permanently been abandoned. No access has been granted from the sensitive receivers in vicinity A1 due to which are normally empty during the working hours. Considering other air monitoring locations have not covered one of the most important sensitive receivers Ho Pul Village. Therefore ET are recommended the house No.66 Ho Pul Village (A1(a)), which locate at fronting of the site, to replace A1

Noise monitoring location N1 is proposed to relocate to N1(a) as recommended by IEC due to the recommended monitoring point is mostly for monitor.

Noise monitoring location N2 has permanently been abandoned. No access has been granted from the sensitive receivers in vicinity N2 due to which are normally empty during the working hours. Considering other noise monitoring locations have not covered one of the most important sensitive receivers Ho Pul Village. Therefore ET are recommended the house No.66 Ho Pul Village (N2(a)), which locate at fronting of the site, to replace N2

Water monitoring location W3 are proposed to relocate about 55 meters down stream, namely W3(a), for safety reason. The recommendation are base on there no any discharge points are observed between W3 and the proposed location
