PROJECT No.: TCS/00408/08

DSD CONTRACT NO. DC/2007/17  
DRAINAGE IMPROVEMENT WORKS IN  
CHEUNG PO, MA ON KONG, YUEN KONG SAN TSUEN  
AND TIN SAM TSUEN OF YUEN LONG DISTRICT AND  
SEWERAGE AT TSENG TAU CHUNG TSUEN, TUEN MUN

MONTHLY EM&A REPORT FOR KT13  
(DECEMBER 2009)

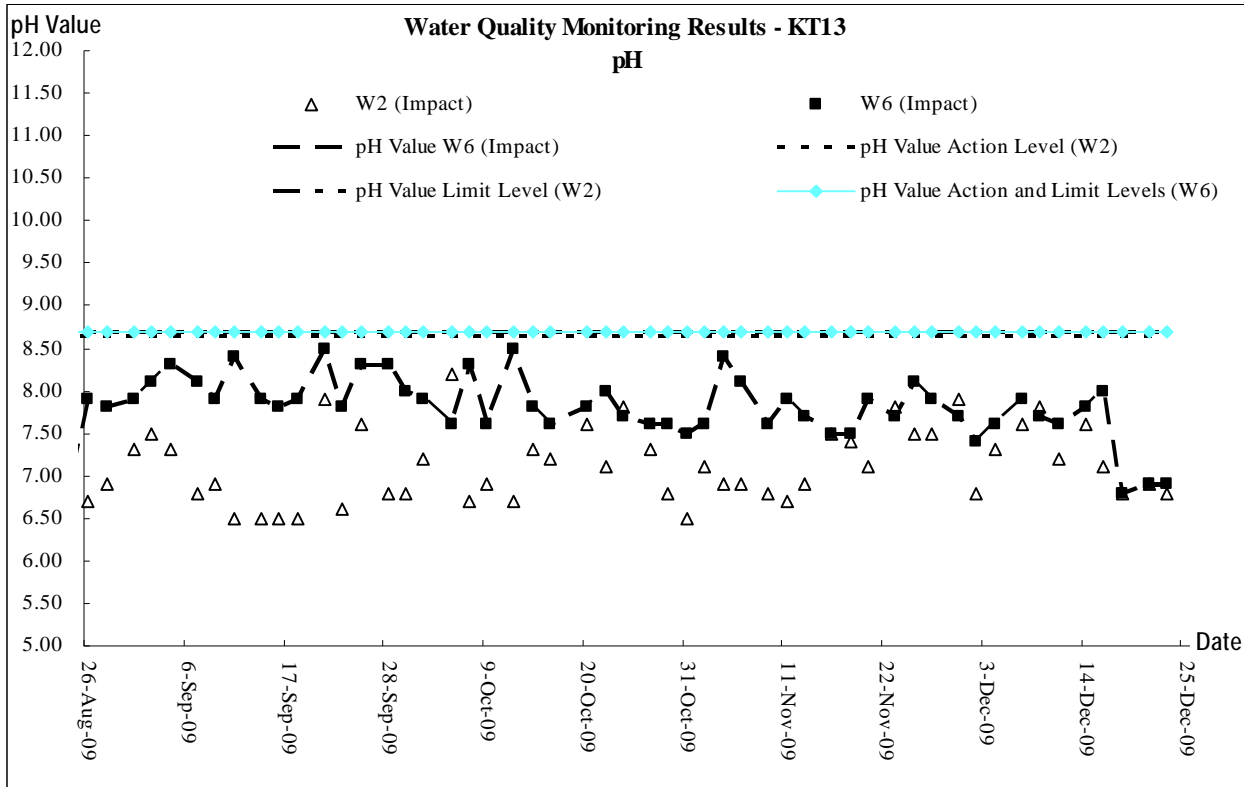
### Graphic Plot of Monitoring –Water Quality

According to the existing Action/Limit Levels, five (5) and one (1) Limit Level exceedances each of suspended solids and zinc were recorded during the Reporting Period as shown in **Table 3-3-2**. NOEs were issued upon confirmation of the monitoring results, and investigation was conducted upon receipt of the information of construction activities and implementation status of mitigation measures provided by CRBC. The causes of the exceedances were being investigated.

During the Reporting Period, no excavation work was being carried out at downstream near Location W6 was undertaken. Water mitigation measures such as sedimentation tanks, temporary earth bunds and sand bags had been equipped on site properly. However, during regular site inspection, influx of discharge from the nearby pig farm into the channel which resulted in increased turbidity of the water body was observed. Preliminary investigation concluded that the exceedances were likely to be due to the discharge from the pig farm. CRBC was reminded to fully implement the required water quality mitigation measures during construction under the Project, in particular when excavation and the associated channel works are undertaken and construction wastewater is generated and discharged to the Channel KT13.
