PROJECT No.: TCS/00408/08

DSD CONTRACT NO. DC/2007/17
DRAINAGE IMPROVEMENT WORKS IN
CHEUNG PO, MA ON KONG, YUEN KONG SAN TSUEN
AND TIN SAM TSUEN OF YUEN LONG DISTRICT AND
SEWERAGE AT TSENG TAU CHUNG TSUEN, TUEN MUN

MONTHLY EM&A REPORT FOR KT13
(FEBRUARY 2011)

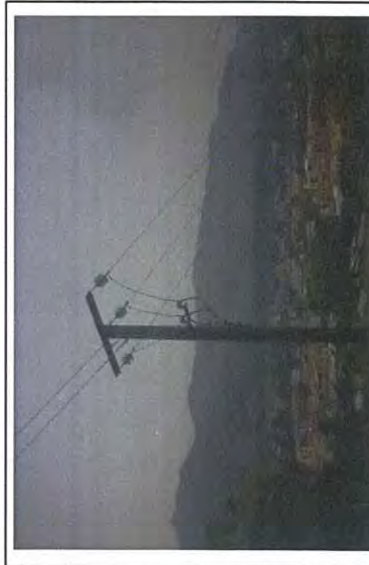
Photo No. A6 – LR2.1

10.7.4	LR2.1 (Fish Pond) within site boundary	A6	There are 4 numbers of fallowed fish ponds at the upstream of the Ma On Kong Channel. A chain of fish ponds near downstream but distant from the Channel is noted. The fish ponds cover area of in total 23,000 m2. Most of them are heavily colonized by aquatic plants, which attribute to their low visual quality as a water landscape element. They have low landscape value and sensitive to change.	Minor change due to construction of structures within site boundary. A soil platform was
	LR2.2 (Fish Pond) outside site boundary	A7

Fish Pond within site boundary

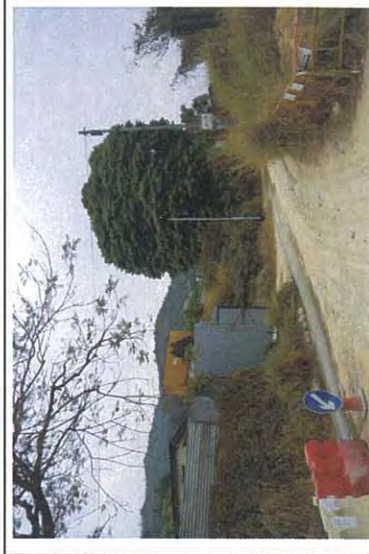
Photo No. A8 – LR3

created outside site boundary due to other project was noted.
Marsh				
10.7.5	LR3 (Marsh)	A8	It comprises 2 marshes at the upstream channel of the Channel. They are inundated lowland heavily colonized with wetland aquatic plants. They have low landscape value and sensitive to change.	Remain the same as the baseline
Vegetation

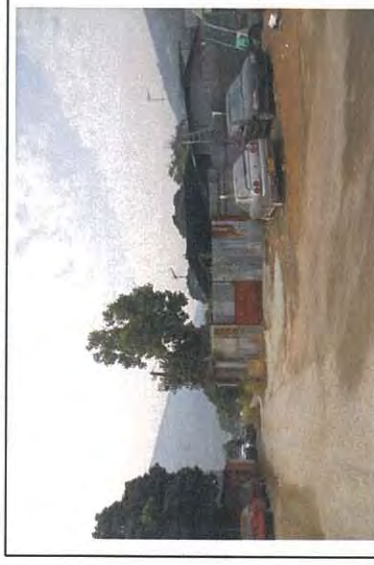
Photo No. B11—LCA 6 Industrial Landscape Character Area

10.7.17	LCA6 (Industrial Landscape Character Area)	B11 & B12	This comprise collection of slummy-built temporary structure and open storage uses land, which are characterized with metallic hoarding and used for poultry, recycling, vehicle repairing etc. The sensitivity to change of this area is low.	Reconstruction of hoarding was conducted by the land owner

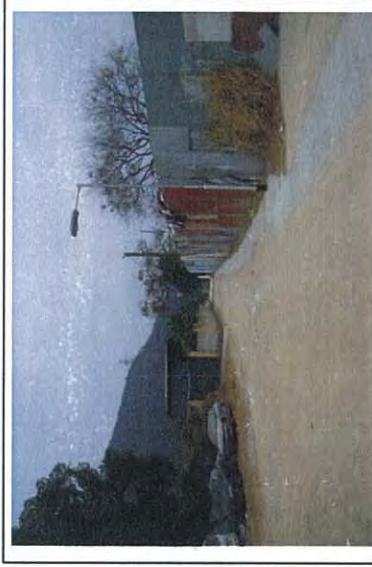
Photo No. C2-12 Plant Nursery at the east of Ma On Kong Channel
