DSD CONTRACT NO. DC/2007/17
DRAINAGE IMPROVEMENT WORKS IN
CHEUNG PO, MA ON KONG, YUEN KONG SAN TSUEN
AND TIN SAM TSUEN OF YUEN LONG DISTRICT AND
SEWERAGE AT TSENG TAU CHUNG TSUEN, TUEN MUN

MONTHLY EM&A REPORT FOR KT13
(APRIL 2011)

PREPARED FOR
CHINA ROAD & BRIDGE CORPORATION

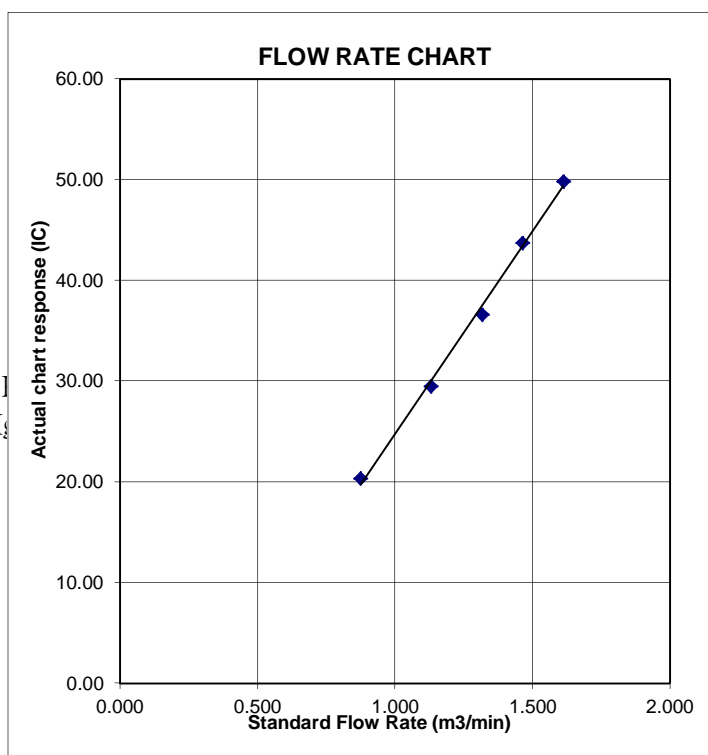
TSP SAMPLER CALIBRATION CALCULATION SPREADSHEET

Location :	No.68 Ho Pui Village	Date of Calibration: 1-Apr-11
Location ID :	ASR14 (A1(a))	Next Calibration Date: 1-Jun-11
Technician: Mr. Ben Tam
