DSD CONTRACT NO. DC/2007/17
DRAINAGE IMPROVEMENT WORKS IN
CHEUNG PO, MA ON KONG, YUEN KONG SAN TSUEN
AND TIN SAM TSUEN OF YUEN LONG DISTRICT AND
SEWERAGE AT TSENG TAU CHUNG TSUEN, TUEN MUN

MONTHLY EM&A REPORT FOR KT13
(MAY 2011)

PREPARED FOR
CHINA ROAD & BRIDGE CORPORATION

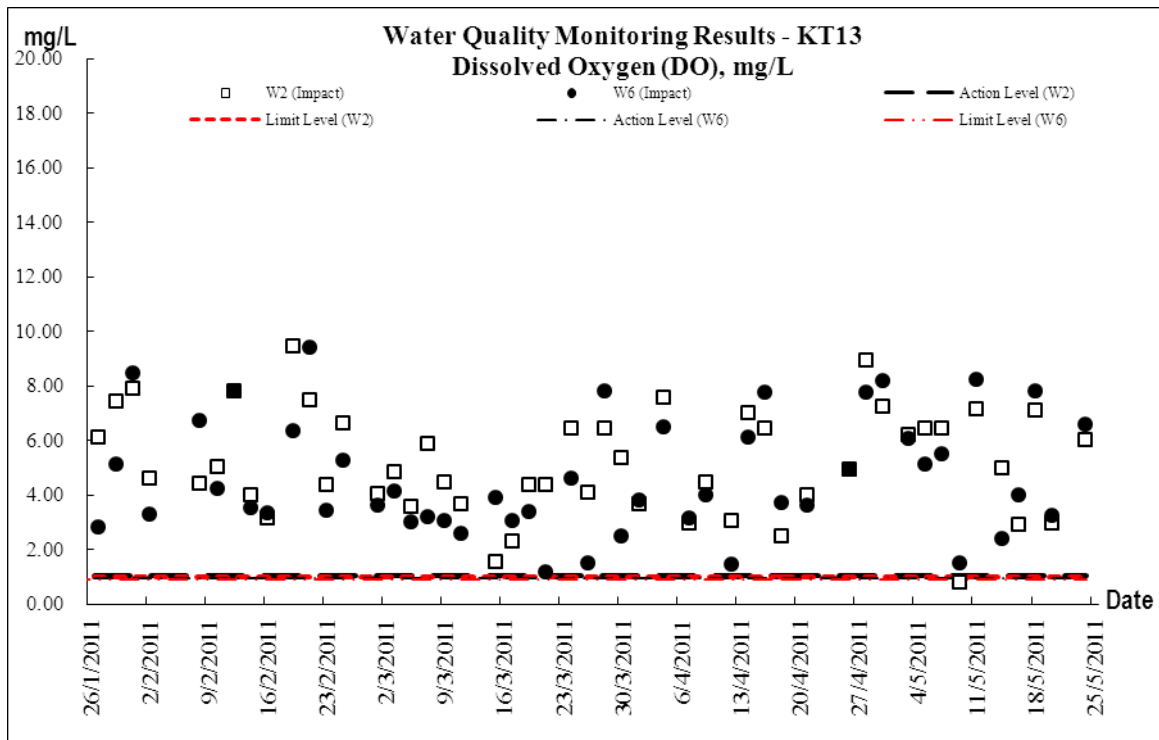
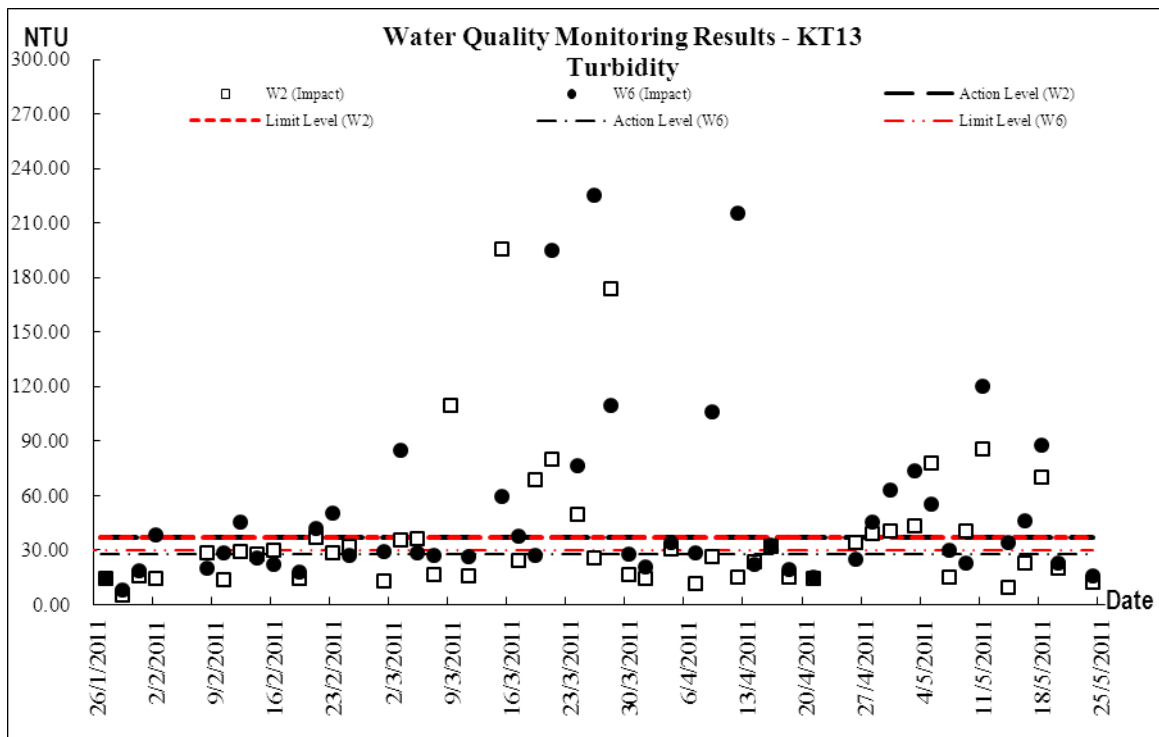
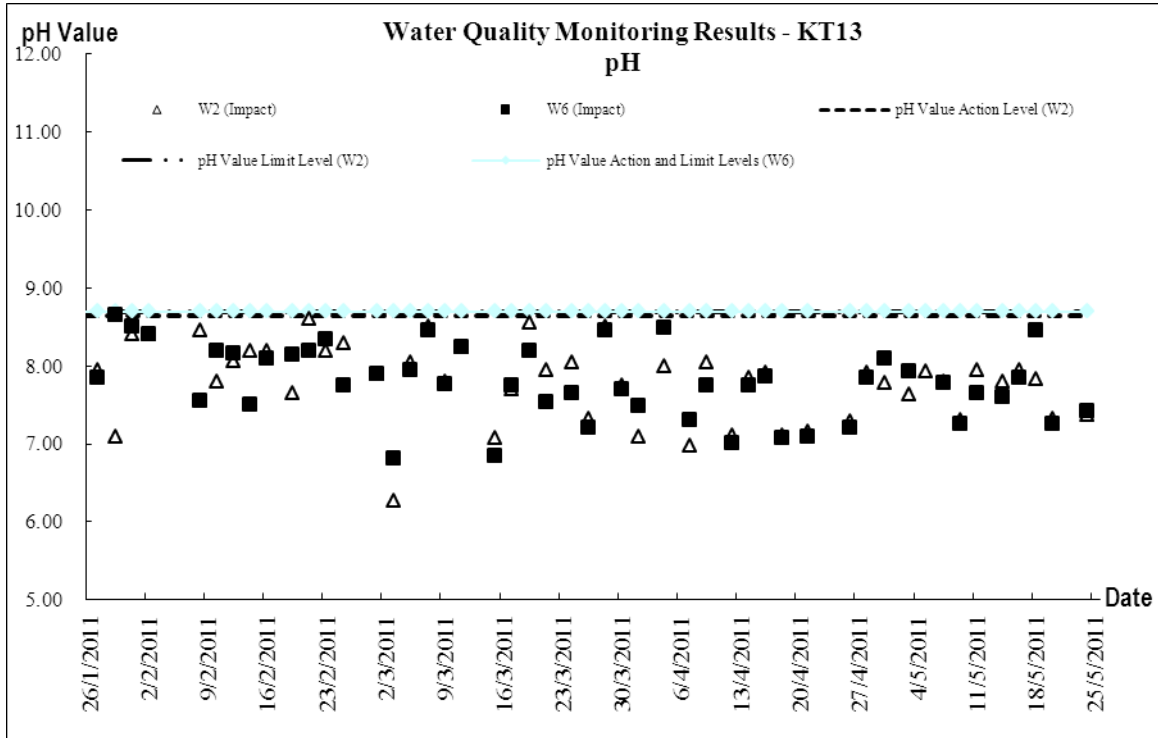
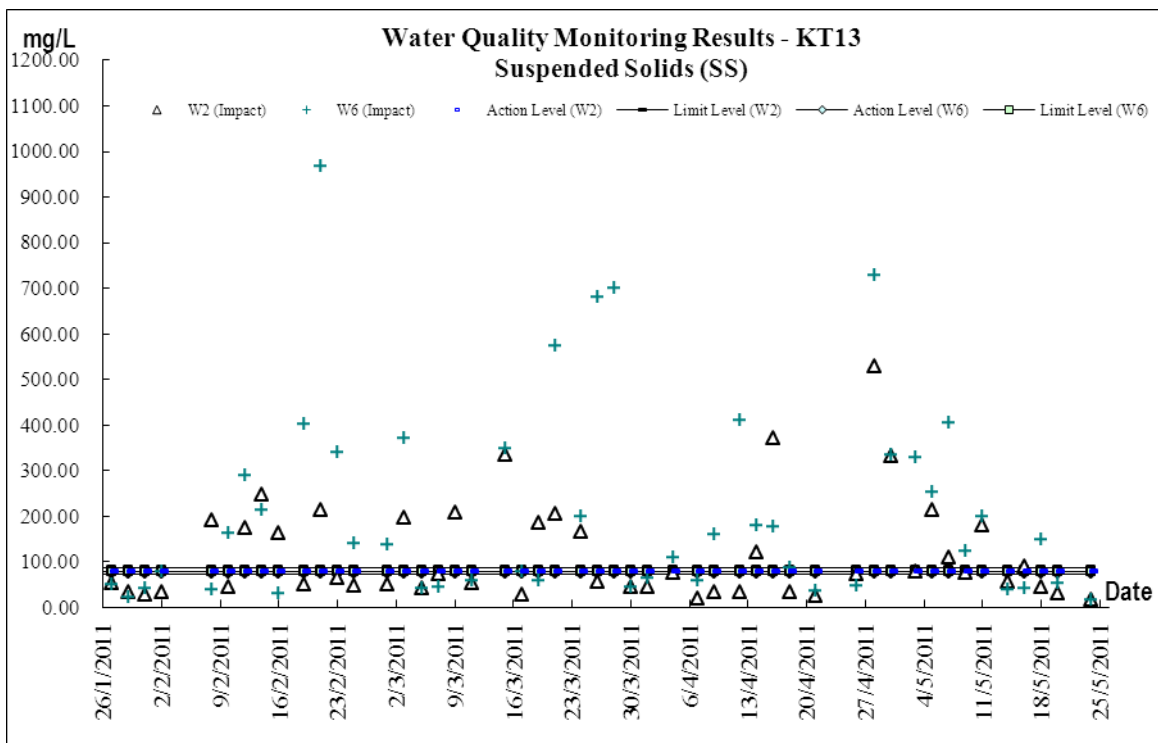
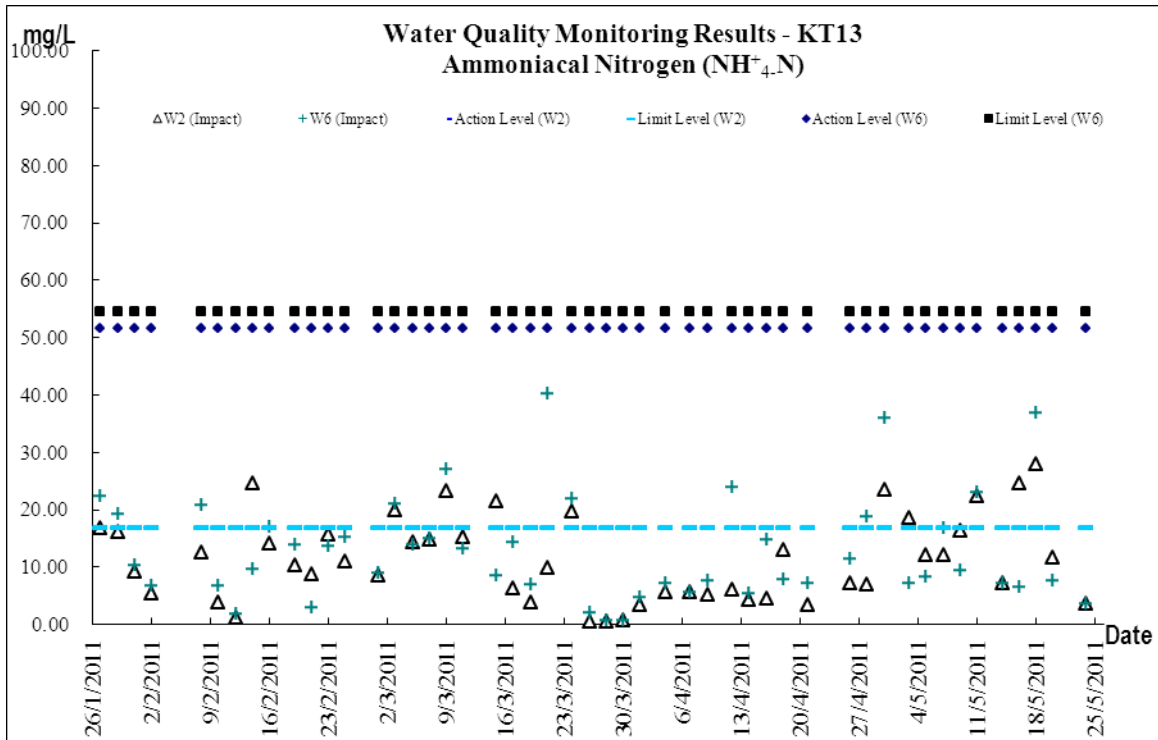
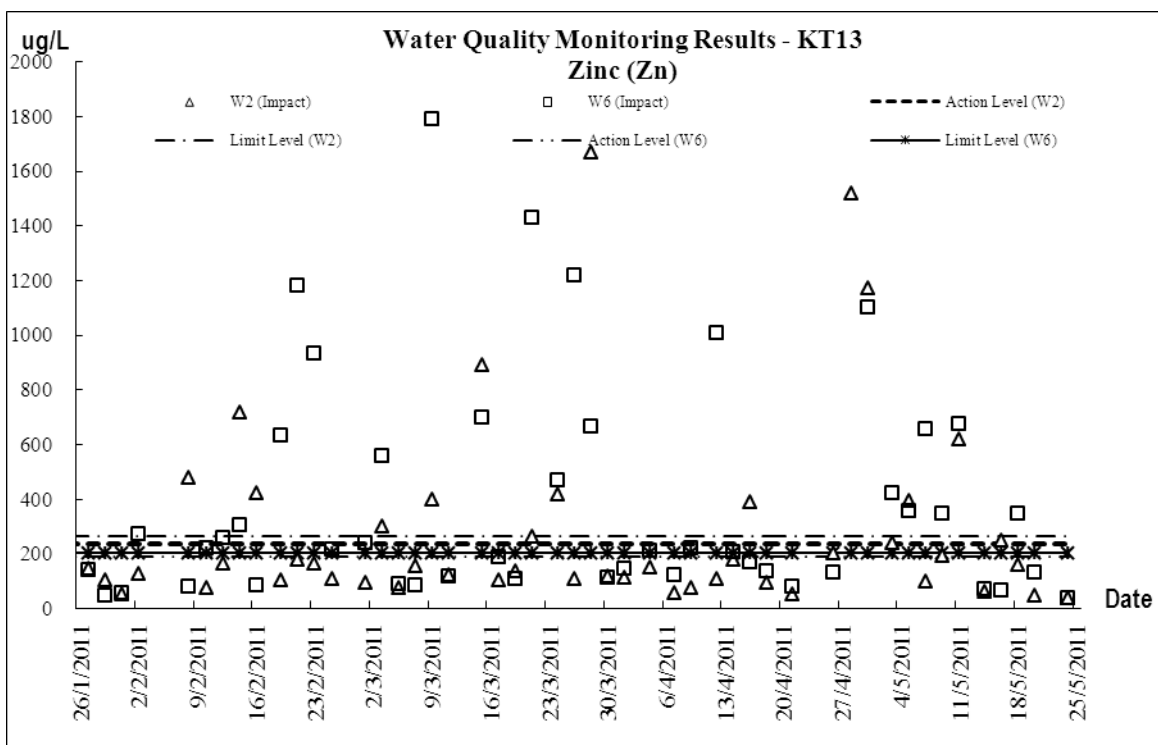
Graphic Plot of Monitoring –Water Quality

In stream water quality monitoring, a total of 48 Action / Limit Level exceedances were recorded, namely 24 exceedances at upstream Location W2 and 24 exceedances downstream Location W6. According to the observation during site inspections by ET and information provided by the Contractor, installation of gabion lining was conducted at downstream. No direct disturbance was made to the stream but pigsty discharge was observed near monitoring location W2. Since high levels of Turbidity, Suspended Solids, NH_4^+ -N and Zinc were also recorded at upstream and control station, it is believed that the exceedances were likely due to the discharge from the agriculture farm and livestock at the vicinity as water quality throughout the channel was affected. Therefore, it is concluded that the exceedances were not related to the works under the Project.

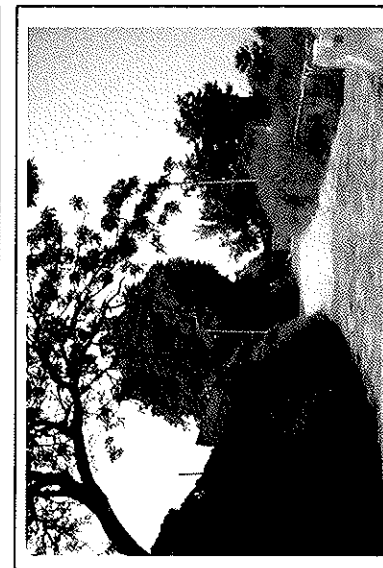
Photo No. A6 - LR2.1

Fish Pond within site boundary

10.7.4	LR2.1 (Fish Pond) within site boundary LR2.2 (Fish Pond) outside site boundary	A6	There are 4 numbers of fallowed fish ponds at the upstream of the Ma On Kong Channel. A chain of fish ponds near downstream but distant from the Channel is noted. The fish ponds cover area of in total 23,000 m ² . Most of them are heavily colonized by aquatic plants, which attribute to their low visual quality as a water landscape element. They have low landscape value and sensitive to change.	Minor change due to construction of structures within site boundary. A soil platform was
		A7

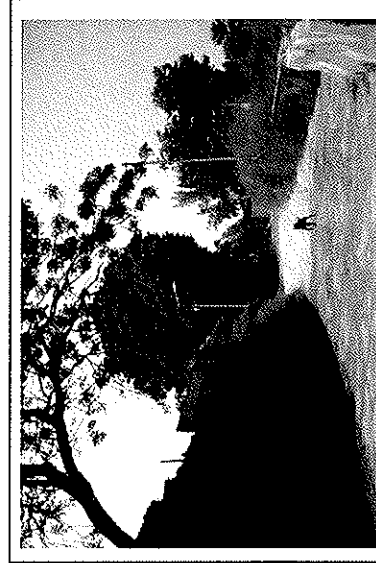
Photo No. A6 - LR2.1

Fish Pond within site boundary
