DSD CONTRACT NO. DC/2007/17  
DRAINAGE IMPROVEMENT WORKS IN  
CHEUNG PO, MA ON KONG, YUEN KONG SAN TSUEN  
AND TIN SAM TSUEN OF YUEN LONG DISTRICT AND  
SEWERAGE AT TSENG TAU CHUNG TSUEN, TUEN MUN

MONTHLY EM&A REPORT FOR KT13  
(SEPTEMBER 2011)

PREPARED FOR  
CHINA ROAD & BRIDGE CORPORATION

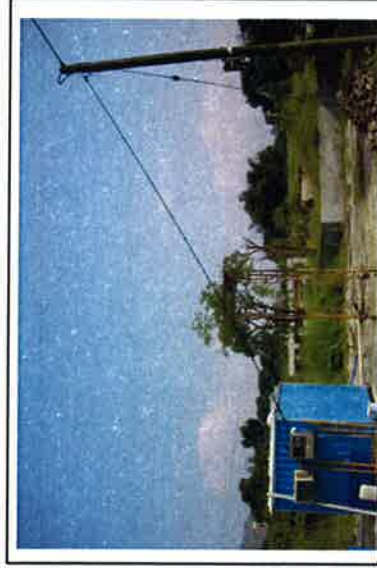
Photo No. B11-LCA 6 Industrial Landscape Character Area

10.7.17	LCA6 (Industrial Landscape Character Area)	B11 & B12	This comprise collection of slummy-built temporary structure and open storage uses land, which are characterized with metallic hoarding and used for poultry, recycling, vehicle repairing etc. The sensitivity to change of this area is low.	Reconstruction of hoarding was conducted by the land owner
