**DSD CONTRACT NO. DC/2007/17  
DRAINAGE IMPROVEMENT WORKS IN CHEUNG PO,  
MA ON KONG, YUEN KONG SAN TSUEN AND TIN SAM  
TSUEN OF YUEN LONG DISTRICT AND SEWERAGE AT  
TSENG TAU CHUNG TSUEN, TUEN MUN**

**FIRST QUARTERLY EM&A SUMMARY REPORT –  
KT13  
OCTOBER – DECEMBER 2008**

PREPARED FOR  
**CHINA ROAD & BRIDGE CORPORATION**

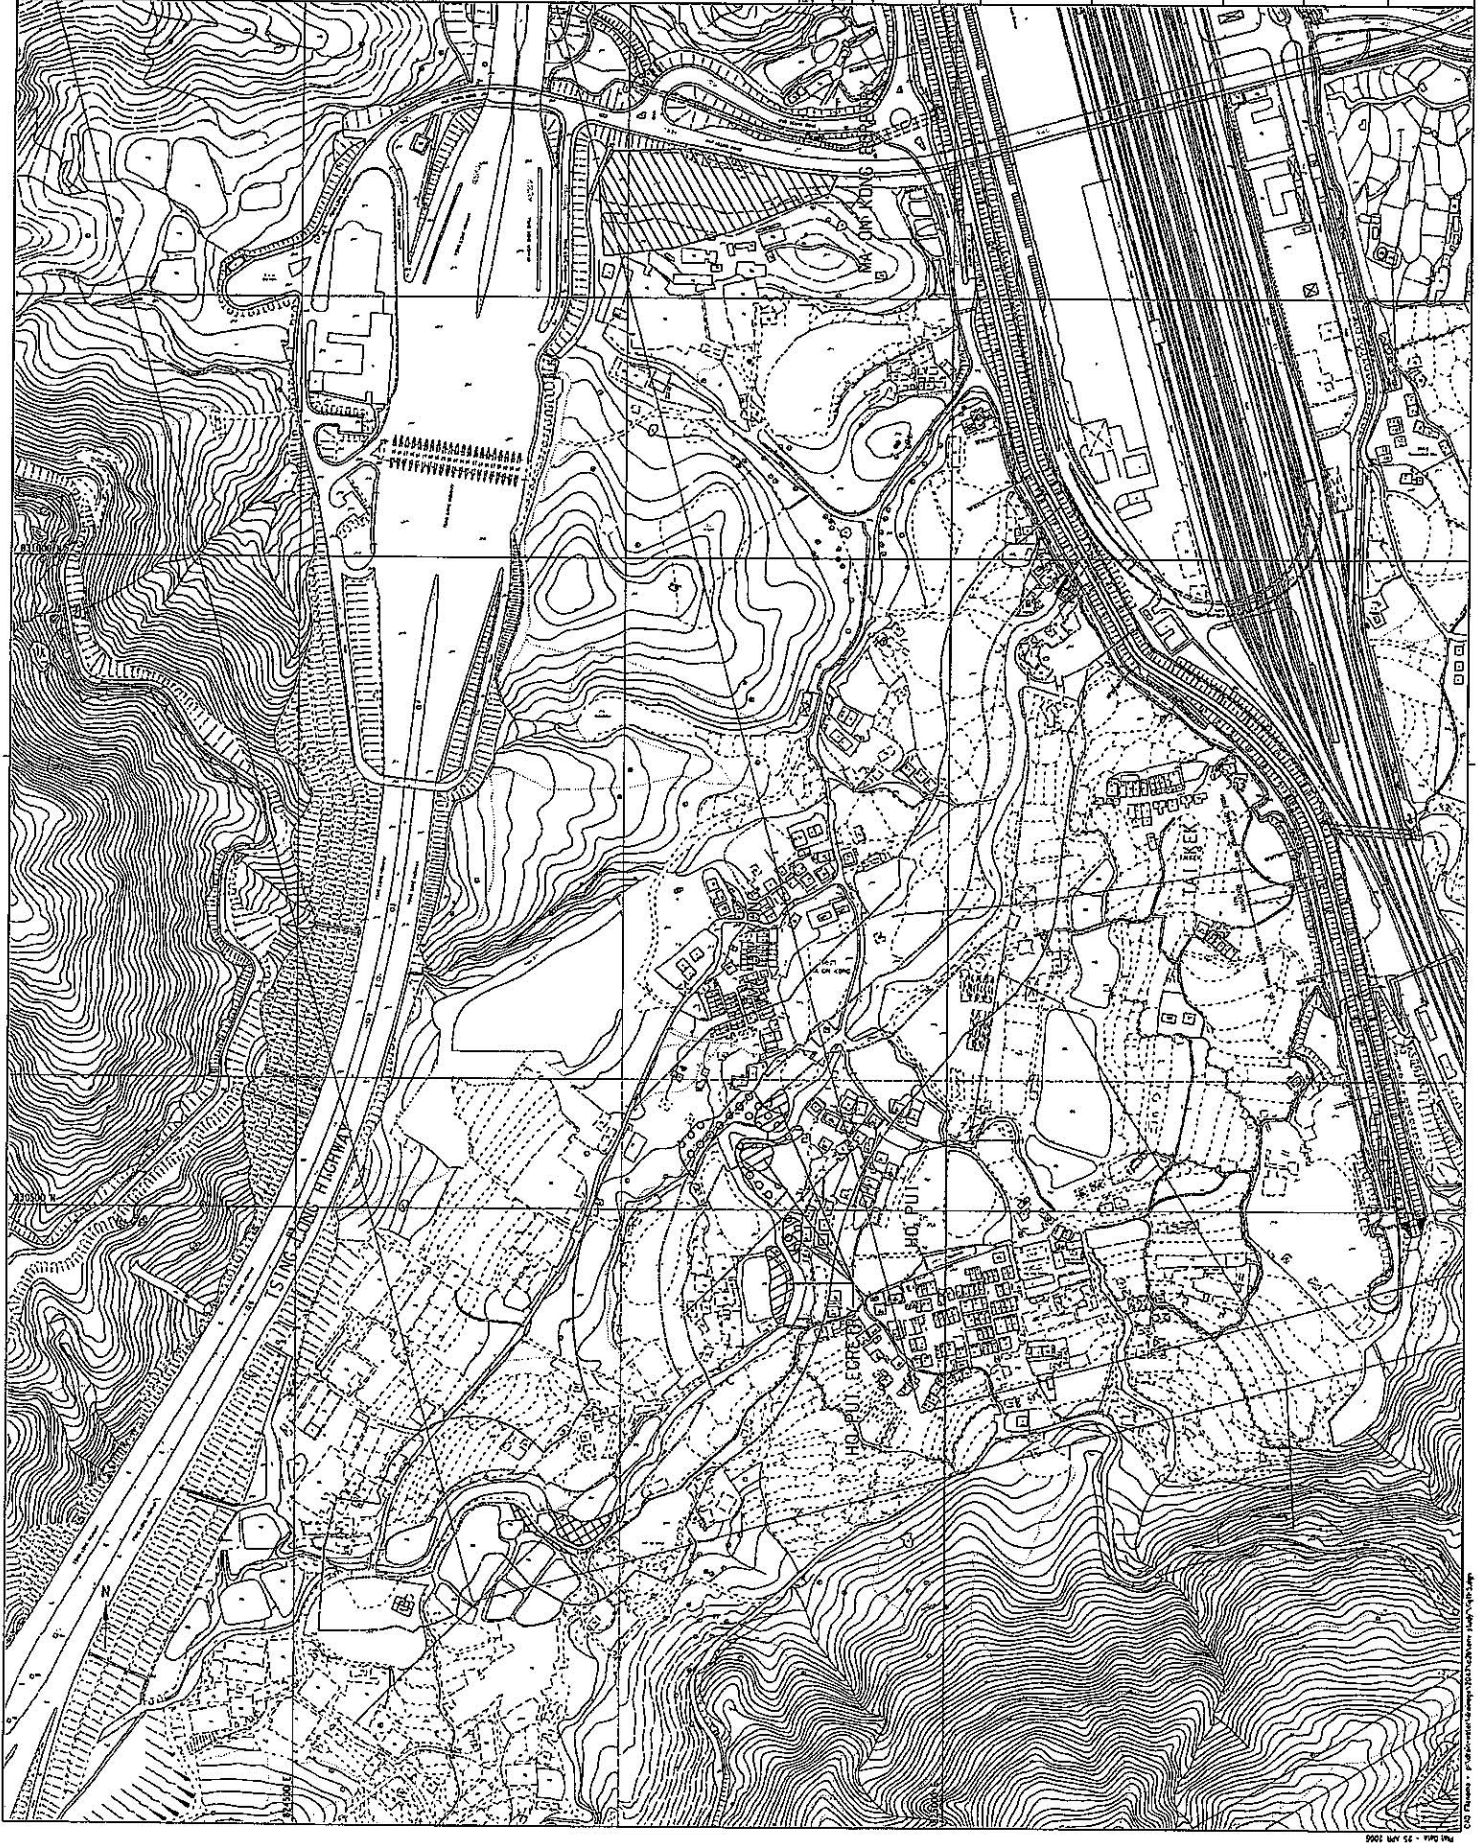
ECOLOGY MONITORING AREAS  
 RECOMMENDED FOR  
 CONSTRUCTION PHASE AND  
 OPERATION PHASE

- IA ON YUEN AND TAI KWOS
- PROPOSED CONSERVATION TREE PLANTING
- CONSERVATION AREA
- WORKS BOUNDARY OF CHANNEL R113
- ECOLOGY MONITORING AREAS

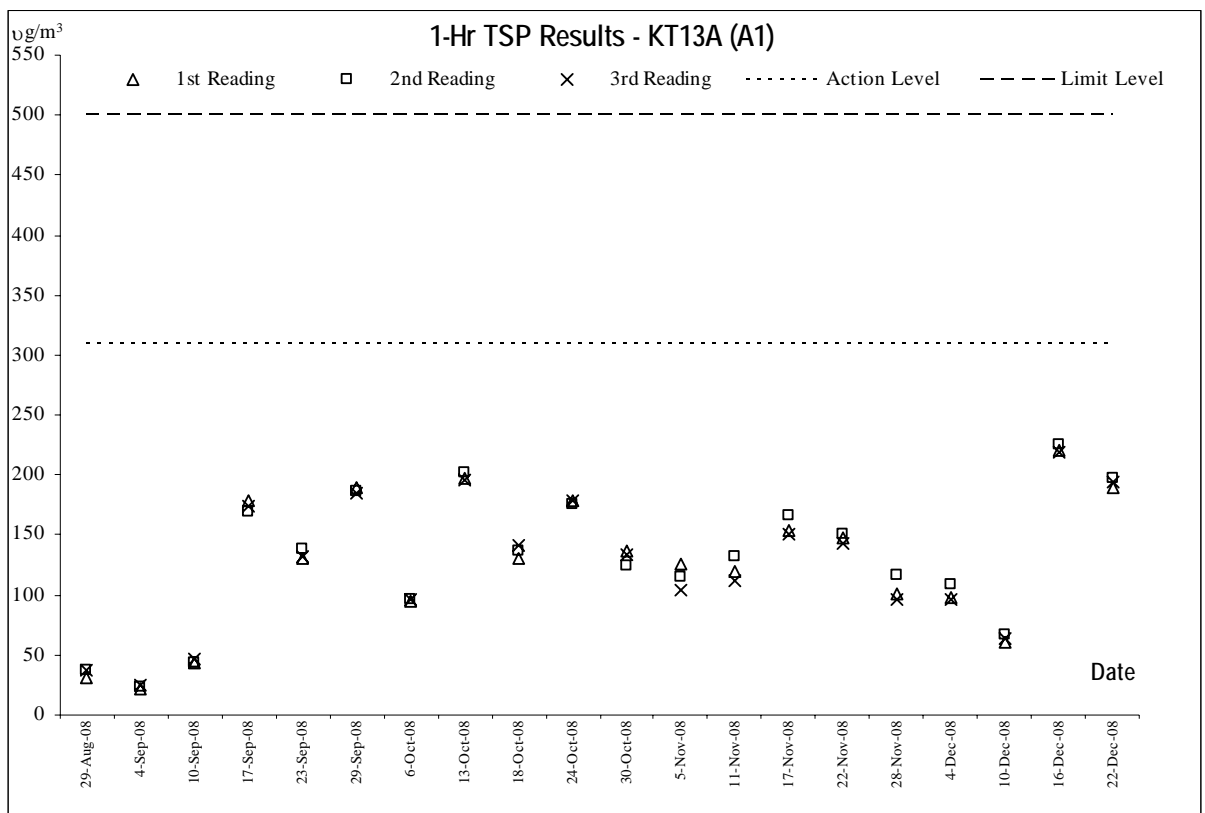
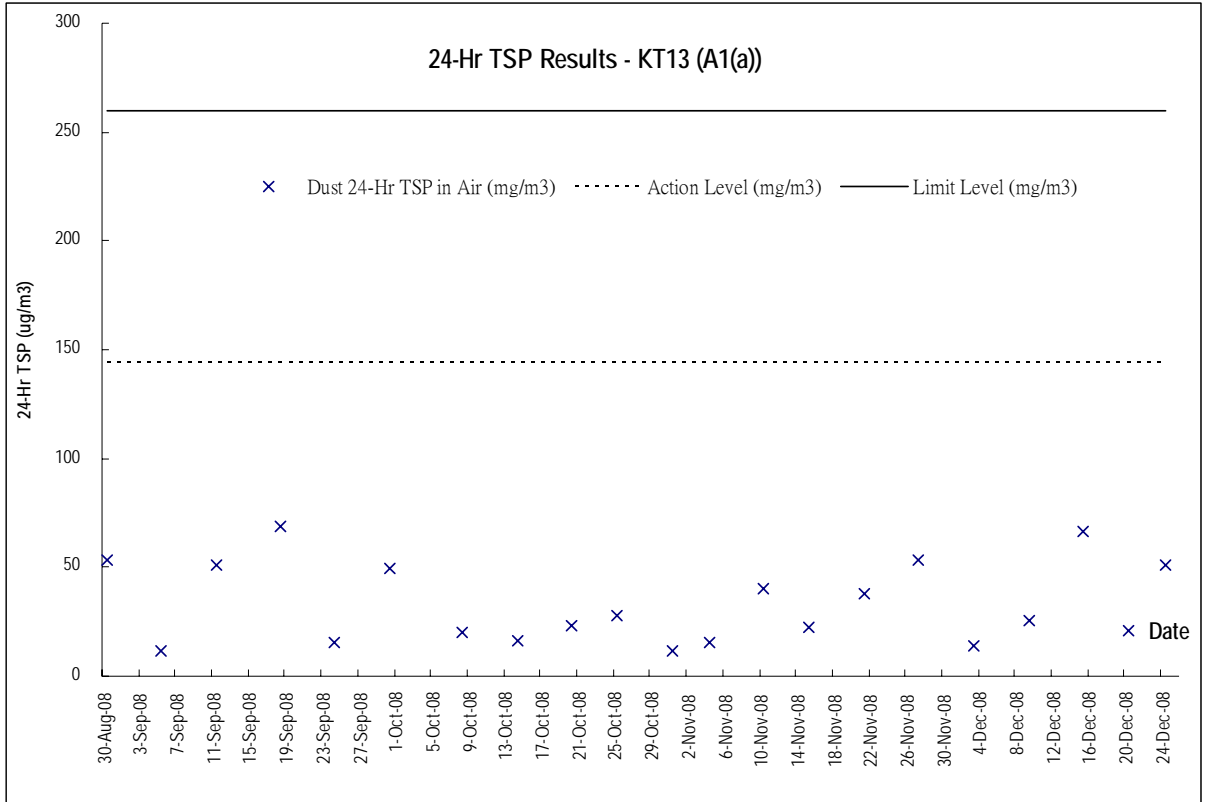
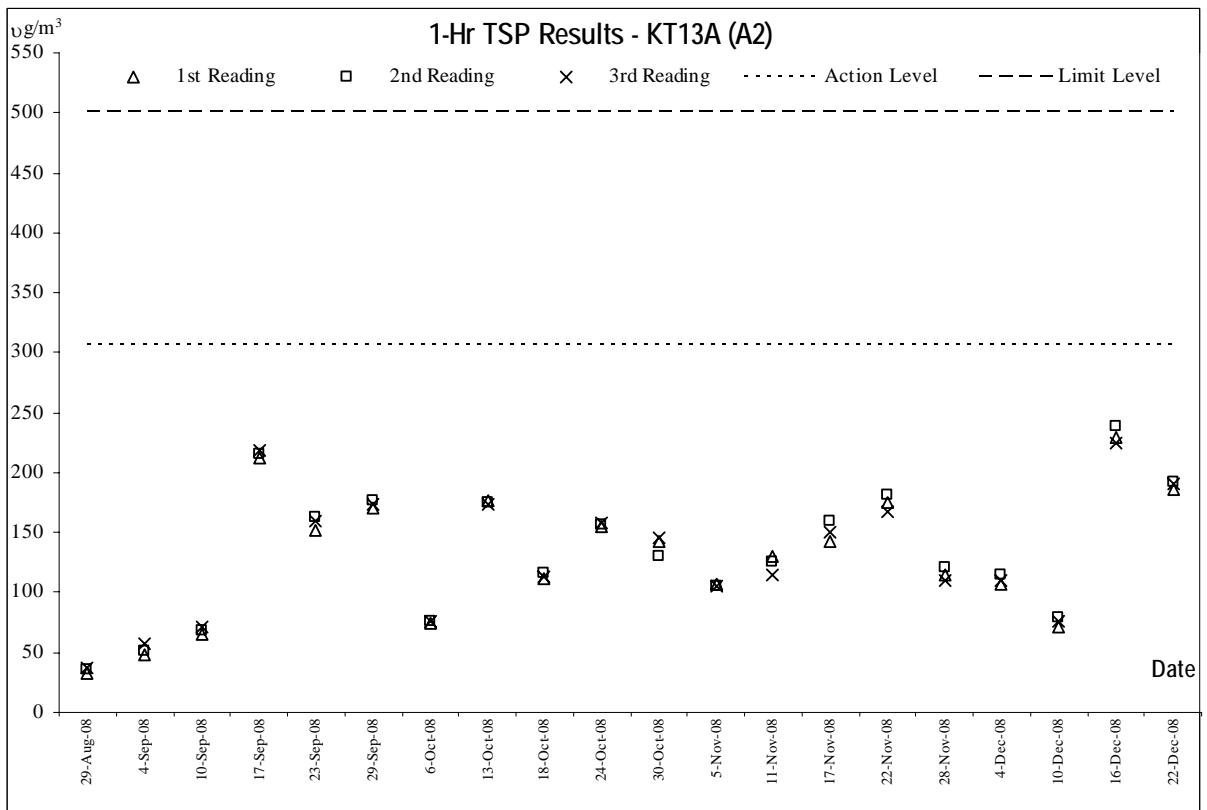
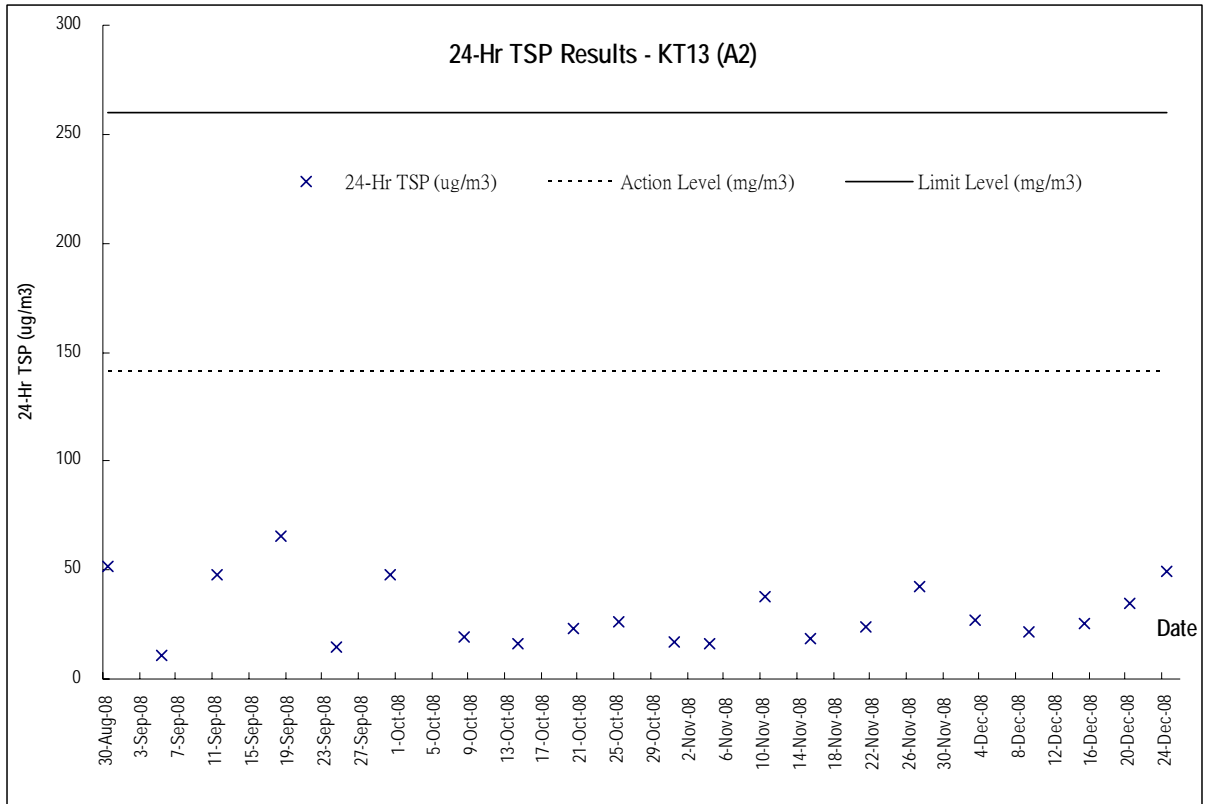
### (B)(1) Air Quality

As shown in graphic plots in **Appendix E**, all the 1-Hr TSP and 24-Hr TSP results fluctuated below the corresponding A/L level. **Table 3-1** above and graphic plots in **Appendix E** also demonstrated no exceedances of the 1-HR TSP and 24-Hr TSP A/L levels were registered during the Reporting Period. Neither notification of exceedance of environmental quality criteria (hereinafter 'NOE') nor corrective action was recommended for the parameters.

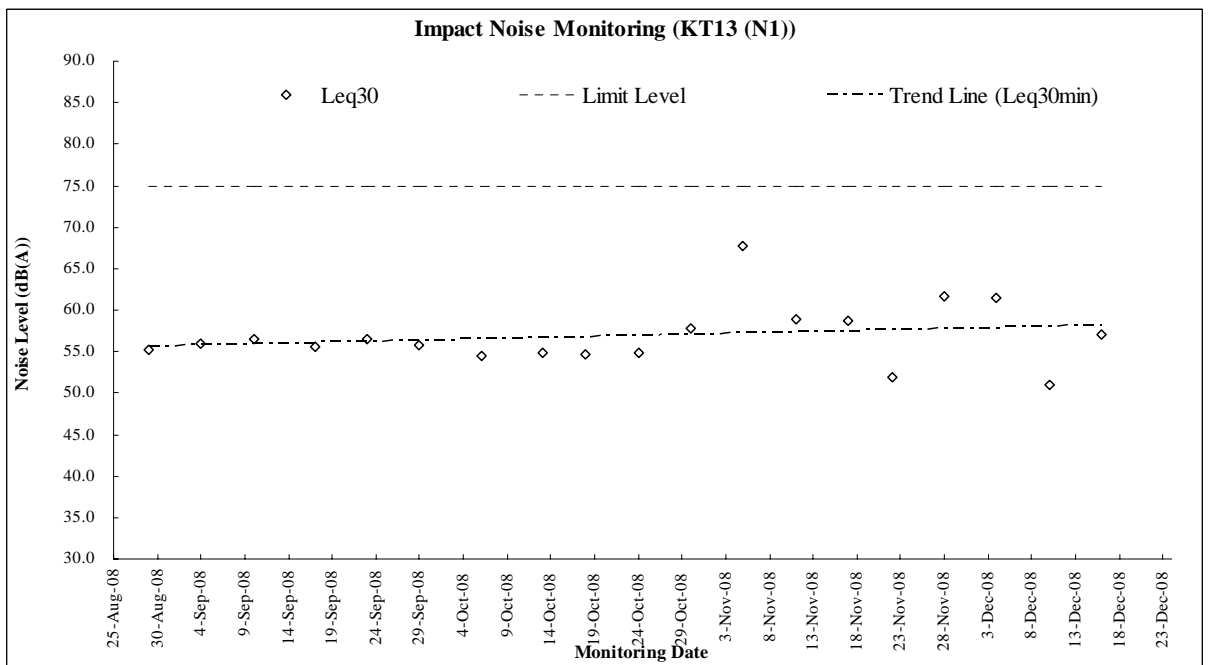
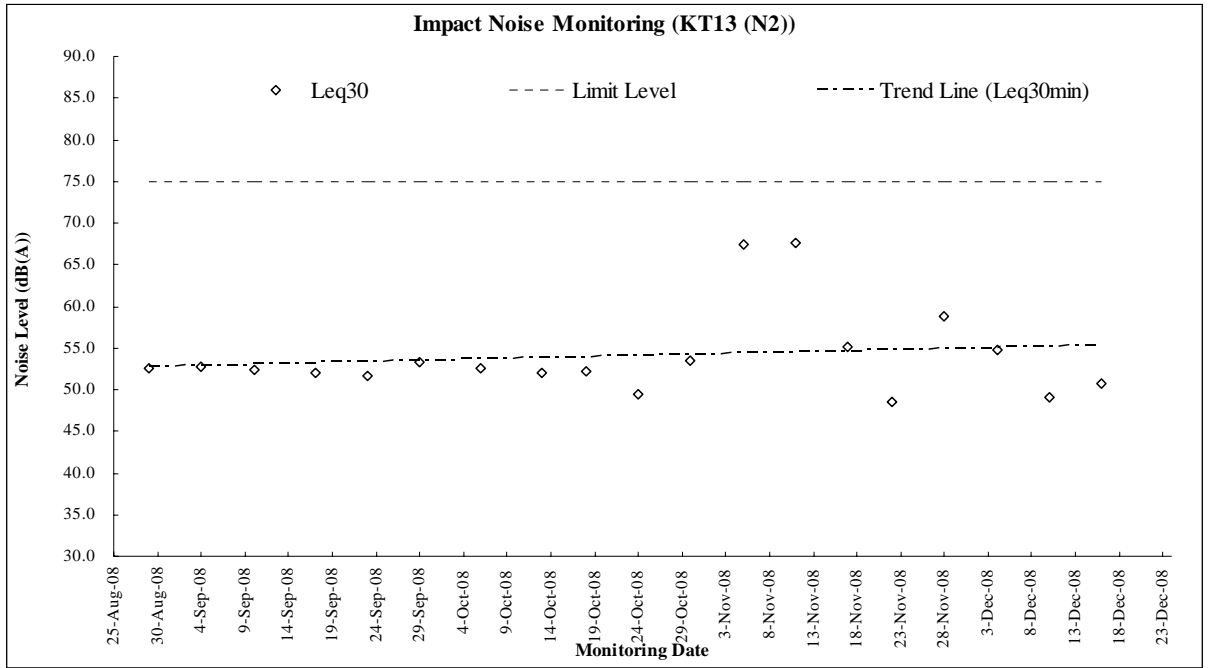
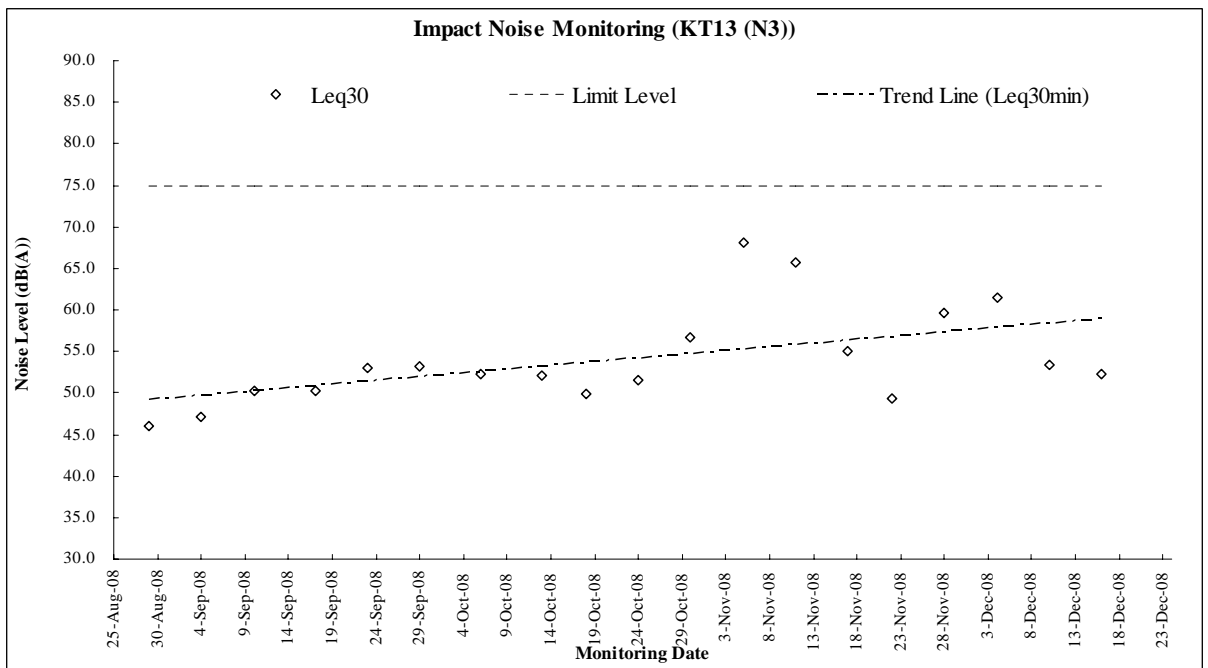
## (B)(2) Construction Noise

As shown in **Tables 3-2** and graphic plots in **Appendix E**, all the construction noise results fluctuated below the Limit level. Neither documented construction complaint nor exceedance of Limit level was recorded during the Reporting Period. Neither NOE nor corrective action was recommended for the parameter.

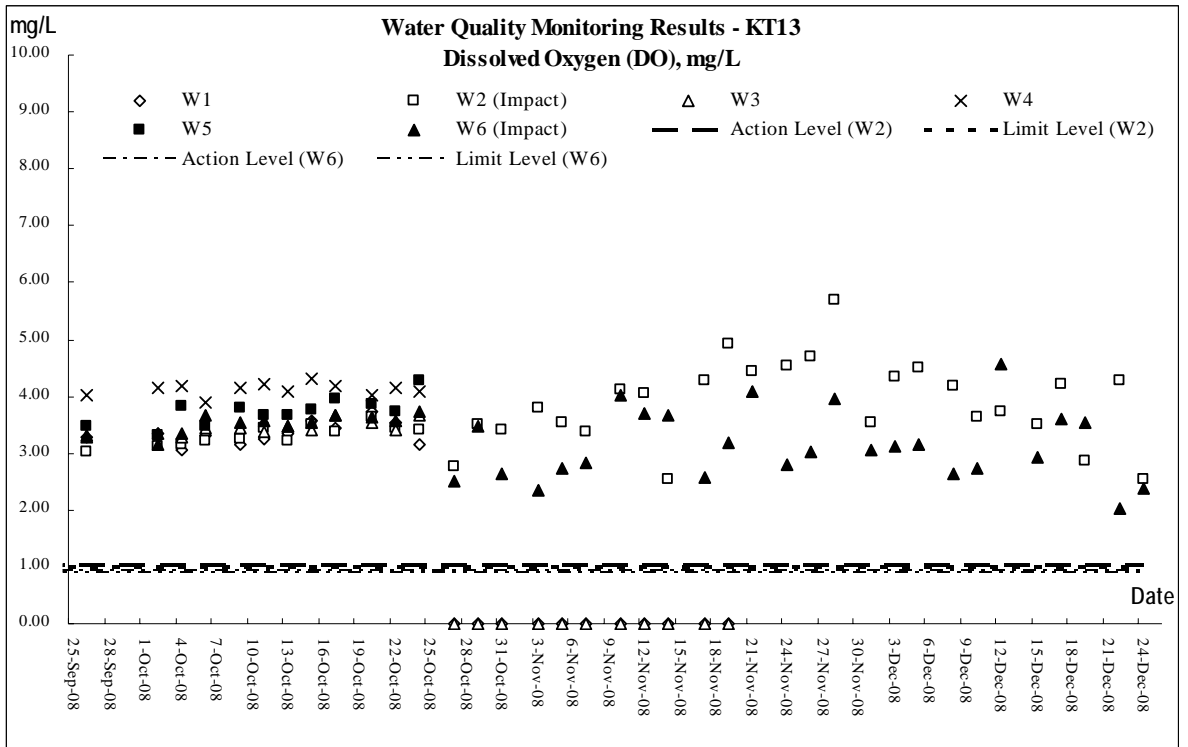
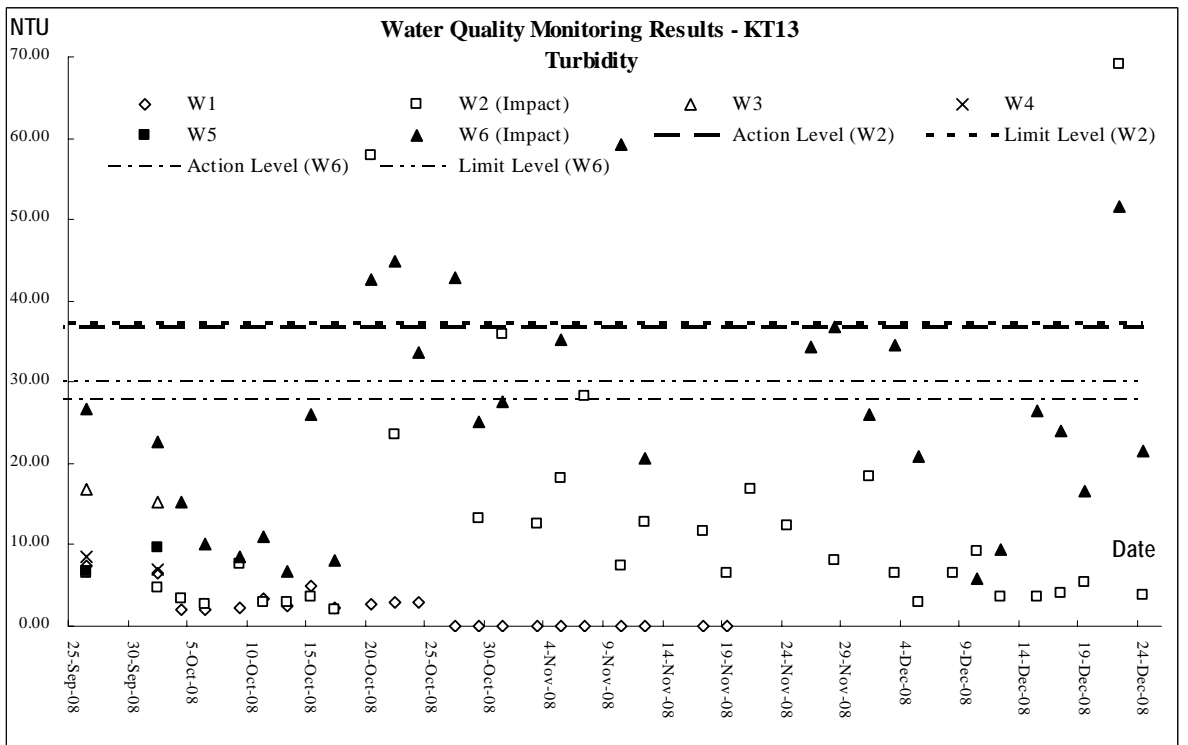
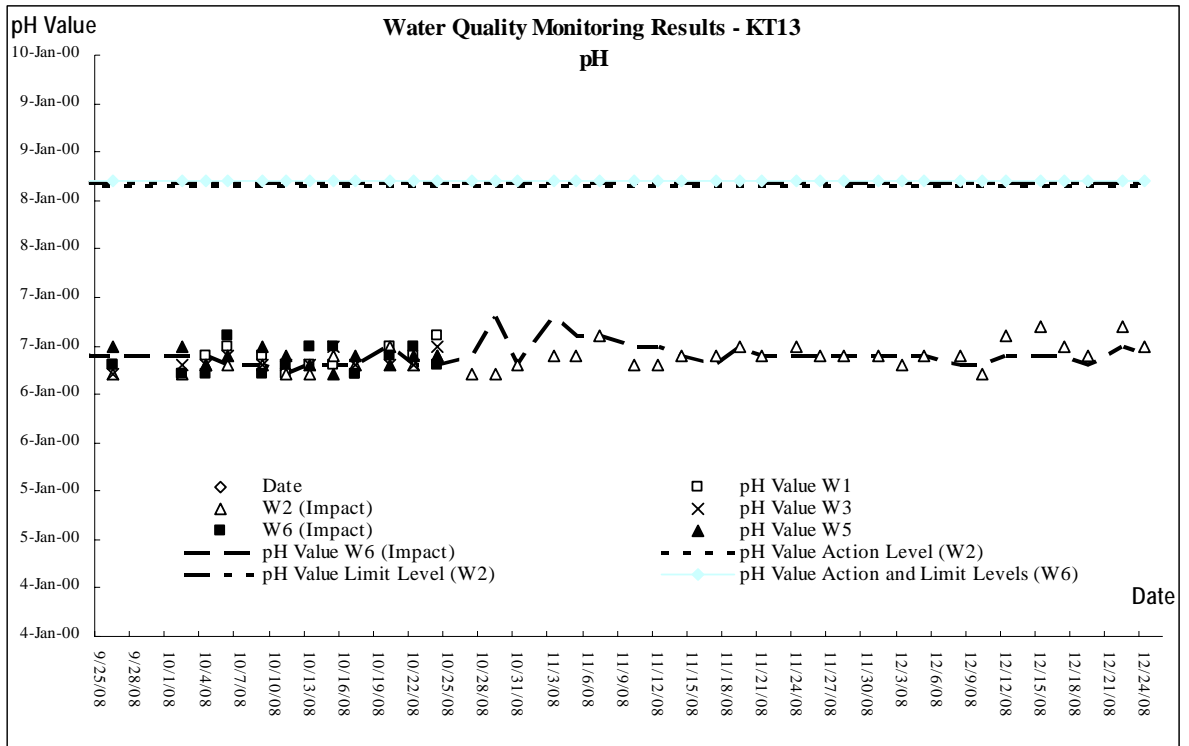
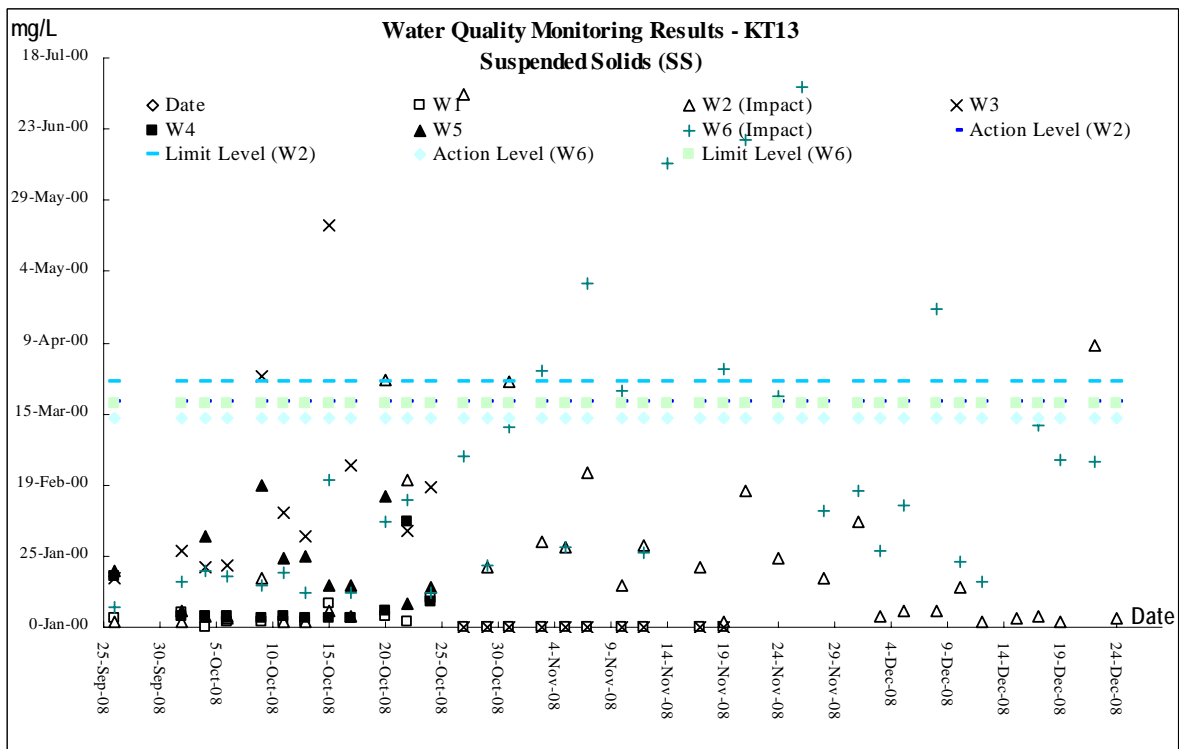
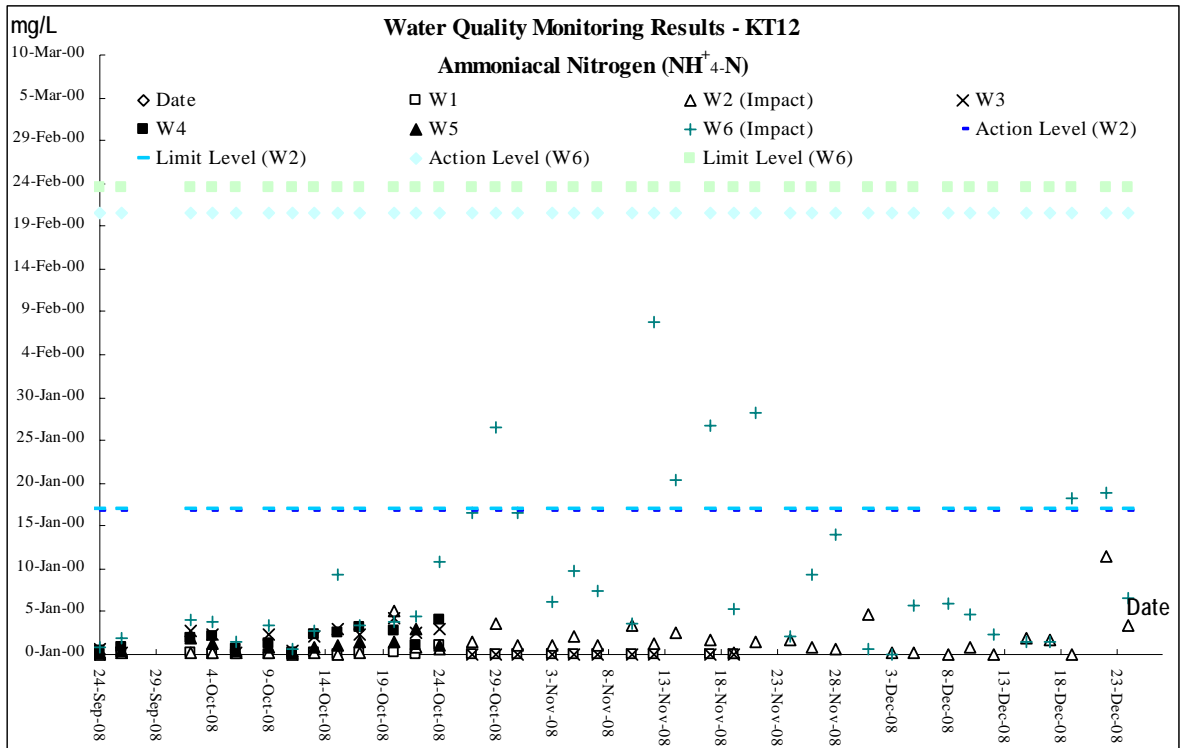
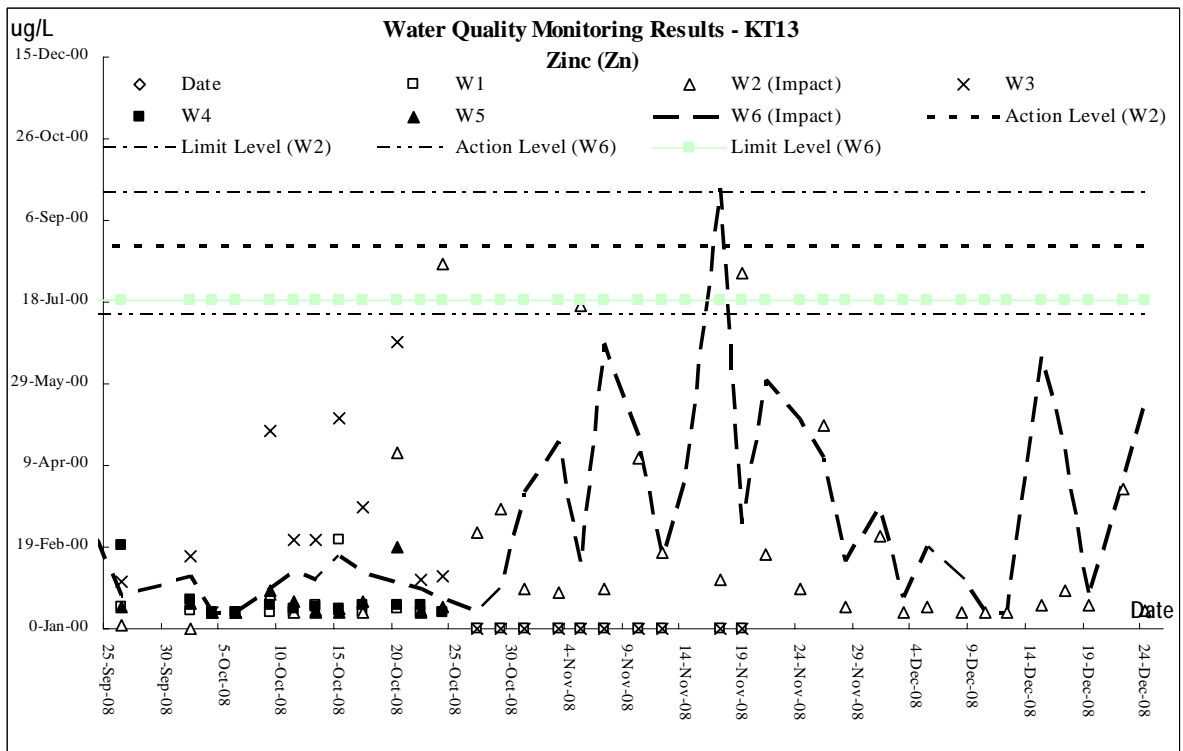
### (B)(3) Water Quality

ES04 For water quality however, a total of 44 exceedances of Limit levels were recorded at W2 and W6 during the Reporting Period as shown below:

ES05 Investigation concluded that the exceedances are not related to the works under the Project. No corrective actions were therefore recommended. Nevertheless, channel excavation near W2 and W6 may have potential water quality impacts to elevation of concentrations of certain water quality parameters, in particular Turbidity and SS. As the attribution of the construction impacts can not be over ruled, it is recommended that water quality mitigation measures stipulated in the EIA and summarized in mitigation measures implementation schedule in the EM&A Manual, including containment structure such as temporary earth bunds, sand bags, sheet pile barriers or other similar techniques, is fully implemented. In addition, the implemented mitigation measures in particular the erected dams with sand bags downstream the excavation site within the water course of KT13 may also be improved to enhance sedimentation of Turbidity and SS, e.g. by using silt curtain, as appropriate.

Nevertheless, channel excavation near W2 and W6 may have potential water quality impacts to elevation of concentrations of certain water quality parameters, in particular Turbidity and SS. As the attribution of the construction impacts can not be over ruled, it is recommended that water quality mitigation measures stipulated in the EIA and summarized in mitigation measures implementation schedule in the EM&A Manual, including containment structure such as temporary earth bunds, sand bags, sheet pile barriers or other similar techniques, is fully implemented. In addition, the implemented mitigation measures in particular the erected dams with sand bags downstream the excavation site within the water course of KT13 may also be improved to enhance sedimentation of Turbidity and SS, e.g. by using silt curtain, as appropriate.
