DSD CONTRACT NO. DC/2007/17
DRAINAGE IMPROVEMENT WORKS IN CHEUNG PO,
MA ON KONG, YUEN KONG SAN TSUEN AND TIN SAM
TSUEN OF YUEN LONG DISTRICT AND SEWERAGE AT
TSENG TAU CHUNG TSUEN, TUEN MUN

5TH QUARTERLY EM&A SUMMARY REPORT –
KT13 (OCTOBER – DECEMBER 2009)

PREPARED FOR
CHINA ROAD & BRIDGE CORPORATION

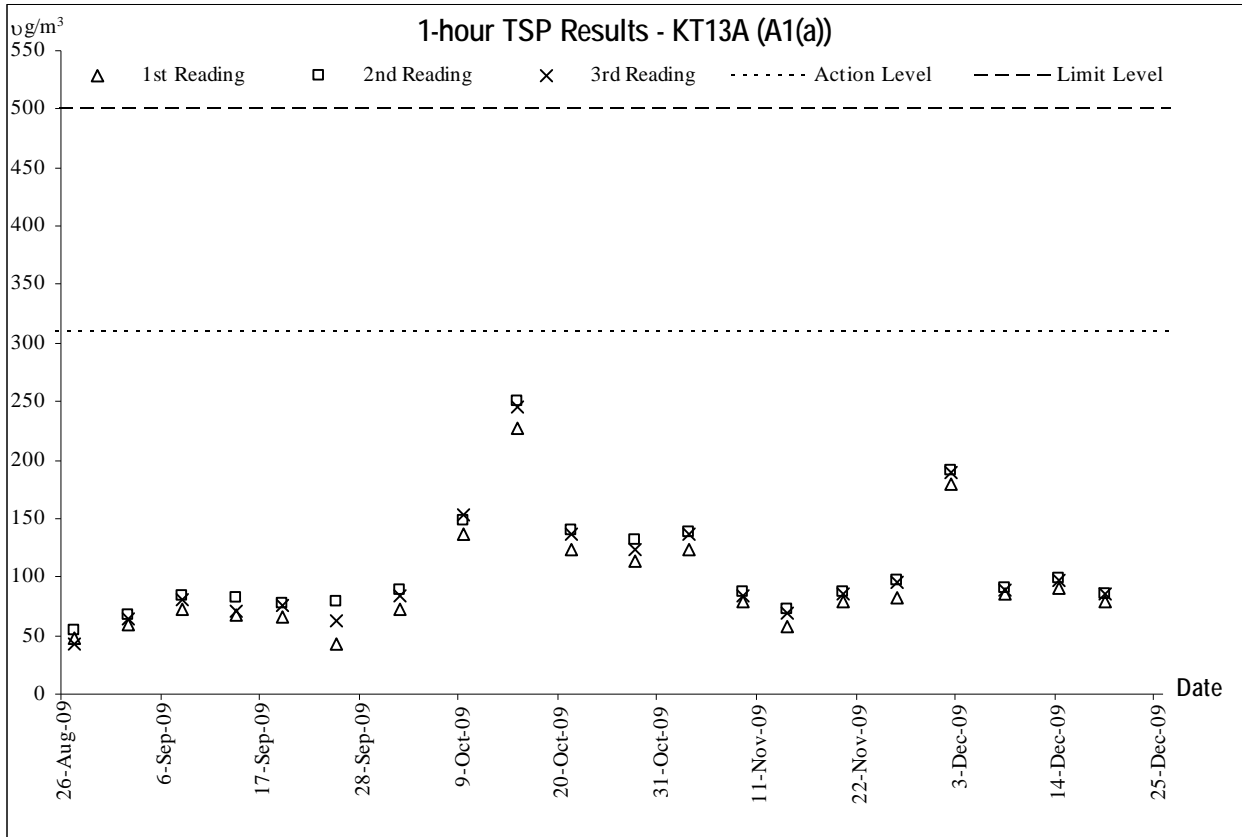
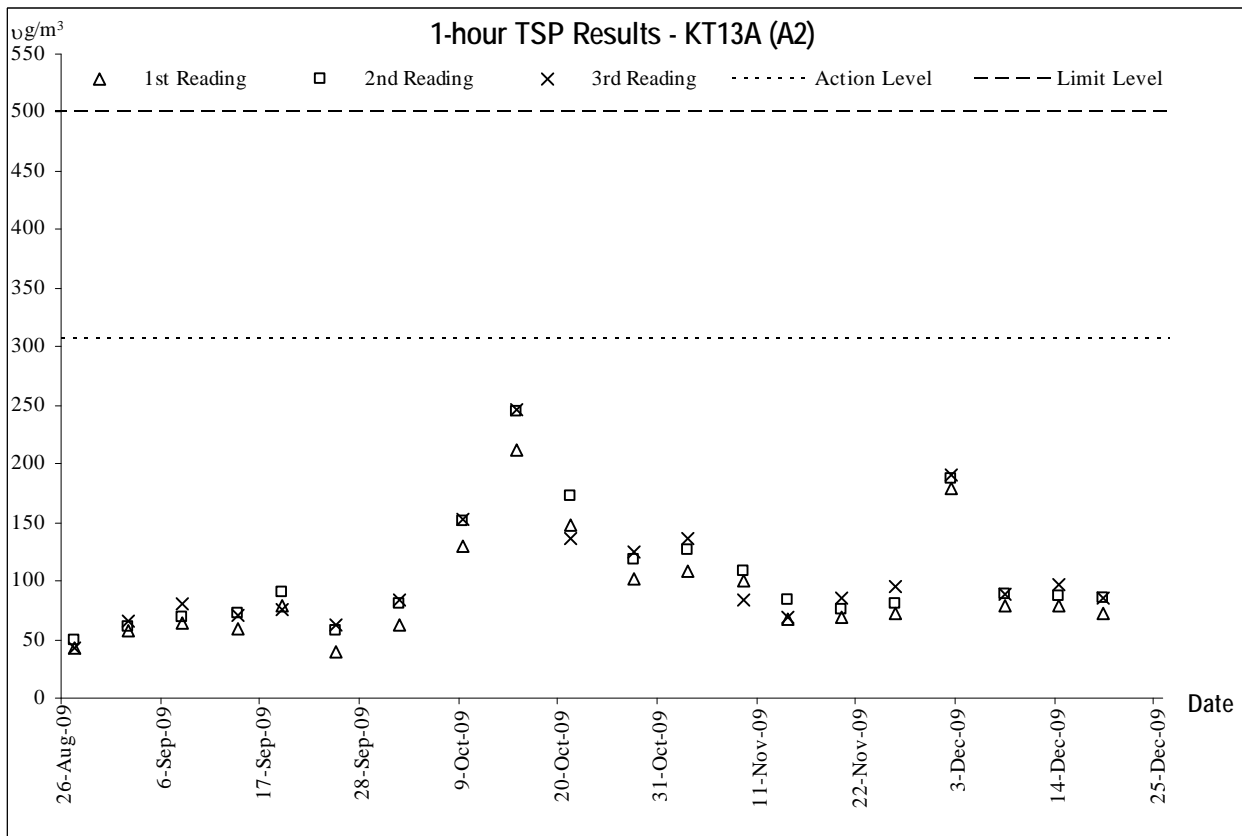
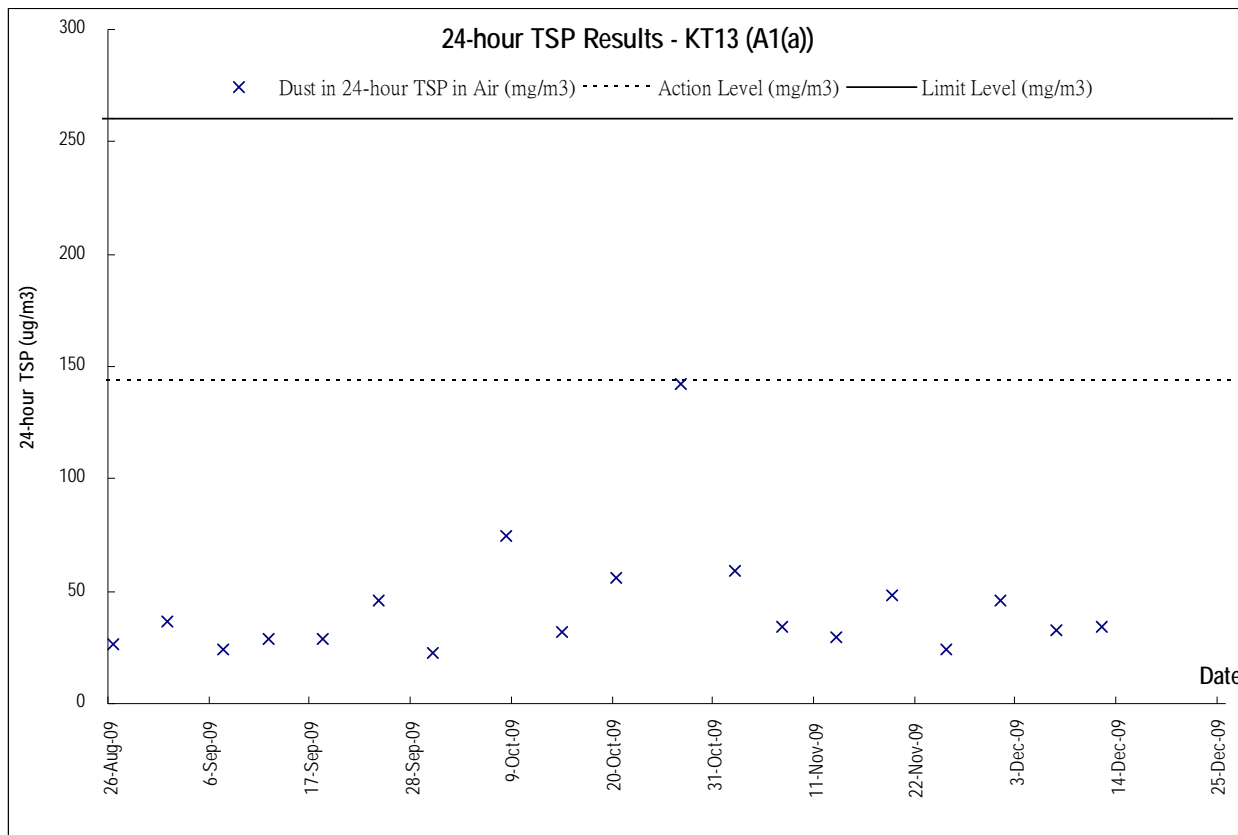
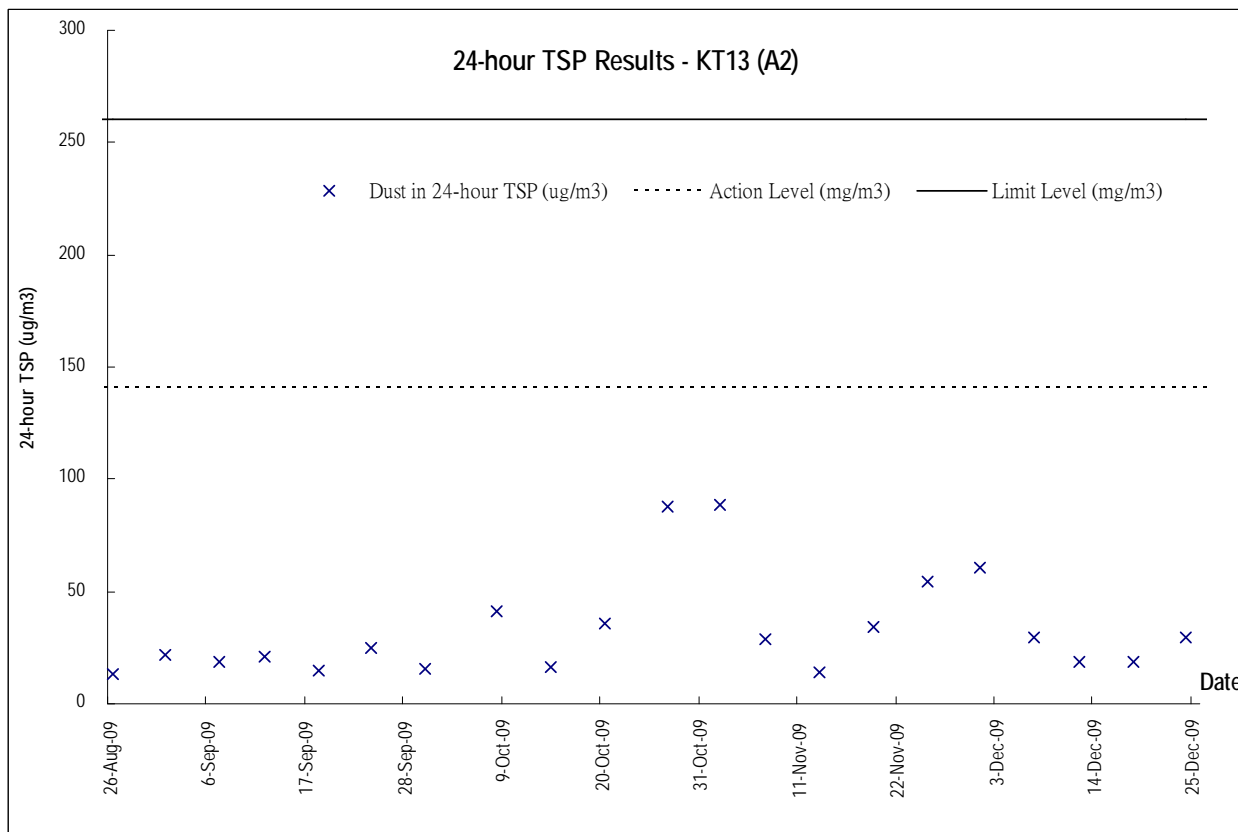
(a) Air Quality

Results of air quality monitoring at the identified locations during the Reporting Period are summarized in **Tables 3-1** below. In this quarter period, a total of 42 events of 1-hour TSP and 15 events of 24-hour TSP measurements were conducted at Locations A1(a) and A2. Due to the power failure of high volume sampler at A1(a) on 18 and 24 December 2009, the two monitoring data were absent in this reporting quarter. No exceedance of Action or Limit Levels was recorded during the Reporting Period. No Notification of Exceedance (NOE) of air quality criteria or corrective action was required.

*Power failure occurred at KT13-A1(a) on 18 and 24 December 2009.

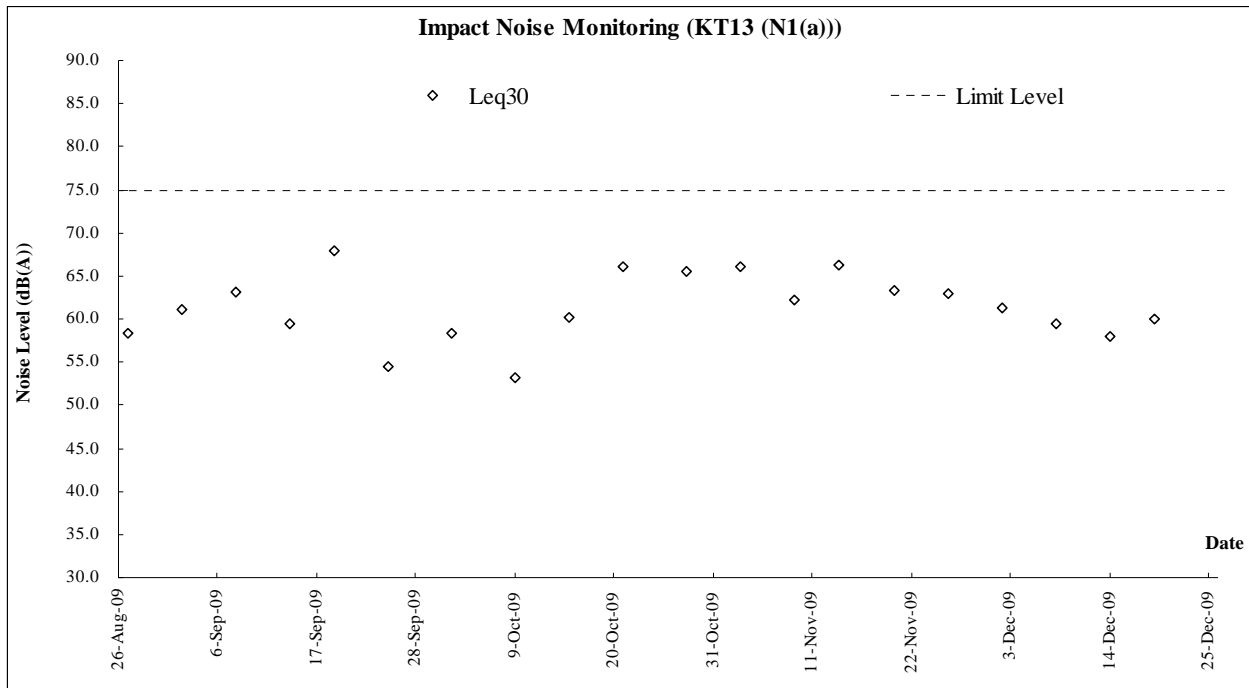
(b) Construction Noise

Summary of construction noise monitoring at the identified locations during the Reporting Period are summarized in **Table 3-2** below and graphic plots are presented in **Appendix E**. In this reporting quarter, a total of 42 events of construction noise measurement were conducted while no documented construction complaint was received and all the construction noise results were below the Limit level. No NOE or corrective action was recommended for this parameter.
