PROJECT NO.: TCS/00408/08

DSD CONTRACT NO. DC/2007/17
DRAINAGE IMPROVEMENT WORKS IN CHEUNG PO,
MA ON KONG, YUEN KONG SAN TSUEN AND TIN SAM
TSUEN OF YUEN LONG DISTRICT AND SEWERAGE AT
TSENG TAU CHUNG TSUEN, TUEN MUN

11TH QUARTERLY EM&A SUMMARY REPORT –
KT13 (APRIL – JUNE 2011)

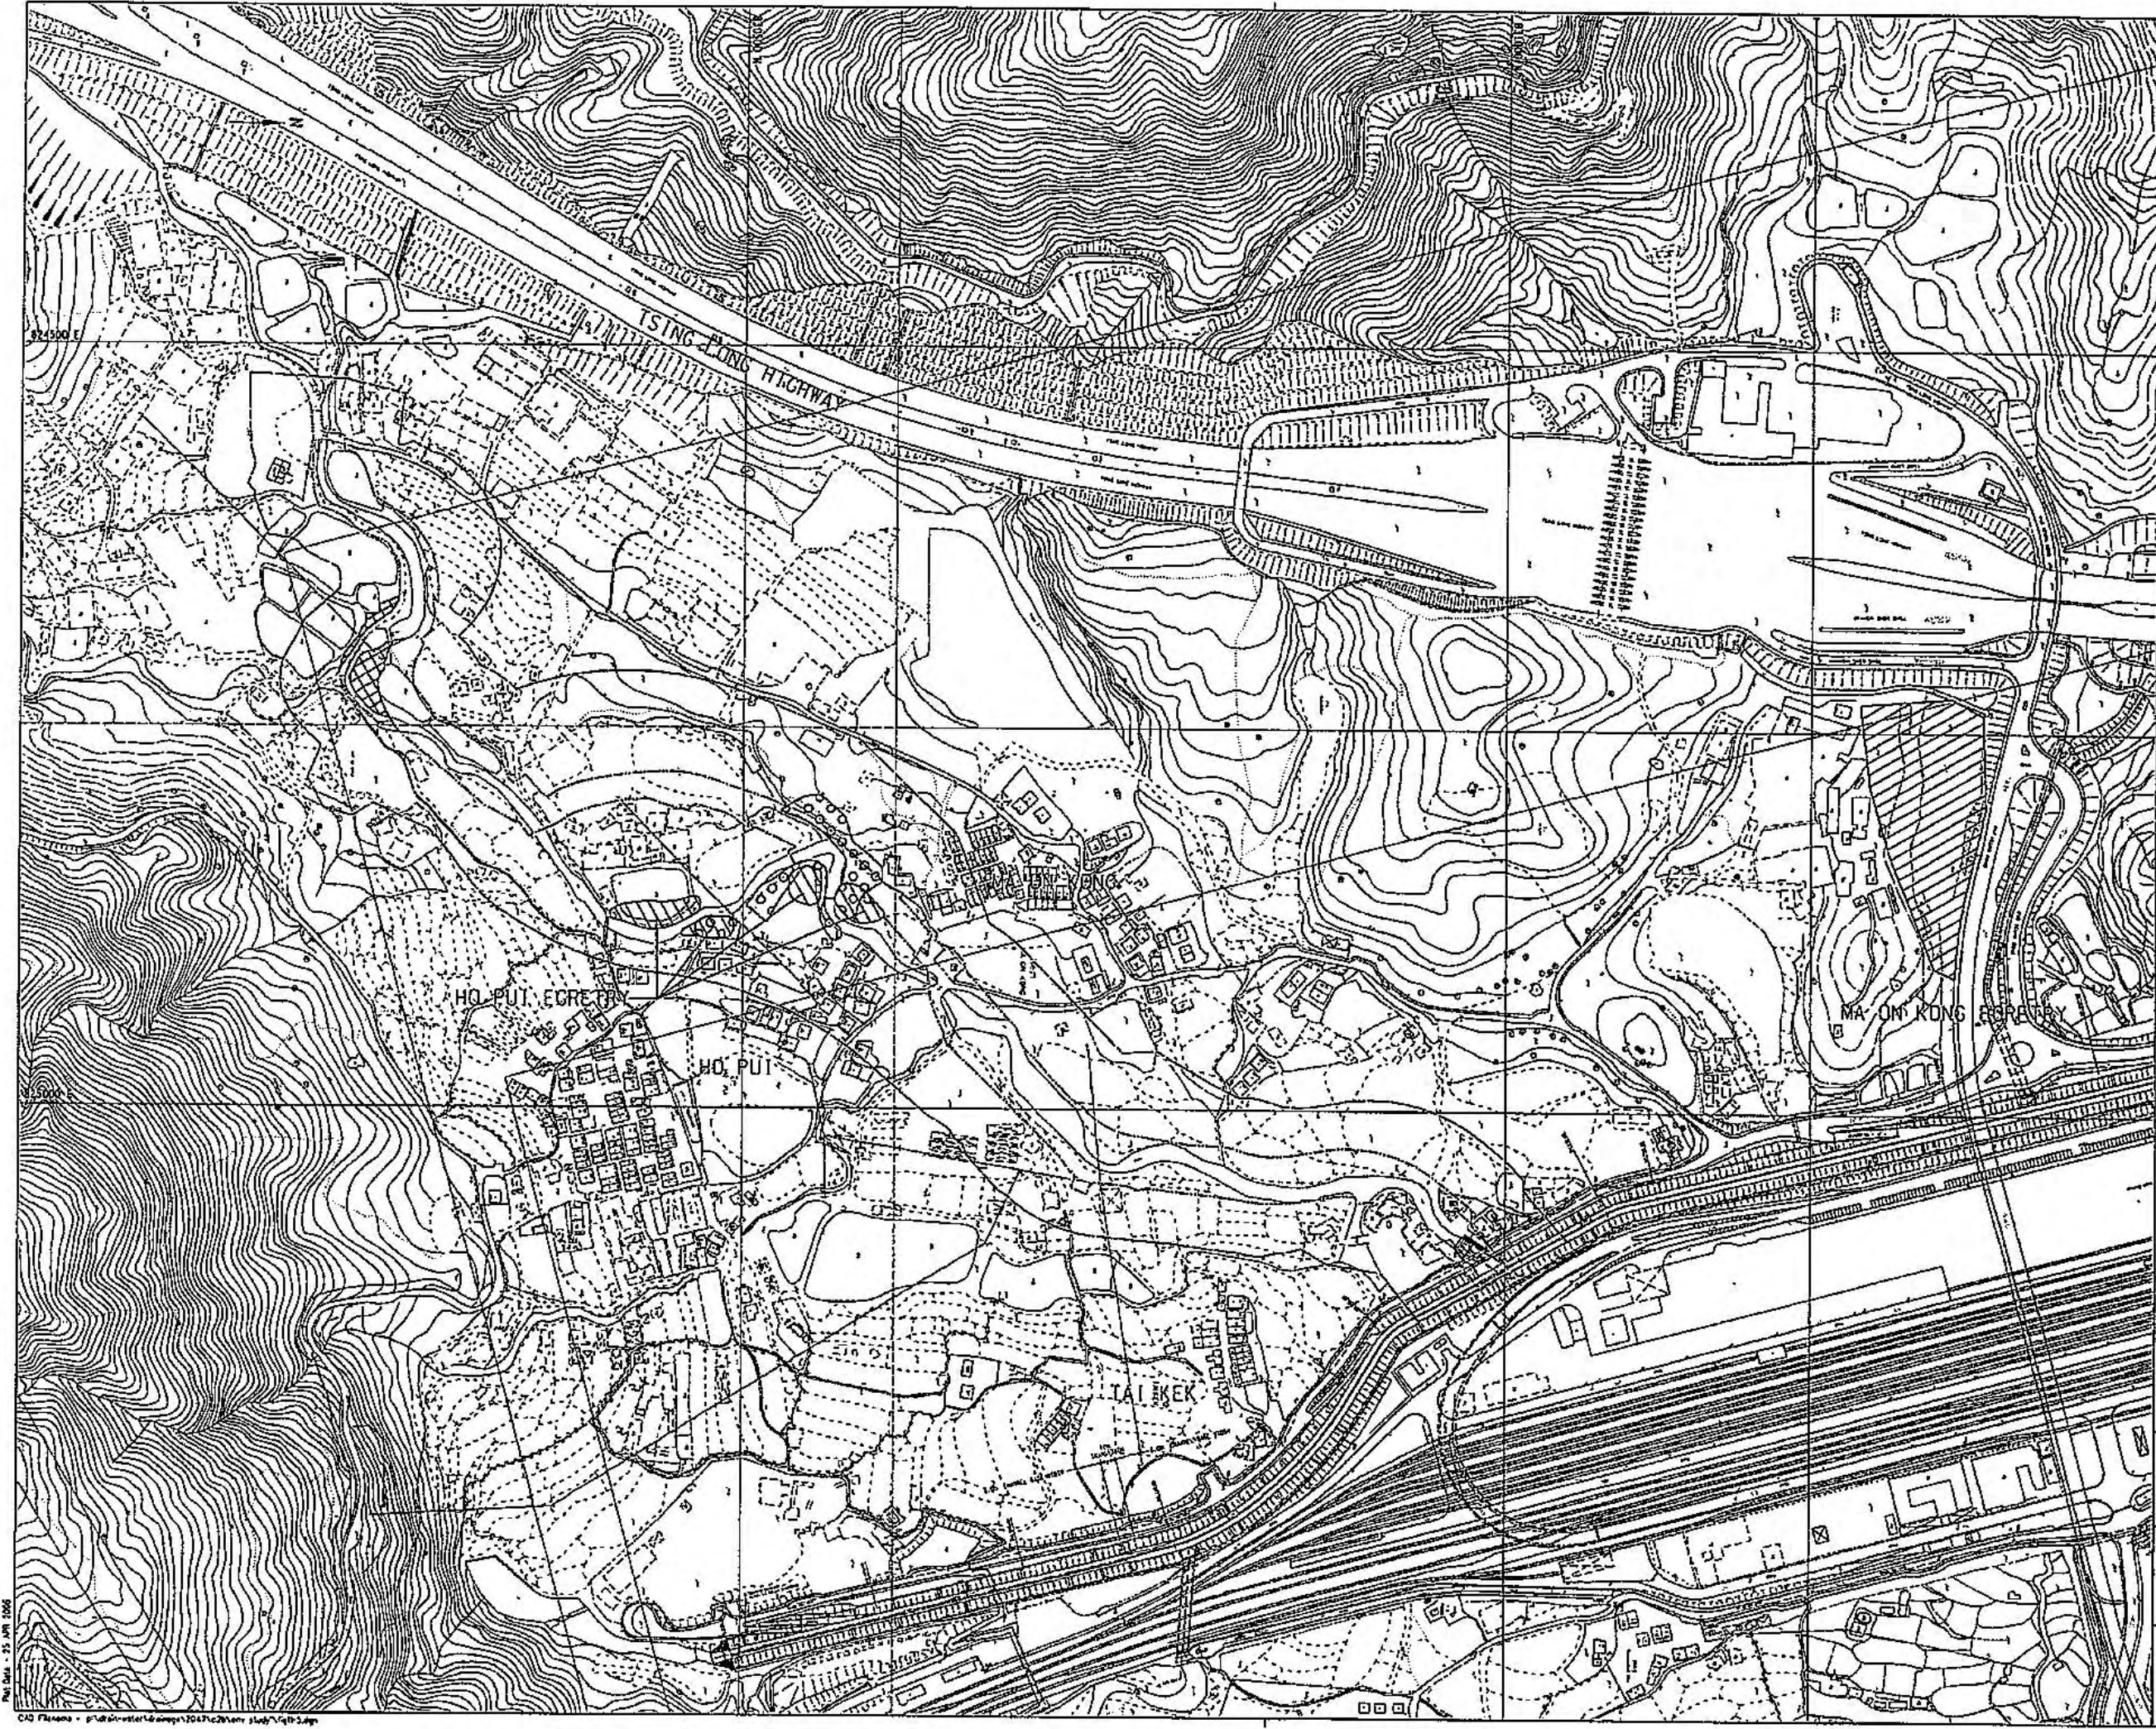
Drawing title
ECOLOGY MONITORING AREAS
RECOMMENDED FOR
CONSTRUCTION PHASE AND
OPERATION PHASE

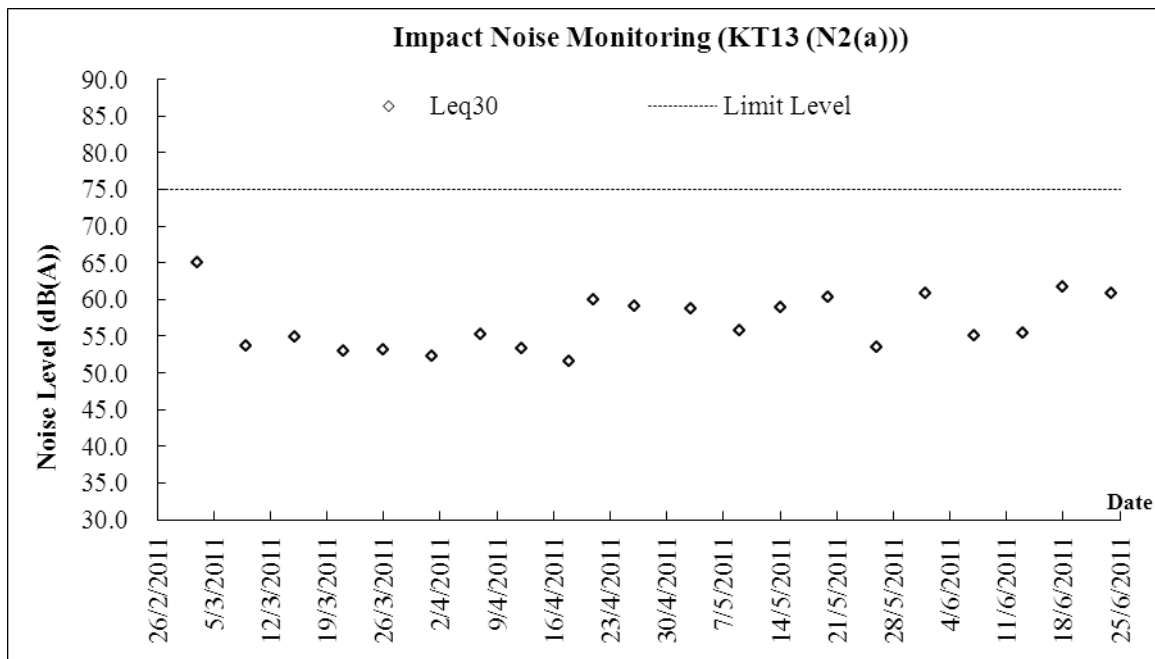
Graphic Plot of Monitoring - Construction Noise

Summary of construction noise monitoring at the identified locations during the Reporting Period are summarized in **Table 3-2** below and graphic plots are presented in **Appendix E**. In this reporting quarter, a total of 51 events of construction noise measurement were conducted while no documented construction complaint was received and all the construction noise results were below the Limit level. No NOE or corrective action was recommended for this parameter.

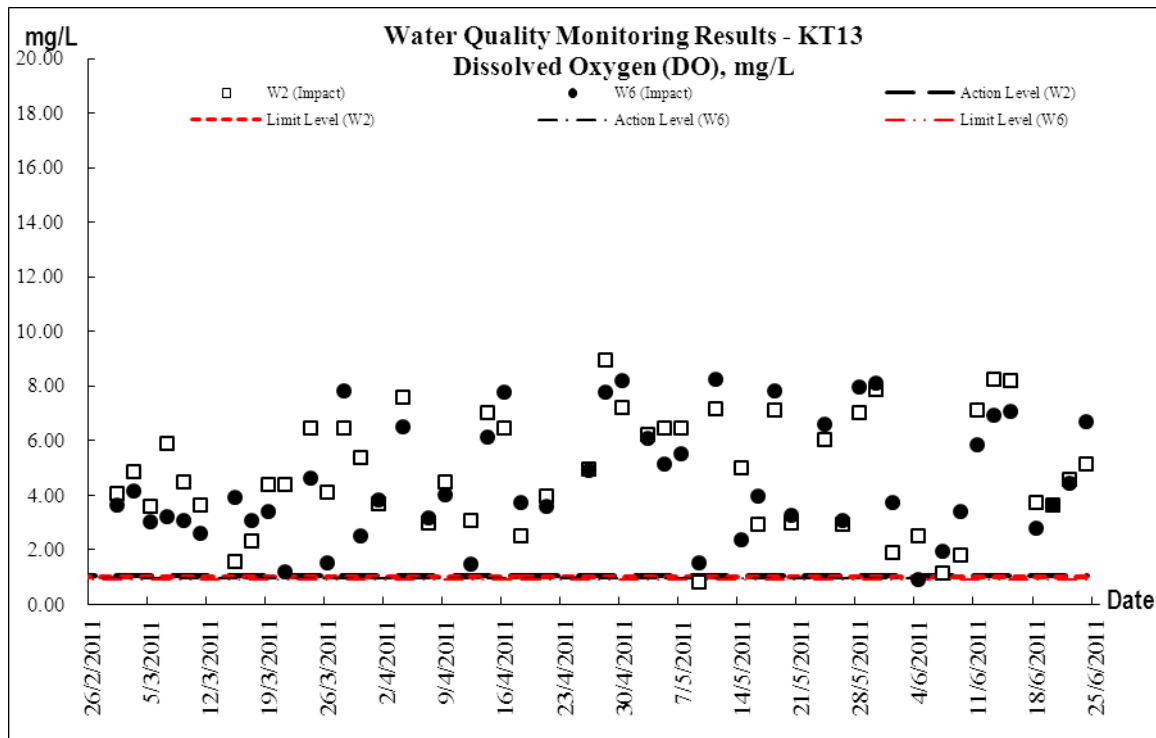
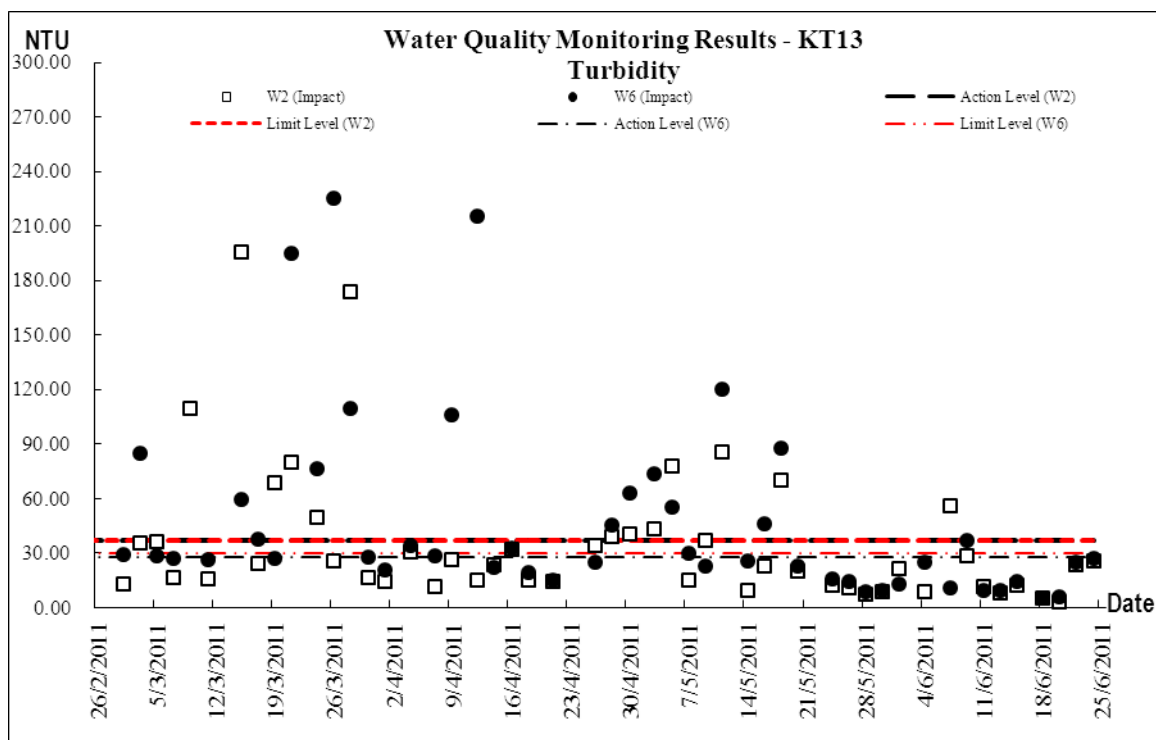
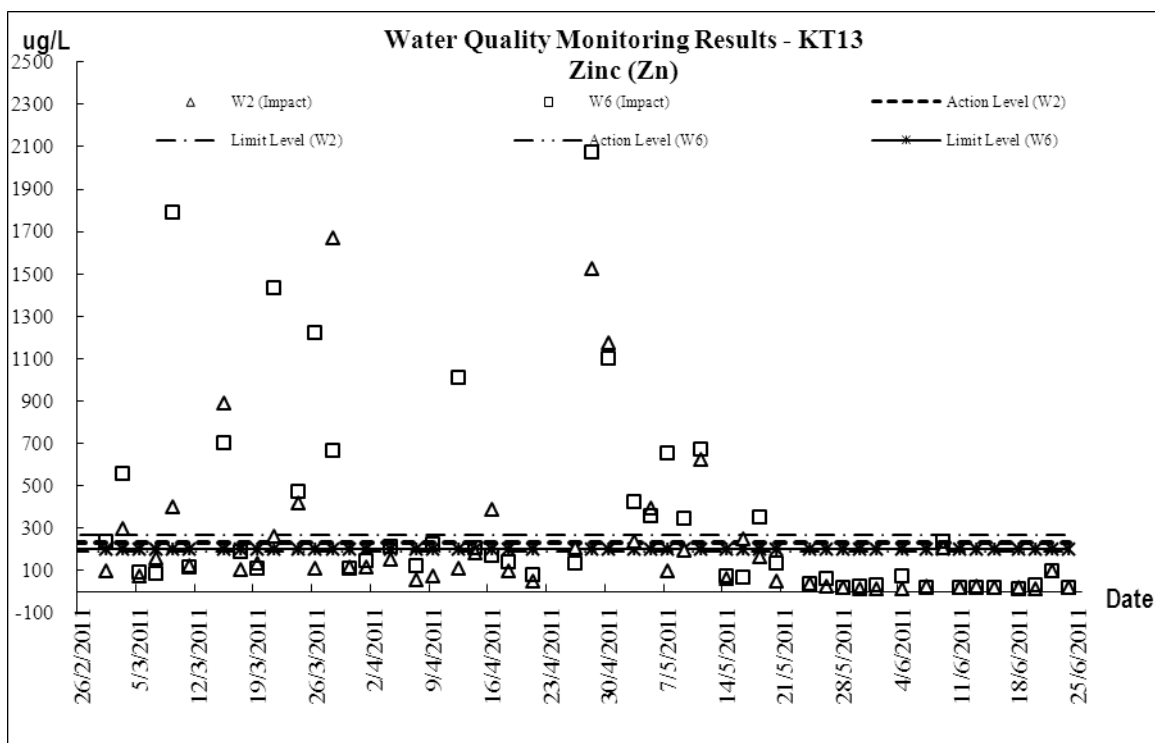
Graphic Plot of Monitoring –Water Quality

In stream water quality monitoring, a total of 26 Limit Level exceedances were recorded at upstream Location W2 and downstream Location W6. According to the observation during site inspections by ET and information provided by the Contractor, installation of gabion lining was conducted at downstream. No direct disturbance was made to the stream but pigsty discharge was observed near monitoring location W2. Since high levels of Turbidity, Suspended solids and Zinc were also recorded at upstream and control station, it is believed that the exceedances were likely due to the discharge from the

In stream water quality monitoring, a total of 48 Action / Limit Level exceedances were recorded, namely 24 exceedances at upstream Location W2 and 24 exceedances downstream Location W6. According to the observation during site inspections by ET and information provided by the Contractor, installation of gabion lining was conducted at downstream. No direct disturbance was made to the stream but pigsty discharge was observed near monitoring location W2. Since high levels of Turbidity, Suspended Solids, NH_4^+-N and Zinc were also recorded at upstream and control station, it is believed that the exceedances were likely due to the discharge from the agriculture farm and livestock at the vicinity as water quality throughout the channel was affected. Therefore, it is concluded that the exceedances were not related to the works under the Project.

In stream water quality monitoring, 7 Limit Level exceedances were recorded which namely 4 exceedances at upstream Location W2 and 3 exceedances downstream Location W6. According to the observation during site inspections by ET and information provided by the Contractor, installation of gabion lining was conducted at upstream. No direct disturbance was made to the stream but pigsty discharge was observed near monitoring location W2. Since high levels of Turbidity, Suspended Solids, NH_4^+-N and Zinc were also recorded at upstream and control station, it is believed that the exceedances were likely due to the discharge from the agriculture farm and livestock at the vicinity as water quality throughout the channel was affected. Therefore, it is concluded that the exceedances were not related to the works under the Project.
