CONTRACT NO. DC/2007/18

**YUNG SHUE WAN AND
SOK KWU WAN VILLAGE SEWERAGE,
STAGE 1 WORKS**

**MONTHLY IMPACT MONITORING
REPORT NO.9**

(FEBRUARY 2009)

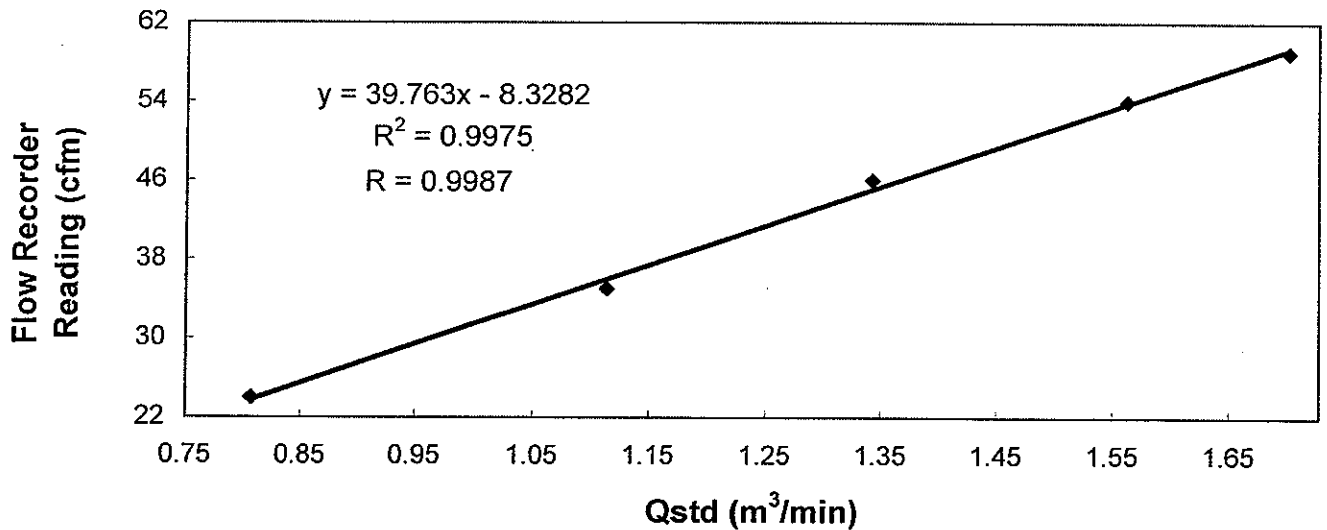
Sampler 1173 Calibration Curve
Site: Sok Kwu Wan (AM-1)

Results	Flow recorder reading (cfm)	59	54	46	35	24
	Qstd (Actual flow rate, m ³ /min)	1.70	1.56	1.34	1.11	0.81
	Pressure : 766.56 mmHg	Temp. : 294 K

Acceptance Criteria : Correlation coefficient (r) of the calibration curve greater than 0.990 after 5-point calibration

The high volume sampler complies* / does not comply* with the specified requirements and is deemed acceptable* / unacceptable* for use.

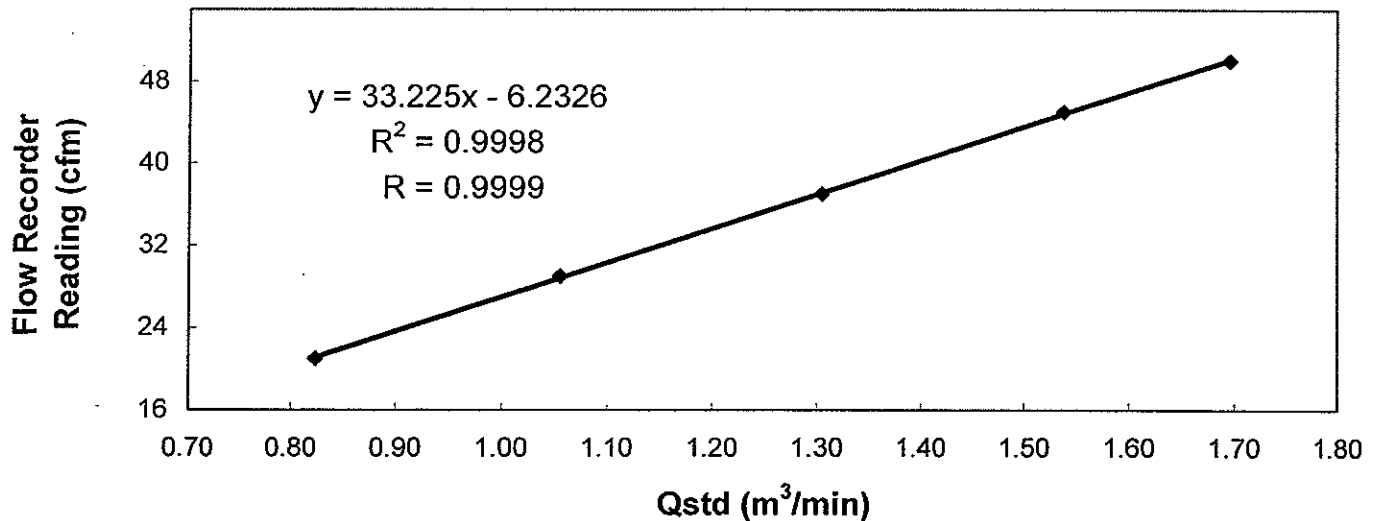
Sampler 9865 Calibration Curve
Site: Sok Kwu Wan (AM-2)

Flow recorder reading (cfm)	50	45	37	29	21
Qstd (Actual flow rate, m ³ /min)	1.70	1.54	1.30	1.06	0.82
Pressure :	766.56 mm Hg		Temp. :	294 K

Acceptance Criteria : Correlation coefficient (r) of the calibration curve greater than 0.990 after a 5-point calibration

The high volume sampler complies* / does not comply* with the specified requirements and is deemed acceptable*/ unacceptable* for use.

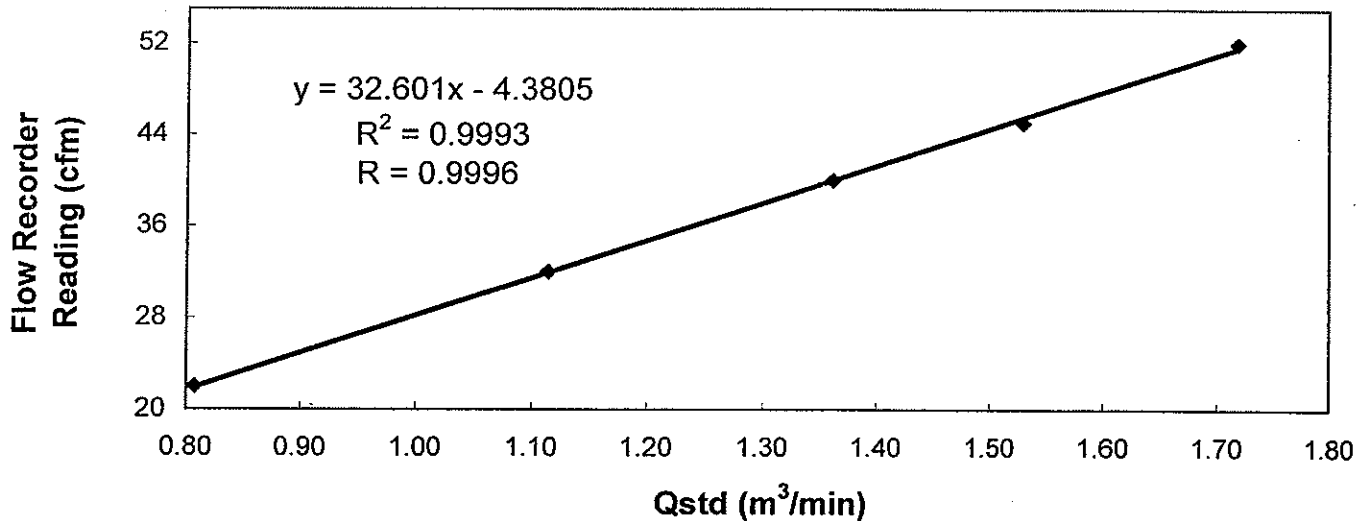
Sampler 9912 Calibration Curve
Site: Sok Kwu Wan (AM-3)

Results	Flow recorder reading (cfm)	52	45	40	32	22
	Qstd (Actual flow rate, m ³ /min)	1.72	1.53	1.36	1.11	0.81
	Pressure : 766.56 mm Hg	Temp. : 294 K

Acceptance Criteria : Correlation coefficient (r) of the calibration curve greater than 0.990 after a 5-point calibration

The high volume sampler complies* / ~~does not comply*~~ with the specified requirements and is deemed acceptable*/ unacceptable* for use.

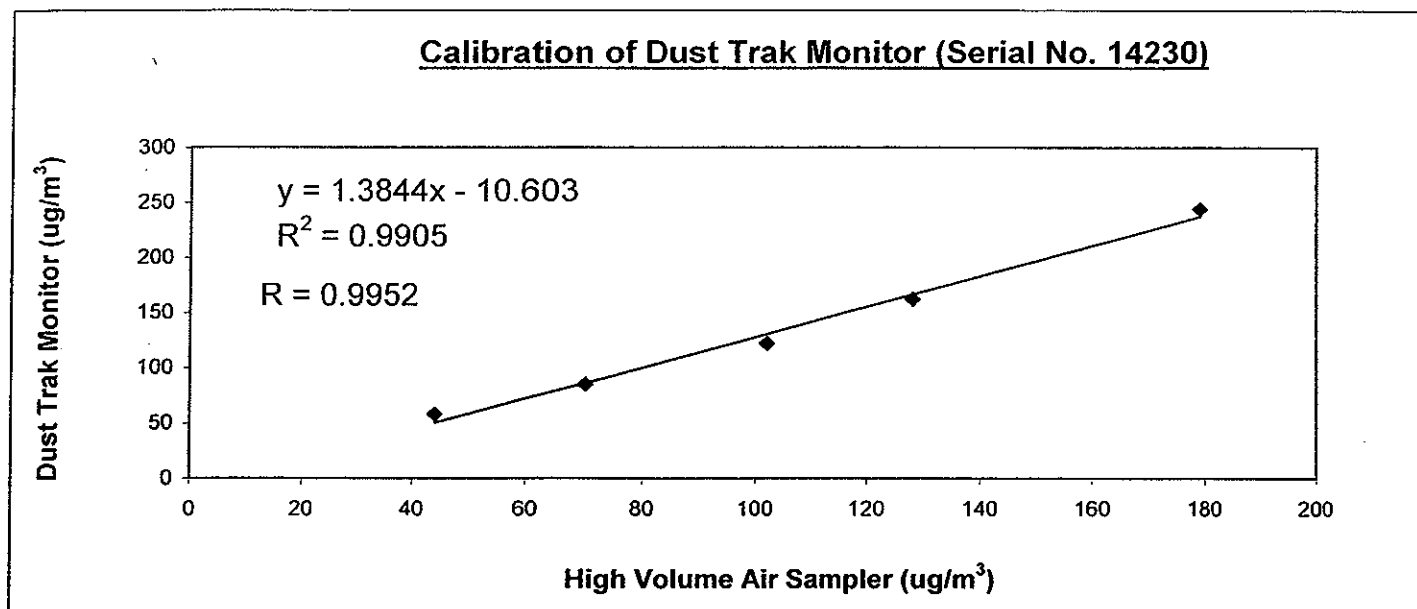
Manufacturer : TSI - 8520 Dust Trak Date of Calibration : 13 January 2009
Serial No. : 14230 (ET/EA/001/04) Due Date : 12 July 2009
Method : Parallel measurement (five-point calibration) by placing the Dust Trak Monitor and High Volume Air Samper together under the same environmental condition

Dust Trak Monitor ($\mu\text{g}/\text{m}^3$)	58	85	155	162	244
High Volume Air Sampler ($\mu\text{g}/\text{m}^3$)	44	70	102	128	179
High Volume Air Sampler Serial No.: 1178			Calibration Due Date: 01 March 2009

Acceptance Criteria : Correlation coefficient (r) of the calibration curve greater than 0.990 after a five point calibration

The Dust Trak Monitor complies * / ~~does not comply~~ * with the internal calibration procedures and is deemed acceptable * / ~~unacceptable~~ * for use.

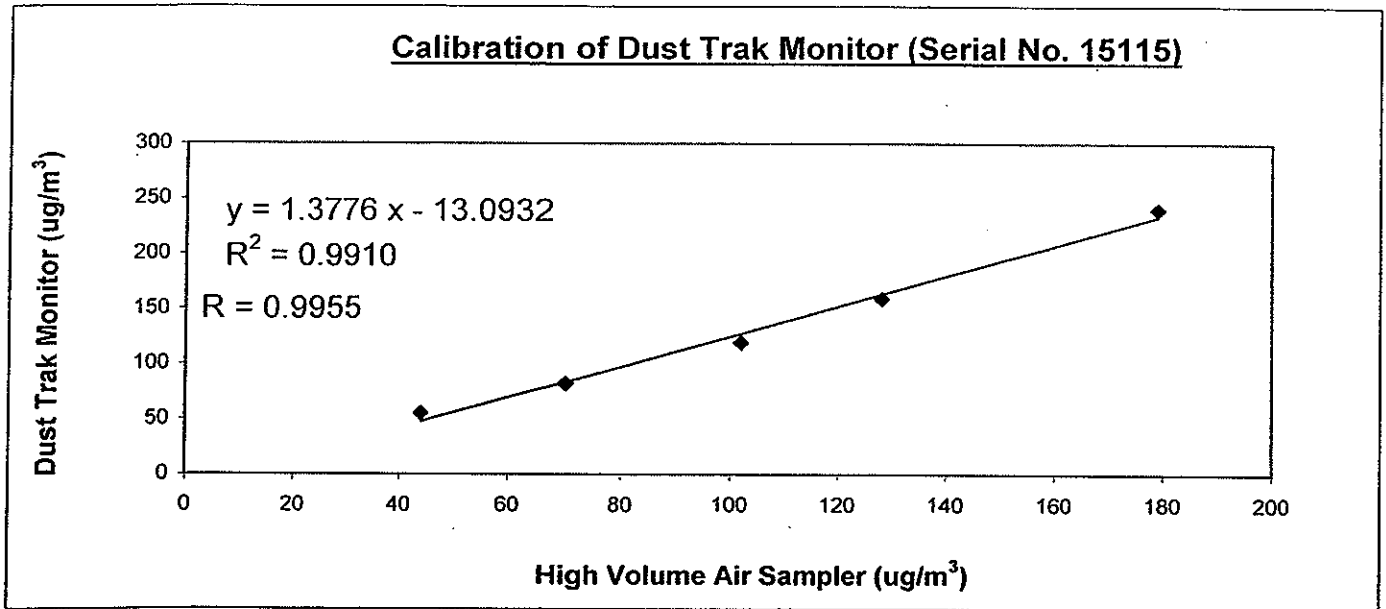
Manufacturer : TSI - 8520 Dust Trak Date of Calibration : 13 January 2009
Serial No. : 15115 (ET/EA/001/02) Calibration Due Date : 12 July 2009
Method : Parallel measurement (five-point calibration) by placing the Dust Trak Monitor and High Volume Air Sampler together under the same environmental condition

Dust Trak Monitor (ug/m ³)	55	82	119	159	240
High Volume Air Sampler (ug/m ³)	44	70	102	128	179
Serial No of High Volume Air Sampler : 1178			Calibration Date: 01 March 2009

Acceptance Criteria :

Correlation coefficient (r) of the calibration curve greater than 0.990 after a five point calibration

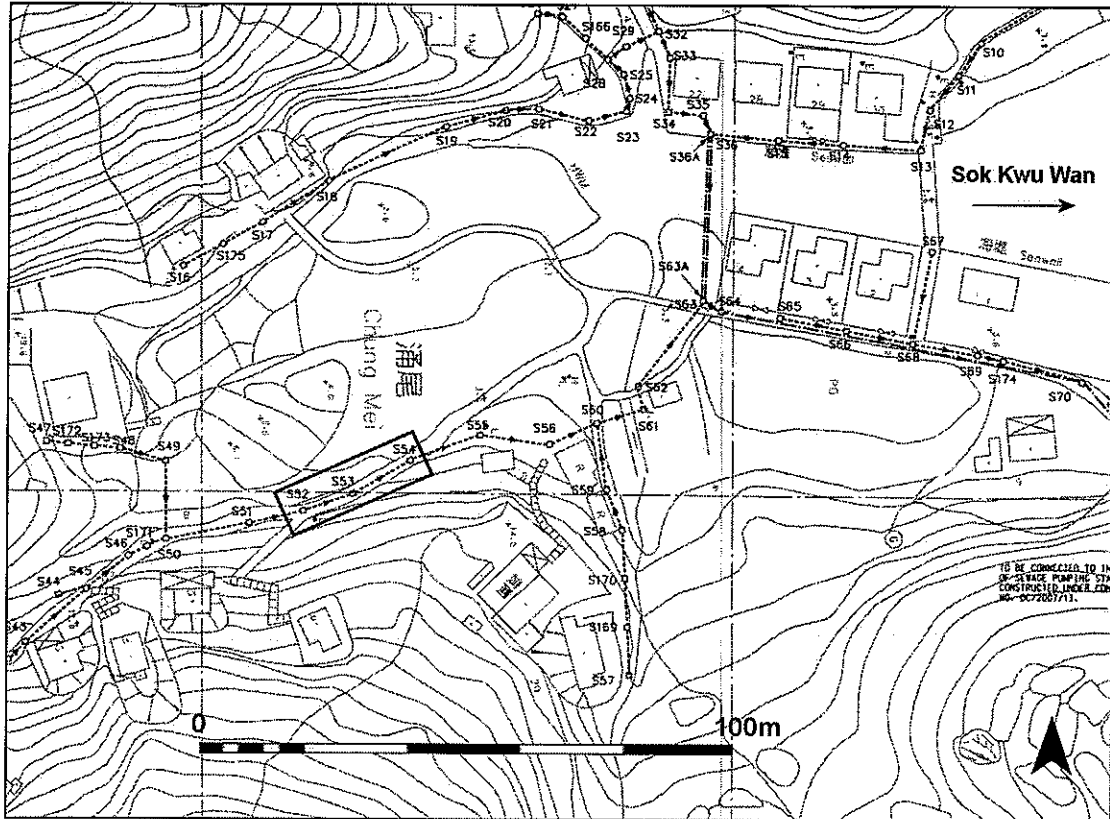
Figure 1: Plan showing location of sewage alignment at Chung Mei, with watching brief section between MH S52 and MH S54 highlighted.

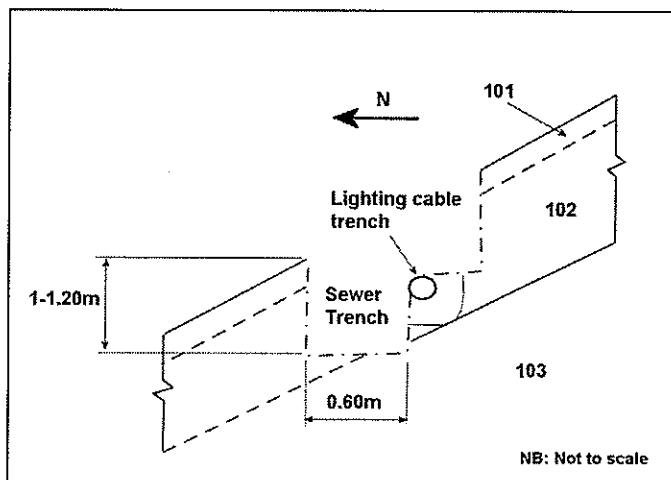
The excavation of the 25m long sewer trench revealed a very simple sequence of three naturally-formed deposits: the lowest of which was an at least 1.5m thick reddish yellow (7.5YR 6/8) clayey gravel (103); over which there was a 0.70-0.80m thick layer of strong brown (7.5YR 5/6) gravelly clay (102); whilst the uppermost layer was an approximately 0.1m thick greyish brown (10YR 5/2) slightly sandy, clayey silt (101). A modern electricity cable trench was noted running along the southern side of the sewer trench, but was not allocated a context number. Save for a single surface find of undiagnostic village ware pottery (Plate 5) all three deposits were sterile and can be interpreted as *in situ* decaying granite (103), overlain by associated hillwash or slope deposits (102), and topped with a naturally-accumulating forest soil (101). No cultural horizons/deposits were identified.

Figure 2: Transverse section across sewer trench (looking approximately east)

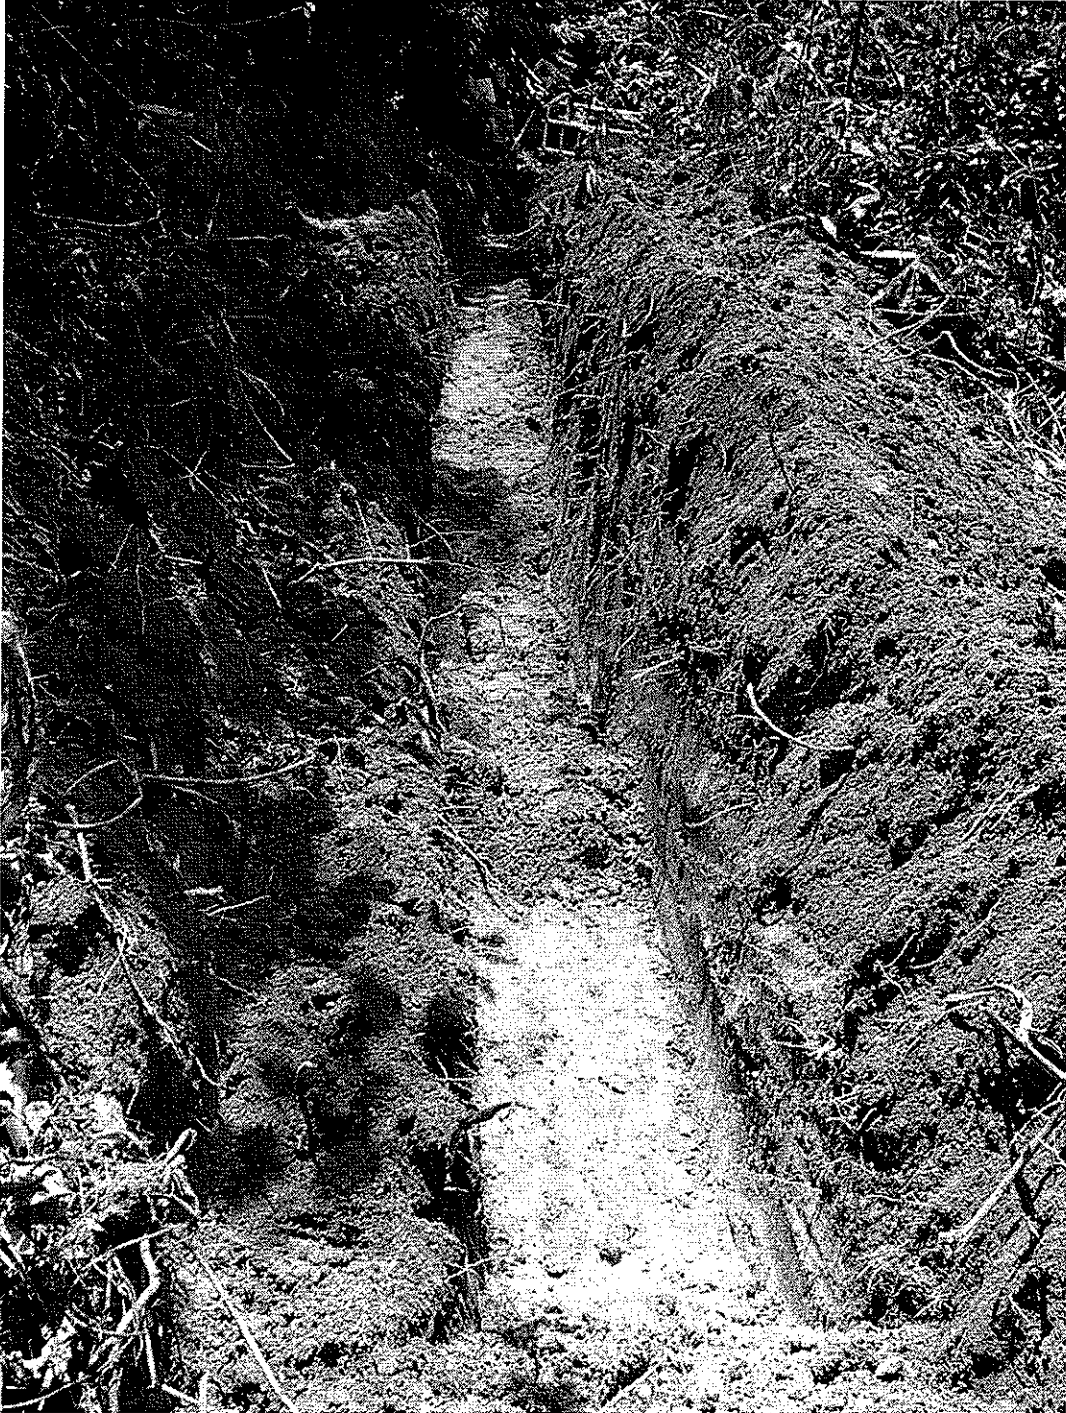
Plate 1: Overview of the machined alignment looking from MH S54 uphill towards MH S52 in the distance

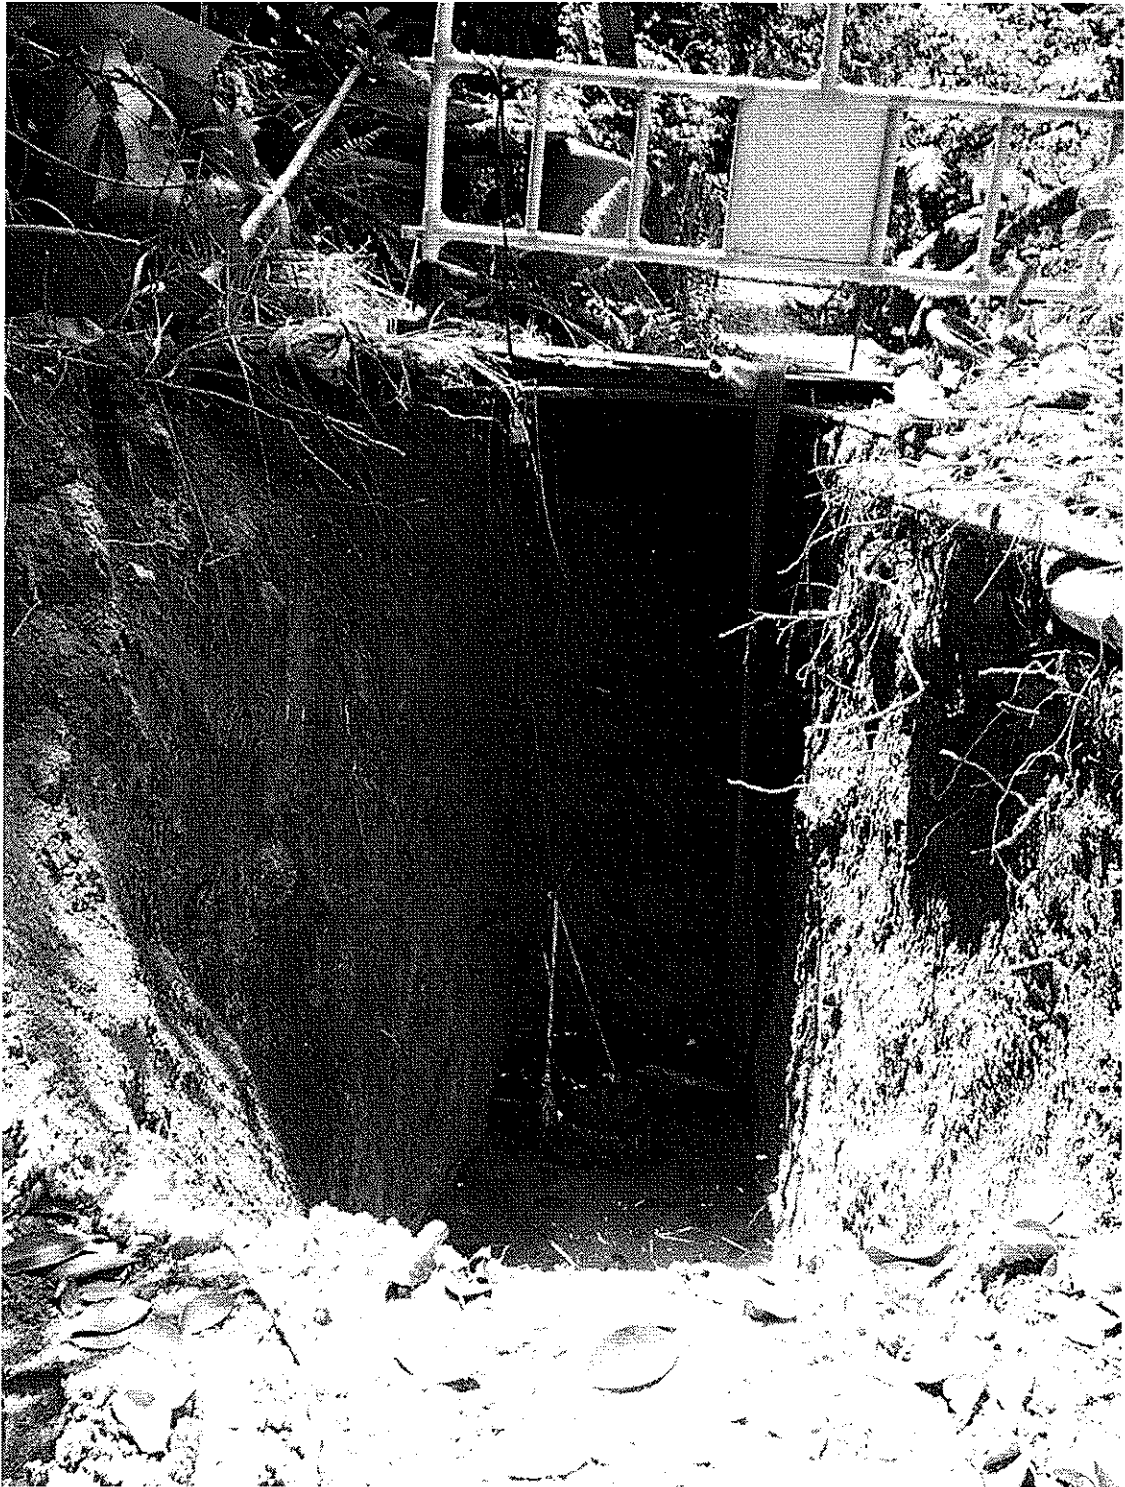
Plate 2: Deeper excavations at MH S52 – view looking west

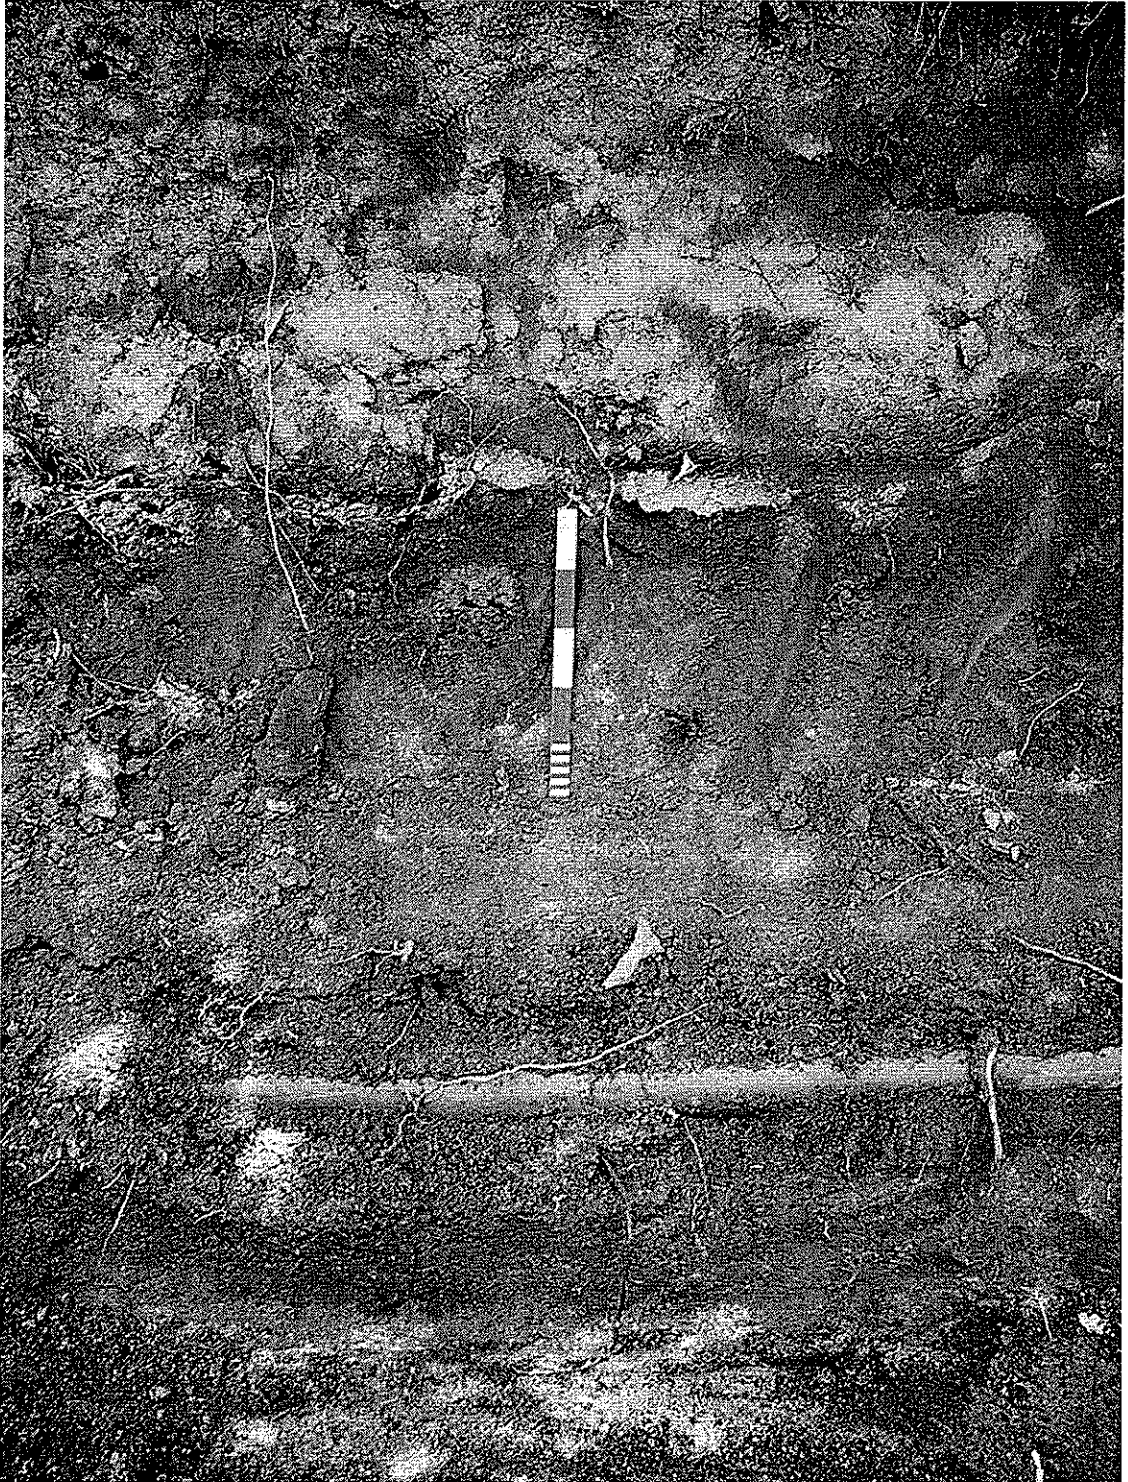
Plate 3: North facing section at MH S53 with modern (purple) electrical cable trench in foreground

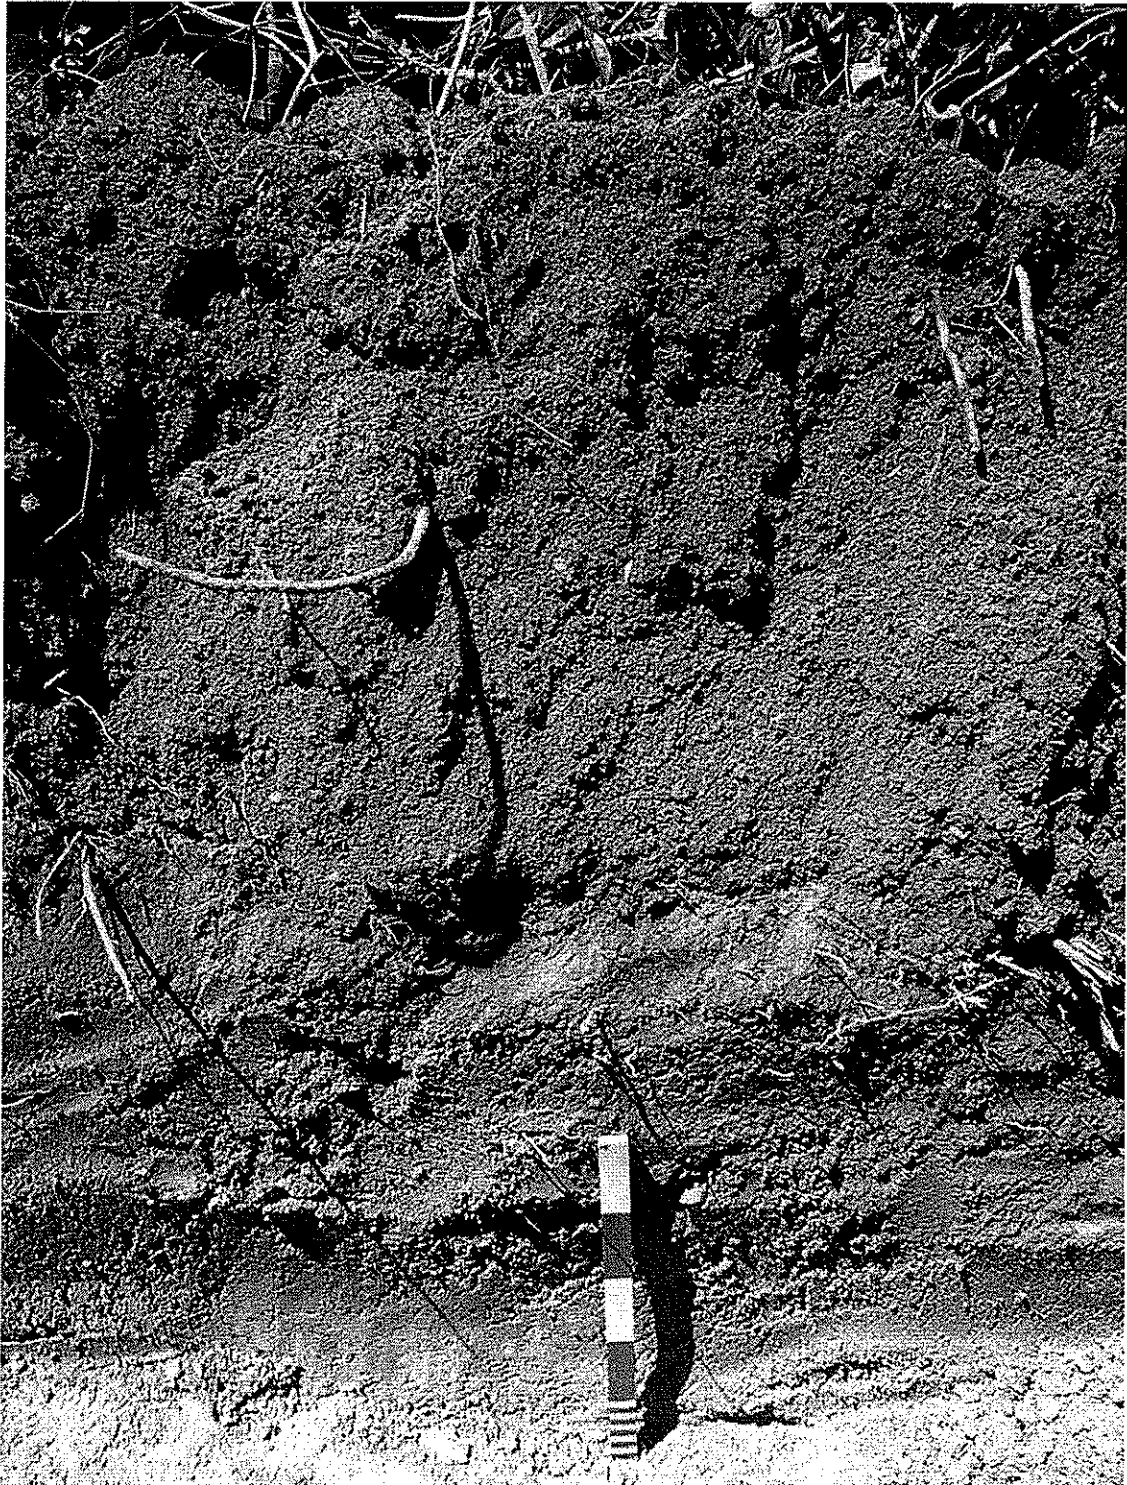
Plate 4: South facing section near location of MH S54

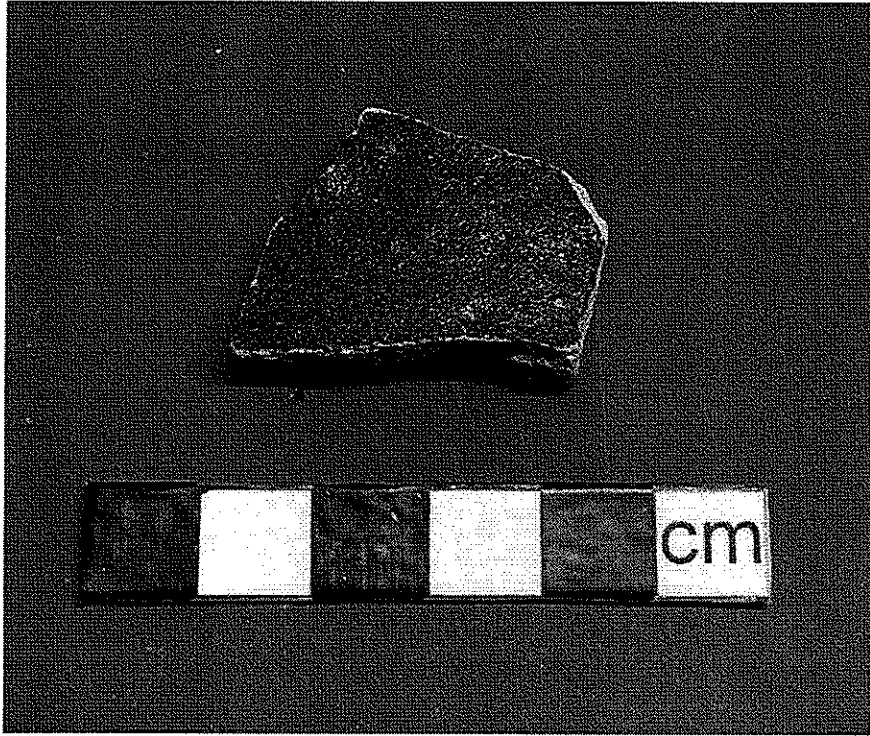
Plate 5: Undiagnostic village ware sherd found on surface of topsoil 101
