東業德勤測試顧問有限公司
ETS-TESTCONSULT LIMITED

**YUNG SHUE WAN AND
SOK KWU WAN VILLAGE SEWERAGE,
STAGE 1 WORKS**

**MONTHLY IMPACT MONITORING
REPORT NO.12**

(MAY 2009)

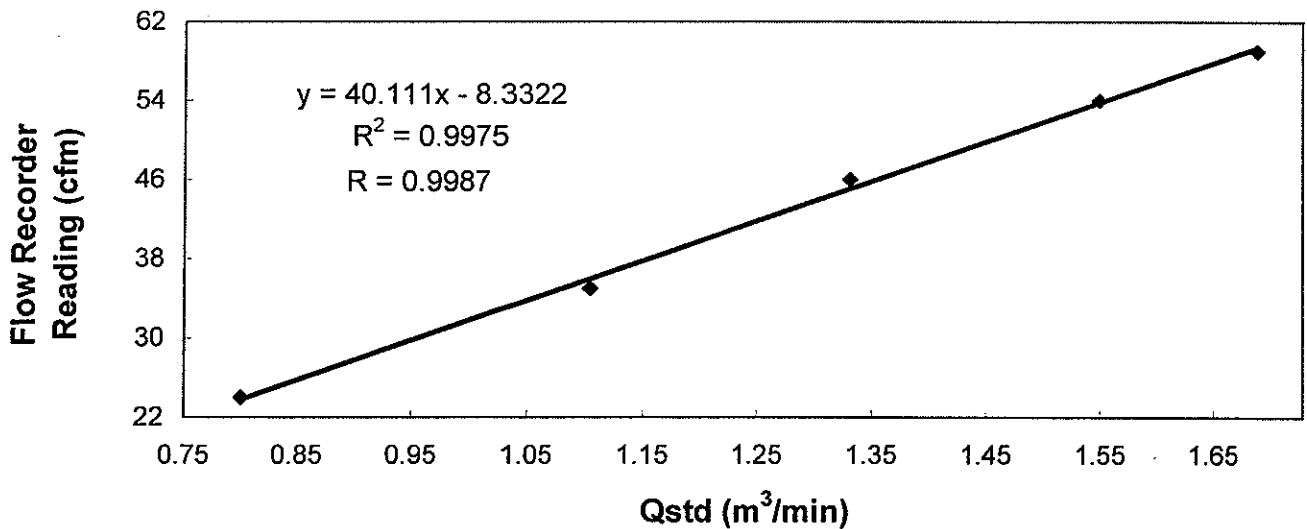
Sampler 1173 Calibration Curve
Site: Sok Kwu Wan (AM-1)

Results	Flow recorder reading (cfm)	59	54	46	35	24
	Qstd (Actual flow rate, m ³ /min)	1.69	1.55	1.33	1.10	0.80
	Pressure : 763.56 mmHg	Temp. : 298 K

Acceptance Criteria : Correlation coefficient (r) of the calibration curve greater than 0.990 after 5-point calibration

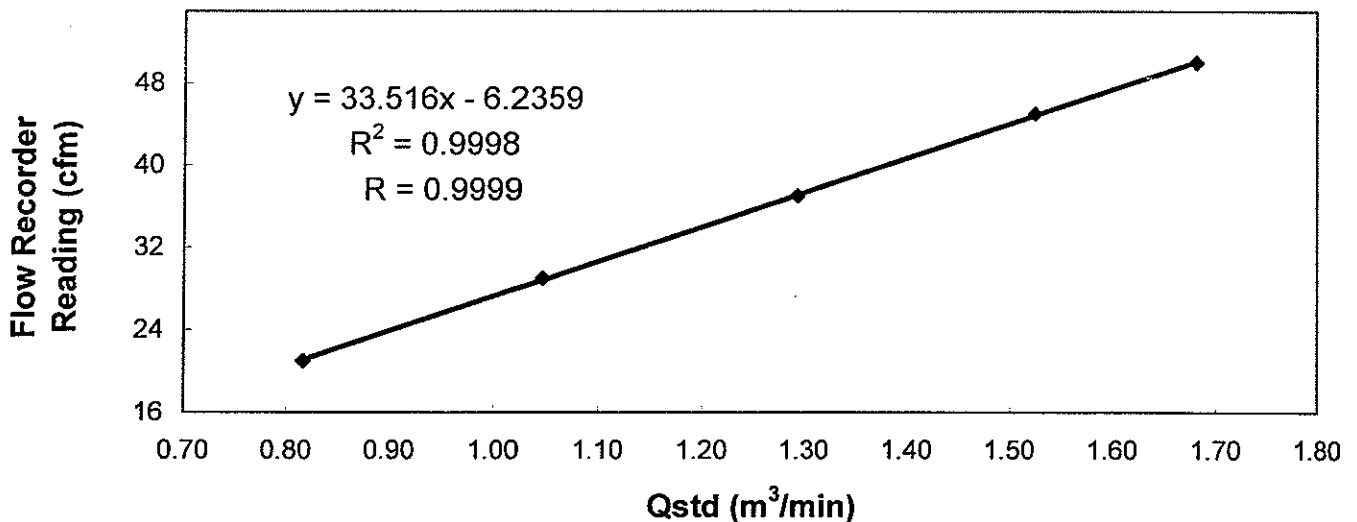
Sampler 9865 Calibration Curve
Site: Sok Kwu Wan (AM-2)

Flow recorder reading (cfm)	50	45	37	29	21
Qstd (Actual flow rate, m ³ /min)	1.68	1.52	1.29	1.05	0.82
Pressure :	763.56 mm Hg		Temp. :	298 K

Acceptance Criteria : Correlation coefficient (r) of the calibration curve greater than 0.990 after a 5-point calibration

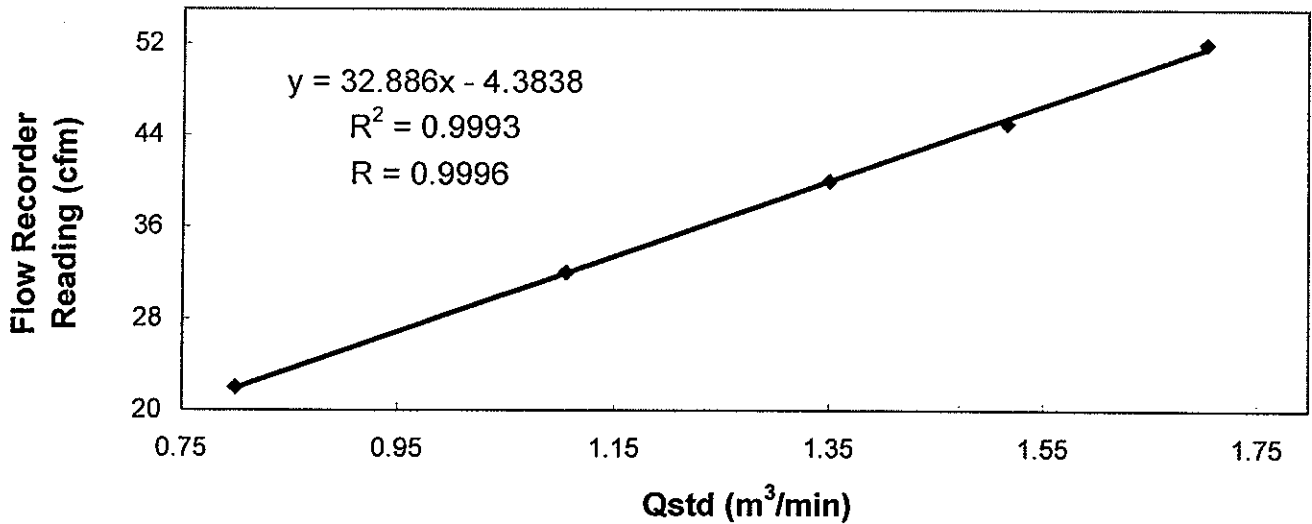
Sampler 9912 Calibration Curve
 Site: Sok Kwu Wan (AM-3)

Results	Flow recorder reading (cfm)	52	45	40	32	22
	Qstd (Actual flow rate, m ³ /min)	1.70	1.52	1.35	1.10	0.80
	Pressure : 763.56 mm Hg	Temp. : 298 K

Acceptance Criteria : Correlation coefficient (r) of the calibration curve greater than 0.990 after a 5-point calibration

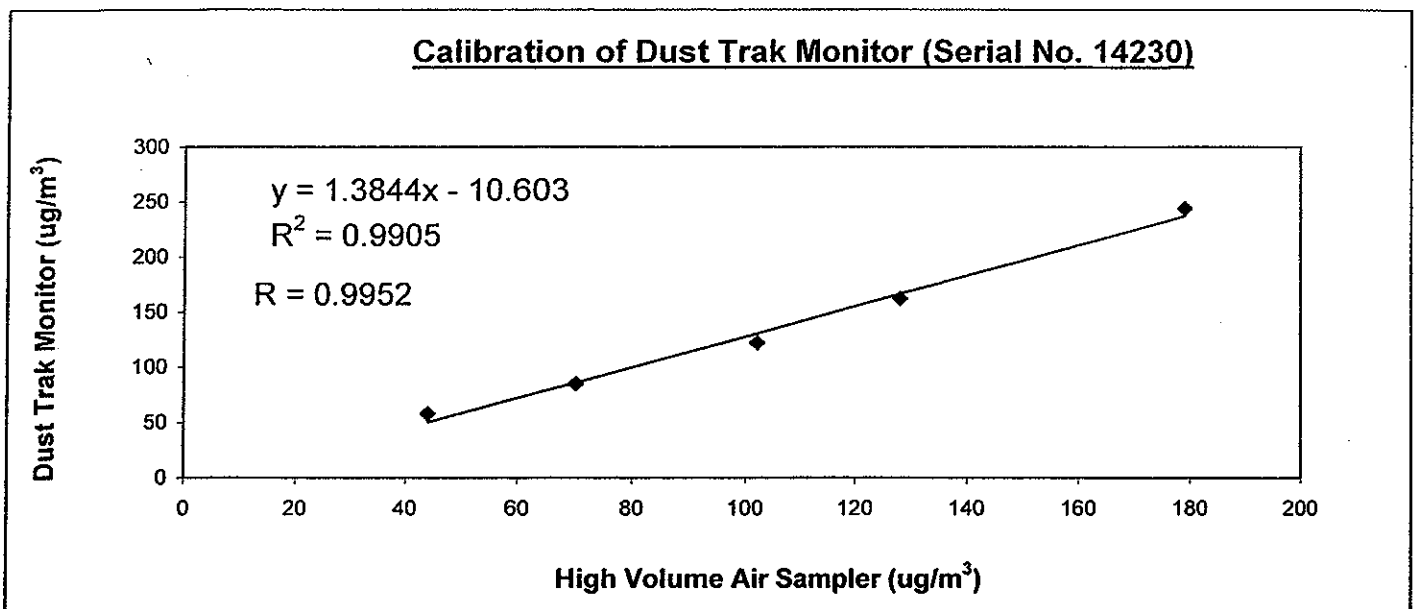
Manufacturer : TSI - 8520 Dust Trak **Date of Calibration** : 13 January 2009
Serial No. : 14230 (ET/EA/001/04) **Due Date** : 12 July 2009
Method : Parallel measurement (five-point calibration) by placing the Dust Trak Monitor and High Volume Air Samper together under the same environmental condition

Dust Trak Monitor ($\mu\text{g}/\text{m}^3$)	58	85	155	162	244
High Volume Air Sampler ($\mu\text{g}/\text{m}^3$)	44	70	102	128	179
High Volume Air Sampler Serial No.: 1178			Calibration Due Date: 01 March 2009

Acceptance Criteria : Correlation coefficient (r) of the calibration curve greater than 0.990 after a five point calibration

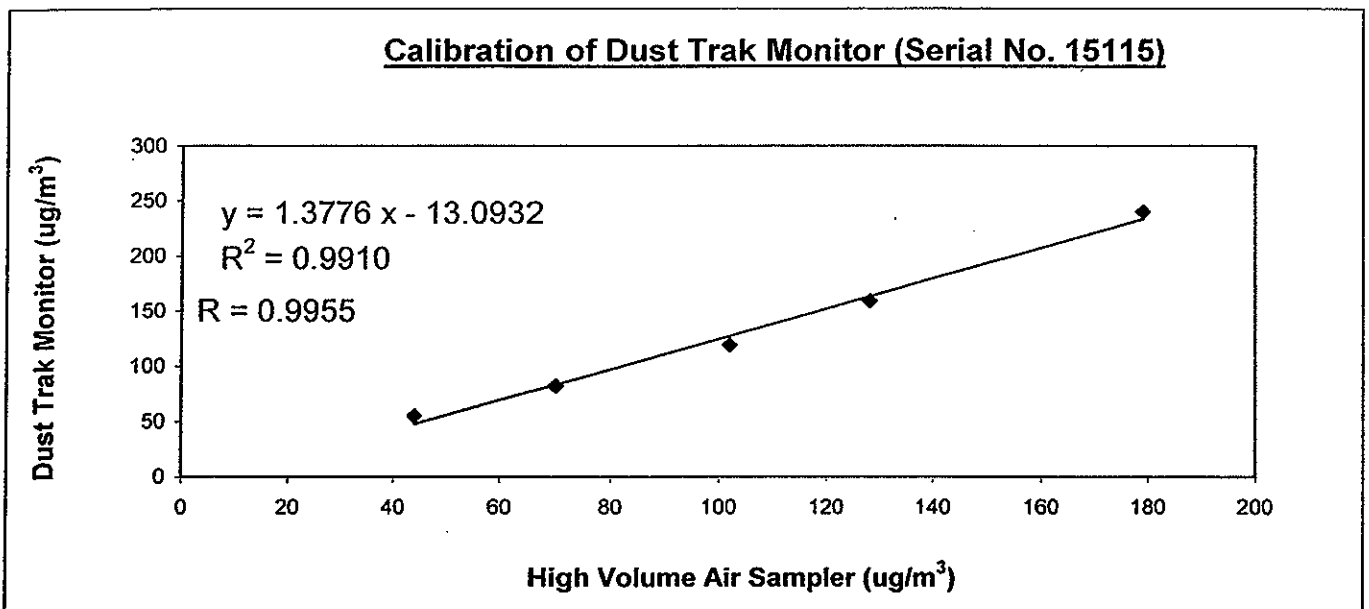
Manufacturer : TSI - 8520 Dust Trak Date of Calibration : 13 January 2009
Serial No. : 15115 (ET/EA/001/02) Calibration Due Date : 12 July 2009
Method : Parallel measurement (five-point calibration) by placing the Dust Trak Monitor and High Volume Air Sampler together under the same environmental condition

Dust Trak Monitor ($\mu\text{g}/\text{m}^3$)	55	82	119	159	240
High Volume Air Sampler ($\mu\text{g}/\text{m}^3$)	44	70	102	128	179
Serial No of High Volume Air Sampler : 1178			Calibration Date: 01 March 2009

Correlation coefficient (r) of the calibration curve greater than 0.990 after a five point calibration

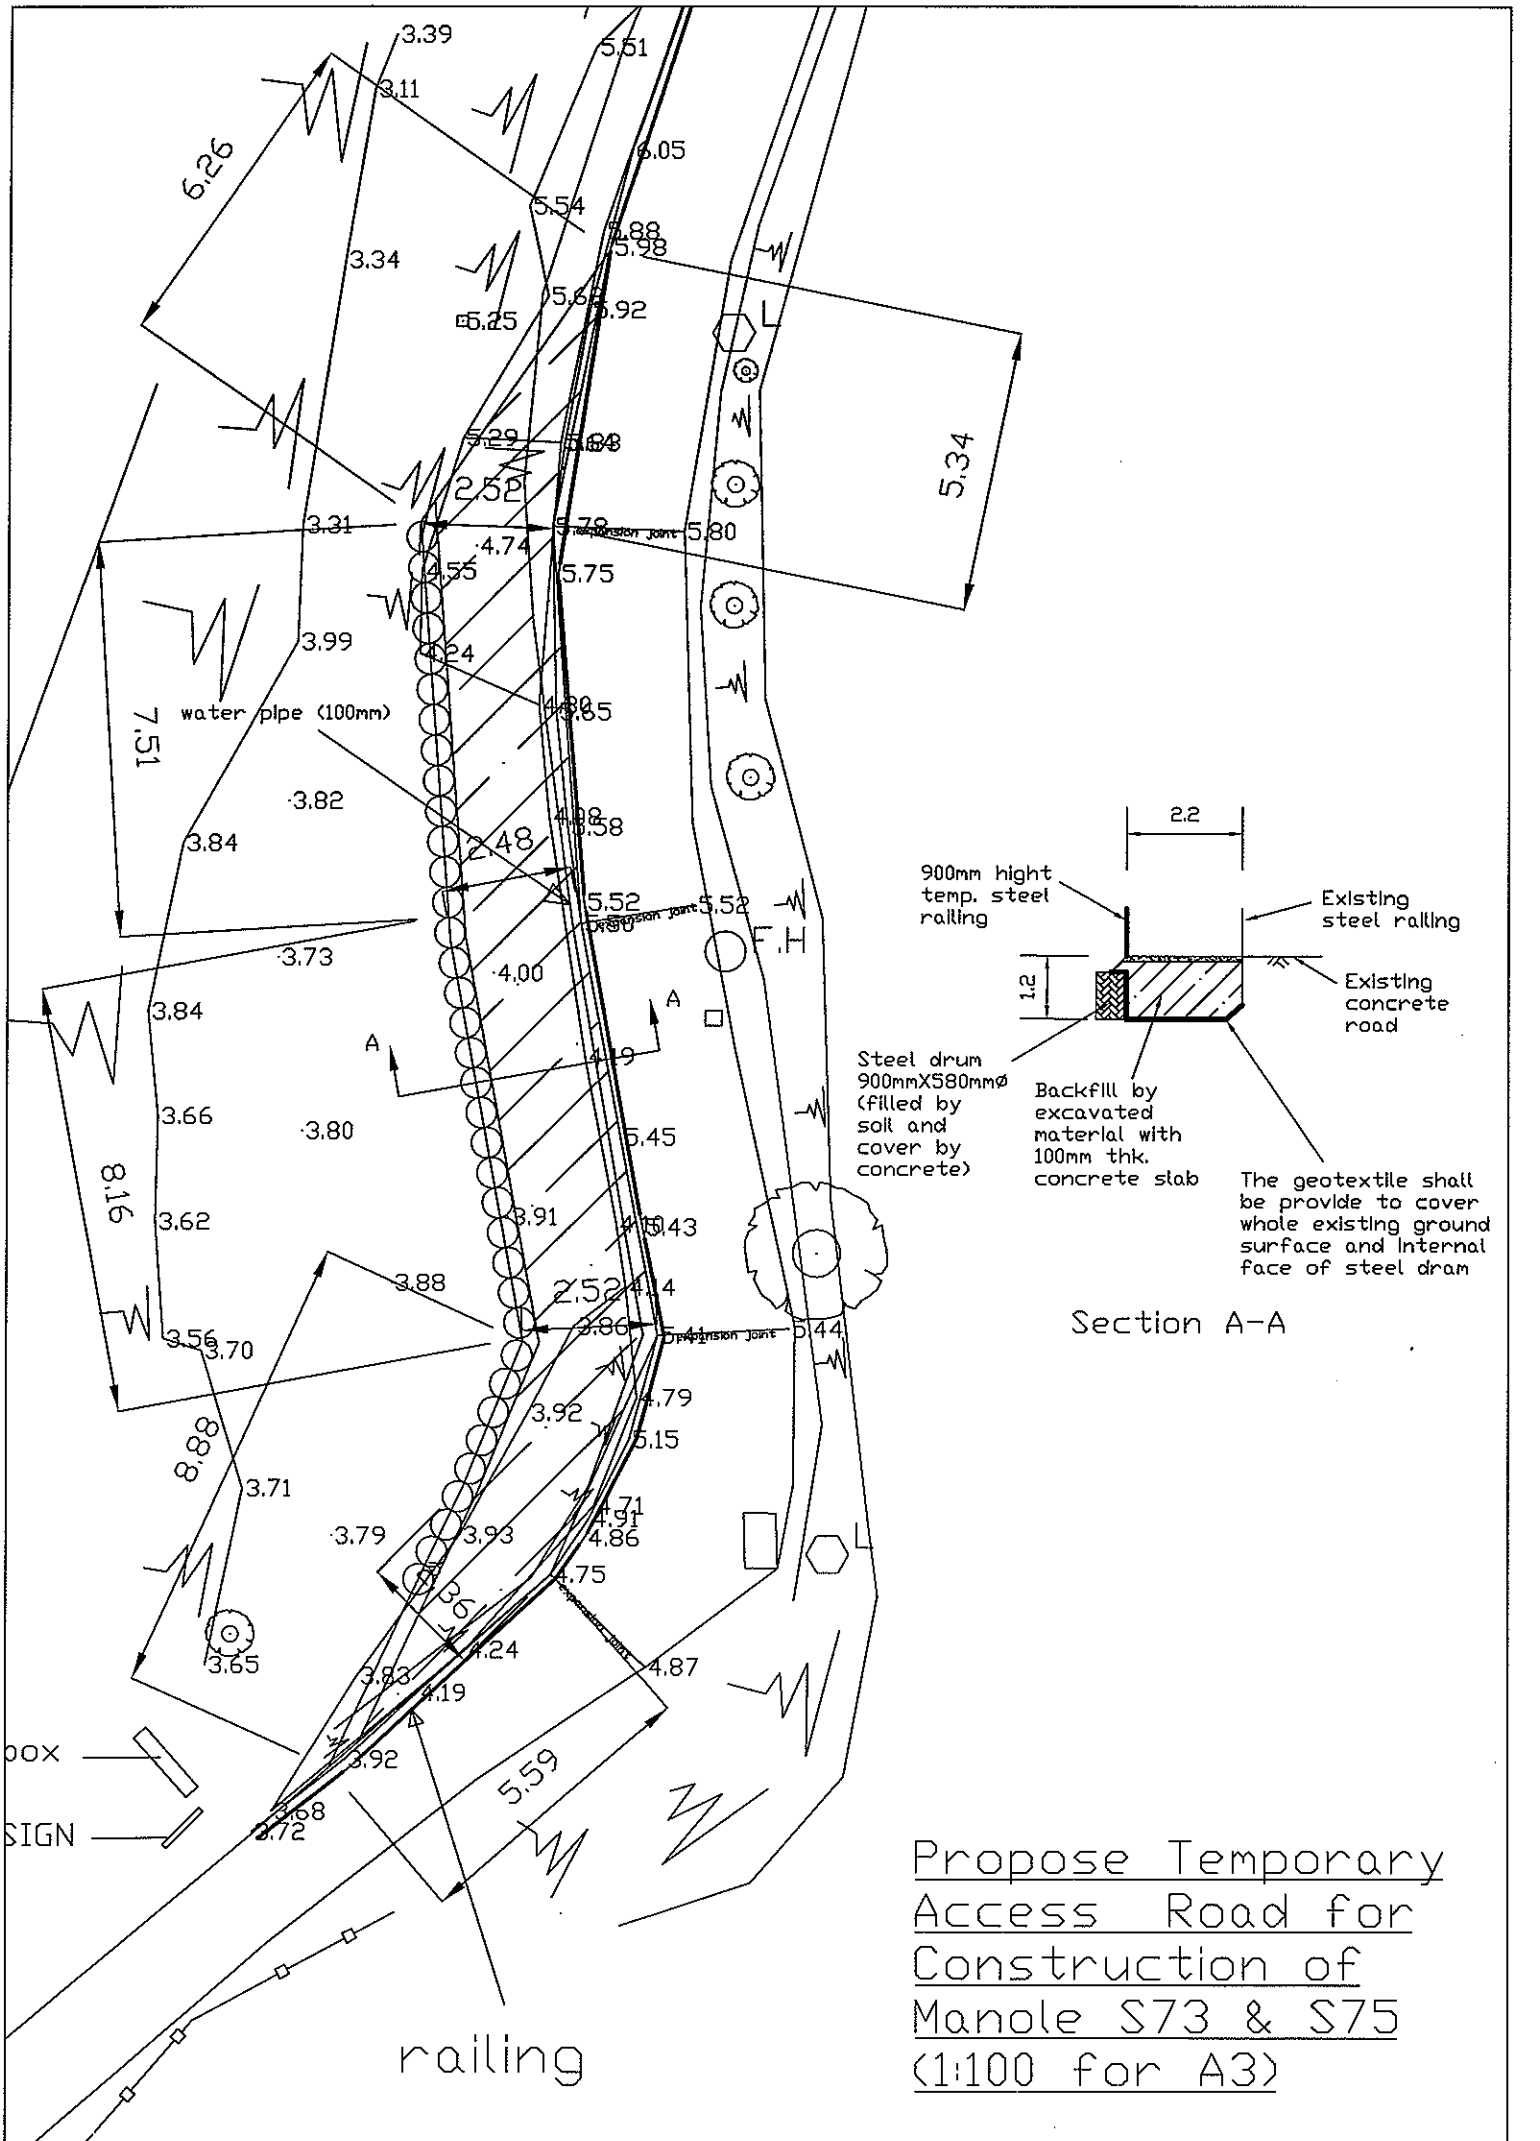
Plan of Temporary Access

Section A-A

Propose Temporary Access Road for Construction of Manole S73 & S75 (1:100 for A3)
