**DSD CONTRACT NO. DC/2009/13  
CONSTRUCTION OF SEWAGE TREATMENT WORKS AT  
YUNG SHUE WAN AND SOK KWU WAN**

**BASELINE SURVEY FOR CORAL MONITORING –  
YUNG SHUE WAN**

PREPARED FOR  
LEADER CIVIL ENGINEERING CORPORATION LIMITED

<b>Date</b>	<b>Reference No.</b>	<b>Prepared By</b>	<b>Approved By</b>
10 February 2011	TCS00512/09/600/R0132v3

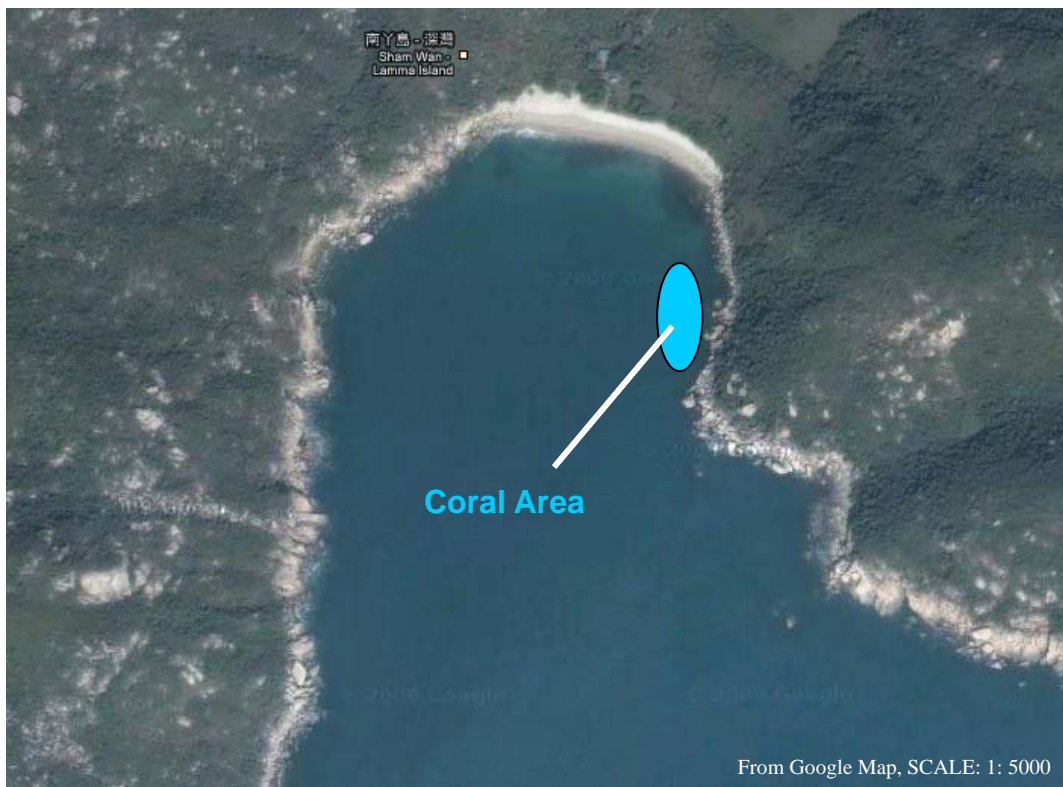
**Figure 3 Coral Area at Sham Wan**

5.2 Hard coral colonies were recorded at both sites during the spot check dives. At Yung Shue Wan, the coral coverage was about 5% in which most of them were located on the artificial sloping boulders. At Sham Wan, the coral coverage was about 10% in which most of corals were located on boulders or rock surfaces. Areas with higher coral coverage were marked (**Figure 1 and Figure 3 - Appendix A**) and their GPS location are summarized in **Table 5-3**

6.2 Scattered patches of hard corals were recorded at the natural shore of SW in which more coral species were recorded and with higher percentage coverage (~10%) when compare with YSW (~5%). Area with higher coral coverage was about 300 m away from the proposed spot check site. Therefore REA transect was laid at the coral area in SW.

7.1 Areas with relatively higher coral coverage were identified during the spot check in both YSW and SW. Corals colonies should be tagged in these two areas for further monitoring during the construction work.

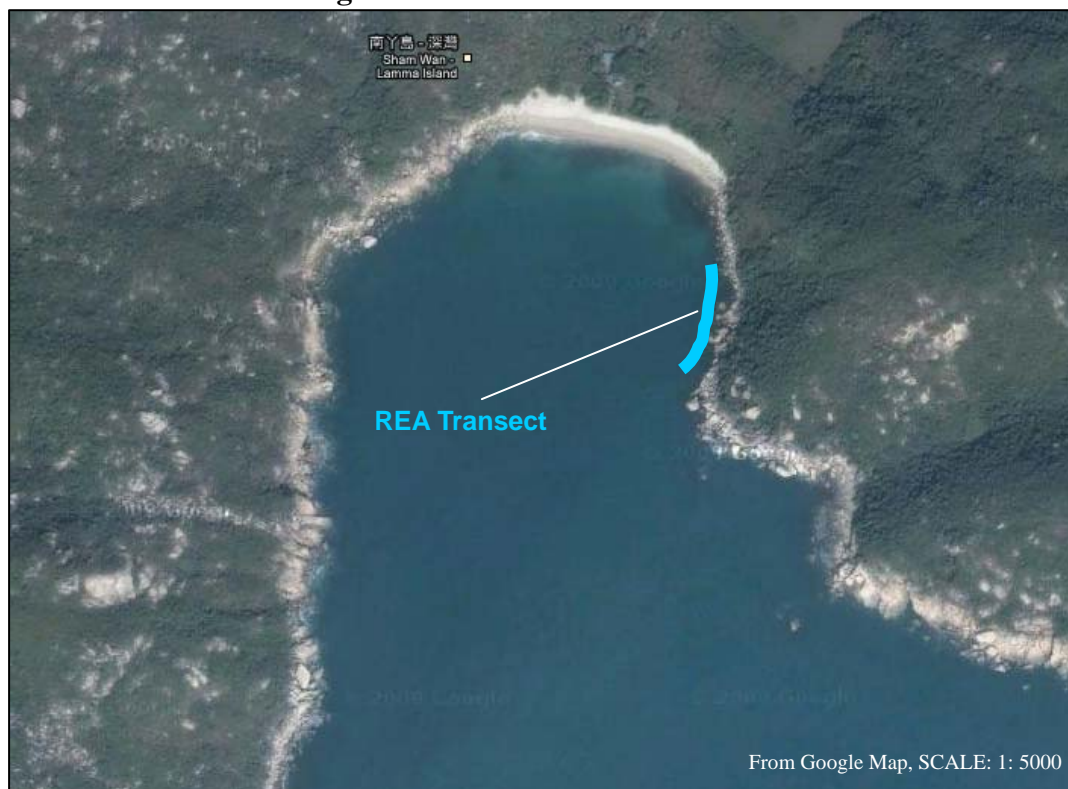
**Figure 4 REA Transect at Sham Wan**

5.7 A 100m transect was laid down at the coral area at Sham Wan (**Figure 4 - Appendix A**) which cover the coral area marked in Spot Check Dives. The start point was at the northeast (near the beach) of the shore and the end point was at the southeast of the shore. The average depth of the transect was about 3 to 3.5 m

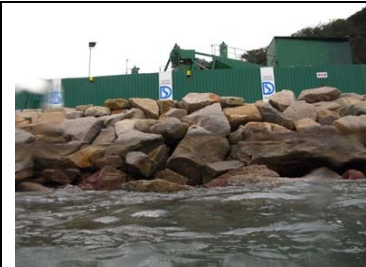
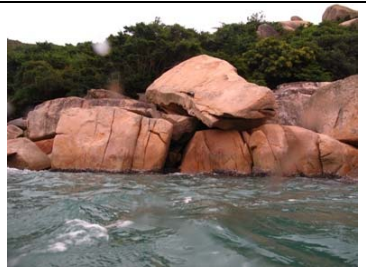
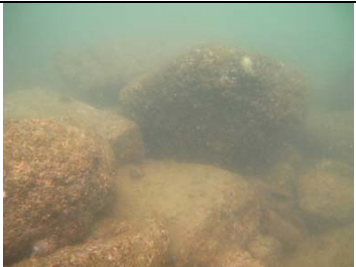
**Photo Plate 1**

5.5 This site is mainly composed of artificial sloping boulders (**Photo Plate 1 - Appendix B**) down to 2.5 meters depth along the surveyed route (**Table 5-4**). Areas deeper than 3 meters are mainly muddy and sandy bottoms (**Photo Plate 1 - Appendix B**). Patches of coral colonies were recorded along the REA transect and 8 species of hard coral were recorded.

5.8 This site is mainly composed of bedrocks and big boulders ((**Photo Plate 1 - Appendix B**) down to 3.5 meters depth along the surveyed route (**Table 5-6**). Areas deeper than 4 meters are mainly sandy bottoms. Patches of coral colonies were recorded along the REA transect and 15 species of hard coral and one species of soft coral were recorded. The abundance of coral species recorded along the transect was shown in **Table 5-7**. Besides, some invertebrates such as common sponges, sea anemone: *Actinia equina*. Sea urchins: *Diadema setosum*, and *Anthocidaris crassispinga* were also found at the surface of the boulders.

Boulders at YSW	Bedrocks at SW	Boulders underwater

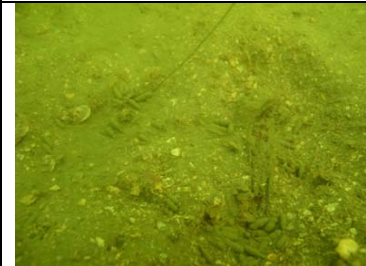
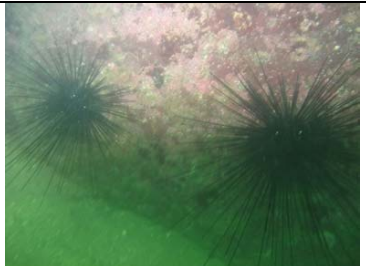
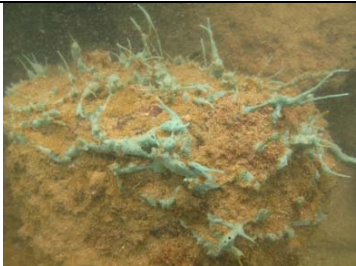
Sandy/Muddy Bottom	Sea urchin	Sponges

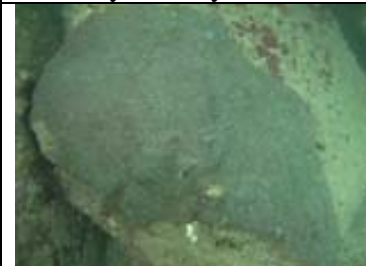
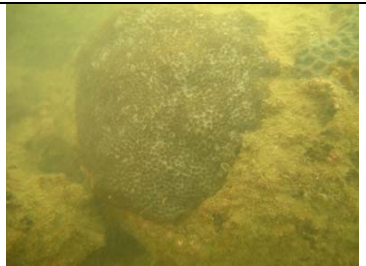
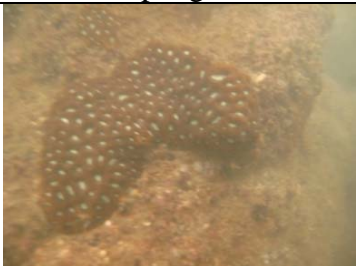
5.6 This site supported a sparse and patchy cover (~5%) of hard coral. Along the REA transect *Goniopora stutchburyi*, *Cyphastrea serailia*, *Favites pentagona*, *Goniastrea aspera* and *Porites lobata* are common coral species in this site. All the recorded coral colonies grow on the boulders and rocks surfaces. All coral colonies recorded along the transect are common species of hard coral in Hong Kong water except an uncommon species *Coscinaraea n sp.* ((**Photo Plate 1 - Appendix B**)).

6.3 All the corals recorded during the survey are common species in Hong Kong water except an uncommon species *Coscinaraea n sp.* was recorded in both sites and mostly of fair conditions on boulders or bedrocks.

<i>Coscinaraea n sp.</i>	<i>Cyphastrea serailia</i>	<i>Favites abdita</i>

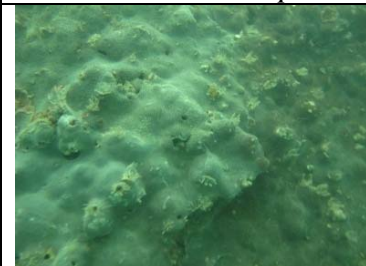
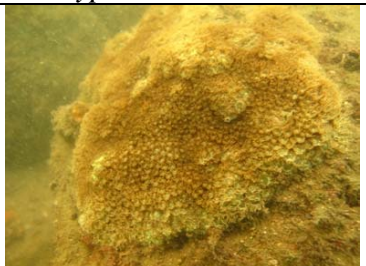
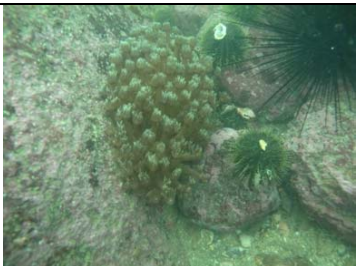
5.9 This site supported a sparse and patchy cover (~10%) of hard coral. Along the REA transect *Goniopora stutchburyi* and *Porites lobata* ((**Photo Plate 1 - Appendix B**) are abundant in the site while *Goniastrea aspera*, *Favia speciosa*, *Cyphastrea serailia*, *Favites chinensis* and *Favites pentagona* are common coral species in this site. All the recorded coral colonies grow on the boulders and rocks surfaces. All coral colonies recorded along the transect are common species of hard coral in Hong Kong water except an uncommon species *Coscinaraea n sp.* ((**Photo Plate 1 - Appendix B**).

<i>Porites lobata</i>	<i>Goniopora stutchburyi</i>	<i>Goniopora columna</i>

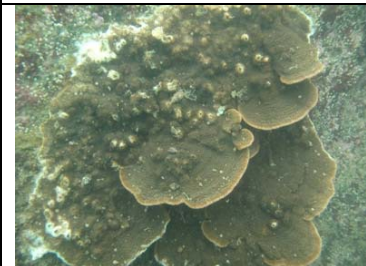
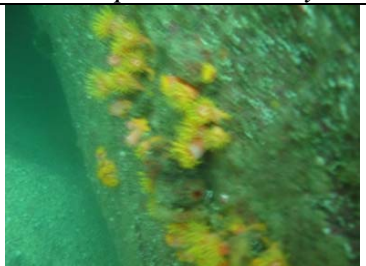
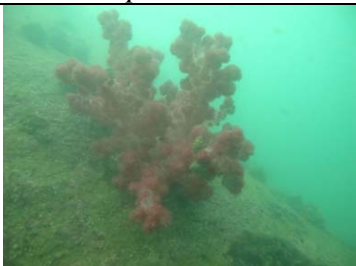
<i>Montipora peltiformis</i>	<i>Tubastrea diaphana</i>	<i>Dendronephthya sp.</i>
