PROJECT No.: TCS/00512/09

DSD CONTRACT No. DC/2009/13 CONSTRUCTION OF SEWAGE TREATMENT WORKS AT YUNG SHUE WAN AND SOK KWU WAN

YUNG SHUE WAN PORTION AREA MONTHLY ENVIRONMENTAL MONITORING AND AUDIT (EM&A) REPORT (NO.9) – MAY 2011

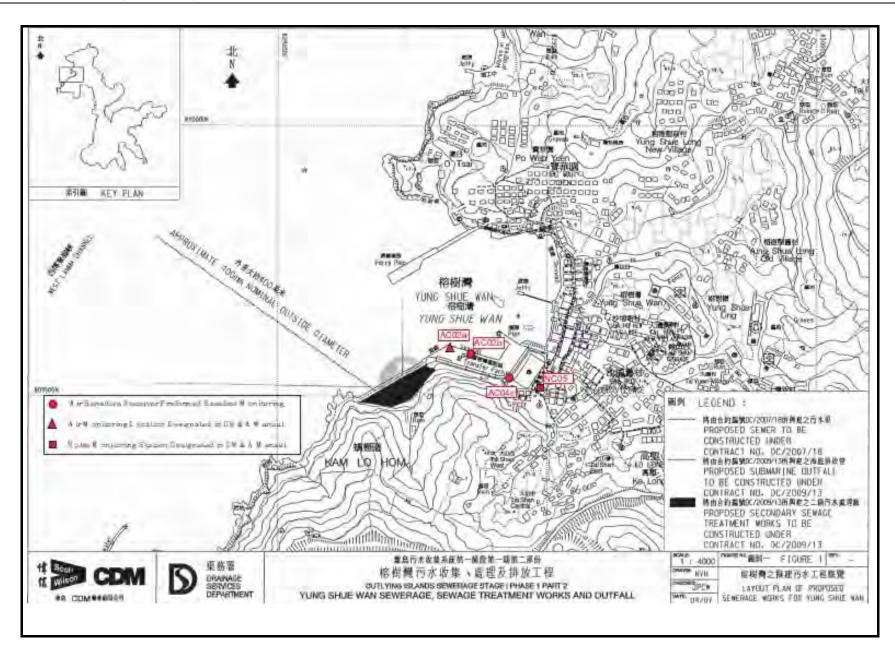
Location of Monitoring Stations (Air Quality / Construction Noise / Water Quality / Dive Surveys of Coral)

- 3.04 Two designated monitoring stations, AC02a located at Yung Shue Wan Refuse Transfer Station and AC04 located at residential area nearby Yung Shue Wan football pitch, were recommended in the *EM&A Manual Section* 2.5. In order to identify and seek for the access of the air monitoring locations designated in the EM&A Manual, site visit was conducted by Leader and ET.

3.06 According to *EM&A Manual Section 3.4*, one noise sensitive receivers (NC05) designated for the construction noise monitoring was recommended at Yung Shue Wan Portion Area of the Project. The designated monitoring station is identified and successfully granted the premises. The detailed construction noise monitoring station is described in *Table 3-3* and graphical is shown in *Appendix D*.

Two control stations (CY1 and CY2) and three impact stations (WY1-WY3) were recommended in the *EM&A Manual Section 4.5*. Impact stations WY1-WY3 were identified close to the sensitive receivers (the coral colonies in the vicinity of Yung Shue Wan, and secondary contact recreation subzone). It is proposed to monitor the impacts from the construction of the submarine outfall as well as the effluent discharge from the proposed STW on water quality. Two control stations: CY1 and CY2 were recommended at locations representative of the project site in its undisturbed condition and located at upstream and downstream of the works area. The marine water quality monitoring stations to be performed under the Project is described in *Table 3-4* and shown in *Appendix D*.

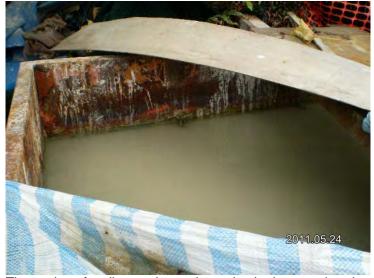
Findings of Site Inspection (24 May 2011):

The setting of sedimentation tank need to be improved such as installing proper filters inside to improve the de-silting effectiveness.
