**DSD CONTRACT NO. DC/2009/13
CONSTRUCTION OF SEWAGE TREATMENT WORKS AT
YUNG SHUE WAN AND SOK KWU WAN**

**YUNG SHUE WAN PORTION AREA
MONTHLY ENVIRONMENTAL MONITORING AND AUDIT
(EM&A) REPORT (No.10) – JUNE 2011**

PREPARED FOR
LEADER CIVIL ENGINEERING CORPORATION LIMITED

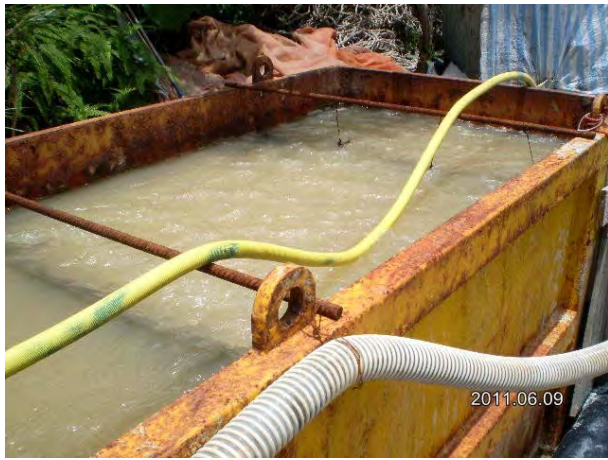
Findings of Site Inspection (9 June 2011):

| Date | Findings / Deficiencies | Follow-Up Status |
|---|---|--|
| 9 June 2011 | <ul style="list-style-type: none"> • Overflow of turbid water was observed. The sedimentation facilities need to be further modified to improve the de-silting effectiveness. • Turbid water was observed at the outfall of the site. The Contractor should carry out immediate action to rectify the problem of water quality. | <p>The water quality in the sed-tank was improved on 14 June 2011.</p> <p>No further discharge of turbid water was observed on 14 June 2011.</p> |

Overflow of turbid water was observed. The sedimentation facilities need to be further modified to improve the de-silting effectiveness.

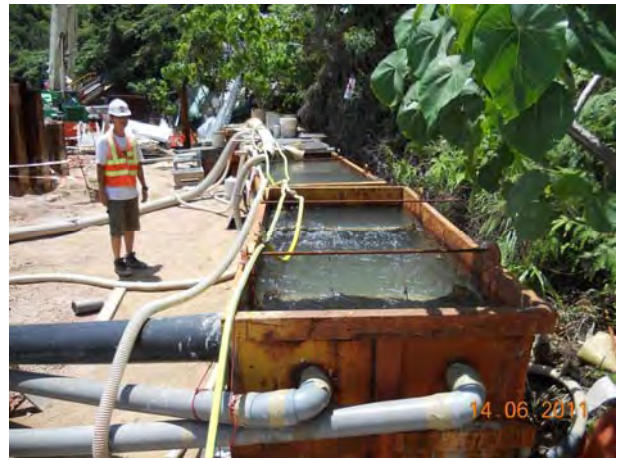
The water quality in the sed-tank was improved. (Rectified on 14-6-2011)

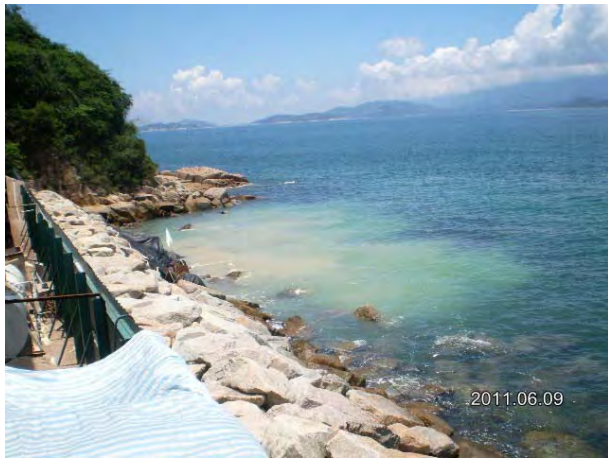
Turbid water was observed at the outfall of the site. The Contractor should carry out immediate action to rectify the problem of water quality.

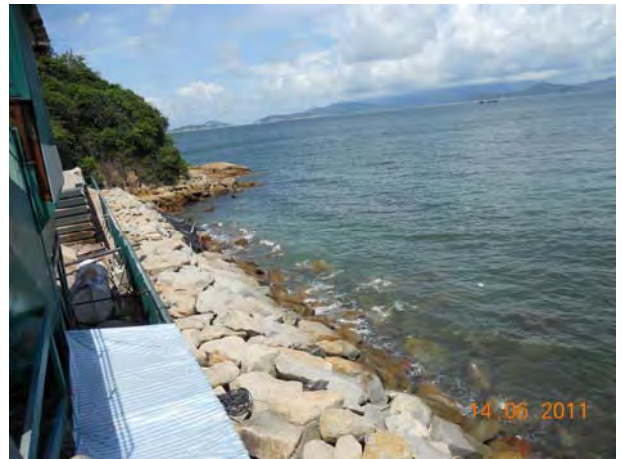
No turbid water was observed. The Contractor should maintain water quality to avoid further turbid water discharging. (Rectified on 14-6-2011)
