PROJECT NO.: TCS/00512/09

**DSD CONTRACT NO. DC/2009/13
CONSTRUCTION OF SEWAGE TREATMENT WORKS AT
YUNG SHUE WAN AND SOK KWU WAN**

**YUNG SHUE WAN PORTION AREA
MONTHLY ENVIRONMENTAL MONITORING AND AUDIT
(EM&A) REPORT (No.11) – JULY 2011**

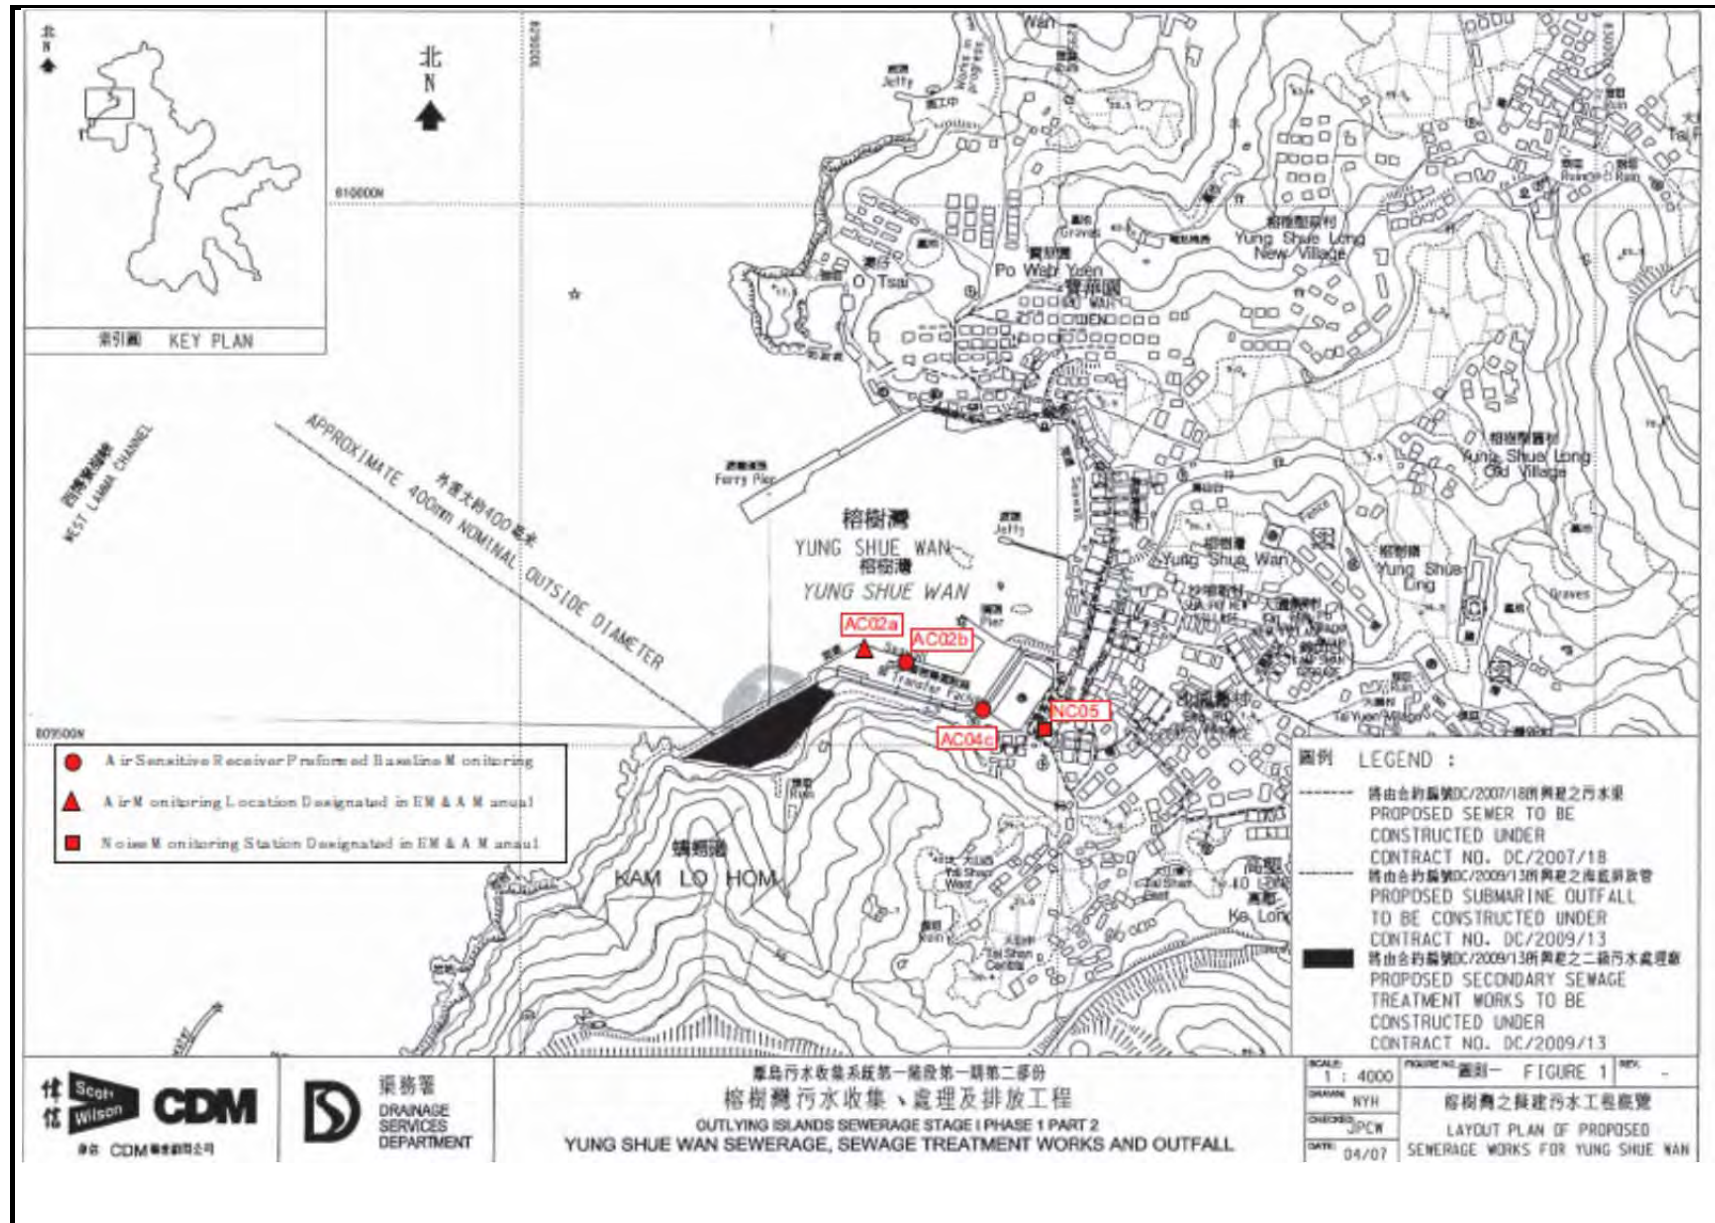
Location of Monitoring Stations (Air Quality / Construction Noise / Water Quality / Dive Surveys of Coral)

- 3.04 Two designated monitoring stations, AC02a located at Yung Shue Wan Refuse Transfer Station and AC04 located at residential area nearby Yung Shue Wan football pitch, were recommended in the *EM&A Manual Section 2.5*. In order to identify and seek for the access of the air monitoring locations designated in the EM&A Manual, site visit was conducted by Leader and ET.

- 3.06 According to *EM&A Manual Section 3.4*, one noise sensitive receivers (NC05) designated for the construction noise monitoring was recommended at Yung Shue Wan Portion Area of the Project. The designated monitoring station is identified and successfully granted the premises. The detailed construction noise monitoring station is described in **Table 3-3** and graphical is shown in **Appendix D**.

- 3.07 Two control stations (CY1 and CY2) and three impact stations (WY1-WY3) were recommended in the *EM&A Manual Section 4.5*. Impact stations WY1-WY3 were identified close to the sensitive receivers (the coral colonies in the vicinity of Yung Shue Wan, and secondary contact recreation subzone). It is proposed to monitor the impacts from the construction of the submarine outfall as well as the effluent discharge from the proposed STW on water quality. Two control stations: CY1 and CY2 were recommended at locations representative of the project site in its undisturbed condition and located at upstream and downstream of the works area. The marine water quality monitoring stations to be performed under the Project is described in **Table 3-4** and shown in **Appendix D**.

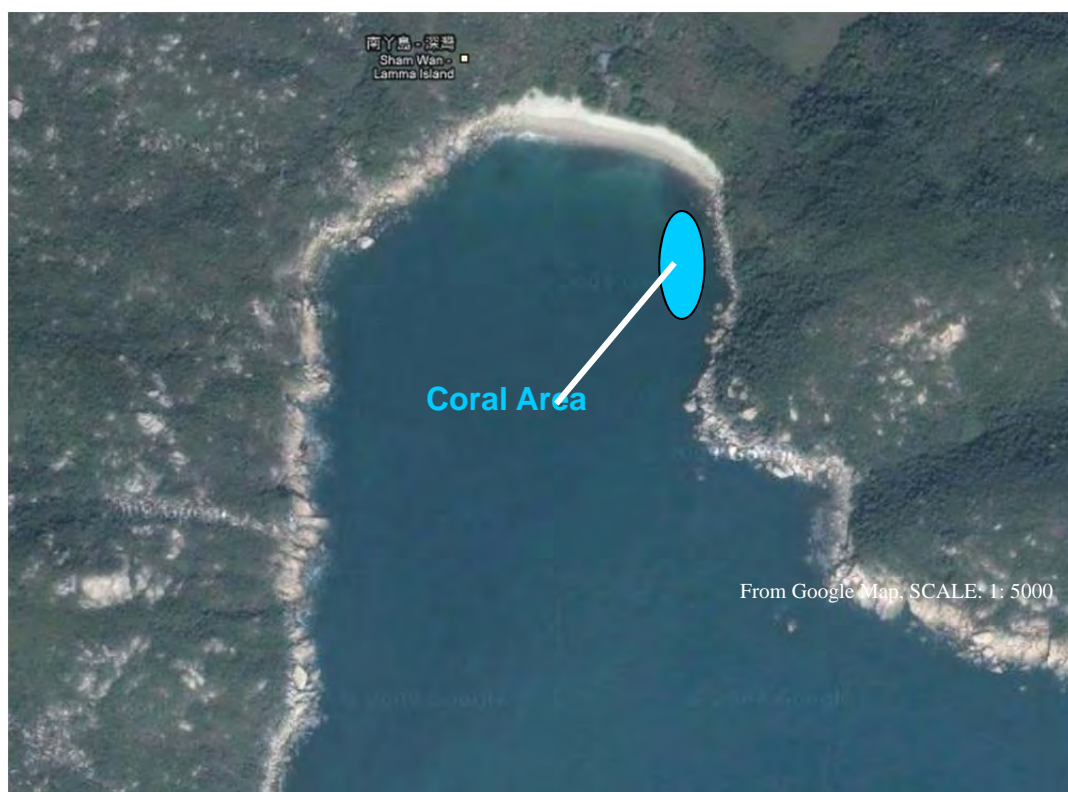
Coral Area at Sham Wan

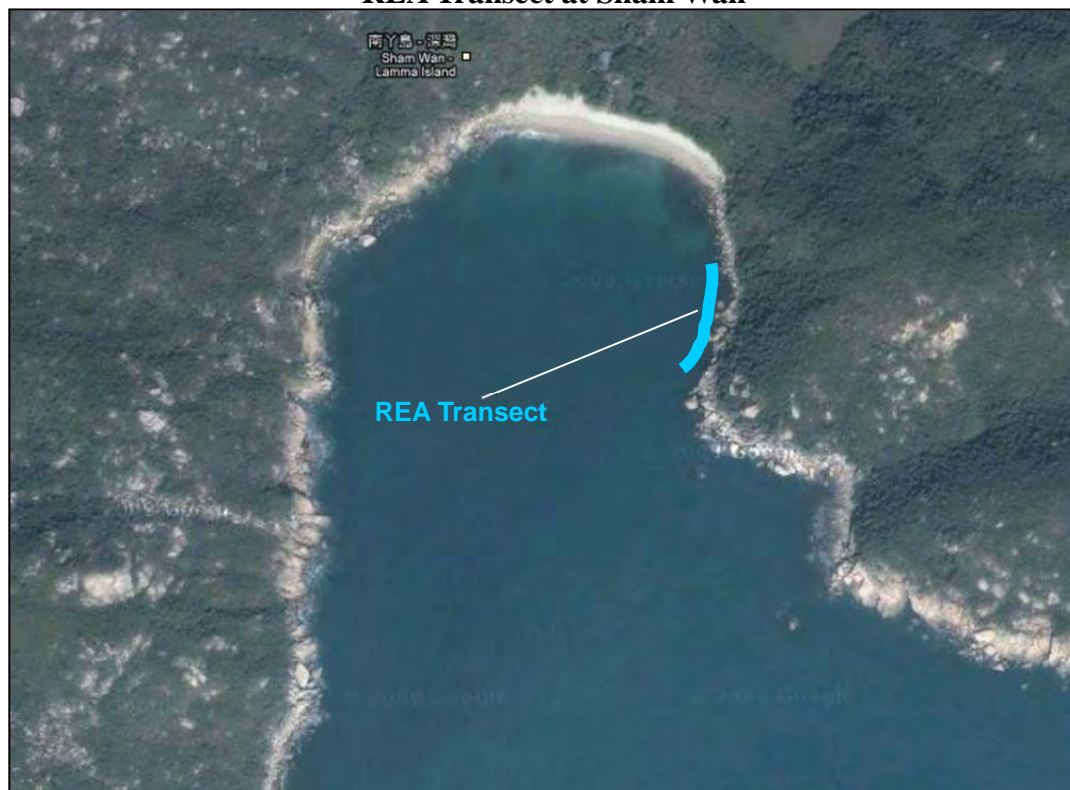
REA Transect at Sham Wan

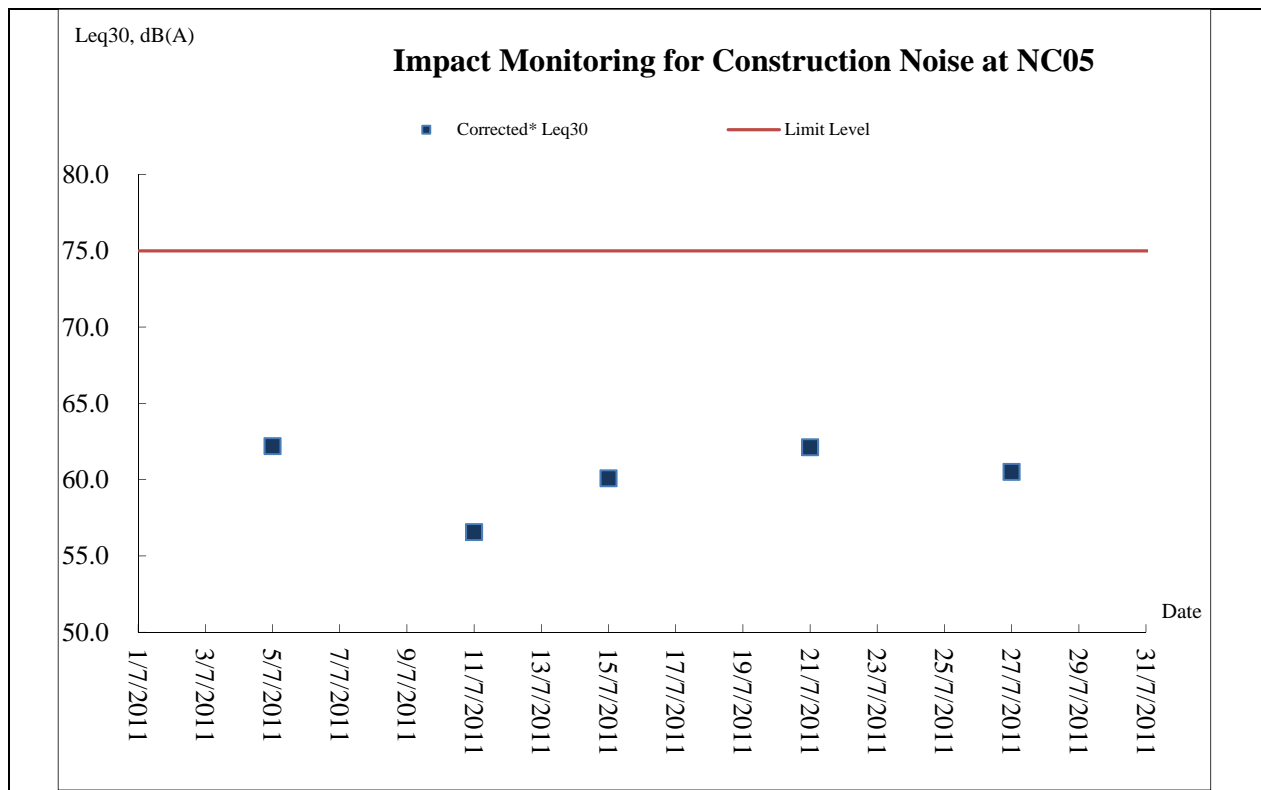
Noise Monitoring

5.03 It was noted that no noise complaint (which is an Action Level exceedance) was received. In view of the results shown in **Tables 5-1**, all the values are well below 75dB(A), therefore, no Action or Limit Level exceedance was triggered during this reporting month.

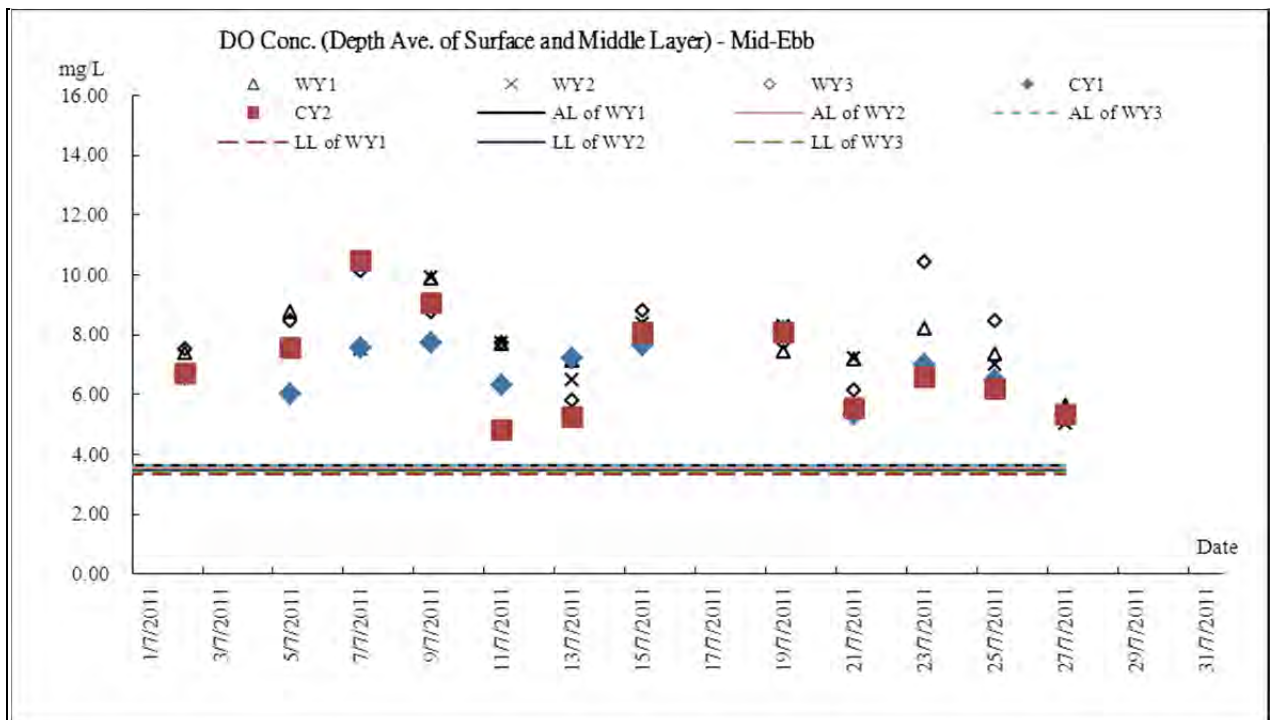
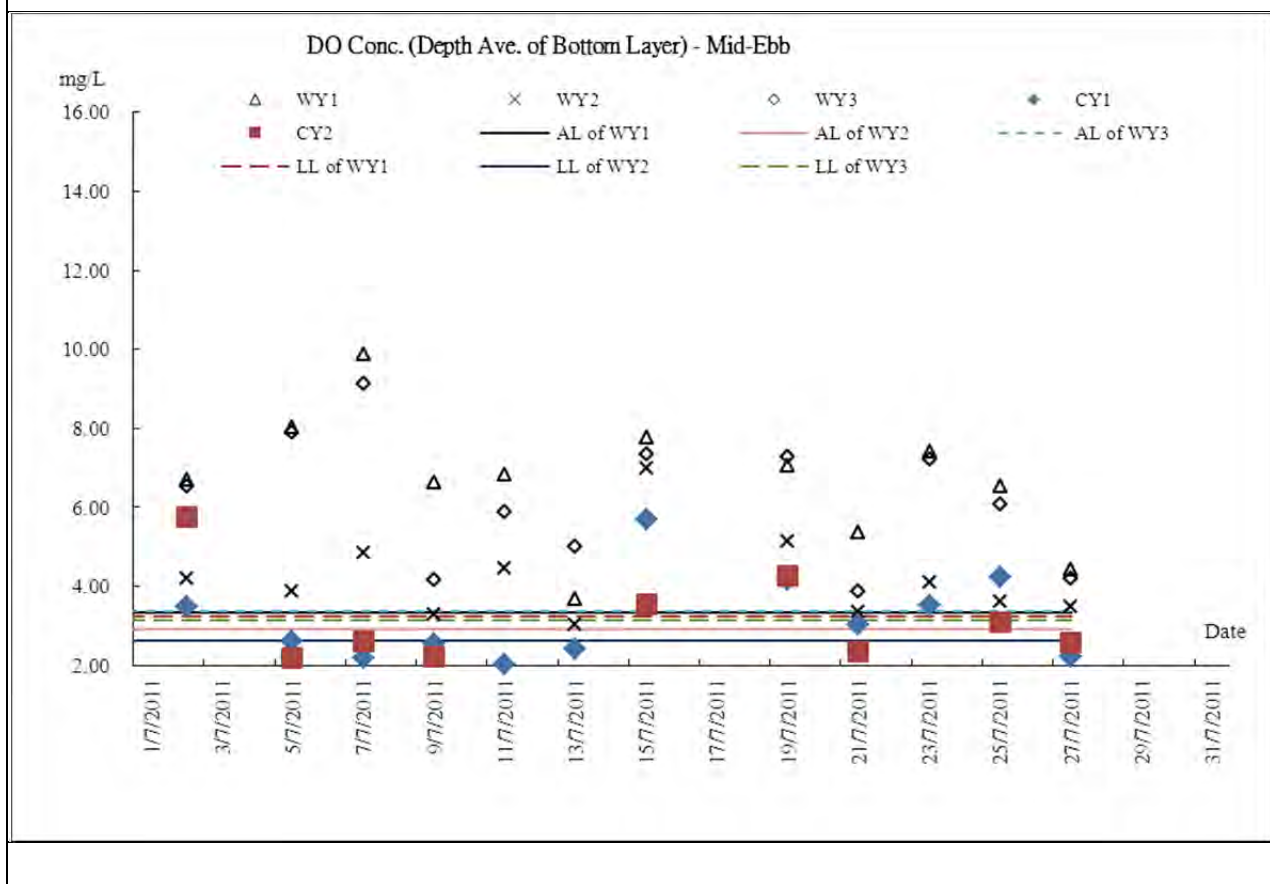
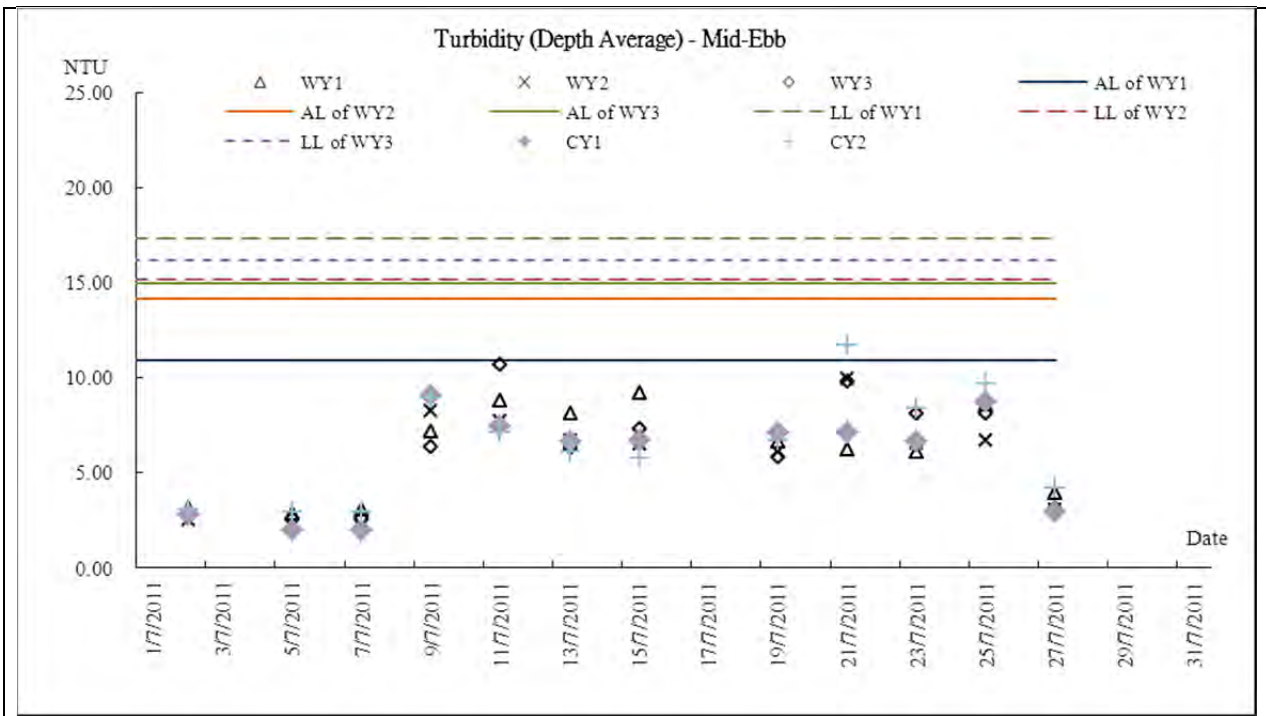
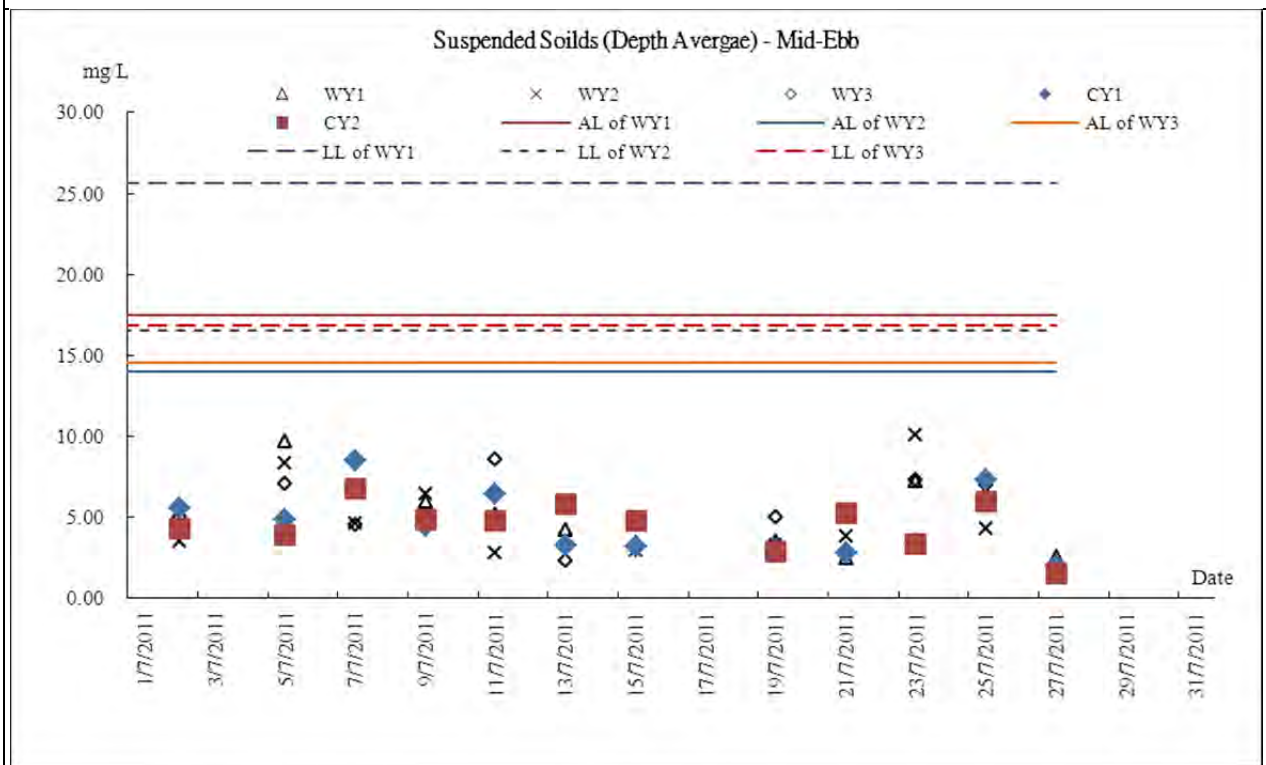
Marine Water Quality Monitoring – Mid Ebb Tide

6.04 For marine water monitoring, no exceedance of Action/Limit level was recorded in this reporting month. Therefore, no associated corrective actions were then required. Besides, due to inclement weather and marine condition (refer to Appendix I), the monitoring works scheduled on 29 July 2011 was cancelled. The cancellation of the monitoring has been notified to the Contractor, RE and IEC by at the same day.

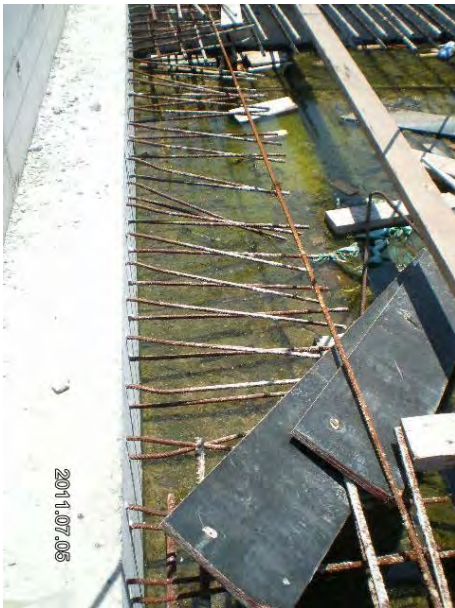
Findings of Site Inspection (5 July 2011):

Stagnant water was accumulated on the roof of building structure. The Contractor should drain away stagnant water or apply larvicidal oil to avoid mosquito breeding.

The stagnant water was drained away.

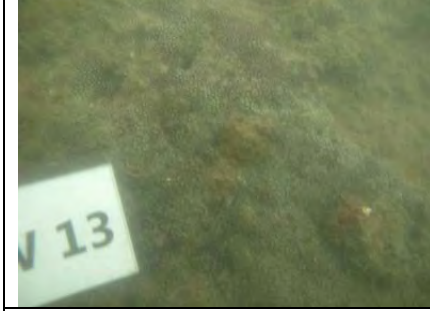
<i>12. Favites pentagona</i>

suspected it was killed by coral feeding snail *Drupella* sp. A new coral colony (*Coscinaraea n* sp.) was re-tagged on 22nd July 2011 to replace the unhealthy coral #12. To report such incident, an investigation report for the partial dead coral was conducted and submitted to EPD and AFCD (ref: 1004/03.09.00.00/2769/L). Besides, 10% mortality of coral colony #16 (*Favia rutomana*) was recorded on 22nd July 2011. It was suspected the 10% dead was eaten by coral feeding snail *Drupella* sp. Since there is no further increased in % mortality to the coral during the next monitoring on 28 July 2011, the ecologist decides to closely monitor the health condition of the coral and no replacement would be made at this stage. The relevant investigation report has been submitted to the Contactor for further submission to EPD and AFCD. No sediment was recorded during the survey. No bleaching was recorded for other corals during the survey. Photos of each tagged corals were shown in **Appendix II**.

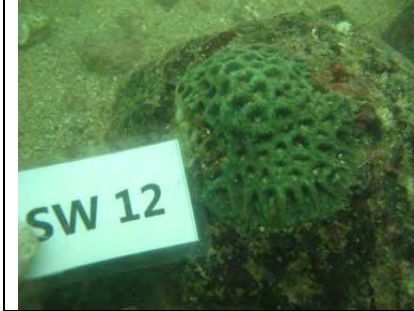
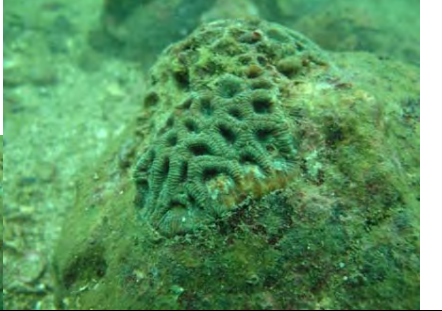
<i>12. Favia fava</i>

- 5.5 This site is mainly composed of bedrocks and big boulders down to 3.5 meters depth along the surveyed route. Areas deeper than 4 meters are mainly sandy bottoms. The coral coverage was about 10% in which most of corals were located on boulders or rock surfaces. 20 hard coral colonies were monitored on 7th, 14th, 22nd and 28th July-2011 and their species name, size and health condition were shown in **Table 5-6** to **Table 5-9**.
- 5.6 Corals in this site showed fair to healthy condition. 50% mortality of coral colony #12 (*Favia fava*) was recorded during monitoring on 14th July 2011 in which it was
