**DSD CONTRACT NO. DC/2009/13
CONSTRUCTION OF SEWAGE TREATMENT WORKS AT
YUNG SHUE WAN AND SOK KWU WAN**

**YUNG SHUE WAN PORTION AREA
MONTHLY ENVIRONMENTAL MONITORING AND AUDIT
(EM&A) REPORT (No.13) – SEPTEMBER 2011**

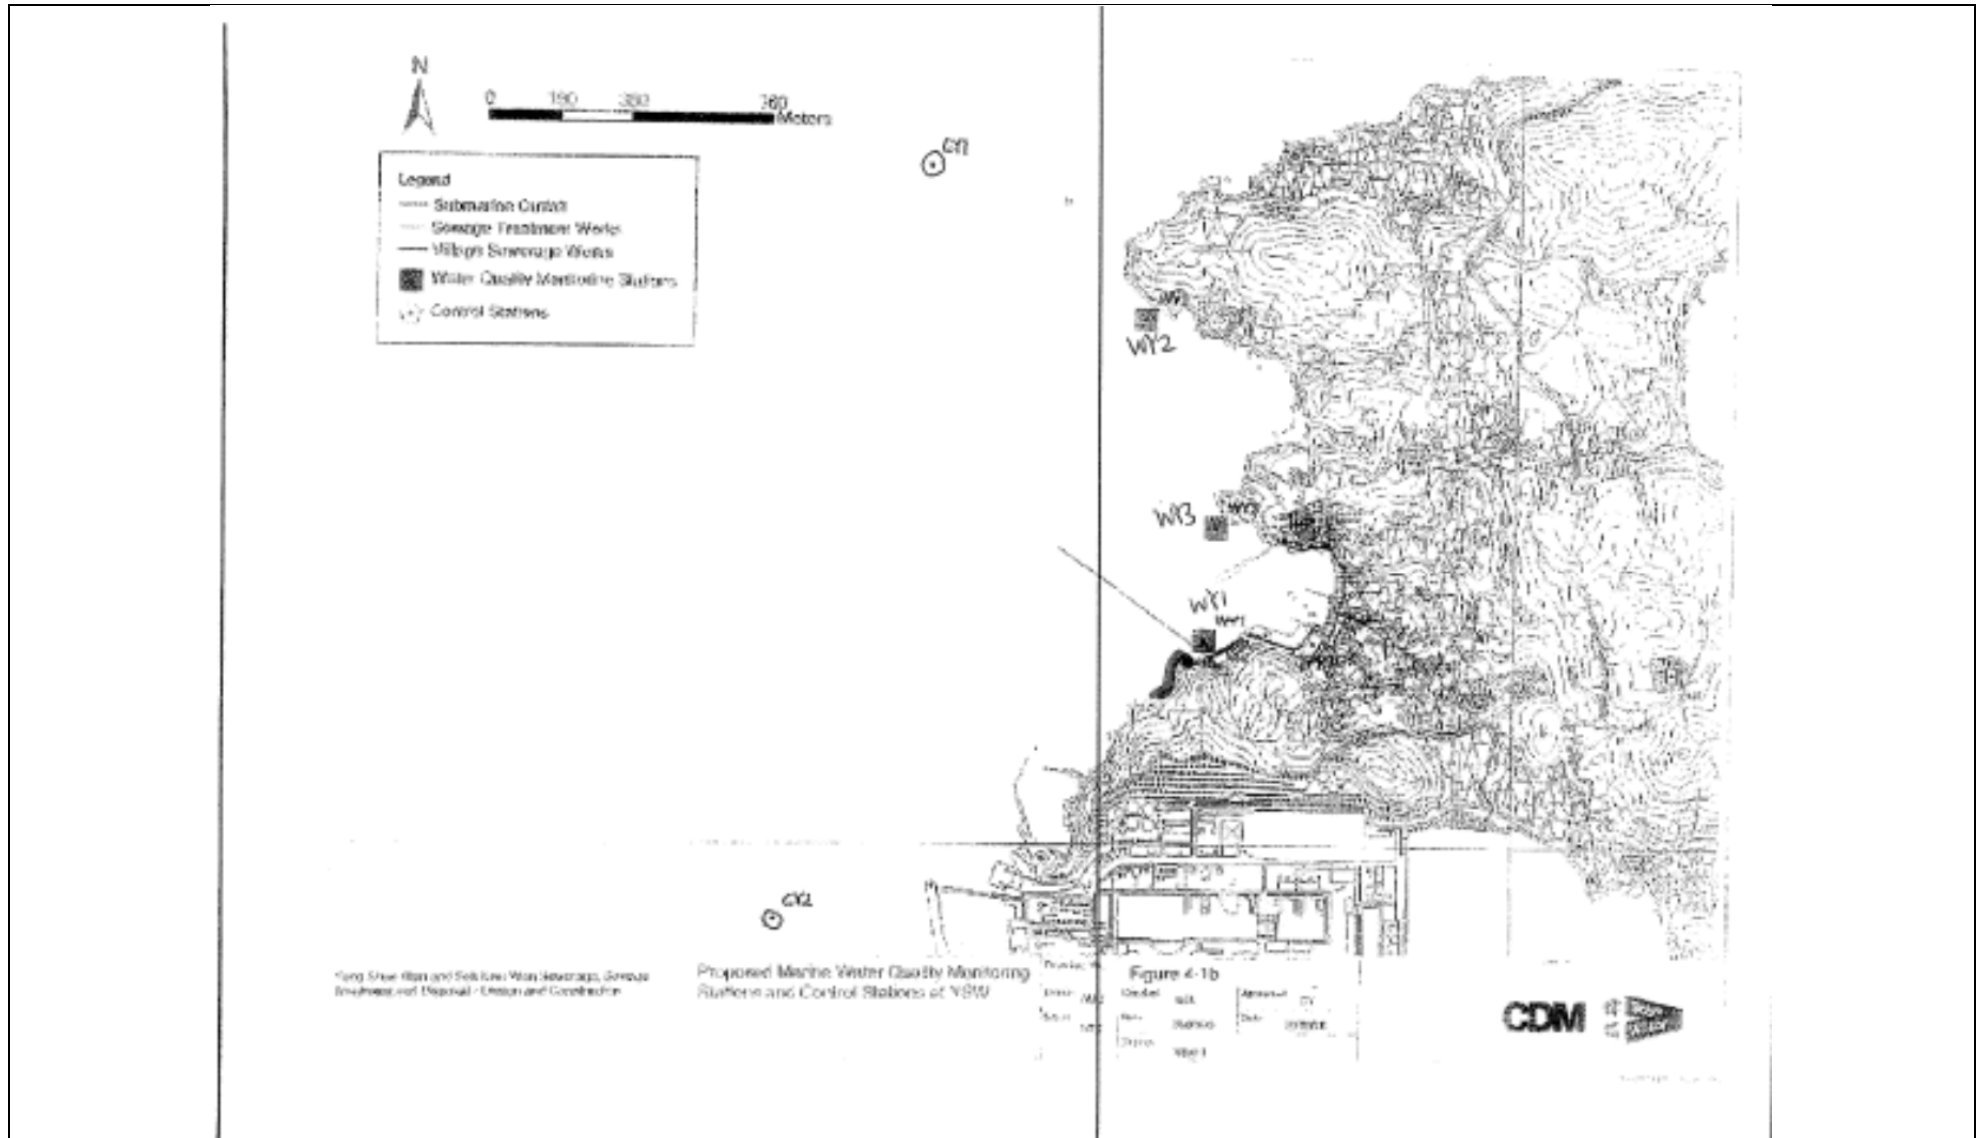
Location of Monitoring Stations (Air Quality / Construction Noise / Water Quality / Dive Surveys of Coral)

- 3.04 Two designated monitoring stations, AC02a located at Yung Shue Wan Refuse Transfer Station and AC04 located at residential area nearby Yung Shue Wan football pitch, were recommended in the *EM&A Manual Section 2.5*. In order to identify and seek for the access of the air monitoring locations designated in the EM&A Manual, site visit was conducted by Leader and ET.

- 3.06 According to *EM&A Manual Section 3.4*, one noise sensitive receivers (NC05) designated for the construction noise monitoring was recommended at Yung Shue Wan Portion Area of the Project. The designated monitoring station is identified and successfully granted the premises. The detailed construction noise monitoring station is described in **Table 3-3** and graphical is shown in **Appendix D**.

- 3.07 Two control stations (CY1 and CY2) and three impact stations (WY1-WY3) were recommended in the *EM&A Manual Section 4.5*. Impact stations WY1-WY3 were identified close to the sensitive receivers (the coral colonies in the vicinity of Yung Shue Wan, and secondary contact recreation subzone). It is proposed to monitor the impacts from the construction of the submarine outfall as well as the effluent discharge from the proposed STW on water quality. Two control stations: CY1 and CY2 were recommended at locations representative of the project site in its undisturbed condition and located at upstream and downstream of the works area. The marine water quality monitoring stations to be performed under the Project is described in **Table 3-4** and shown in **Appendix D**.
