**Agreement No. CE
20/2004(EP) North
East New
Territories (NENT)
Landfill Extension**

Monthly Environmental
Monitoring and Audit Report
(No. 1) – December 2022

Re: Contract No. EP/SP/77/15
North-East New Territories Landfill Extension (NENTX)
Monthly Environmental Monitoring and Audit Report (No.1) – December 2022

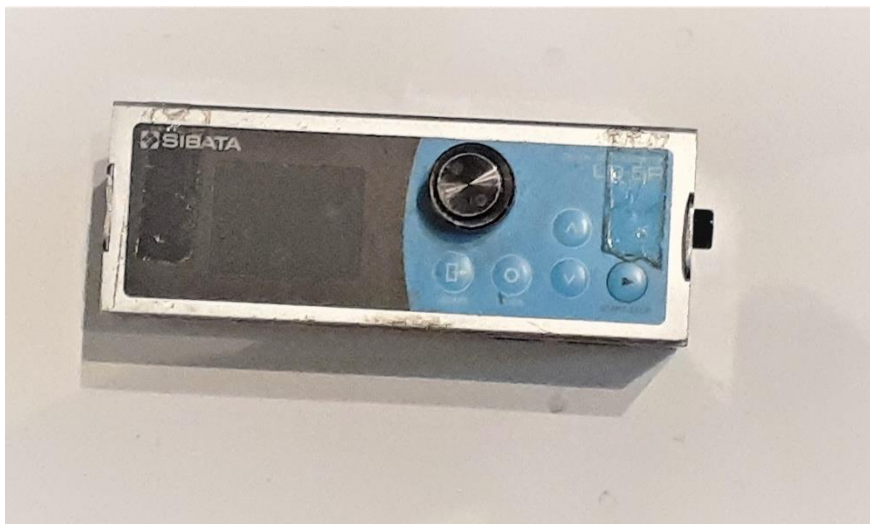
Figure 3.1 Top view of Sibata LD-5R digital dust indicator

3.1.1 Sibata LD-5R digital dust indicator is a compact handheld dust indicator, which perform real time measurement of suspended particle matter in indoor spaces, public space. Component of Sibata LD-5R digital dust indicator us shown in Figure 3.1 and Figure 3.2

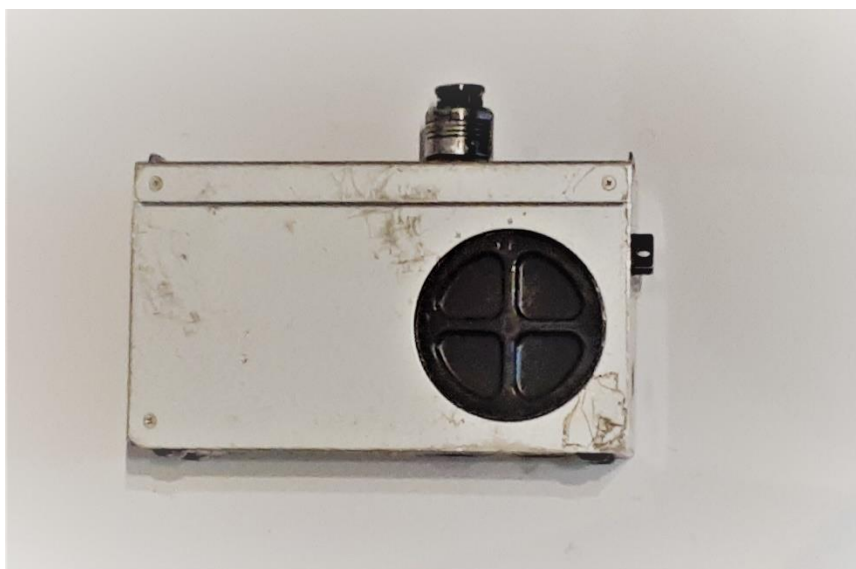
Figure 3.2 Side view of Sibata LD-5R digital dust indicator

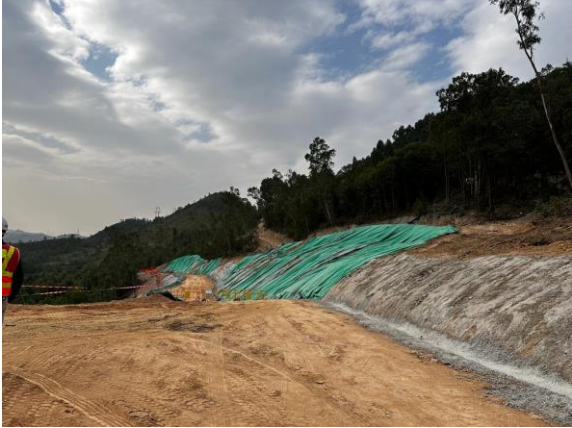
<p>2.The open cut slop shall be covered with impervious sheet.</p>

<p>The exposed slope has been covered with impervious sheets.</p>

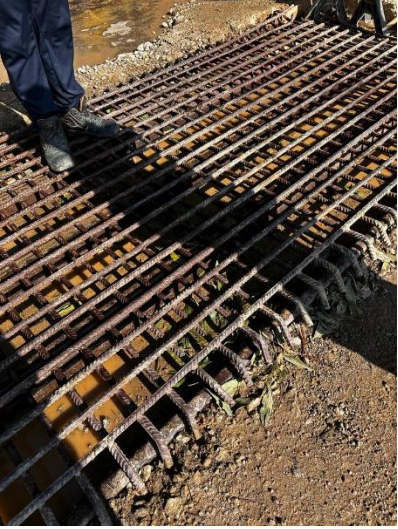
<p>1. Sediments are accumulated in the channel at the vehicle wash bay.</p>

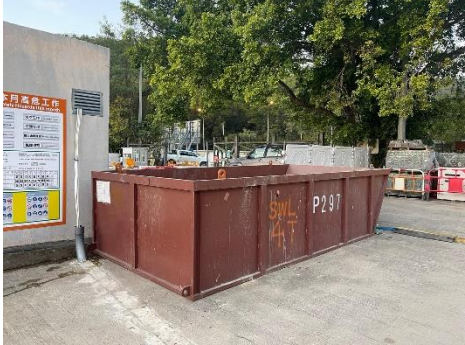
<p>2.The Contactor had been recommended to increase the frequency of waste disposal to avoid accumulation of waste.</p>

<p>The waste has been disposed.</p>

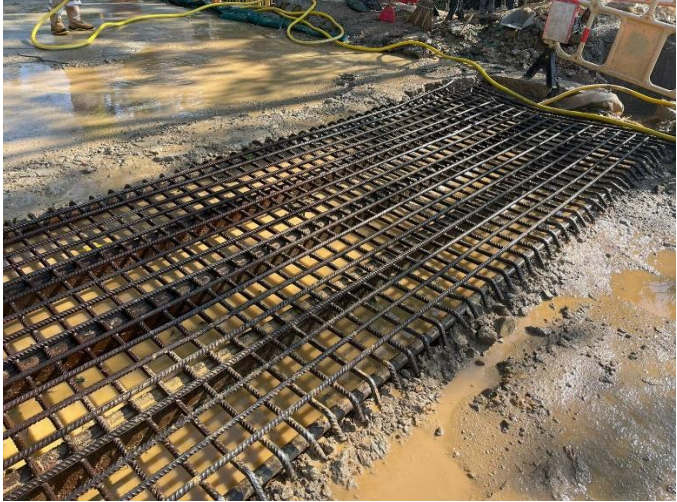
<p>3.Sediments were accumulated in the channel at the vehicle wash bay in Portion A.</p>

<p>The Contractor has cleaned up the channel at the vehicle wash bay in Portion A.</p>

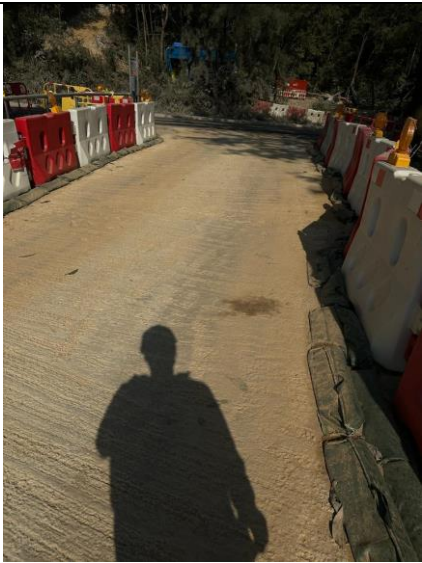
<p>Observation 1 : The vehicle road is covered with dusty materials in Portion A.</p>	  <p>The entrance has been cleaned up in Portion A after site inspection.</p>

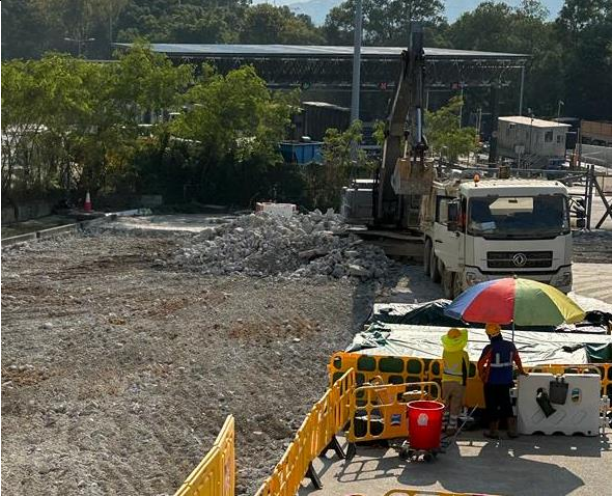
<p>Reminder 1 : The work area is dry and fugitive dust is observed from loading and unloading activity in Portion D.</p>

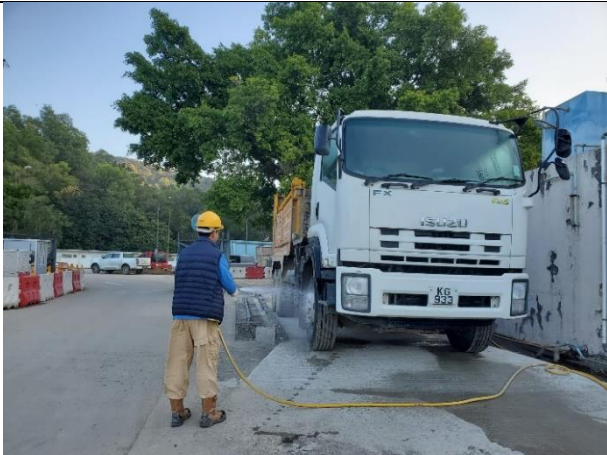
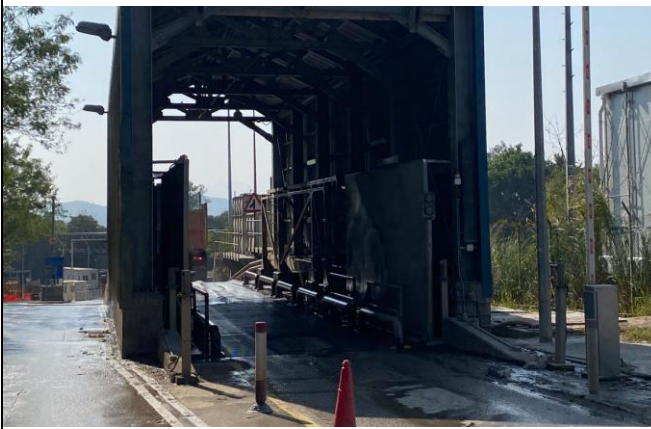
Photo 6	Photo 7

Site Exit at Portion D of NENTX project	Site Exit of NENT

Recommendations/ Mitigation Measures/ Actions if necessary:
Based on the investigation result, there is no direct evidence showing that the complaint is likely related to the NENTX project. The Contractor has been reminded to implement the mitigation measures such as the provision of the concrete paved wheel washing area and other measures specified and required in the EIA Report, the EM&A Manual and the EP/FEP to minimize dust impact/ improve cleanliness.
