JOINT USER COMPLEX AND WHOLESALE FISH MARKET AT AREA 44, TUEN MUN

**SECOND QUARTERLY ENVIRONMENTAL MONITORING &** AUDIT REPORT (NOVEMBER 2008 - JANUARY 2009)

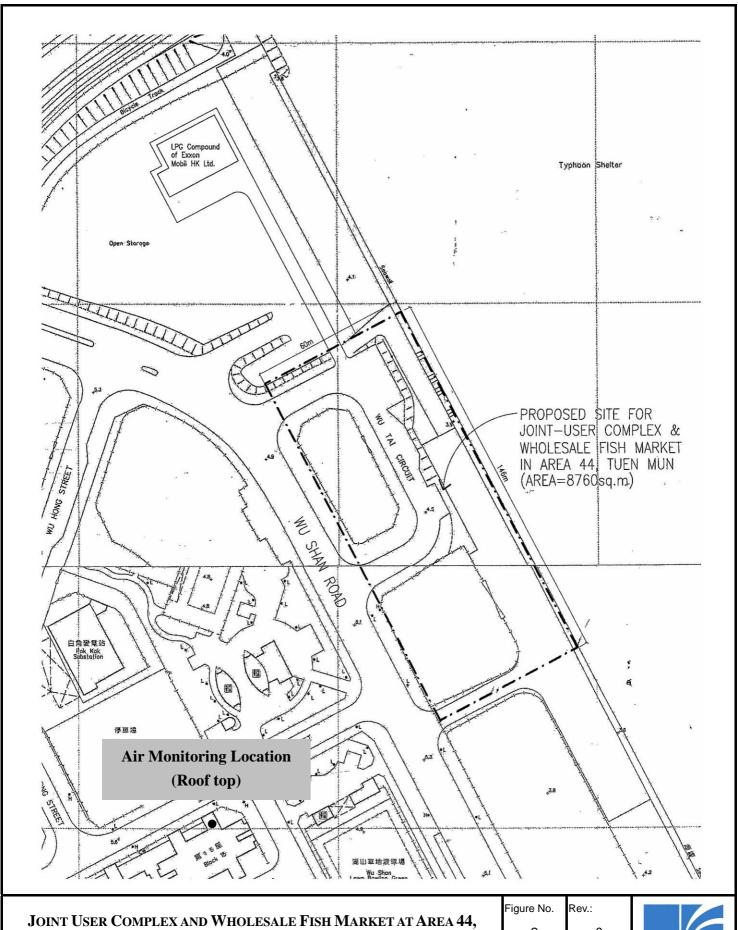
2 0

LOCATION OF AIR QUALITY MONITORING STATION

Air quality monitoring and noise monitoring were conducted at Block 15, Yuet Wu Villa. Air quality monitoring station was set up at the roof top of the residential block and noise monitoring was conducted at 1.2m above ground level at the junction of Wu Sau Street and Wu On Street as given in Figure 2 and 3. Figure 4 and 5 show photos taken during monitoring at the two locations.

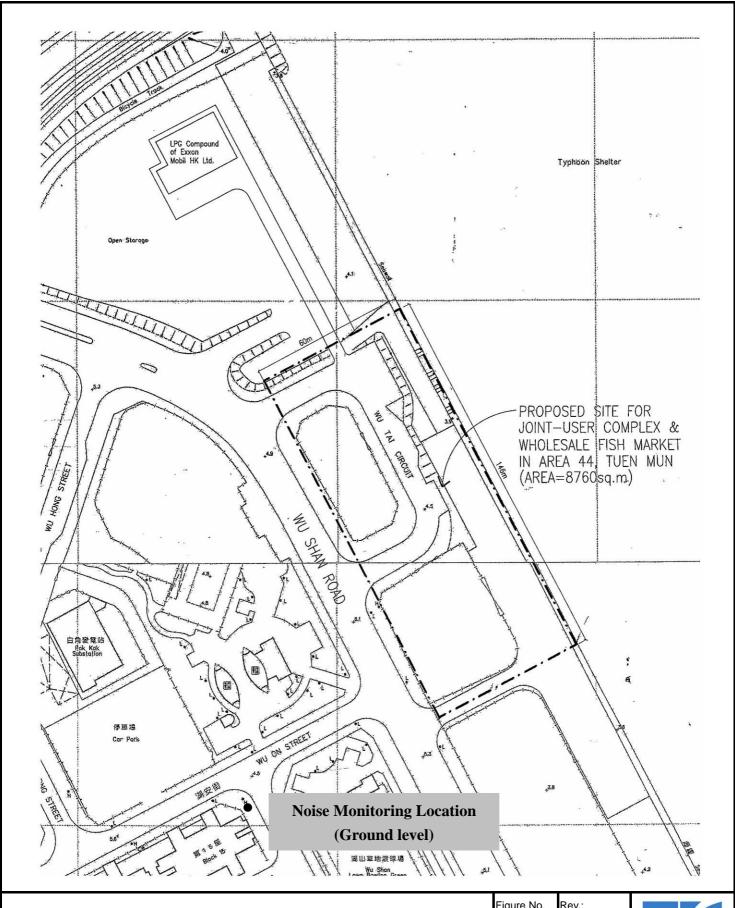
Figure No.	Rev.:
3	0
Scale	Date
NTS	02/09

LOCATION OF NOISE MONITORING STATION

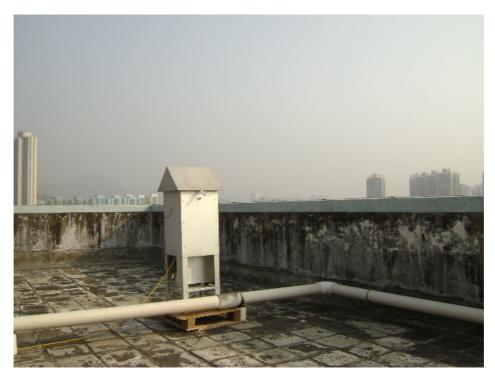
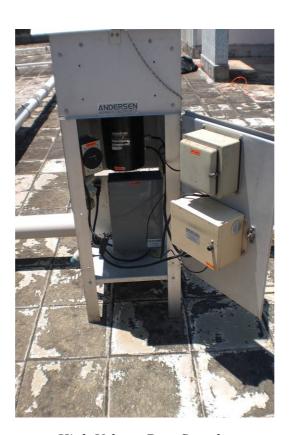
Figure No.	Rev.:	
4	0	
Scale	Date	
NTS	02/09

Roof top of Block 15, Yuet Wu Villa

High-Volume Dust Sampler

PHOTOS OF AIR QUALITY MONITORING STATION

1-hour and 24-hour TSP air quality monitoring was conducted at the designated air quality monitoring location using a High Volume TSP Sampler (Model No: Anderson GMWS-2310 ACCU-VOL) at the designated location. The Calibration Record of the High-Volume TSP Sampler is given in Appendix A. 24-hour TSP samples were taken every six days. 1-hour TSP samples were taken three times a day between 0700-1900 hours.

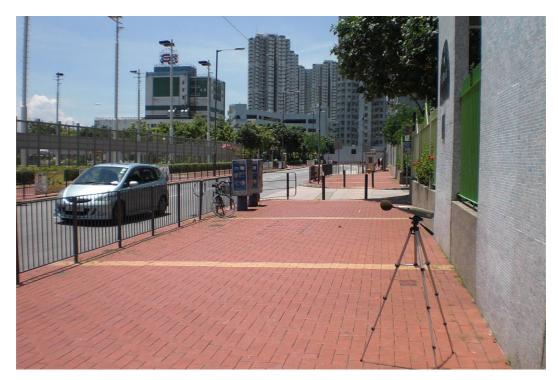
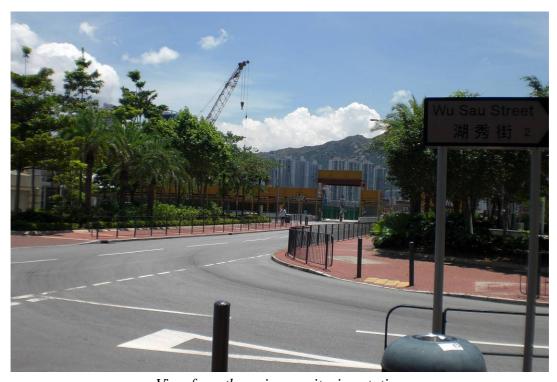
Figure No.	Rev.:	
5	0	
Scale	Date	
NTS	02/09

Noise monitoring station

View from the noise monitoring station

PHOTOS OF NOISE MONITORING STATION

Noise levels measurements were recorded in terms of thirty minutes A-weighted equivalent continuous sound pressure level (Leq(30min)) on a weekly basis. The sound level meter was calibrated immediately prior to and following each noise measurement. The meter was mounted on a tripod at a height of 1.2m and the microphone was positioned at 1m away the building façade of the noise monitoring station facing the construction site.

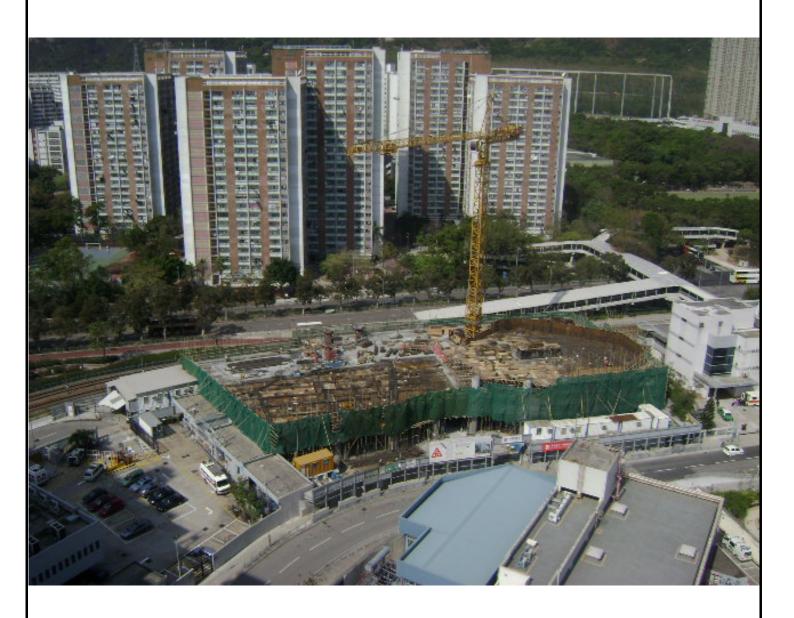
Figure No.	Rev.:
6	0
Scale	Date
NTS	02/09

PHOTO OF CONSTRUCTION SITE FOR JUNIOR POLICE OFFICERS'

MARRIED QUARTERS

A construction site for the proposed Junior Police Officers' Married Quarters is located at Wu Hong Street which is 110m northwest from the monitoring location, which is also a potential major source of the TSP generation. Figure 6 shows the photos of the construction site.

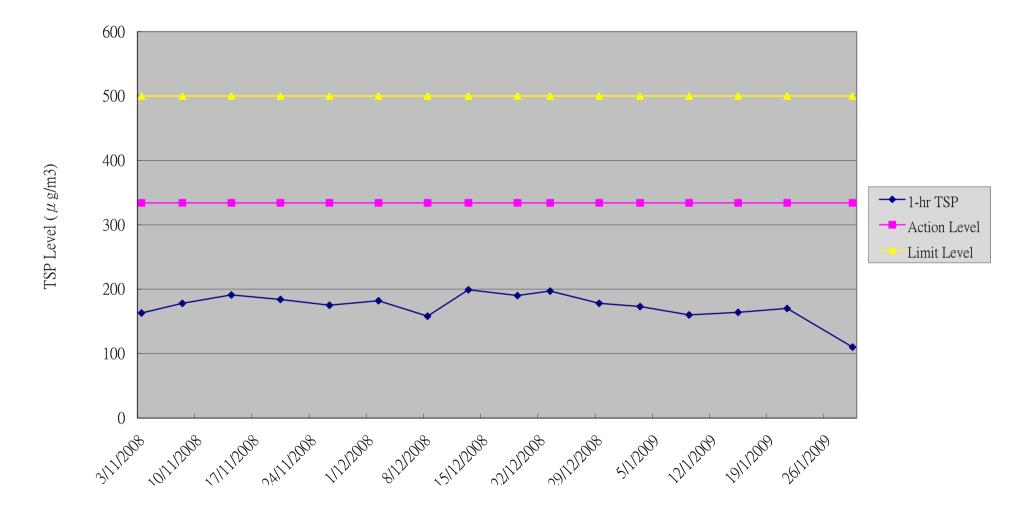
Summary and Graphical Plot of 1-Hour TSP Monitoring Record

# Impact Monitoring for Fish Market Project in Tuen Mun Air Quality Monitoring: 1-hour TSP

No exceedance was recorded in this quarter. Summary and graphical plots of air quality monitoring record of 1-hour TSP levels and 24-hour TSP levels are provided in Appendices C and D.

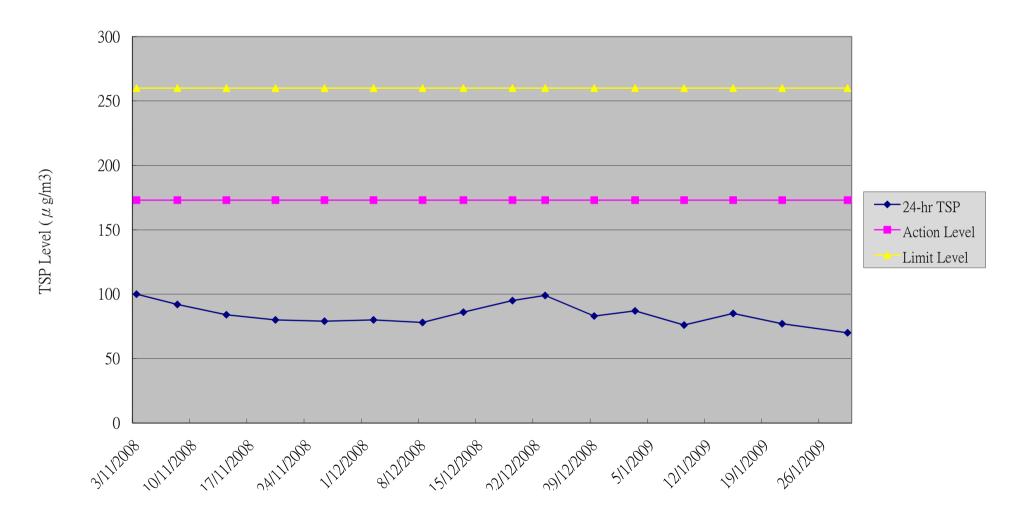
Summary and Graphical Plot of 24-Hour TSP Monitoring Record

# Impact Monitoring for Fish Market Project in Tuen Mun Air Quality Monitoring: 24-hour TSP

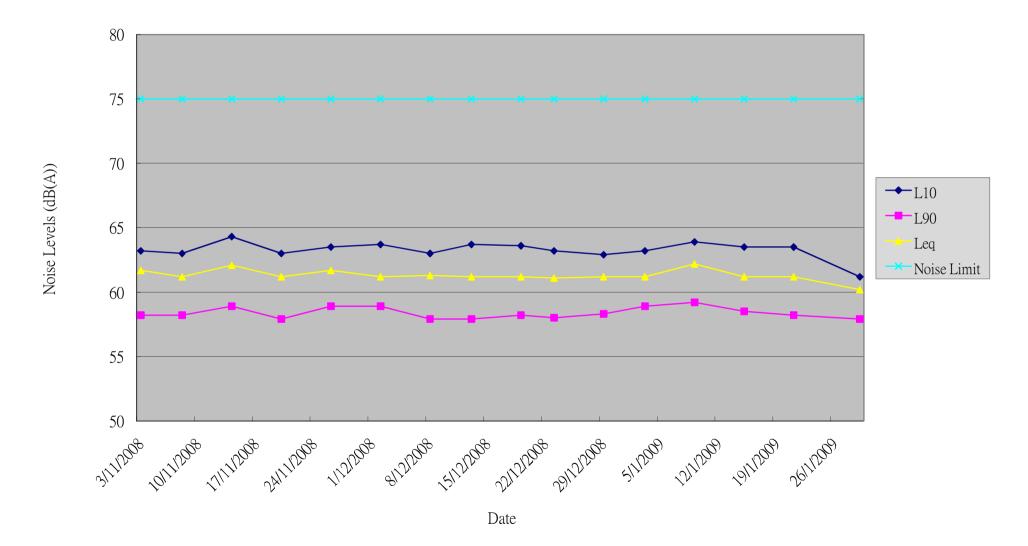
Summary and Graphical Plot of Noise Monitoring Record

### Impact Monitoring for Fish Market Project in Tuen Mun Noise Monitoring

No exceedance was recorded in this quarter. Summary of noise monitoring record is provided in Appendix E.
